Federal Railroad
Administration

Validating Electromagnetic Walking Stick Rail Surface Crack Measuring Systems

6. AUTHOR(S) and FRA COTR Eric Magel				
7. PERFORMING ORGANIZATION NAME(S) AND ADDRESS(ES) National Research Council, Canada 2320 Lester Road, Ottawa, Canada K1V 1S2			8. PERFORMING ORGANIZATION REPORT NUMBER AST-R-LR-0102

9. SPONSORING/MONITORING AGENCY NAME(S) AND ADDRESS(ES) U.S. Department of Transportation Federal Railroad Administration Office of Research, Development, and Technology Washington, DC 20590			10. SPONSORING/MONITORING AGENCY REPORT NUMBER DOT/FRA/ORD-16/23

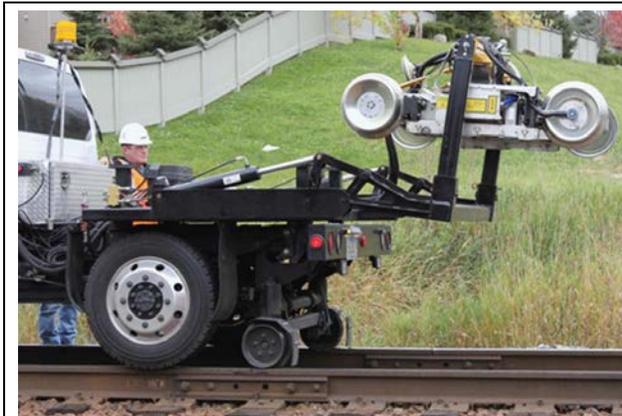
The MRX hy-rail RSCM unit

In North America, Loram Maintenance of Way, Inc. has acquired a system from MRX Technologies in Australia that uses the level of magnetic flux leakage to estimate the crack depth directly. Rohmann GmbH (based in Germany) has over the last several years continued to improve the capabilities of its eddy-current-based Draisine unit and has begun using it on select test locations in North America. Finally, Sperry Rail Services has introduced an eddy current based system, which is included in its multi-technology platform for complete rail inspection. Hy-rail based systems have arrived in North America and are now being tested in the field.

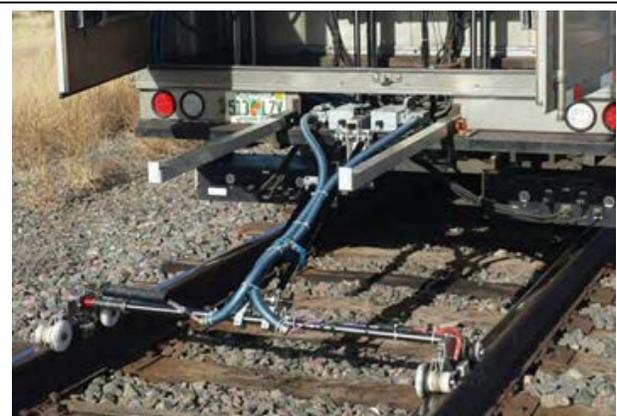
Rohmann's hy-rail eddy current unit can have as many as 6 probes per rail. Operating speeds are up to 40 mph.

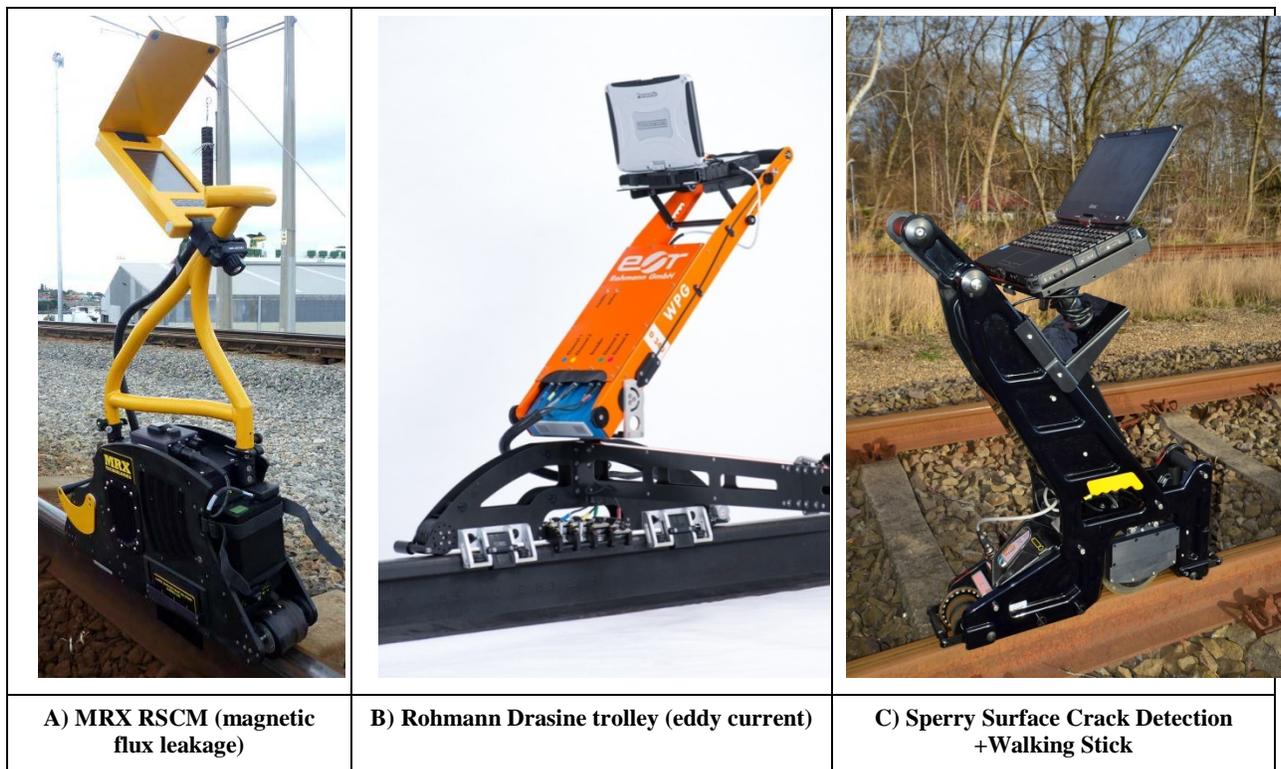
Figure 16: The three electromagnetic based systems evaluated through this program.

All units record data for later playback and include software for analysis. Although these systems can in principle detect subsurface cracks, they are optimized for surface breaking cracks. Furthermore, all of the systems measure along the trajectory of the walking stick and do not see cracks that have a strong longitudinal orientation. A comparison of several of these systems is shown in Table 4.

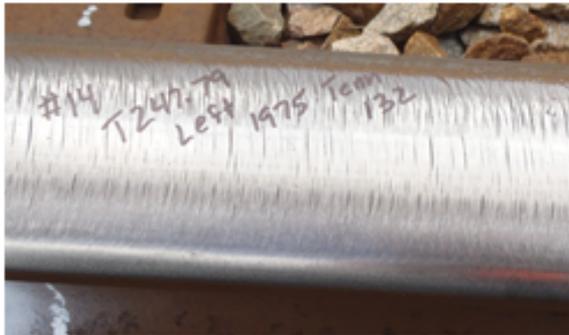
CSX Blue Ridge Subdivision Sample #14

Measured crack depth
MRX: 4.8
Rohmann: 2.0-5.0

MP C259.05 High
Rail Manufacturer: Tennessee
Rail Year: 1967
Rail Type: E rail
Rail Weight: 132

Figure 23: CSX Rail sample #14. Milled through the rail crown in 0.4 mm increments.

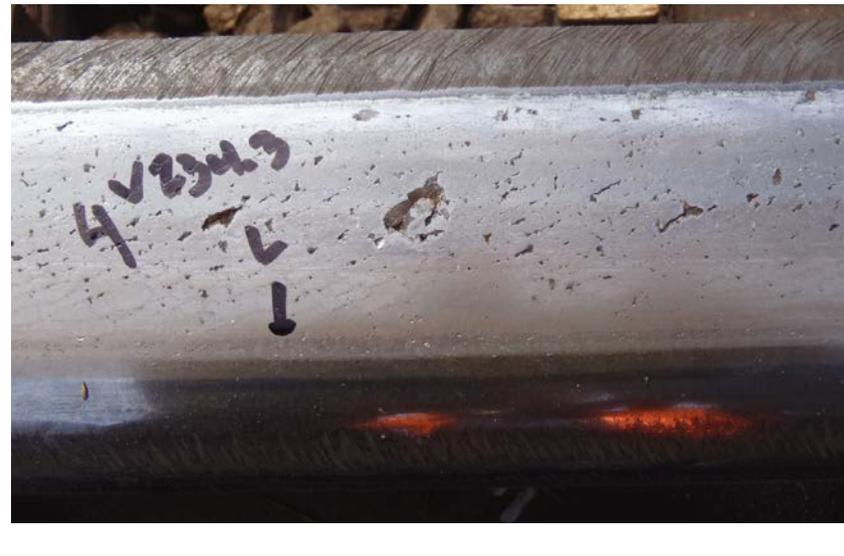
Surface condition

Cross section

Crack measurement

Figure 28: NS Labs analysis of Sample 4

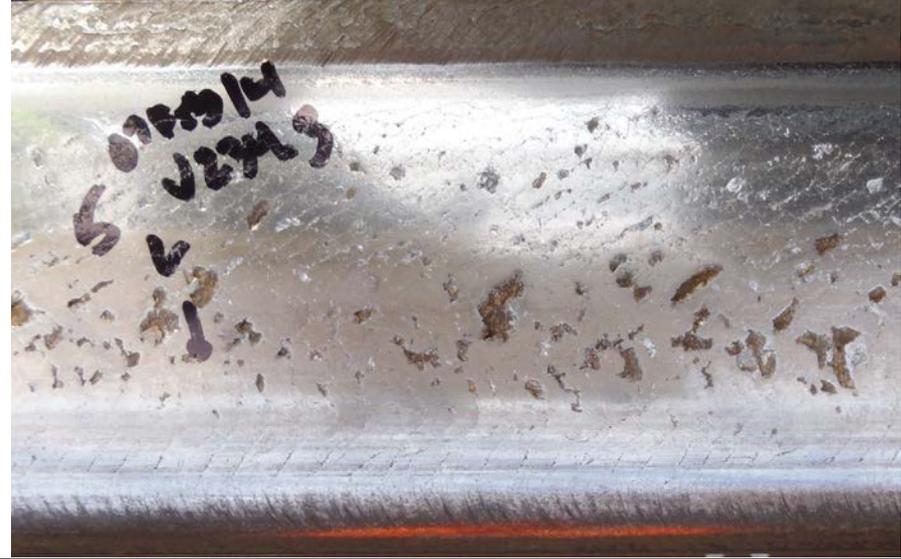
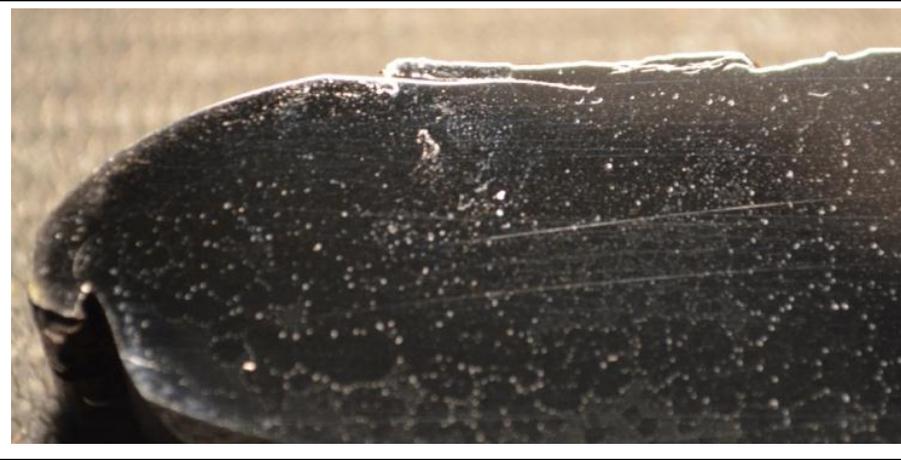
Surface condition

Cross section

Crack measurement

Figure 29: NS Labs analysis of Sample 5

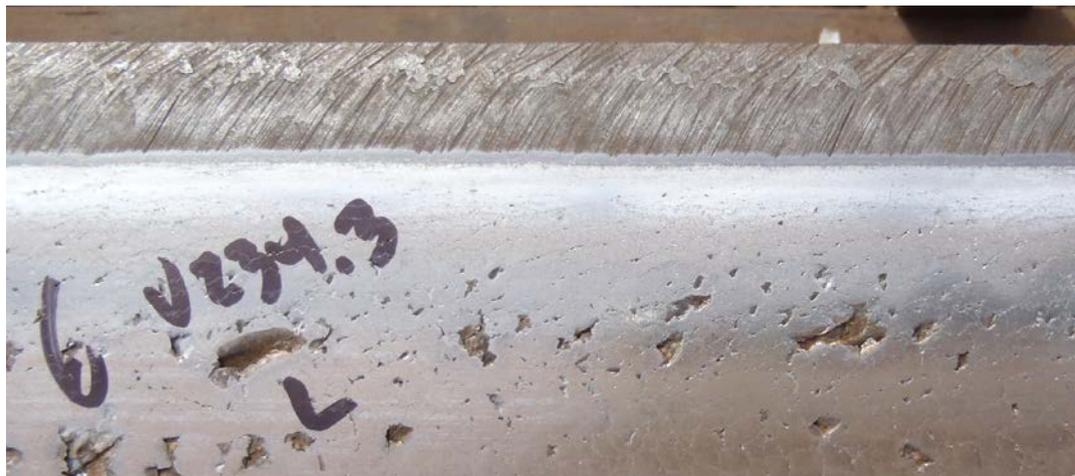
Surface condition

Longitudinal section

Crack measurement
