5.4. STATE-DEPENDENT INSPECTION RESULTS

5.4.1. State-Dependent Task Descriptions

5.4.2.1. TASK I INFORMATION RECORDED BY OBSERVERS

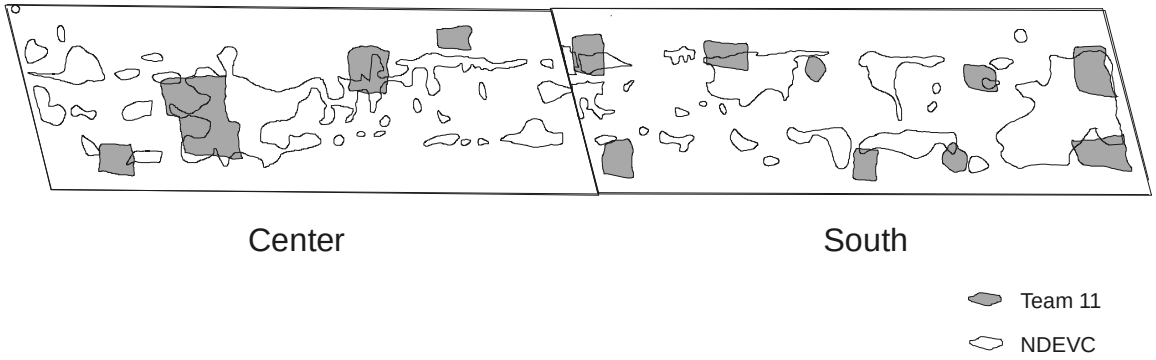
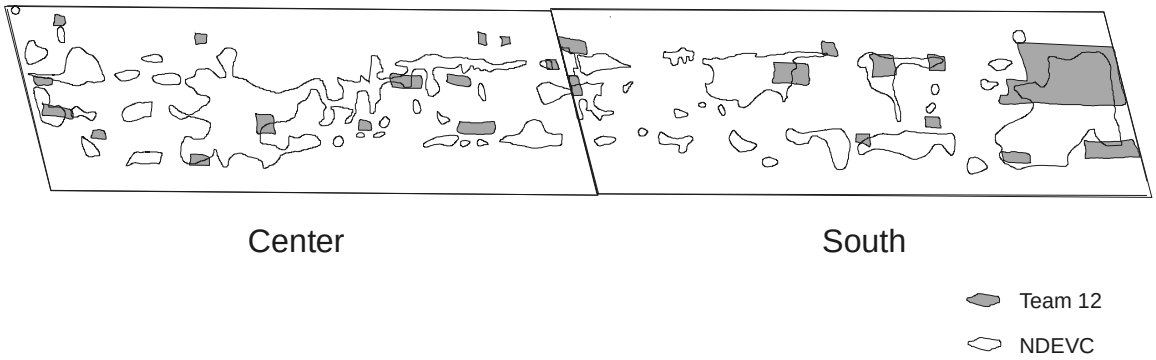
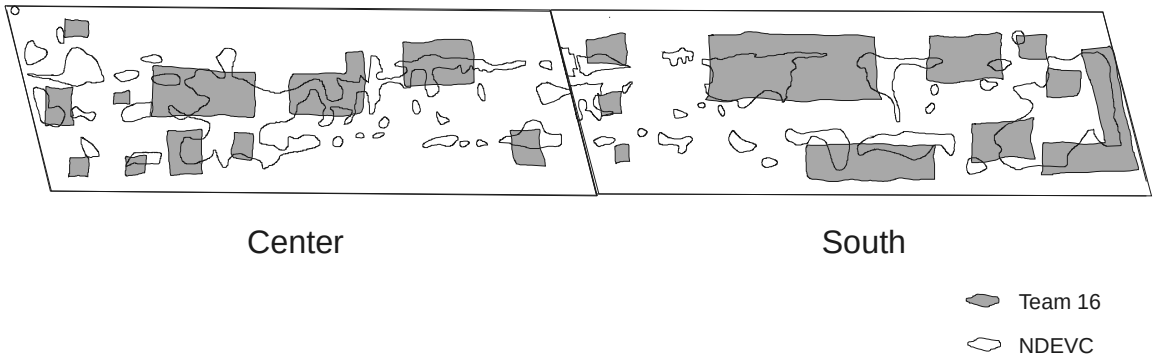
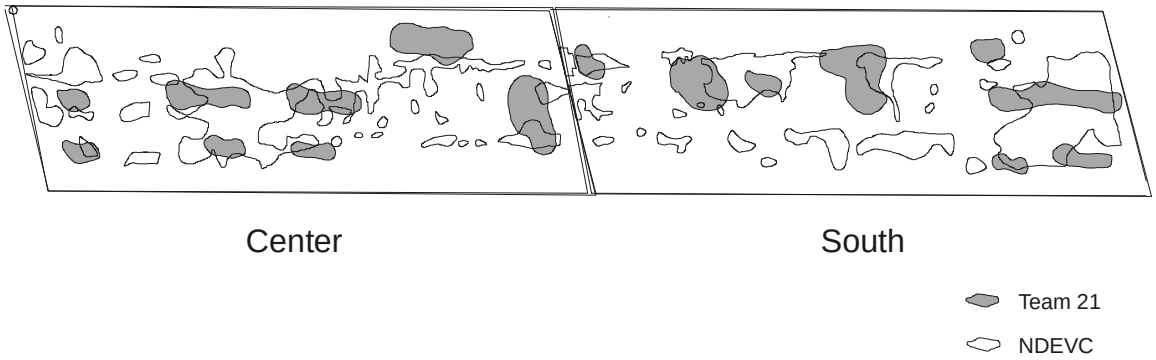
Figures 192 through 211 show overlays of the team sketches superimposed upon the delamination outlines determined by the NDEVC. These figures are identified using the same team identifiers used in table 235. Recall that Teams 5 and 6 did not submit delamination maps; therefore, data from these teams are not included in figures 192 through 211. These overlays were created assuming that the maps submitted by the teams were drawn to scale. For most of the sketches, this assumption is justifiable. However, a few of the maps were drawn to an inconsistent scale, with 0.6-m by 0.6-m dimensioned areas drawn about the same size as 1.8-m by 1.8-m dimensioned areas. Attempts were made to regenerate some of these maps using the position and size information provided, but these “corrected” maps had enough other errors in positioning and sizing that they were not considered to have improved on the original sketch that was submitted. Therefore, all areas are shown without modification. In two cases, automobiles were parked on the deck, preventing complete inspection of the deck. These areas have been noted.

RECTANGULAR OUTLINES VERSUS ACTUAL OUTLINES: Looking at the delamination maps presented in figures 192 through 211, it appears that two different philosophies were used to develop these sketches. One philosophy uses rectangular areas to mark the delaminations. The other philosophy uses areas that are either generally circular or oval to mark the actual outlines of the delaminations. Table 237 summarizes the delamination percentages indicated by each of these two groups. As shown in table 237, the teams that mainly seemed to indicate actual areas had a much smaller average delamination percentage than those who indicated rectangular areas. The indication from this table is that inspector accuracy of delamination percentage estimates may actually be poorer than previously reported. Although the average delamination estimates of the teams that indicated rectangular areas are much closer to the

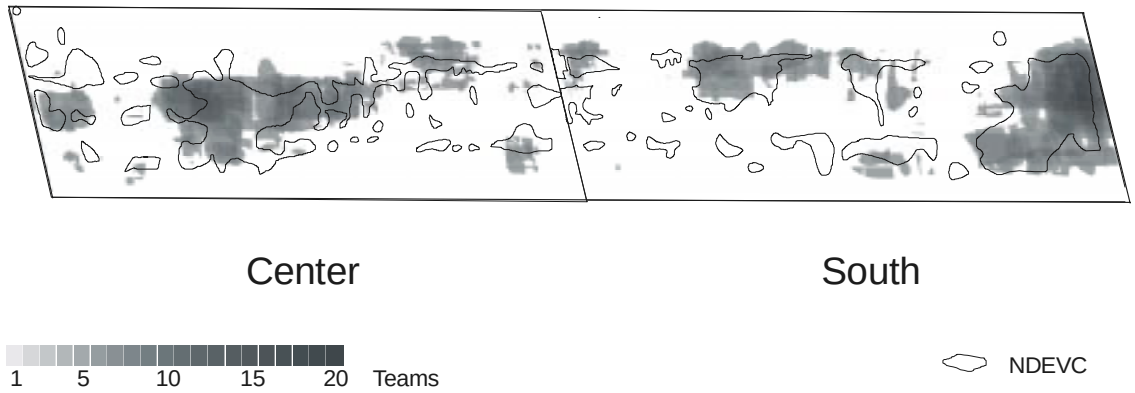
Figure 216. Areas indicated as containing delaminations by five or more teams, together with the results of the NDEVC survey.

Two other commonality levels were studied graphically. First, since the delamination maps submitted by the teams were approximate, the areas indicated as being delaminated by at least three teams were investigated. This investigation may reduce some of the errors within the maps by eliminating unique delamination calls and the first intersection level, both of which may be mislocated due to positioning errors in recording the data. As shown in figure 215, the total area with at least three delamination calls covers 40 percent of the deck area. Second, it was calculated that the amount of the deck area covered by at least five delamination calls was 21 percent. This level is closest to the 19 percent indicated by the NDEVC survey. Figure 216 compares the delamination map showing at least five delamination calls with the survey performed by the NDEVC.

The coring program that was mentioned previously also investigated some of the differences between team delamination calls and the NDEVC survey. Specifically, four of these disputed areas were cored; half of which were considered to be delaminated by the NDEVC. In addition, one of the disputed areas had at least five delamination calls by teams, although the NDEVC did not detect any signs of delamination. The results of the coring program determined that all four of the disputed areas were properly called by the NDEVC.
