LTPP Pavement Maintenance Materials: SPS-4 Supplemental Joint Seal Experiment, Final Report

PUBLICATION NO. FHWA-RD-99-151

OCTOBER 1999

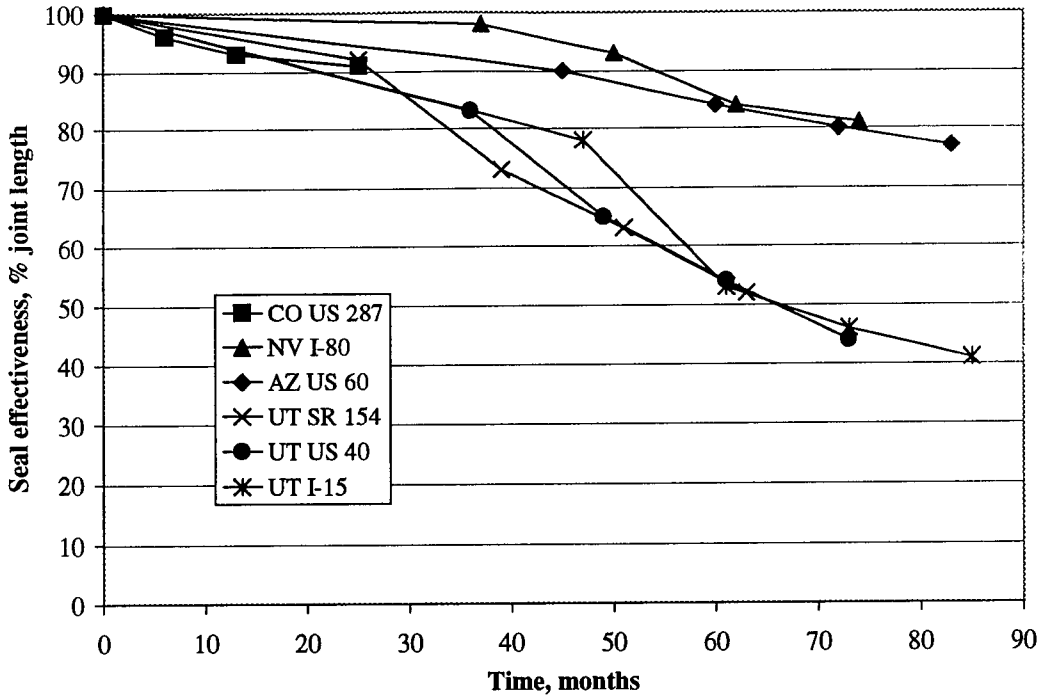
Figure 23. Overall performance of primary transverse joint seals at each test site.

As seen in figure 23, a comparison by test site of the overall performance of the transverse joint seals gives an indication of the rate of joint seal deterioration at each site. Though these performance trends are based on the individual performance trends of different groups of joint seal treatments, the greatest deterioration rates have been at the three Utah sites, whereas the lowest deterioration rates have been at the Mesa and Wells sites.

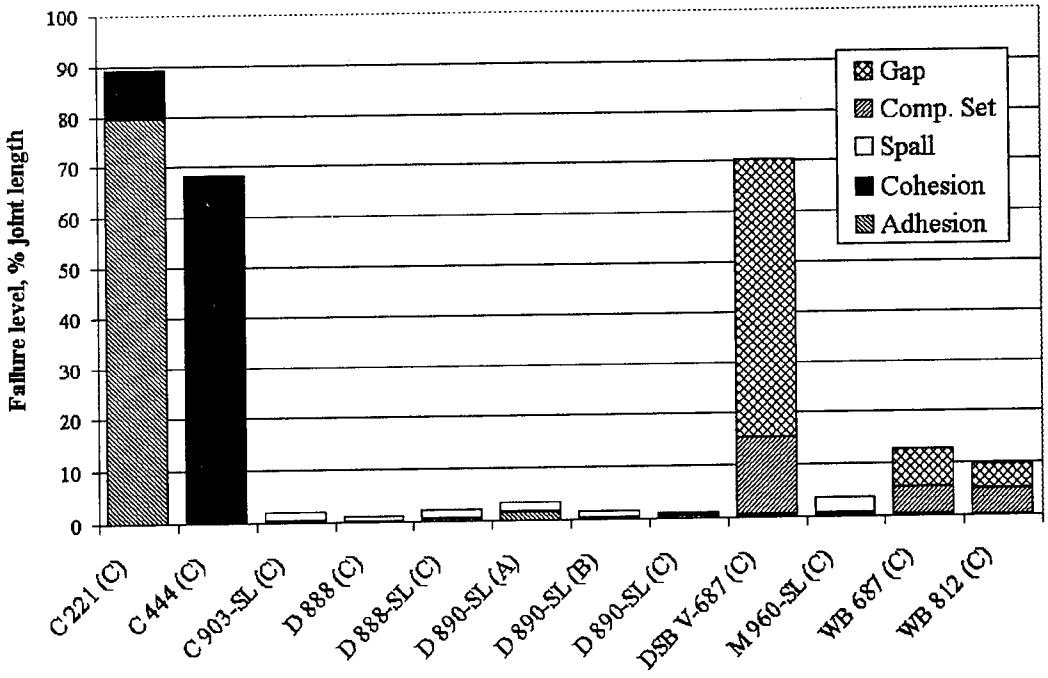
Figure 24. Overall failure of transverse joint seals at Mesa, Arizona test site.

Figures 24 through 29 show, by test site, the overall percentage of failure that each treatment exhibited at the time of the 1997-1998 field inspections. These figures also show the types and percentages of individual failure modes contributing to the overall failure percentage. As can be seen, the predominant modes of failure varied by sealant type and by test site. Generally speaking, the main mechanism of failure in hot-applied seals (e.g., Crafco RS 221, Koch 9012) was adhesive failure, as illustrated in figure 30. Cohesive failure, which can also be seen in figure 30, was significant in some of the seals.

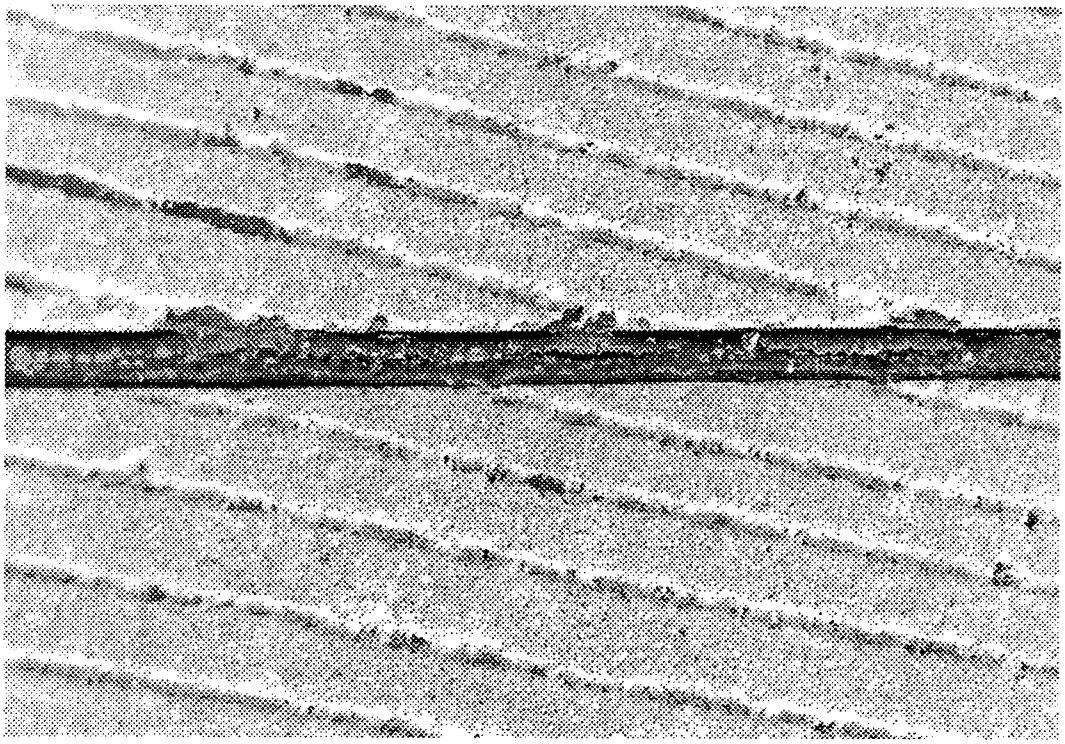
Figure 30. Adhesion and cohesion failure in hot-applied rubberized asphalt seal.

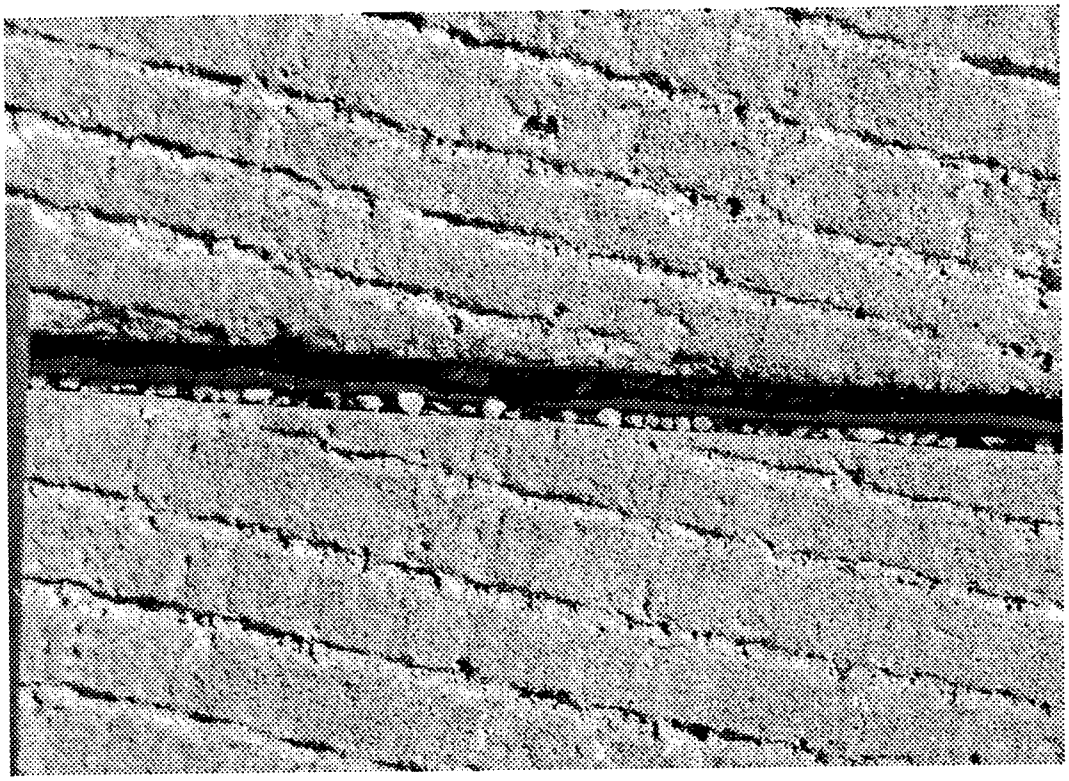
Figure 32. Gap failure in preformed neoprene compression seal.

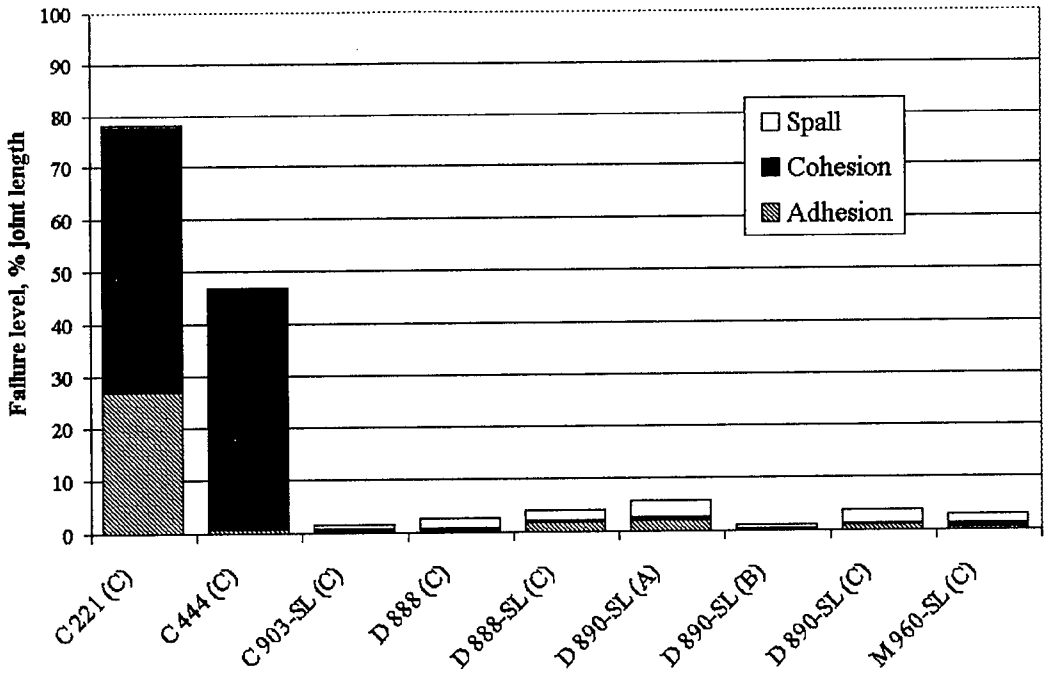
Figure 33. Overall failure of longitudinal joint seals placed at Mesa, Arizona test site.

ASTM D 3406 hot-applied PVC-coal tar sealants were placed in the Mesa and three Utah test sites, using either Crafco SS 444 or Koch 9012. The average effectiveness of these materials placed in transverse and longitudinal joints was 32 and 53 percent, respectively. Full-depth adhesion loss was the predominant failure mode, as it comprised 55 percent of the overall failure in transverse seals. Cohesion failure was also a significant contributor, particularly at the Mesa site, where possible overheating of the sealant prior to installation may have altered the properties of the Crafco SS 444 in one of the replicates.

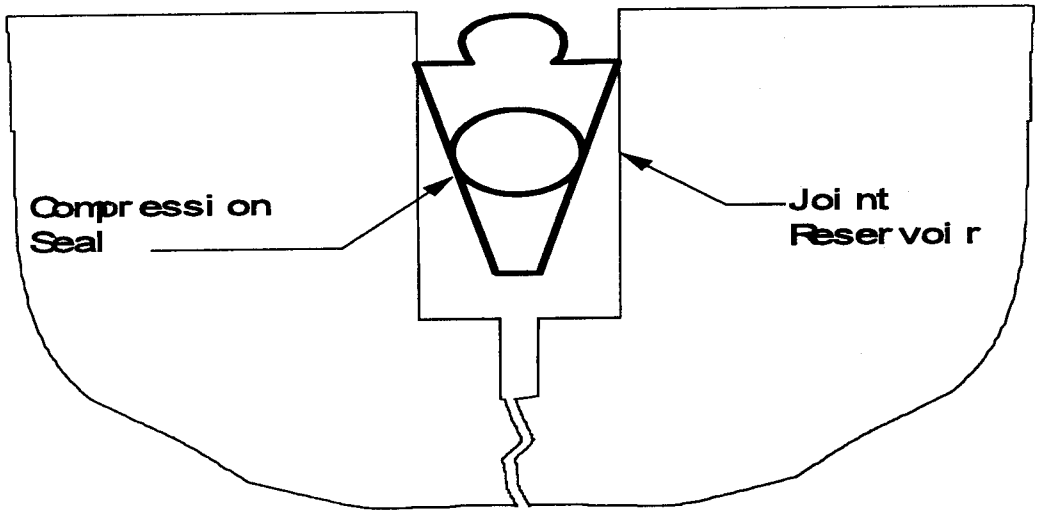
The one-celled Kold Seal Neo Loop seal (figure 35), installed at Tremonton, performed very poorly, with only 1 percent of its length still effective after the 1997-1998 field inspections. The primary mode of failure in this product was gap failure, which is believed to be partly the result of the seal's design and the roadway conditions. The seal has a bulb at its surface that projects

Figure 35. Kold Seal Neo Loop compression seal design.

above the top of the main seal flanges. Small stones and sand wedged between the bulb and the joint edges when the joints were at their widest opening. In the summer, the joints closed to a smaller width, but the stones between the bulb and the joint walls remained in place. Because the bottom of the seal was allowed to compress inward toward the center of the joint, a gap developed between the seal flanges and the joint edge. In some cases, the width of the gap was nearly 3 mm, thus allowing the infiltration of water and debris into the joint.

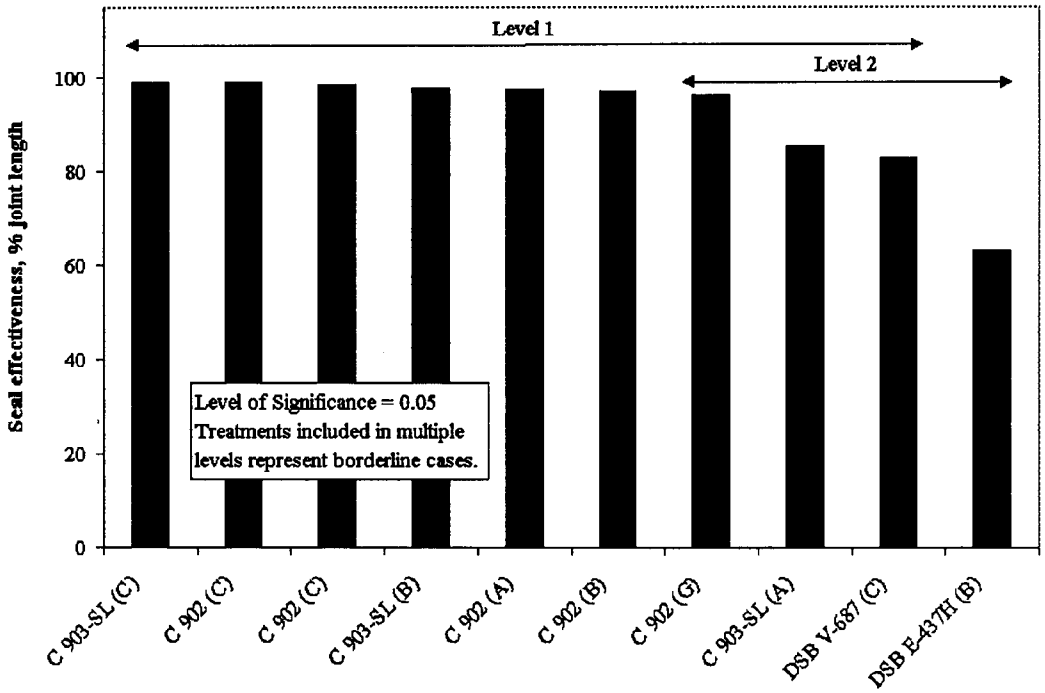
Figure 37. Overall effectiveness groupings for Campo, Colorado transverse joint seal treatments.

- Compression seals are performing statistically poorer than silicone seals after a period of 24 months, primarily because of improper installation techniques. As mentioned in chapter 2, the compression seal installation machine did not function well during the installation process, so the two compression seals were installed by hand using putty knives. The result was considerable failure in the form of twisted seal and compression set.

- In general, insufficient failure has occurred in the silicone treatments in order to find any statistical differences at this time. However, marginally poorer performance has been identified in the Crafco 902 seals placed in 9-mm-wide beveled joints and the Crafco 903-SL seals placed in 6-mm-wide joints. The former treatment was placed too thin in several joints (mean shape factor of 0.32 in one section), resulting in some cohesive failure. The latter treatment was placed too high in many locations, which exposed the seal to contact with traffic and has resulted in considerable adhesion failure.

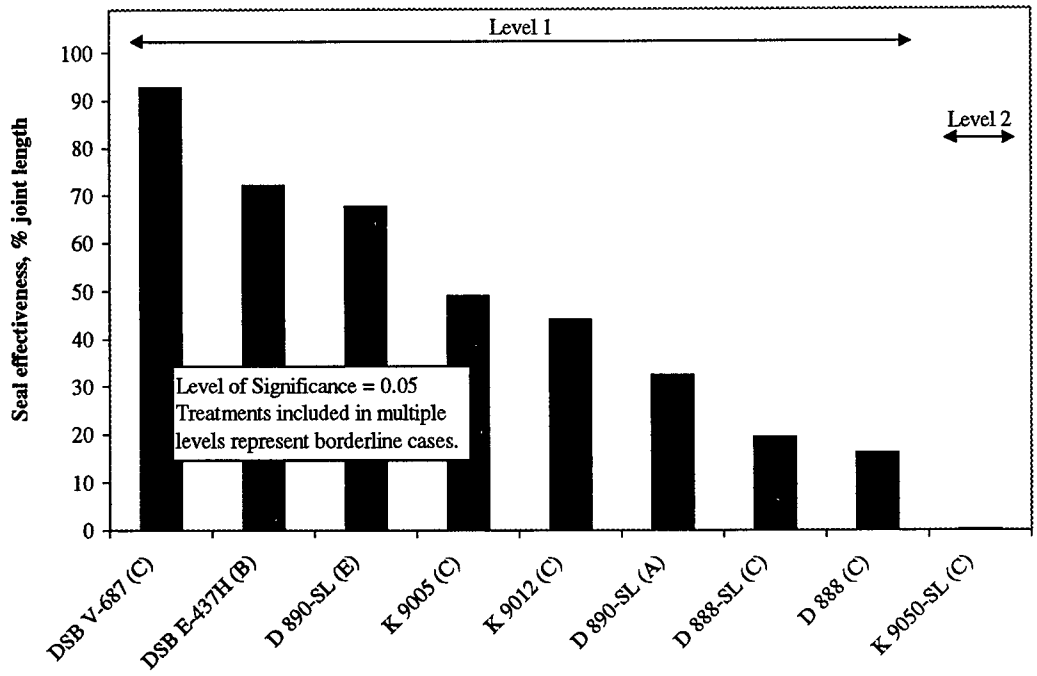
Figure 41. Overall effectiveness groupings for Heber City, Utah transverse joint seal treatments.

- Tukey groupings indicate that all treatments, except Koch 9050-SL polysulfide, are statistically performing the same at this site. However, as seen in figure 41, there is a wide range in the effectiveness levels of the various treatments. It is believed that the variability in performance between replicate sections is the reason for no overall statistical differences among eight of the nine treatments. Recall from table 3 (chapter 2) that the joints in the eastbound lane test sections received much higher waterblasting and airblasting pressures than the joints in the westbound lane test sections. Other factors in the performance of some of these sealants are as follows:

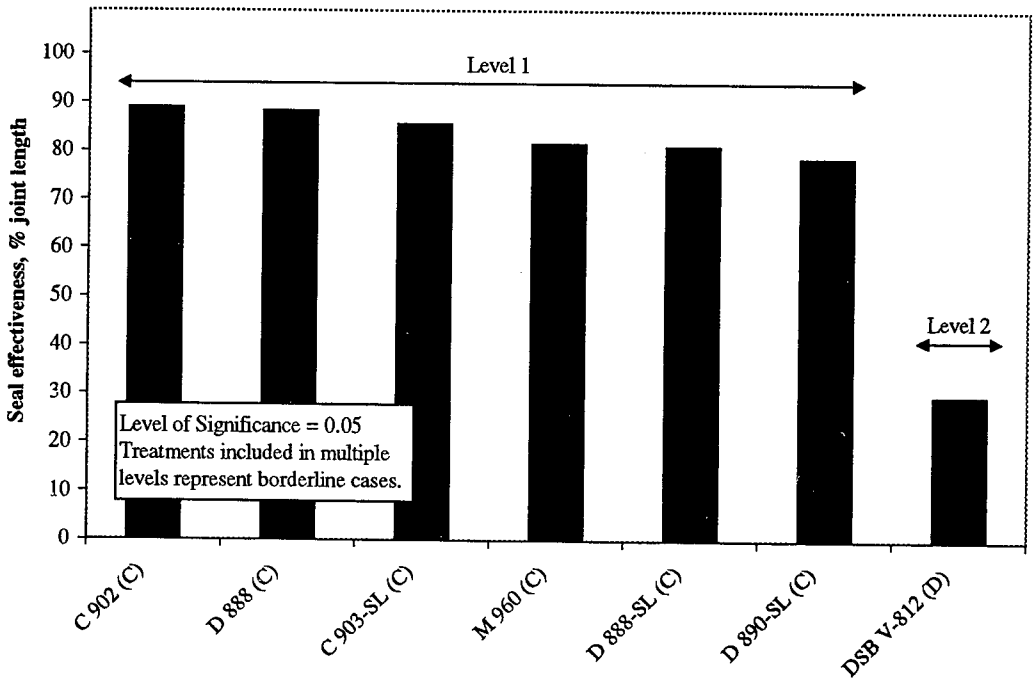
Figure 42. Overall effectiveness groupings for Mesa, Arizona longitudinal joint seal treatments.

The results of the Tukey comparisons of current (1997-1998) longitudinal joint seal effectiveness are illustrated in figures 42 and 43. Noteworthy observations regarding the performance groupings of these seals at the Mesa and Wells sites are given below.

- Generally speaking, the performance patterns of the longitudinal joint seals at Mesa mirror those of the transverse joint seals. No statistical differences in current performance were found, even though two hot-applied joint seal treatments (Crafco SS 444 and Crafco RS 221) showed substantial levels of failure. As with the transverse joint seals, extended heating and overheating of the Crafco SS 444 sealant (in one replicate) are likely to have attributed to this material's current poor performance.

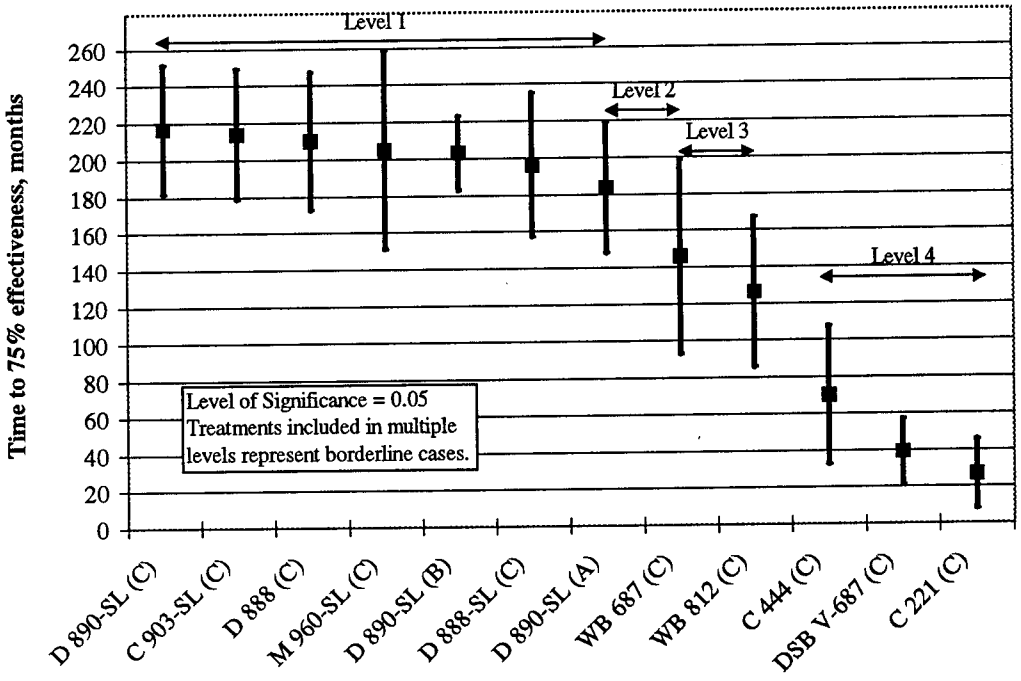
Figure 46. Tukey analysis of estimated transverse joint seal service lives at Mesa, Arizona test site.

In general, the Tukey service life groupings reinforce the observations made previously regarding current performance groupings. For instance, at Mesa, the standard silicone seal treatment and five of the six self-leveling silicone seal treatments showed statistically longer service lives than the compression seals and hot-applied seals. The sixth self-leveling silicone seal treatment, Dow 890-SL placed in 3-mm-wide joints, showed a statistically longer service life than the two hot-applied seals and two of the three compression seals. However, this material showed a marginally shorter service life in 3-mm-wide joints than in 6- and 9-mm-wide joints.

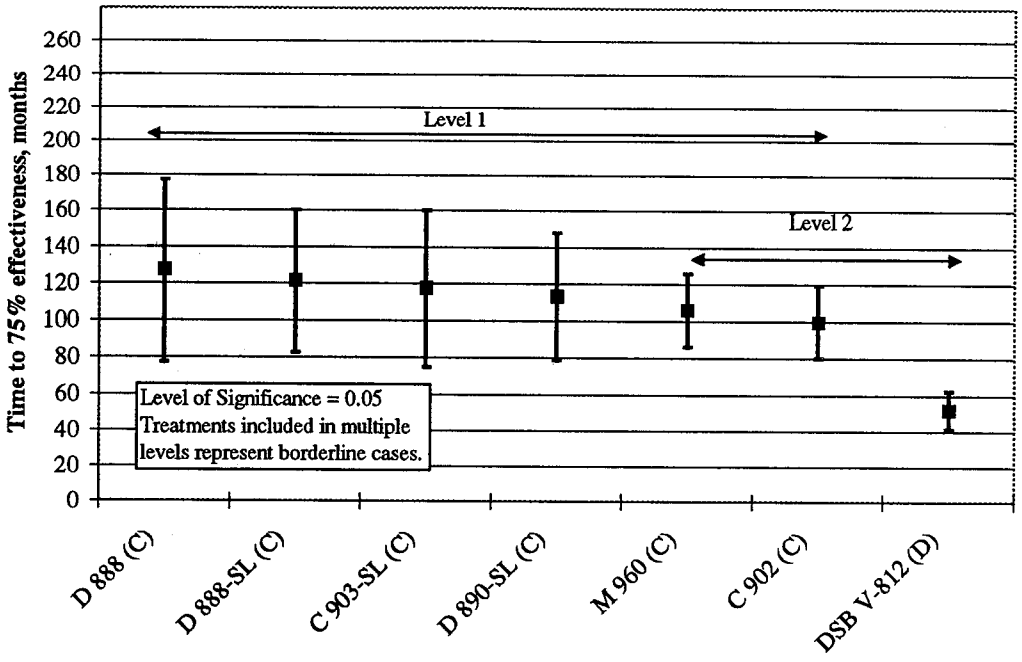
Figure 47. Tukey analysis of estimated transverse joint seal service lives at Wells, Nevada test site.

Most of the silicone seal treatments at Wells have statistically outperformed the compression seal at that site. Only the Mobay 960 and Crafco 902 seals placed in 9-mm joints showed the same statistical service life as the D.S. Brown V-812 compression seal. Due to the lack of pre-1991 performance data on the polyethylene seal, no estimates of service life could be made for this material. Though it was installed in 1980, it showed 100 percent failure in the initial field inspections of 1994-1995.

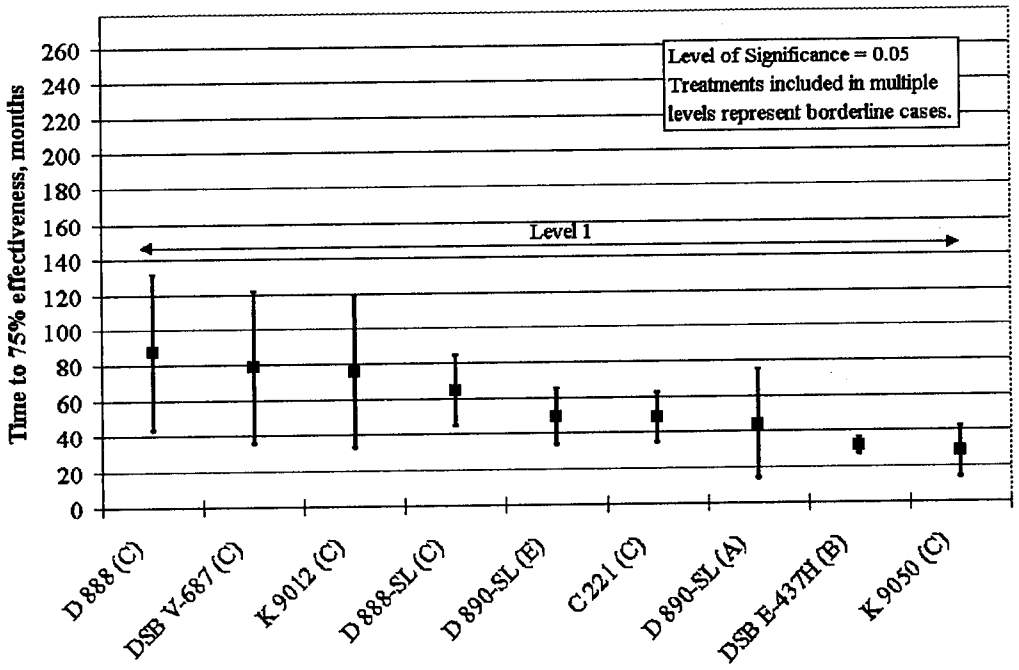
Figure 49. Tukey analysis of estimated transverse joint seal service lives at Salt Lake City, Utah test site.

As with the results of the Tukey analysis of current performance, no statistical distinctions in estimated service life were found among the treatments at the Salt Lake City site. However, it can again be pointed out that a more cost-effective sawing method than conventional sawcutting is the Soff-Cut method.

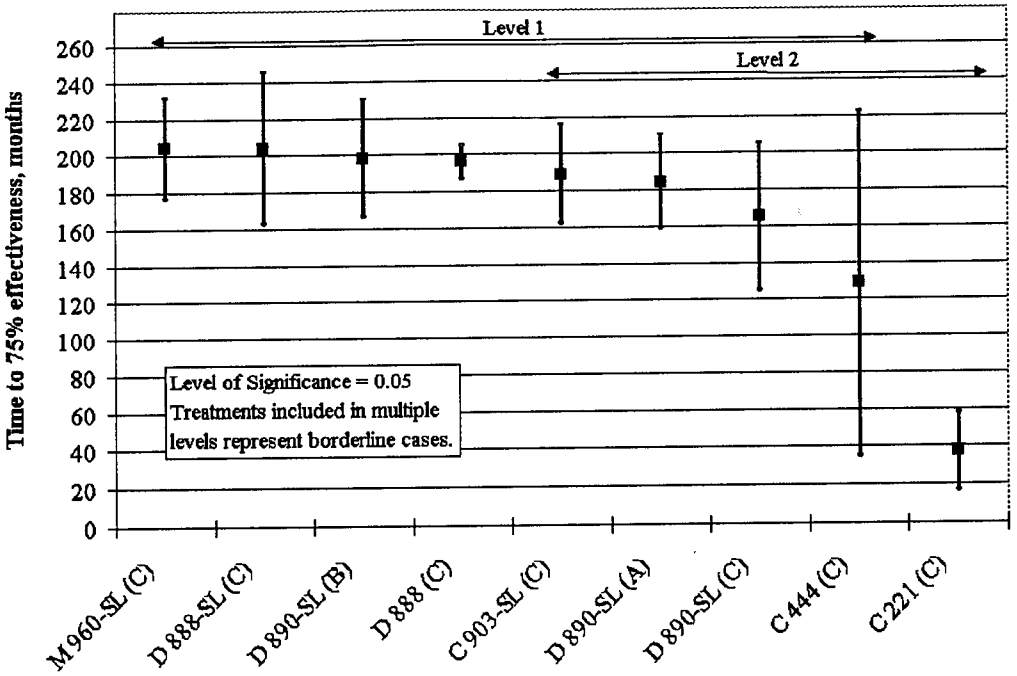
Figure 51. Tukey analysis of estimated longitudinal joint seal service lives at Mesa, Arizona test site.

The results of the Tukey analysis of estimated longitudinal joint seal service lives are illustrated in figures 51 and 52. The only statistical distinction in estimated service life at Mesa was between the Crafco RS 221 joint seal treatment (significantly lower service life) and four of the seven silicone seal treatments. Recall that no distinctions were apparent in the evaluation of current performance levels.

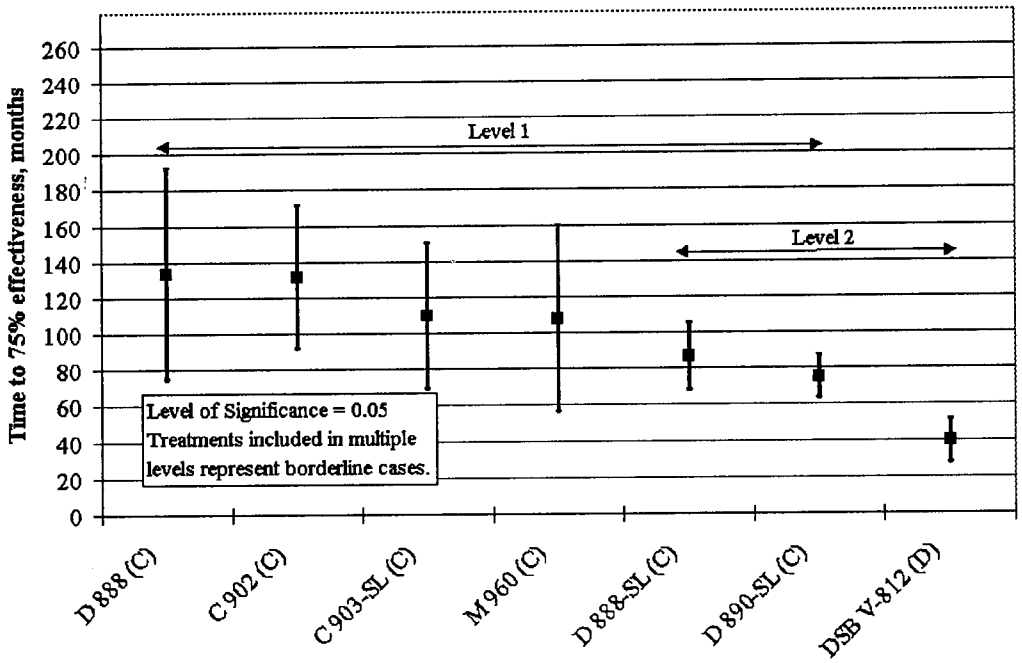
Figure 52. Tukey analysis of estimated longitudinal joint seal service lives at Wells, Nevada test site.

Among the longitudinal joint seal treatments at Wells, it was found that the D.S. Brown V-812 compression seal treatment showed a statistically shorter service life than the three standard silicone treatments installed at that site and one of the three self-leveling silicone treatments. This compression seal showed statistically poorer performance than its counterparts during the 1997-1998 field inspections.
