PREDICTING SCOUR IN WEAK ROCK OF THE OREGON COAST RANGE

Final Report

SPR 382

October 1999

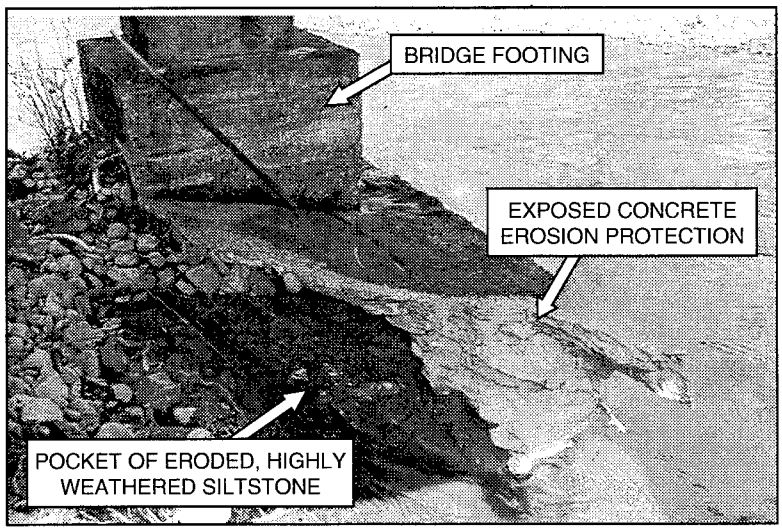
The Mill Creek - Rosenbalm Road site (Polk County bridge no. 53C068) is located off of Harmony Road approximately 1.5 km south of Highway 18 and roughly 6 km north of Highway 22 near Buell in Polk County. The bridge footings on the west side of Mill Creek were exposed with obvious signs of rock erosion and undermining as shown in Figure 3.2. The bridge at this site was replaced during the summer of 1997 by a single span structure.

Figure 3.2: Evidence of Bedrock Erosion at Mill Creek - Rosenbalm

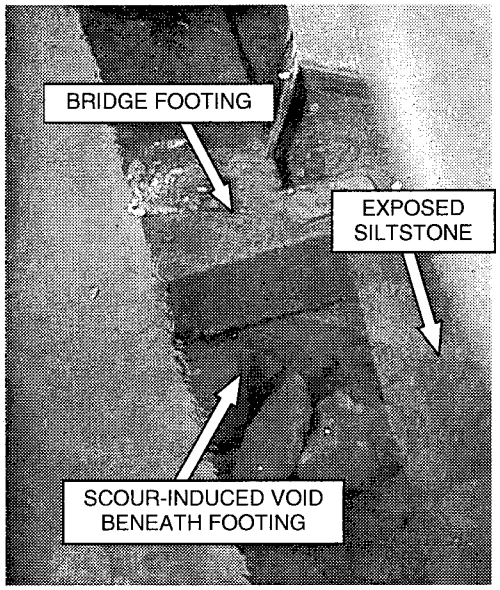
Figure 3.3: Evidence of Erosion under a Bridge Footing at Mill Creek - HWY 22
