NTIA REPORT 00-374

Lower Mississippi River Ports and Waterways Safety System (PAWSS) RF Coverage Test Results

technical report

November 1999

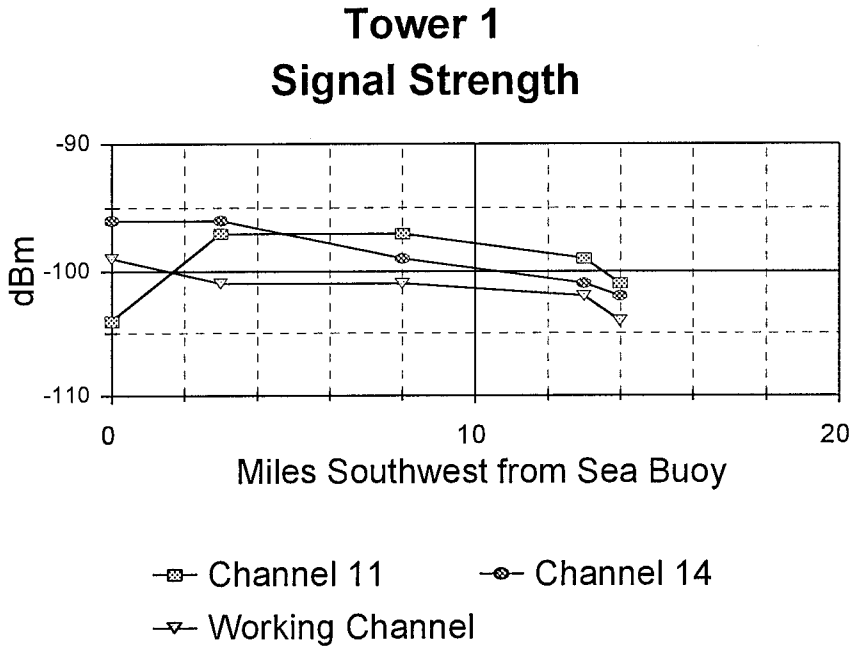
Graph 1A
Tower 1 Signal Strengths Referenced from Sea Buoy

Graph 1A shows that the signal strength of the AIS working channel fell below -100 dBm about 22 miles BHP. This indicates that there is not sufficient signal strength for the working channel from the tower located at Venice from 22 miles BHP and southwest from that location out into the Gulf of Mexico.

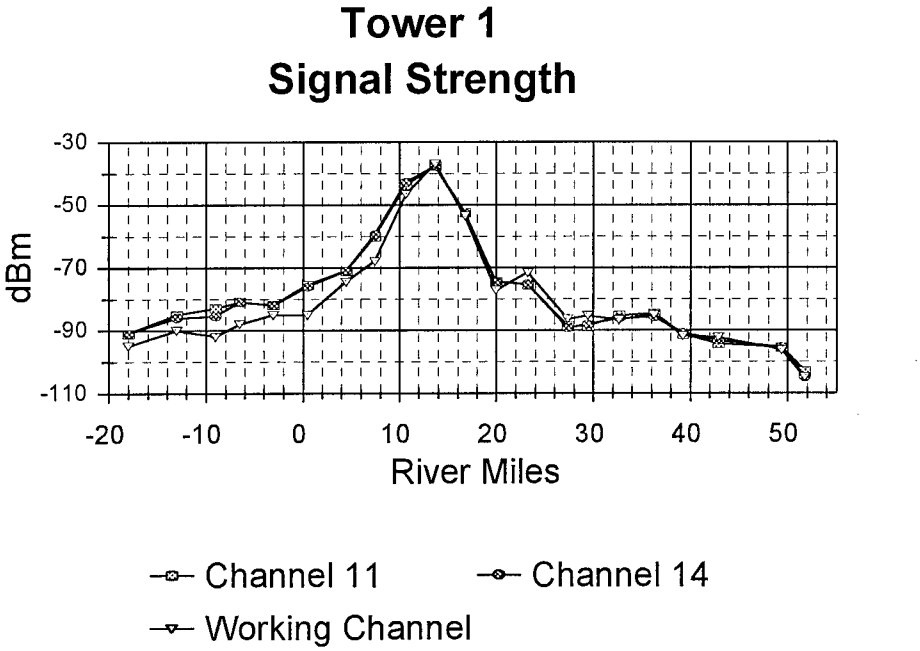
Graph 1B
Tower 1 Signal Strengths

Graph 1B shows that the maximum received power for the AIS working channel and the voice channels occurred at MM 14 AHP and was about -37 dBm. At the northern end of the zone, the power of the working channel fell below -100 dBm at MM 52 AHP.

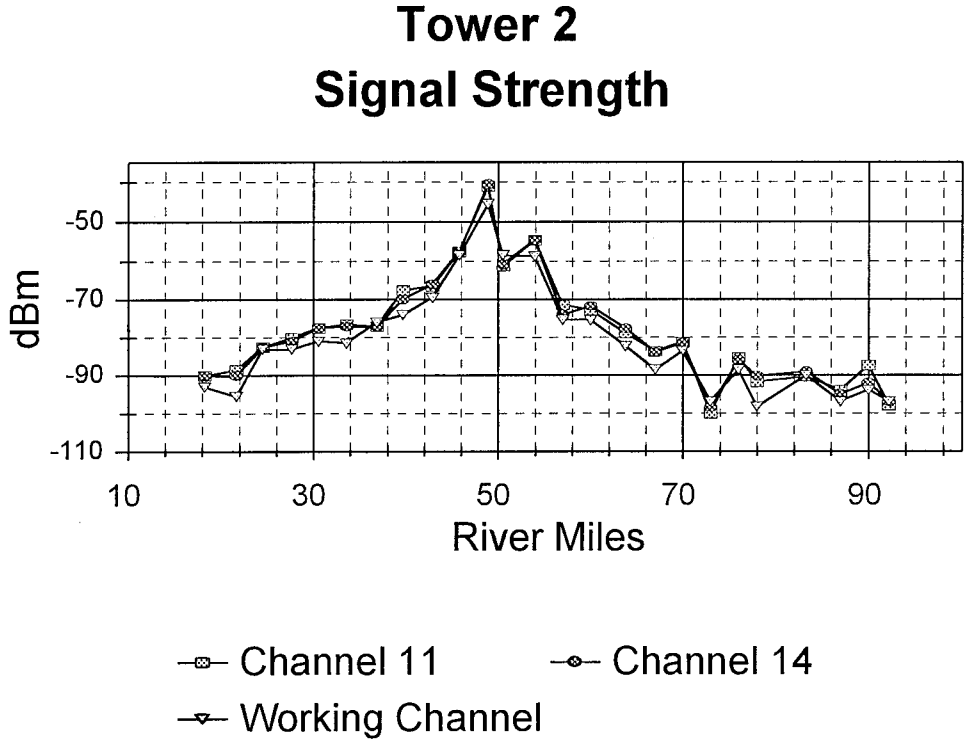
Graph 2A
Tower 2 Signal Strengths

The length of the river that encompassed the measurement locations for tower 2 was MM 17 to 92 AHP. Graph 2A shows that the peak received power for the AIS working channel and voice channels was about -40 dBm and it occurred at MM 46 AHP. The signal power of the AIS working channel did not fall below -100 dBm at the last test locations for the northern and southern measurement locations.

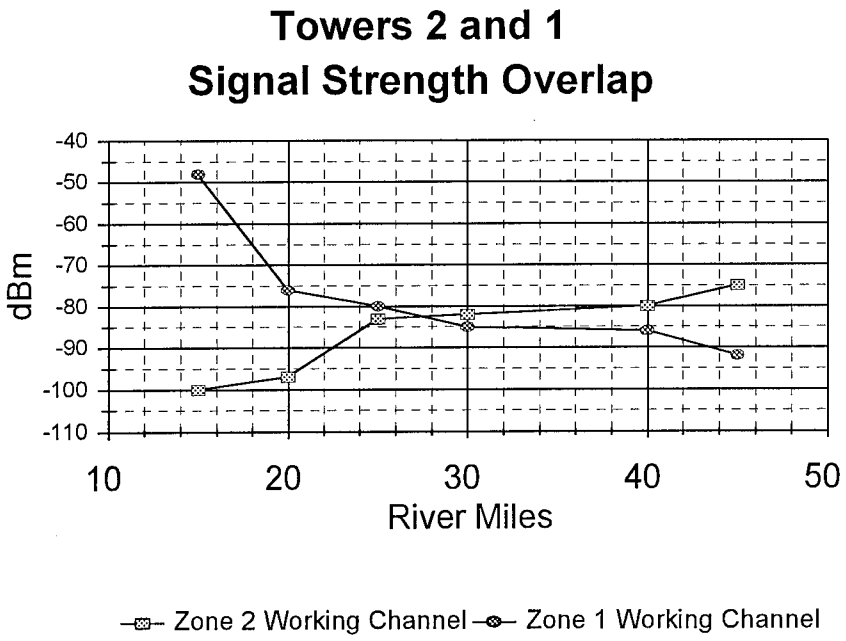
Graph 2B
Towers 2 and 1 Signal Overlap

Using -100 dBm as the reference point for overlapping signal strength between towers 1 and 2, Graph 2B shows that there should be sufficient signal strength for the AIS working channel from tower 1 located at MM 14 to tower 2 located at MM 49.

Graphs 2B also shows that the crossover point for the AIS working channel signal strength measurements between towers 1 and 2 occurred at MM 27 AHP. At that location, the signal power of the working channel was -82 dBm.

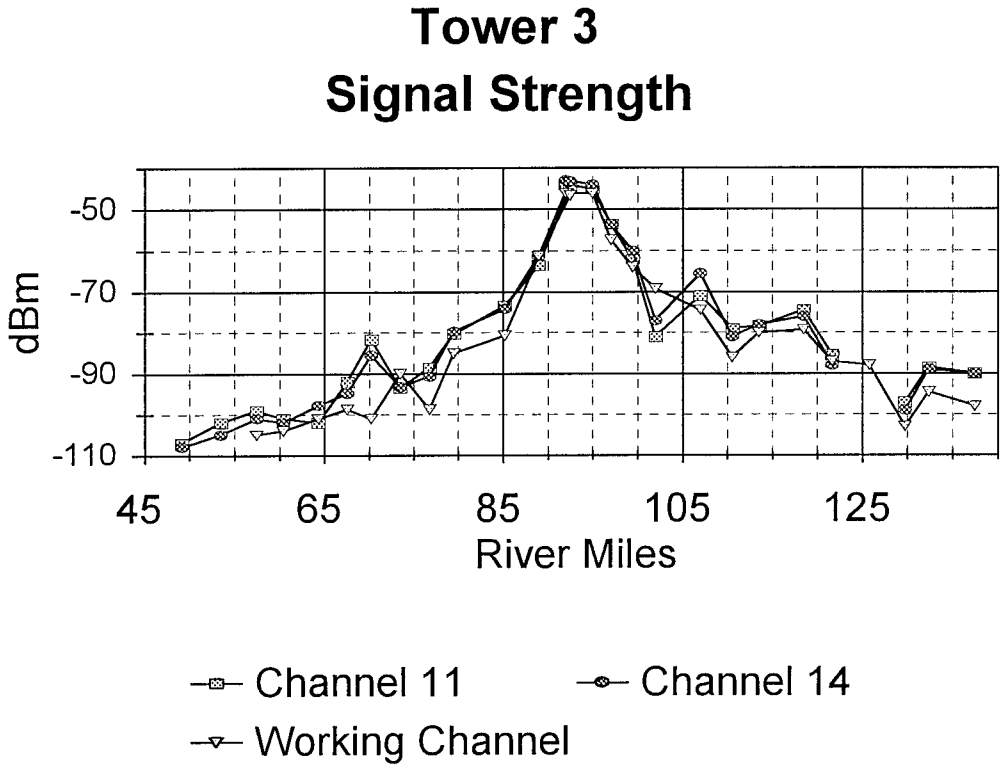
Graph 3A
Tower 3 Signal Strengths

The length of the river that encompassed the measurement locations for tower 3 was MM 49 to137 AHP. Graph 3A shows that the peak received power for the AIS working channel and voice channels was about -45 dBm and it occurred at MM 93. The signal power of the AIS working channel fell below -100 dBm at about MM 70 at the south end of the measurement range, and at about MM 127 at the northern end.

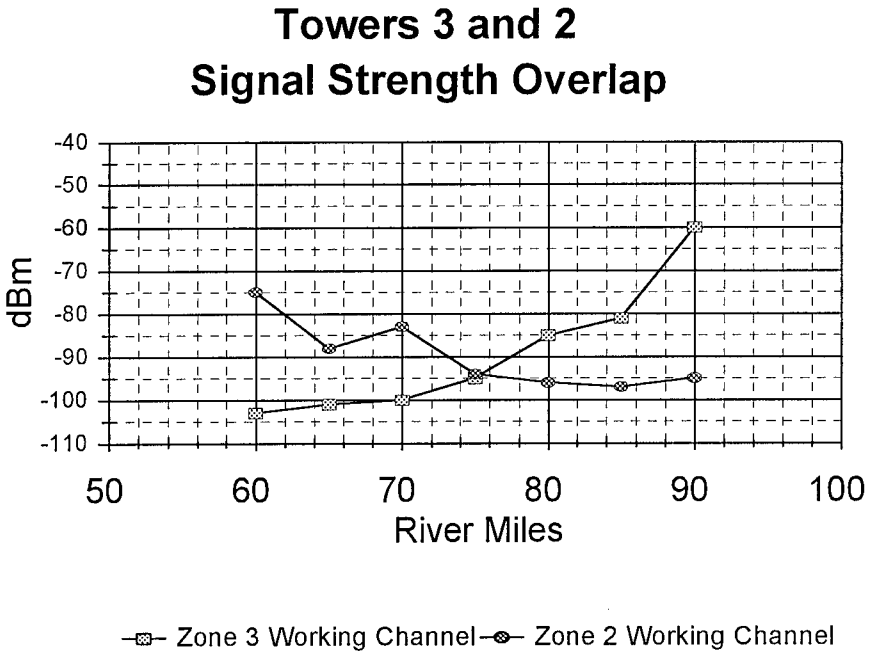
Graph 3B
Towers 3 and 2 Signal Overlap

Using -100 dBm as the reference point for overlapping signal strength between towers 2 and 3, Graph 3B shows that there should be sufficient signal strength for the AIS working channel from tower 2 located at MM 49 to tower 3 located at MM 93.

Graphs 3B also shows that the crossover point for the AIS working channel signal strength measurements between towers 2 and 3 occurred at MM 75. At that location, the signal power of the AIS working channel was -92 dBm.

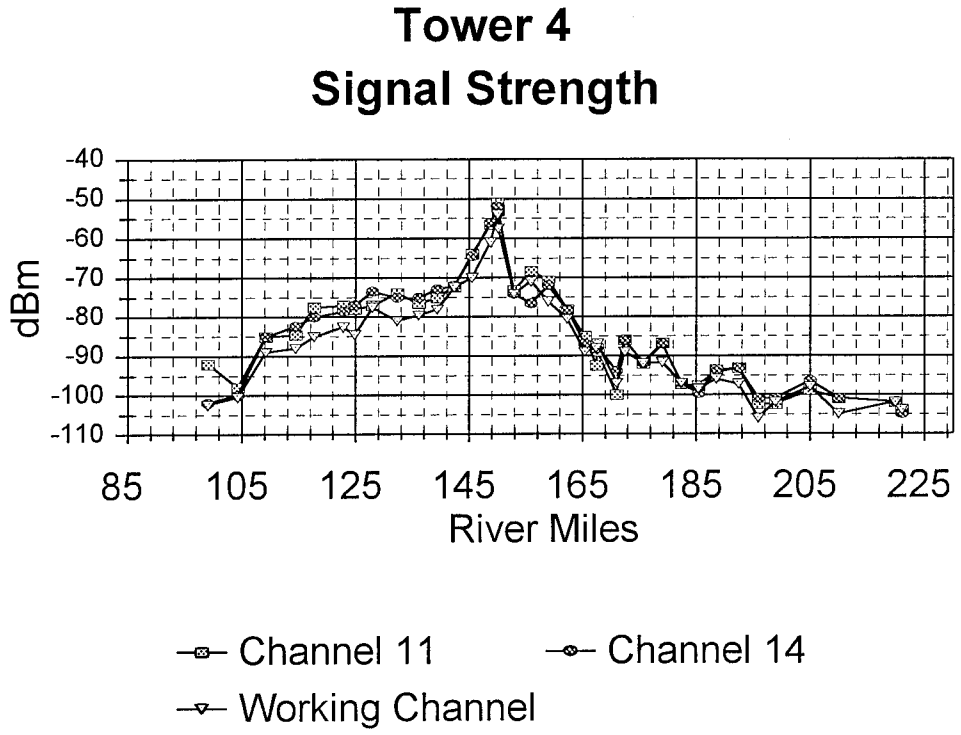
Graph 4A
Tower 4 Signal Strengths

The length of the river that encompassed the measurement locations for tower 4 was MM 99 to 221 AHP. Graph 4A shows that the peak received power for the AIS working channel and voice channels was about -50 dBm and it occurred at MM 150. The signal power of the AIS working channel fell below -100 dBm at about MM 105 at the south end of the measurement range, and at about MM 195 at the northern end.

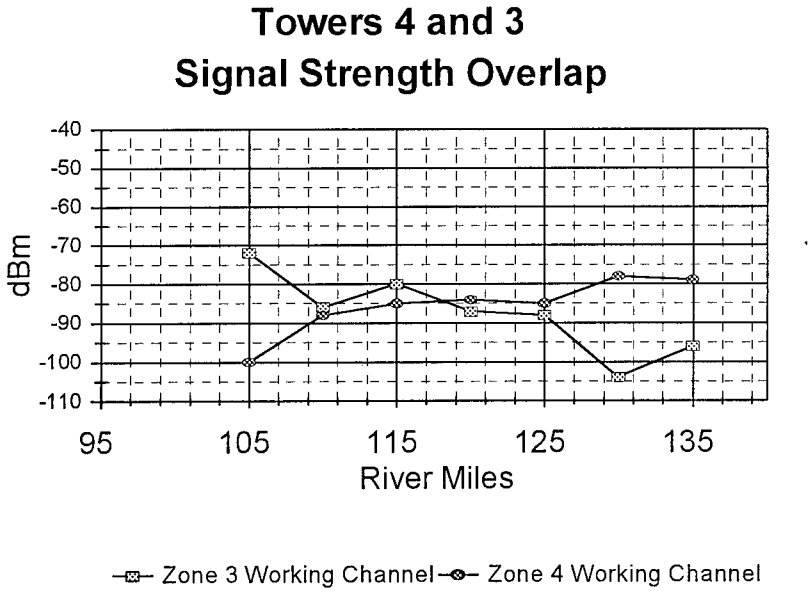
Graph 4B
Towers 4 and 3 Signal Overlap

Using -100 dBm as the reference point for overlapping signal strength between towers 3 and 4, Graph 4B shows that there should be sufficient signal strength for the AIS working channel from tower 3 located at MM 93 to tower 4 located at MM 150. Note that the signal strength graph for tower 4 is not symmetrical and that the measured signal strength for all three channels at the upper end (higher mile markers) is much weaker than the lower end (lower mile markes). This indicates that the optimal antenna azimuth position on the tower may be oriented to the south of tower 4, which results in a greater signal strength in that direction. During other tests, the Coast Guard has tracked transponders well out into the Gulf of Mexico and as far east as Pascagoula, Mississippi from tower four.

Graphs 4B also shows that the crossover point for the AIS working channel signal strength measurements between towers 3 and 4 occurred at MM 118. At that location, the signal power of the working channel was -85 dBm.

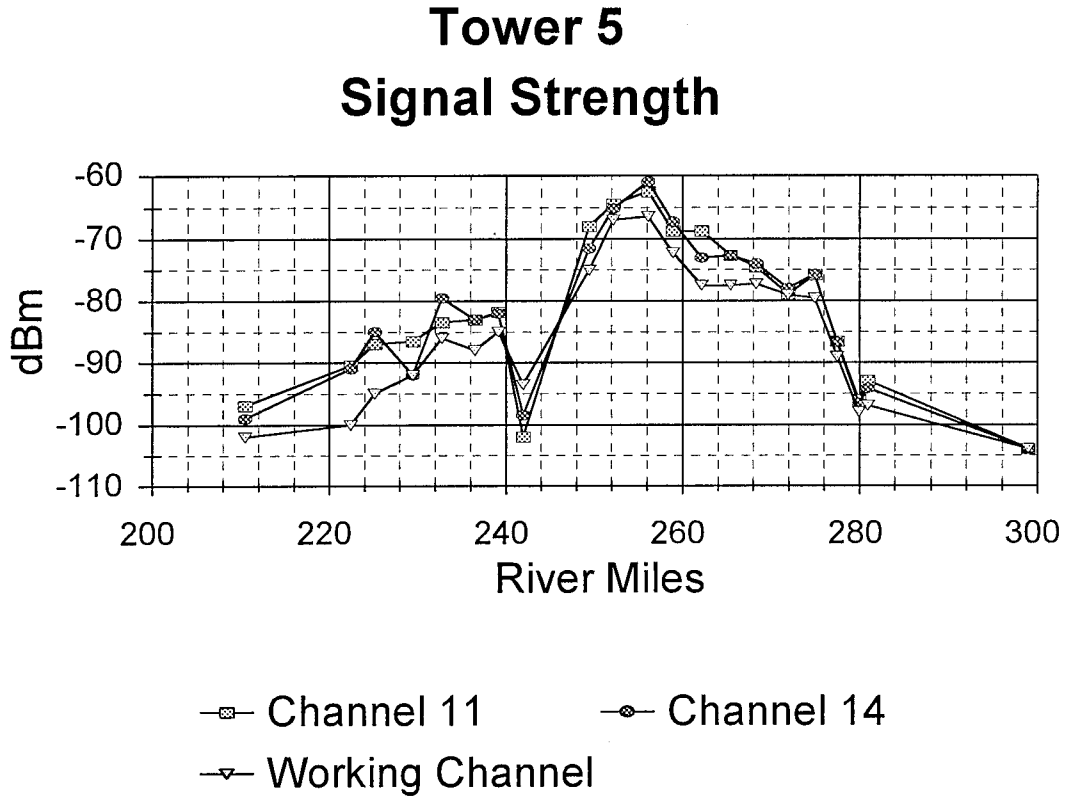
Graph 5A
Tower 5 Signal Strengths

The length of the river that encompassed the measurement locations for tower 5 was MM 210 to 299 AHP. Graph 5A shows that the peak received power for the AIS working channel was about -66 dBm and for the voice channels is about -62 dBm. The peak values occurred at MM 256, which is 1 mile beyond the northern limit of the proposed VTSA. The signal strength was -95 dBm at MM 244 and then rose back to -80 dBm at MM 248. The signal power of the AIS working channel fell below -100 dBm at MM 220 at the south end of the measurement range, and at MM 285 at the northern end.

Note that the signal strength graph for tower 5 is not symmetrical and that the measured signal strength for all three channels at the lower end (lower mile markers) is much weaker than the upper end (upper mile markers). This indicates that the optimal antenna azimuth position on the tower may be oriented to the north of tower 5, which results in a greater signal strength in that direction.

Tower 4 has similar problem. However, the optimal antenna position for tower 4 is oriented to the south which may compound the lack of signal strength between towers 4 and 5.

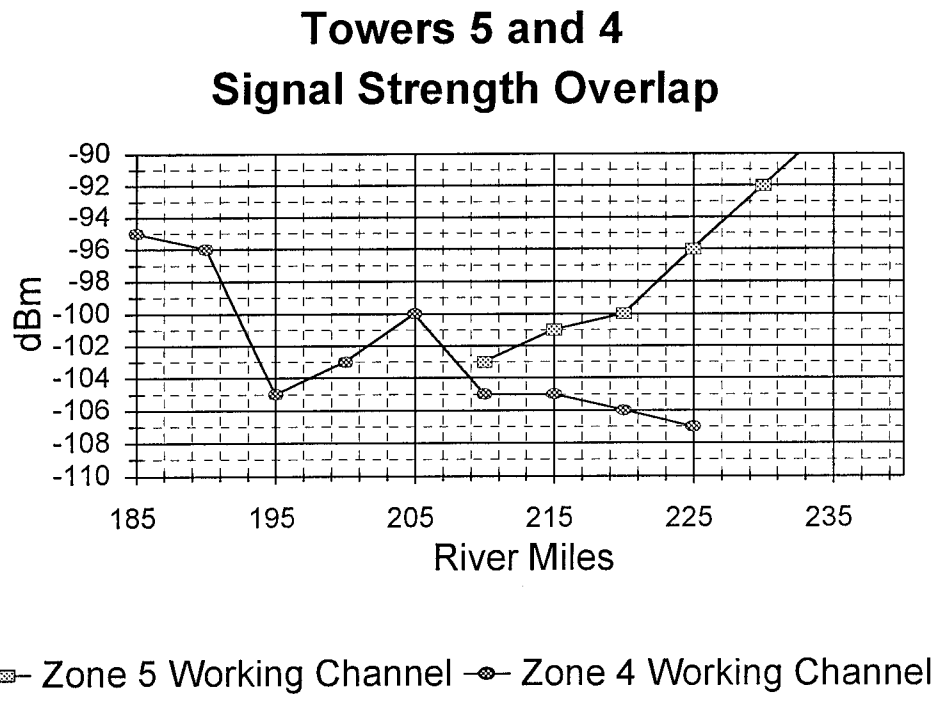
Graph 5B
Towers 5 and 4 Signal Overlap

Using -100 dBm as the reference point for overlapping signal strength between towers 4 and 5, Graph 5B shows that there is not sufficient signal strength for the AIS working channel from MM 195 to 220 AHP.
