DEVELOPMENT OF MAINTENANCE PRACTICES FOR OREGON F-MIX

Final Report

SPR 371

Dave Rogge, P.E.
Associate Professor
Department of Civil Engineering
Oregon State University

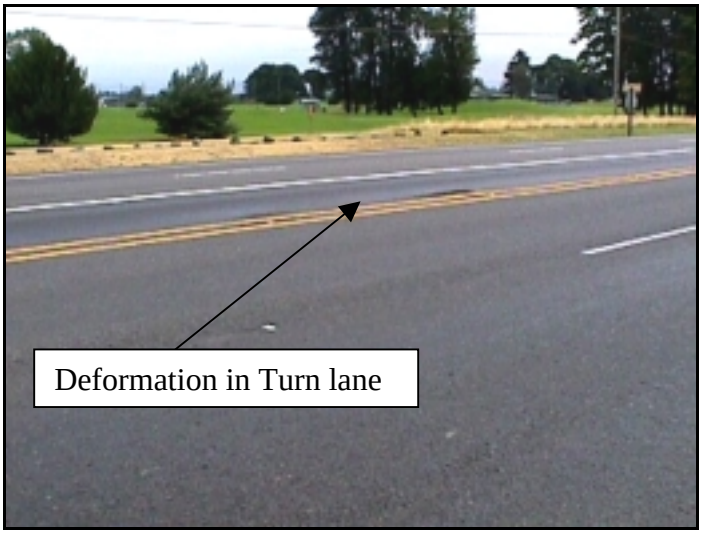
Figure 3.6: Deformation Rutting in WB Left Turn Lane from ORE 34 to Corvallis Bypass, Viewed from the EB Shoulder

The left turn lane from ORE 34 westbound to the Corvallis Bypass was repaired during the summer of 2001. The pavement was milled down through the top 100 mm of F-mix and 150 mm into the underlying dense-graded asphalt pavement. The total depth was replaced with a B-mix inlay.

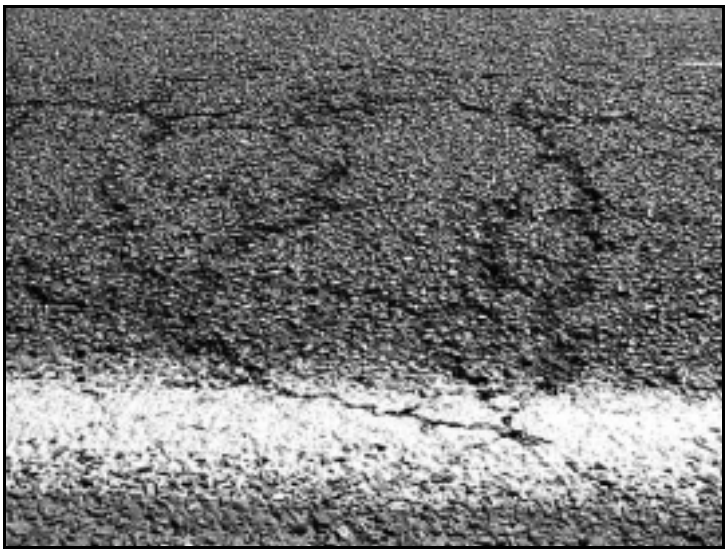
Figure 4.29: Distressed Pavement near Figure 4.28, Planned for Plug Patch Summer of 2001

Another common maintenance technique used by ODOT maintenance forces is referred to as a "plug patch," a small scale mill and inlay. Plug patches were observed on I-5 through Roseburg during the summer of 2001. Figure 4.28 shows a plug patch at least one year old. Figure 4.29 shows a nearby section that was to be plug patched shortly after the time of observation. Figure 4.30 shows distress at the edge of the plug patch of Figure 4.28. The ODOT maintenance representative indicated that problems of this nature are usually experienced at the interface between the dense-graded plug patch and the existing F-mix. Even though the patch extends well beyond the distressed area, this type of problem occurs. It is theorized that the plug patch creates a dam which holds water migrating through the pavement, which over time, leads to the distress shown. Figure 4.31 shows successful plug patches on ORE 42 near MP 58 eastbound.

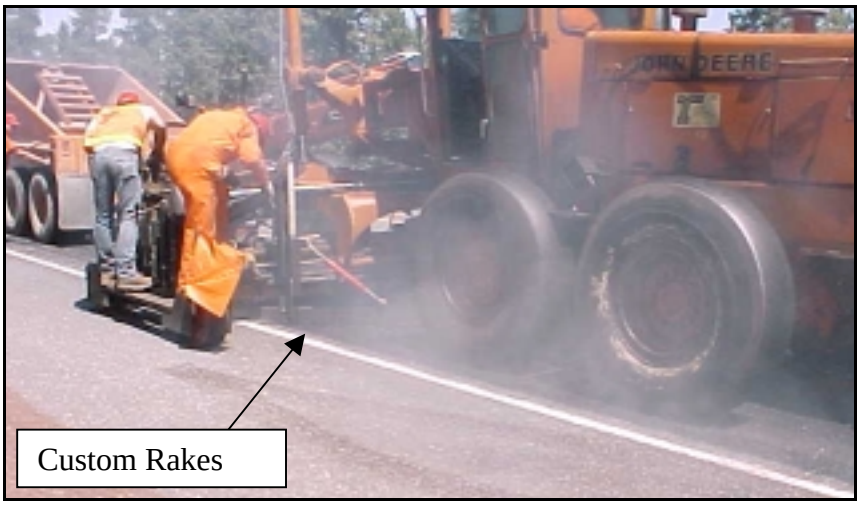
Figure 4.35: ODOT's "Barber Orange"

The repair is a full lane-width repair performed with a modified grader that the maintenance personnel call a Barber Orange *(Hunt 1999)*. The equipment observed in 1999 was built in 1998. It includes a blade with adjustable wings that allows the material placement width to vary from 1.8 to 4.25 m. Figure 4.35 shows the modified blade engaging a windrow of ODOT C mix.
