PERFORMANCE OF COARSE-GRADED MIXES AT WESTRACK—PREMATURE RUTTING

Final Report

June 1998

ANALYSIS CONDUCTED BY AN INDEPENDENT TEAM

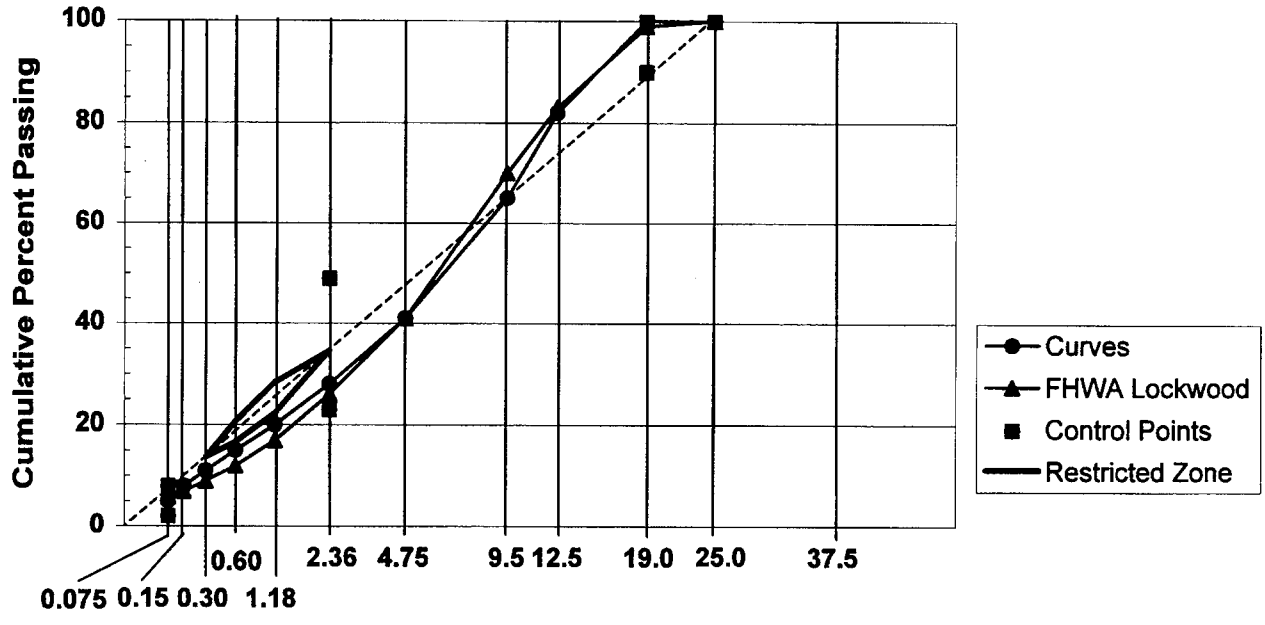
Figure 2. Curve and FHWA Lockwood gradations.

The aggregate gradations for the 11 sections are shown in tables 2 and 3. As shown in figure 2, the design gradations for Sections 35-39 and 54-56 and the curve met all of the requirements for coarse-graded Superpave mixtures recommended in American Association of State Highway and Transportation Officials (AASHTO) provisional specification MP2-97. Figure 3 shows that the design gradations for Sections 43 and 51 did not meet the requirements for coarse-graded Superpave mixtures (both gradations pass through the restricted zone), but were typical of Nevada DOT mixes used prior to Superpave. Generally, the tables show the gradation results from the samples taken behind the paver—and the results from truck and wheelpath core samples—are within typical construction variabilities and tolerances. However, the gradation of the cores, especially the percent passing the 0.075-mm sieve, was finer than truck or behind-the-paver gradations. The cores were typically 1.5 to 2.5 percent higher in fines than the samples taken from the truck or behind the paver. Other than possible traffic degradation, no explanation could be developed for the increased dust in the cores.

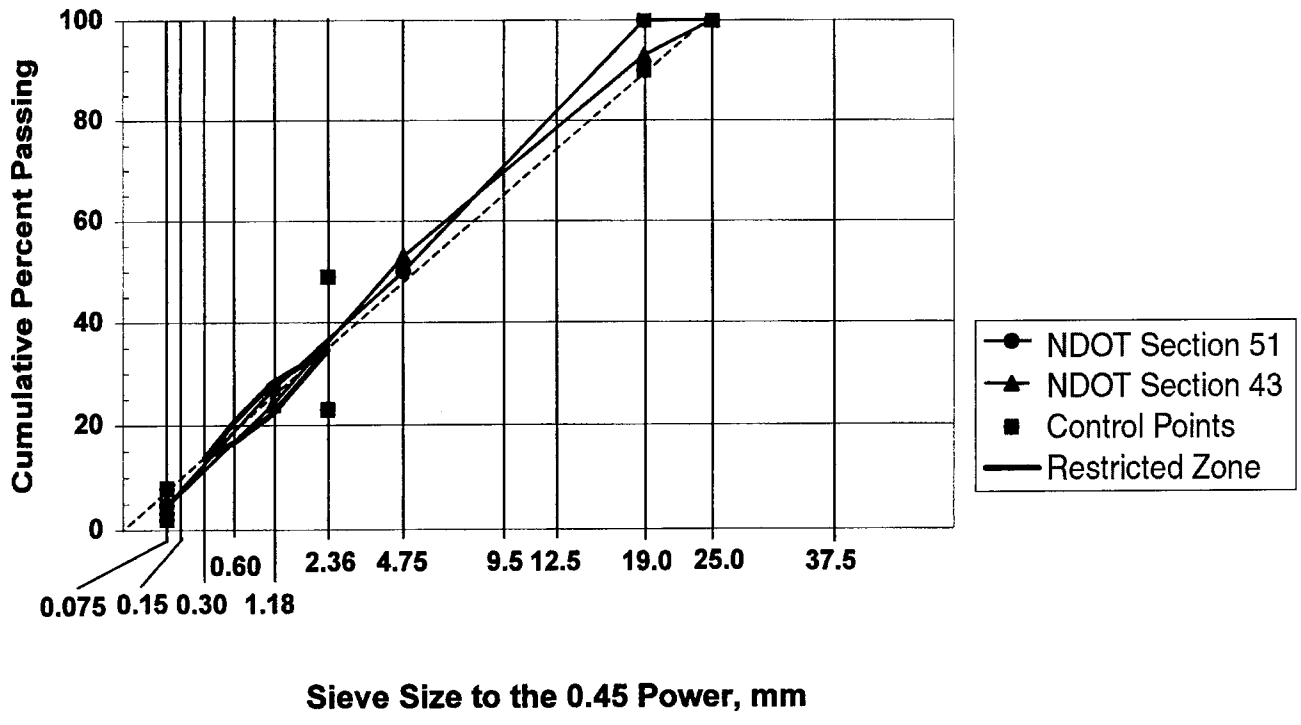
Figure 3. Nevada DOT mixes in Sections 43 and 51.

The Nevada DOT mixes, Sections 43 and 51, were Hveem-design mixes with an AC-20P modified binder; samples of these mixes were also compacted in the Superpave Gyratory Compactor and the properties of the mixes are shown in table 5. The mixture for Section 43 appeared to deviate significantly from the Superpave volumetric requirements. The mix design data for this section showed 1.7 percent air voids and the in-place cores were measured to have 1.6 percent air voids. Based on the volumetrics, this section would have been expected to rut; however, in-place results (table 6) showed this mix to have less rutting than any replacement section except 51. Section 51 had 4.2 percent air voids at design, with in-place air voids of 6.8 percent. This section had minimal downward rutting (3.6 mm). Visually, the rutting performance of these Nevada DOT mixes was similar to that of the curves (data for the latter is not shown in tables, but is estimated typically to be about 2 mm). Table 6 shows the rutting performance of the 10 sections in the field, as well as the performance of roadway samples from those sections in the various performance-testing devices. Figure 4 shows the distinction between total and downward rut-depth measurements.

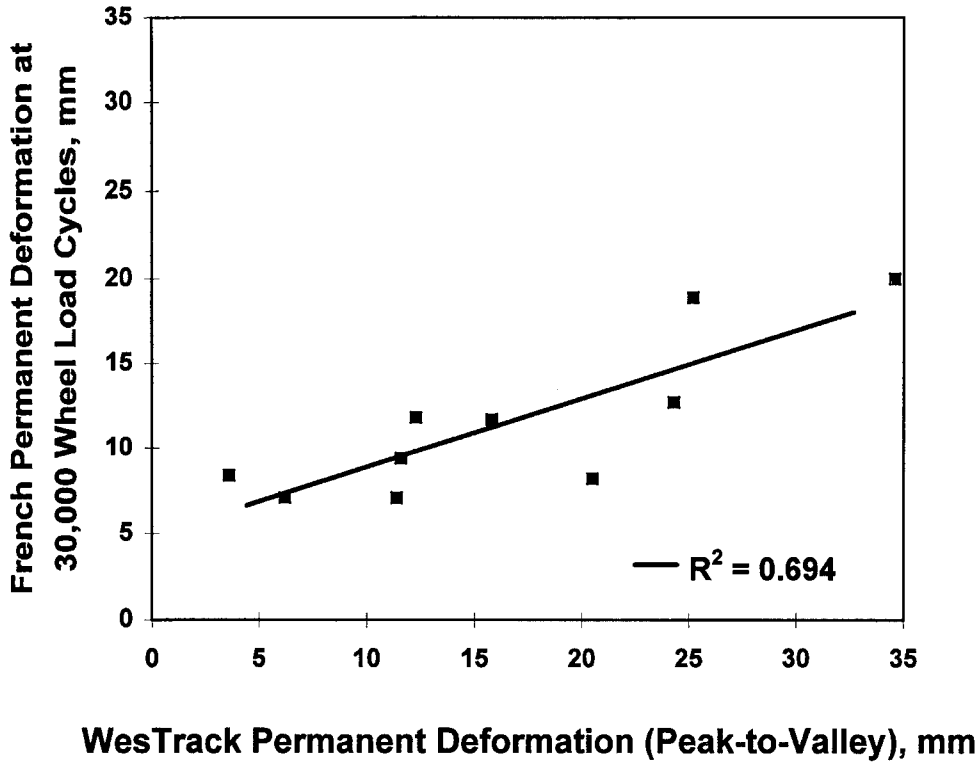
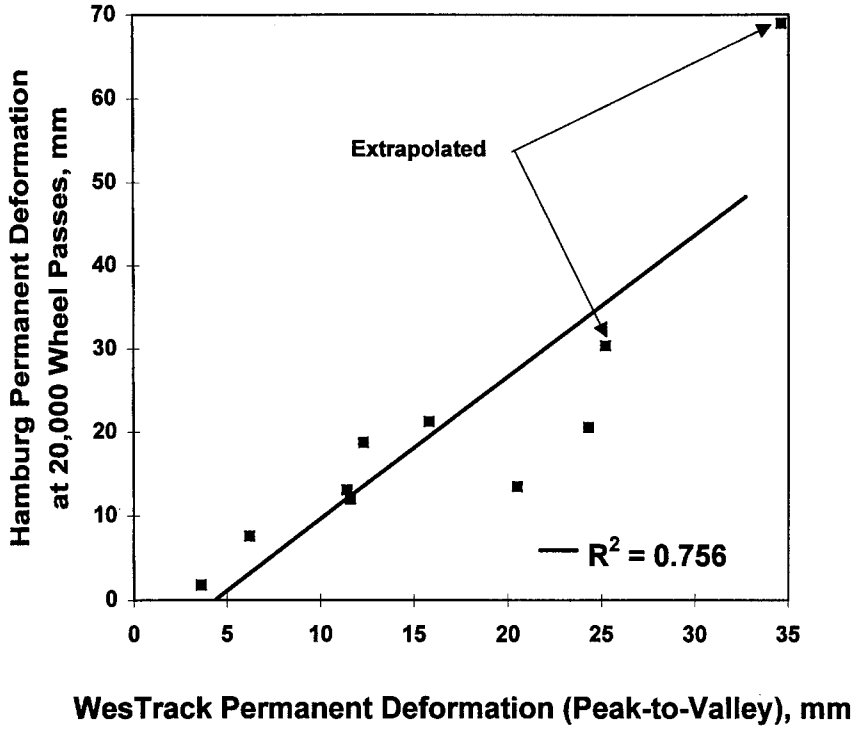
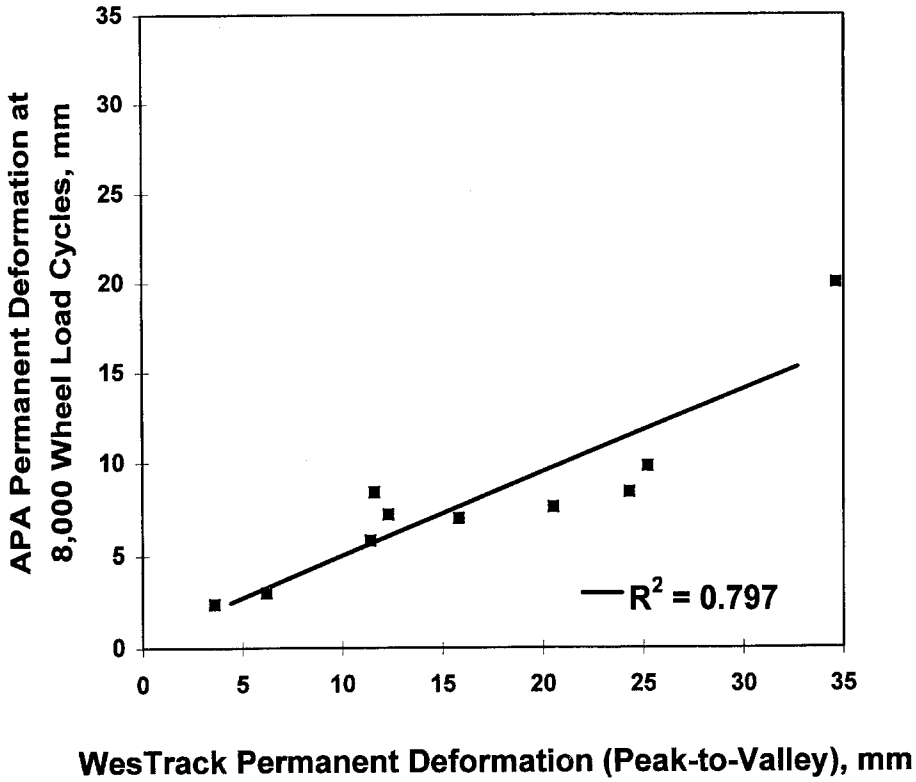
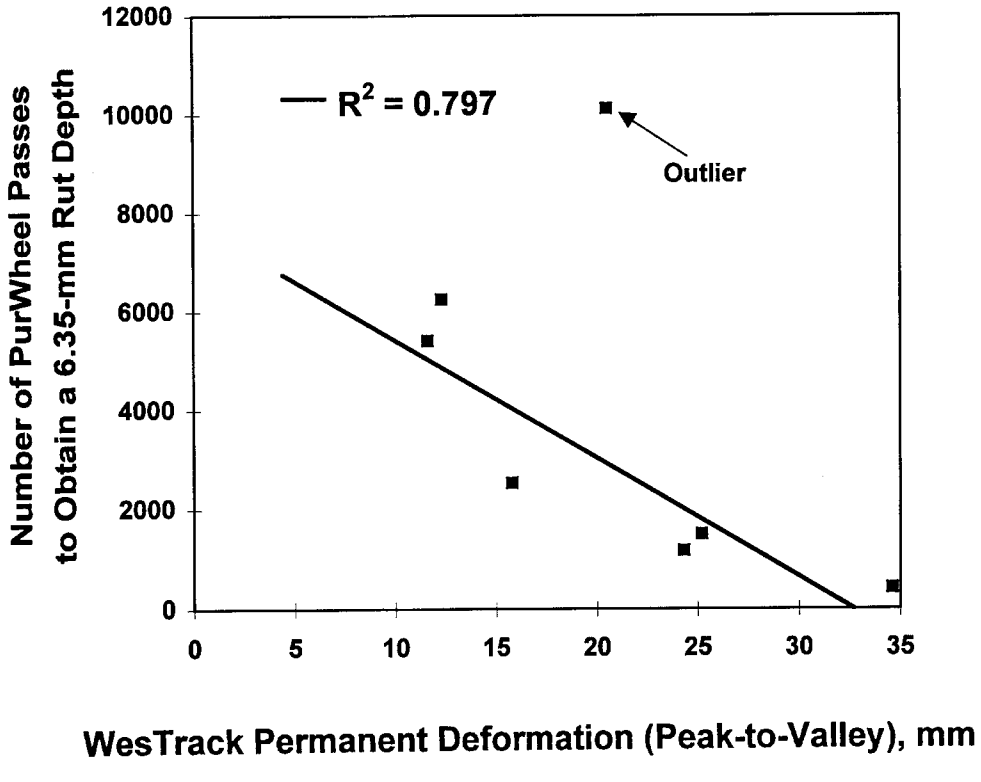
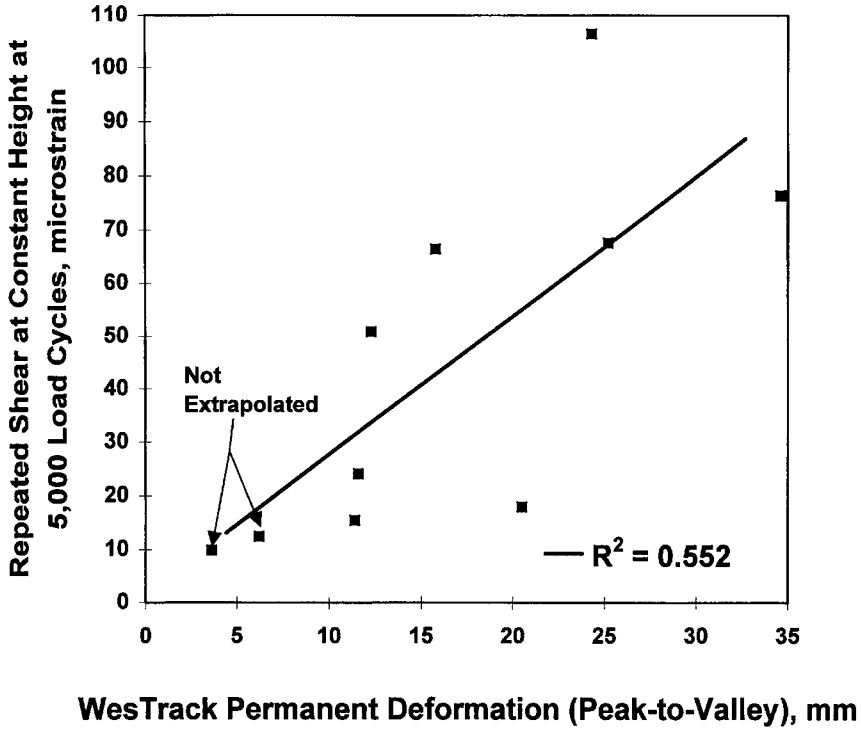
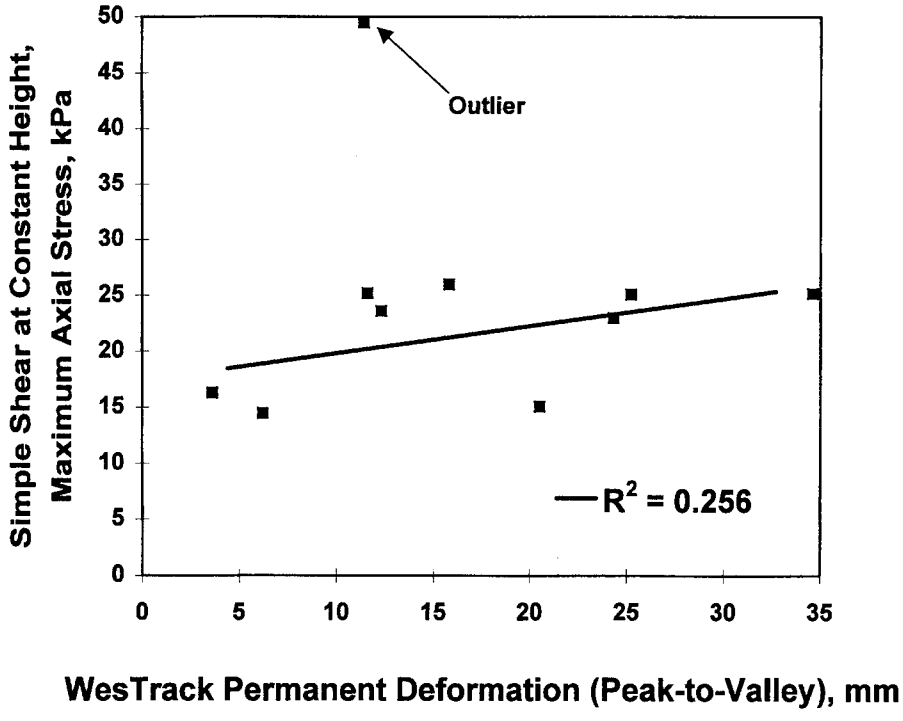
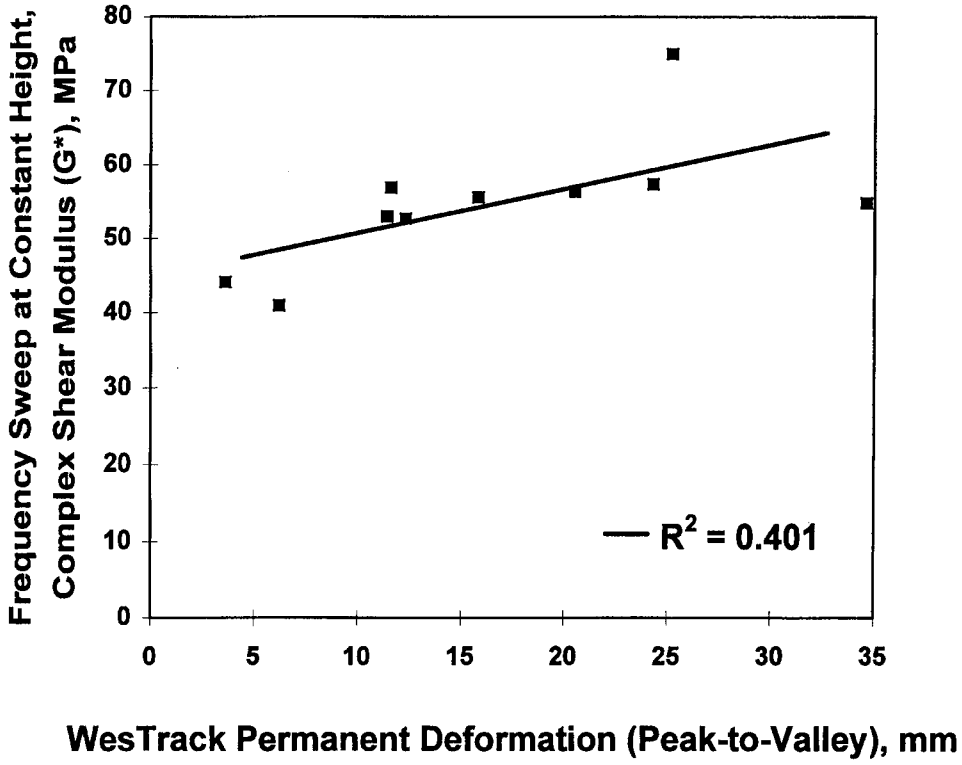
field after 582,000 ESALs and curve pavement samples after 3.3 million ESALs. The samples were taken from untrafficked areas between the wheelpaths. The data is plotted graphically in figures 5 through 11. (Note: In figures 6 and 9, some of the samples failed before the total number of passes or cycles specified in the test had been completed. Although it may unfavorably bias the correlation calculations, extrapolated test results are reported for those samples and are used in the calculations.) The data shows that four rut testers and one of the SST protocols, repeated shear at constant height (RSCH), correlate reasonably well with the rutting on the track. As the figures show, the French device had a correlation coefficient (R^2) of 0.69, the Hamburg tester had an R^2 of 0.76, the Asphalt Pavement Analyzer had an R^2 of 0.80, the PurWheel had an R^2 of 0.80 (with one outlier removed), the SST RSCH had an R^2 of 0.55, the SST simple shear at constant height (SSCH) had an R^2 of 0.26 (with one outlier removed), and the SST frequency sweep at constant height (FSCH) at 10 Hz had an R^2 of 0.40. Moreover, the slope of the line for the frequency sweep data was in the opposite direction from what it should have been, i.e., the frequency sweep results should decrease as rut depth increases. This limited set of results appears to show that use of the rut testers or the SST RSCH may indicate that a satisfactory mix has been designed and produced.

Based on previous experience, the forensic team members suggest that SST RSCH and the rut testers provide the most useful data when experience with similar material (aggregates and asphalts) is available. Properly calibrated rut testers have been used by some agencies as effective proof testers. However, they should not be used to predict actual pavement performance because of differences in the in-service temperature and loading conditions. The devices use empirical evaluation of some measured response to a loaded wheel as an indicator of performance. Local criteria from one region are not applicable to another. Each potential user agency needs to develop its own evaluation of wheel-test results using local conditions.

- For high-volume roads, a performance test should be conducted on the mixture design established by volumetric procedures. The four rut testers and SST RSCH showed some merit in identifying unsatisfactory mixtures. Until a universally acceptable test and performance criteria can be established, agencies should rely on local experience with existing devices.

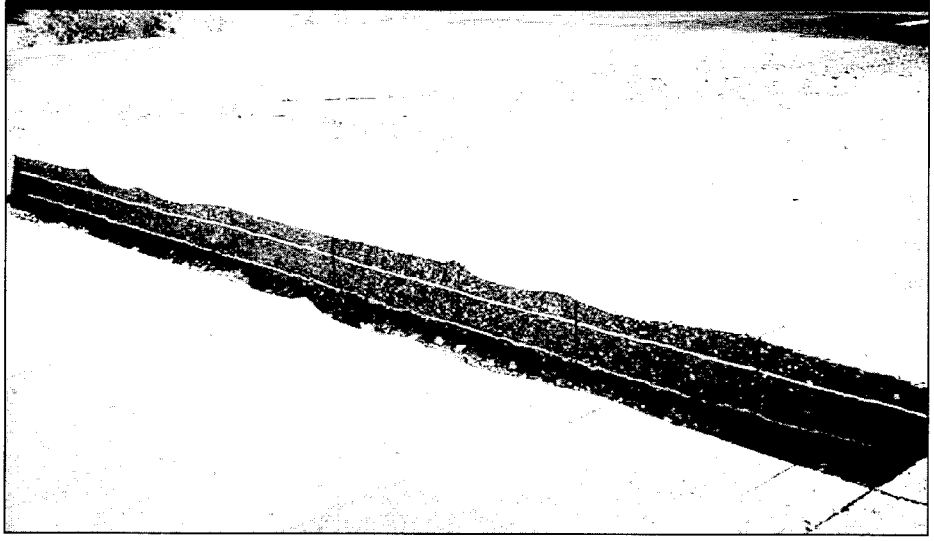
Figure A-2. Forensic trench showing rutting confined to upper asphalt layer.

In the original WesTrack sections, the coarse gradation mixtures showed more rutting than the fine mixtures. Trenching in fall 1996, after 1.1 million ESALs, showed that the rutting was occurring within the asphalt mixture and not in the aggregate base as shown in figure A-2.
