HIGHWAY CONSTRUCTION, MAINTENANCE, AND SERVICE EQUIPMENT WARNING LIGHTS AND PAVEMENT DATA COLLECTION SYSTEM SAFETY

Report 3972-1
Project Number 7-3972
Research Project Title: Maintenance Vehicle Warning Light Systems and Safety Evaluation of Pavement Data Collection Systems

Sponsored by the
Texas Department of Transportation

October 1998

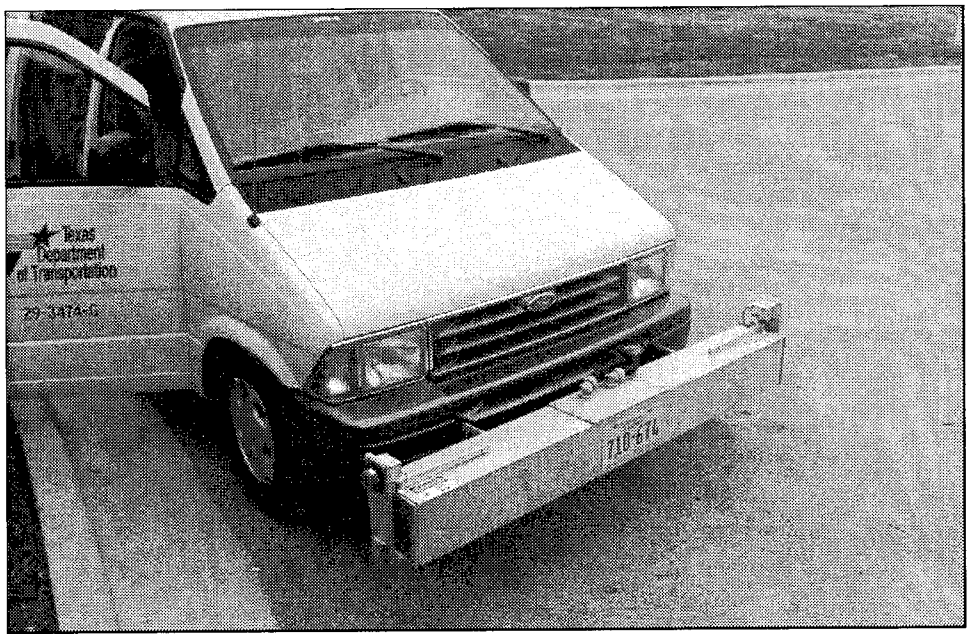
Figure 1. Profile/ Rut Bar on the Front of the Test Vehicle

Similar to the profiler, the primary concern for the MFV is the equipment mounted on the front of the vehicle that stretches the entire width of the vehicle. As noted above, researchers suggest that a small reflector be added to each side of the sensors that extend outside the vehicle during data collection.

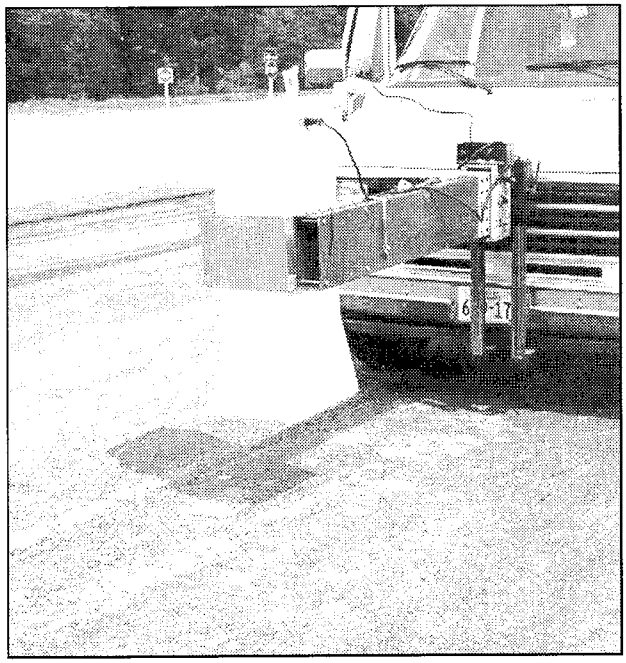
Figure 4. Front of GPR Van

The biggest concern while collecting data with this van is with the radar antenna and mounting boom. These items protrude 1.8 m (6 ft) in front of the van. Equipment operators have noted problems with motorist changing lanes extremely close to the front of the radar van and the protruding equipment. Currently, the boom for the antenna is red but the radar antenna is white. Unfortunately, the radar equipment itself is extremely sensitive and any item fabricated from metal or wood or that produces electromagnetic noise will degrade the quality of the radar data. Consequently, any potential additions to the antenna to increase visibility would have to first be evaluated by radar design experts. Researchers think that attaching a flag to the front corners of the vehicle (possibly attached to the bumper) would call attention to the front of the vehicle and the protruding antenna. The height of the flags would have to be kept low so as to not interfere with driver visibility.

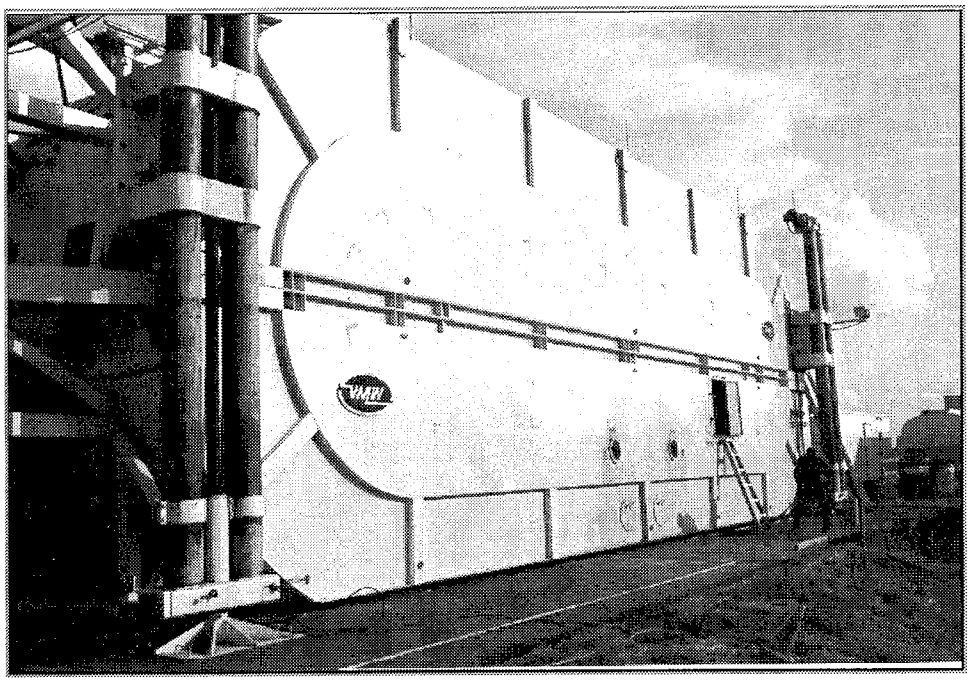
Figure 5-8. Illustration of the MLS

The last data collection device discussed is the MLS, shown in Figure 8. The time required for an accelerated pavement test under optimal conditions is currently 3 months. Installation of the MLS is a major undertaking requiring oversize permits, long-term lane closures protected by concrete median barriers (CMB) and full advance signing, and more. Consequently, the traffic control plan at this type of data collection location is as safe as any other long-term construction project. However, in the interviews of the MLS operators, one concern that was noted involved public curiosity about the device. Specifically, when the MLS is first installed on a section of road, the public has a tendency to stop on the road to ask personnel present about the purpose and operation of the device. In fact, this type of event occurred during one time researchers were present observing the operation of the device. The motorist actually stopped in the travel lane and asked for an explanation of the device. Such behavior is clearly undesirable from a safety standpoint.

Obviously, it is critical that the overall traffic control set up at a site for this activity provide adequate sight distance to the closure. However, it is also desirable to attempt to provide adequate sight distance to the MLS itself if possible so that anyone who inadvertently stops in the road does not create an unseen hazard to approaching motorists. At the same time, it appears beneficial to try and discourage such stopping behavior in the first place. Researchers recommend the use of portable changeable message signs (CMS) as part of the advance warning signing. The CMS would be positioned 150 to 1000 m (500 to 3700 ft) upstream of the first advance warning sign, depending on roadway type (data collection personnel should refer to the TxDOT standard traffic control plans for the appropriate CMS location for a given facility). Once in place, researchers recommend a two panel message be displayed, each panel approximately 4s long:

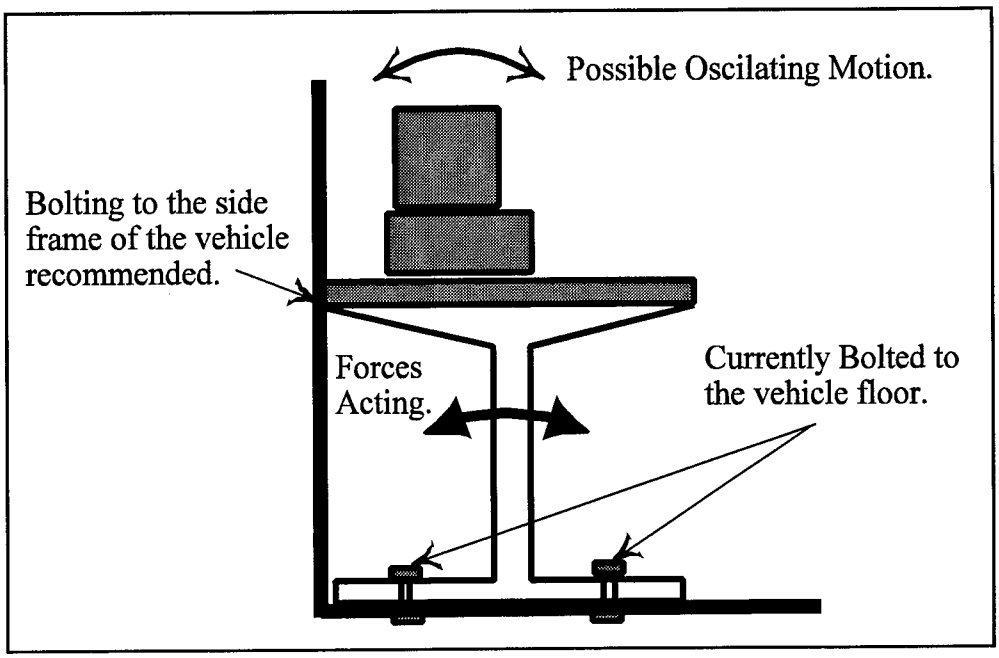
Figure 11. Properly Securing a Computer Desk.

Another concern noted during the research vehicle critique was with how the tables were secured to the vehicle. Typically, a desk or table is secured by using bolts only to the vehicle floor. This restraint is sufficient for normal driving conditions. However, it may not be sufficient under all scenarios. The reason is that any sideways movement of the vehicle will cause the tabletop to oscillate left and right. These oscillations can become more pronounced

1. Forces pulling the bolts upward, and
2. Forces that will have a tendency to bend the table legs.

Under severe conditions (collision and/or rollover), there is a possibility that the legs either bend or become loose due to a broken bolt. If this happens, forces generated and the inertia of object on the table can cause an object to become a dangerous projectile. This potential hazard can be virtually eliminated simply by additionally bolting the top part of the table to the vehicle frame (as shown in Figure 11). The same safety rule can be applied to any cabinet/table used for setting or mounting data collection equipment.

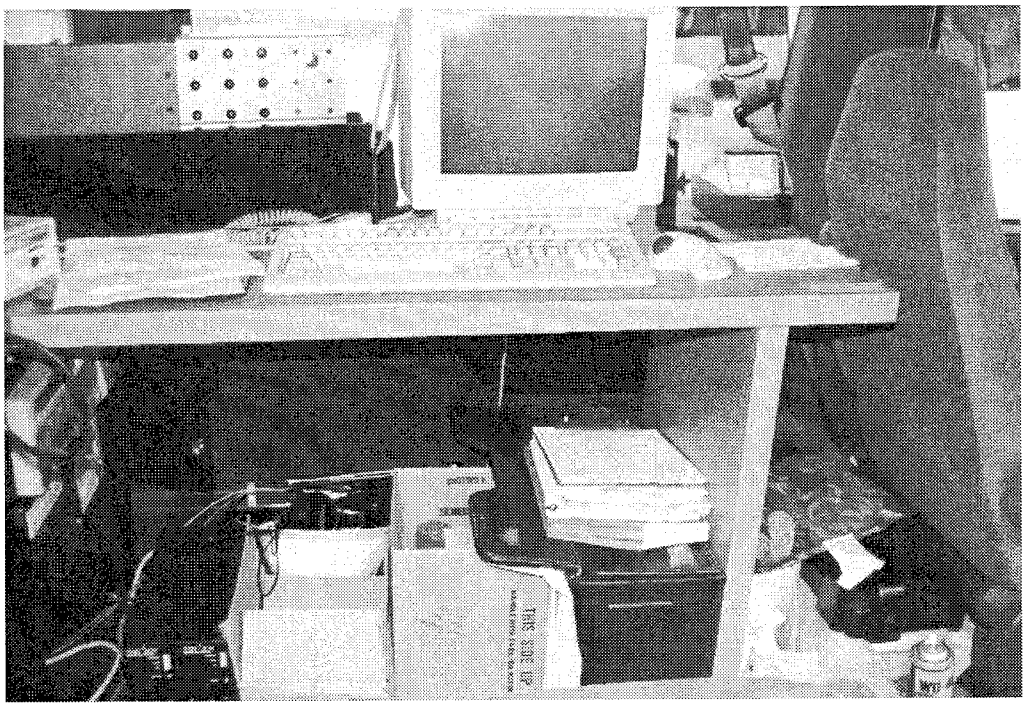
Figure 12. Example of Unsecured Equipment in Research Vehicle

Figure 12 illustrates another case where a computer desk is being used for the electronic equipment and deficiencies are believed to exist in terms of how equipment is secured within the vehicle. Three key observations from this figure are listed below:

- The computer monitor is strapped to brackets that are secured to the table using screws. This method of securing larger items is sufficient for normal vehicle movements (forward or reverse) but may not be sufficient for movements or forces perpendicular to the monitor screen. For instance, the monitor might slip out and become a projectile in a

side-impact or rollover situation. The possibility of this happening is higher when the tabletop is not properly secured against the side of the vehicle as described earlier.

- There are unsecured items (equipment, papers, aerosol can, etc.) under the table and between the table and the driver seat. Under normal driving conditions, this does not pose any significant safety threat, however, under extreme conditions, loose items may be potentially dangerous to the vehicle occupants. According to basic laws of dynamics, the force with which a moving object hits something in its path is dependent on the velocity at the time of impact and the mass of the object. Thus, a small object moving at a high velocity can be as dangerous as a larger object moving slowly, and

- The top-left corner of Figure 12 shows a section of mounting boom for the ground penetrating radar when it is transported inside a vehicle. It is 1.8 m (6 ft) long and has a significant weight. Figure 13 illustrates how the boom is stored in the vehicle in a full length U-bracket. This bracket is secured to one side of the vehicle and has plates at the two ends to prevent the boom from sliding out. However, note that the center of mass of the boom is located at a point that is higher then the top edges of the U-bracket. In addition, the radar boom is not secured to the bracket. Under normal driving conditions,

the weight of the boom will keep it inside the bracket. However, there is a possibility of the boom falling out if the vehicle traverses a large bump, or if the vehicle is involved in a rollover situation. Thus, researchers strongly recommend that a metal locking bracket or other sort of mechanism be used for properly securing the boom to the vehicle.

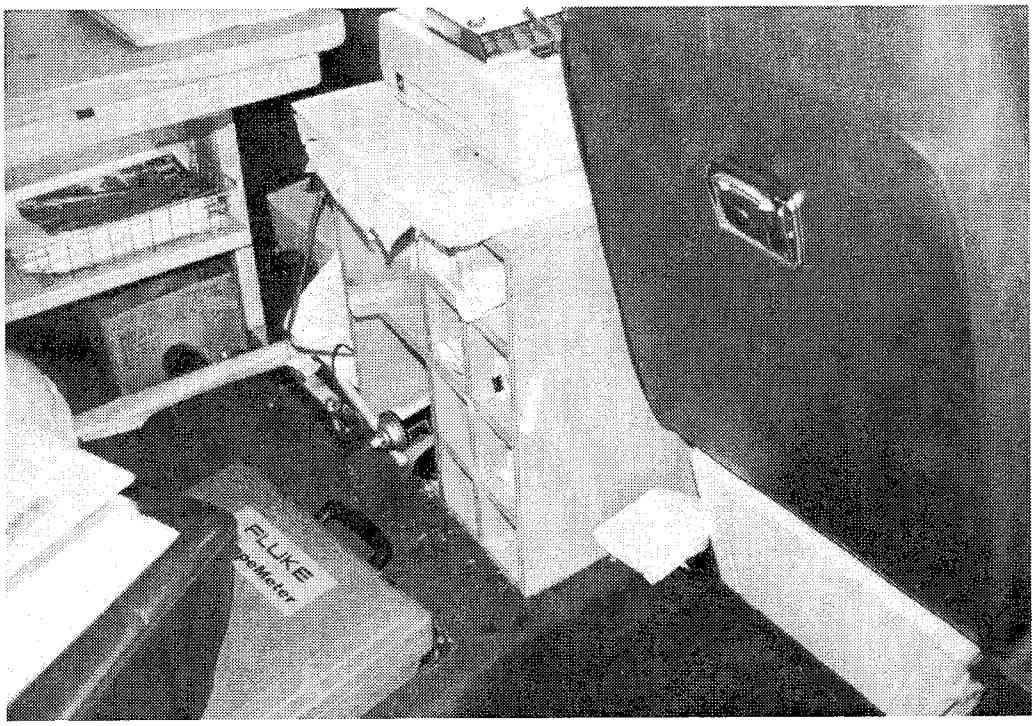
Figure 14. Equipment Added at District

Figure 14 illustrates an instance where a wooden table was placed between the front seats of the vehicle. Safety consideration regarding this application are discussed below.

- This table is not secured to the vehicle as discussed above.

- The table has open bins facing backward. Even the normal motion of the vehicle can throw items out of the bins. One way of avoiding any associated hazard would be to either cover the openings with doors or to use top-load bins, and

- TxDOT staff informed the researchers that this table was not installed at the design shop but was placed in the vehicle at the District where it was used. TxDOT can avoid such situations by developing a policy that provides Districts with design/installation guidelines (such as these provided in this chapter) for installing additional equipment in the research vehicles.

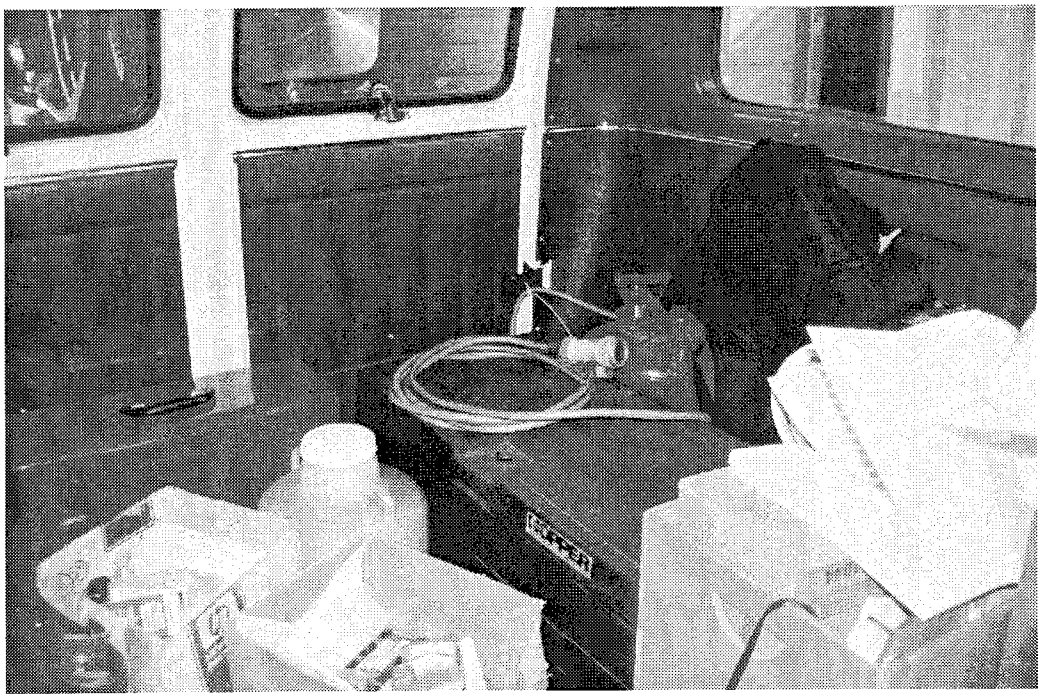
Figure 15. Unsecured Items in a Data Collection Vehicle.

Figure 15 shows a case where the back half of a vehicle included several unsecured items, such as: a bottle of hydraulic fluid, a tool box, and several cardboard boxes with miscellaneous equipment. Researchers were also informed that it is also not uncommon to carry, unsecured, weights for the (FWD) inside a vehicle. Under normal driving conditions, these unsecured items may not pose any threat but may turn into deadly projectiles in collision or rollover conditions. Researchers also strongly suggest that provisions be made to secure such items and that the operators secure all items before using a data collection vehicle.
