1. Report No. FHWA/TX-00/0-1814-3	2. Government Accession No.	3. Recipient's Catalog No.
4. Title and Subtitle PERFORMANCE OF REHABILITATED LIGHTWEIGHT AGGREGATE ASPHALT CONCRETE PAVEMENTS UNDER WET AND HEATED MODEL MOBILE LOAD SIMULATOR TRAFFICKING: A COMPARATIVE STUDY WITH THE TxMLS		5. Report Date March 2000

PERFORMANCE OF REHABILITATED LIGHTWEIGHT AGGREGATE ASPHALT CONCRETE PAVEMENTS UNDER WET AND HEATED MODEL MOBILE LOAD SIMULATOR TRAFFICKING: A COMPARATIVE STUDY WITH THE TxMLS

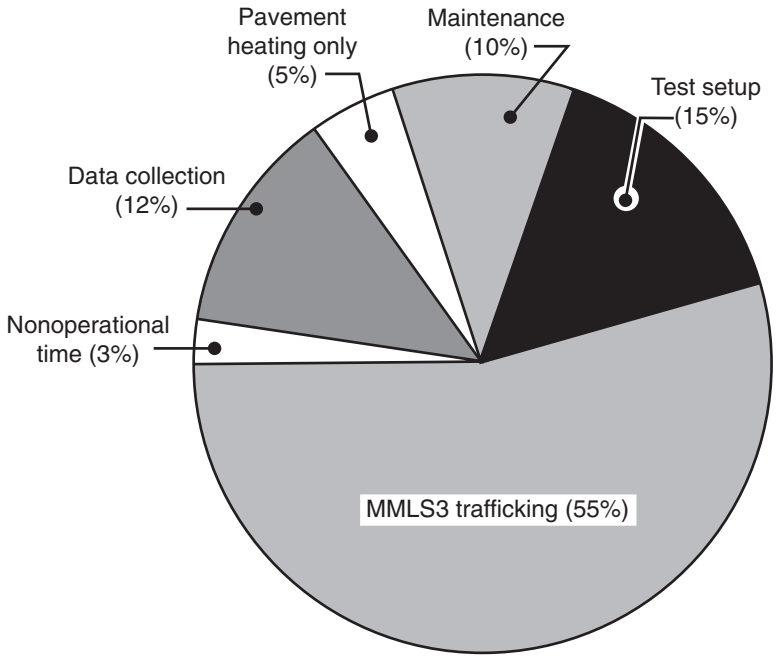
Figure 10: MMLS3 time productivity pie chart

Maintenance included MMLS3 inspection and repair to the machine. A substantial amount of time was spent on maintenance, particularly on the milled test pads. The major mechanical problems experienced were snapping of the internal drive belt, shearing off of rim bolts and nuts, skewing and ripping off of rims, and puncturing of tire tubes. These problems were subsequently addressed with the switch to more robust wheel rims.

One minor electrical problem experienced was fusing, a problem that was probably due to overload caused by the drive wheels' failure to rotate, which resulted in more electrical power being drawn from the power source. No water-related problems were encountered.

As can be seen from the time pie chart (Figure 10), the test set-up (15%), data collection (12%), and maintenance (10%) times were relatively high. The high set-up time arose from the MMLS3 setup on the milled southbound test pads, including traffic control and handling of the sand and steel plates. Measurements on the milled surfaces likewise required extra care and precision. PSPA measurements had to be repeated several times to get good readings. The high maintenance time was basically due to the mechanical problems mentioned.

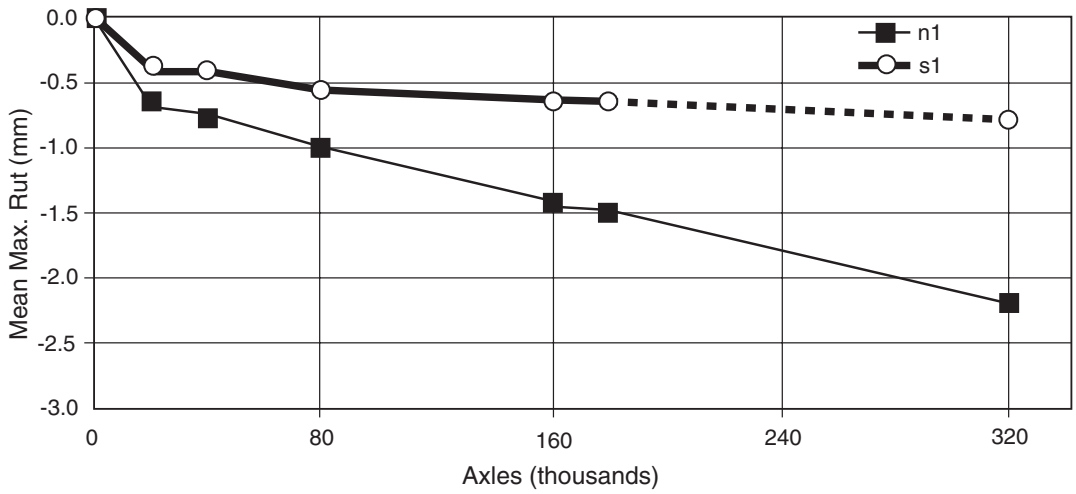
Figure 16: n1 and s1 ruts

After 160k, the ruts in n1, n2, and n3 were 1.39, 2.69, and 1.40 mm, respectively. At 320k, the rut depth on n1 was 2.17 mm and the rut depth on n3 was 2.35 mm. It was clearly evident that the in-situ processed Dustrol and LWAC layers (n2 and n3) were less resistant to permanent deformation than the limestone AC overlay. The layers were highly sensitive to temperature and susceptible to water damage.

On average, the northbound lane had rutted about 2 times more than the southbound lane. The maximum n1 rut after 320k axles was 2.1 mm, and the 320k extrapolated s1 rut was about 0.8 mm. Similar conditions were present during testing on the two test pads. The maximum rut of s1 at the termination of testing at 180k was 0.6 mm, and the rut for n1 was about 1.5 mm. The rutting trend was the same in both cases (Figure 16). However, n1 had rutted about 2.8 times more than s1. Figure 22 shows the n1 and s1 rut profiles. The figure clearly shows the increased rutting of n1 and the coarse surface texture of the southbound structure (s1) that perhaps contributed to its resistance to rutting.

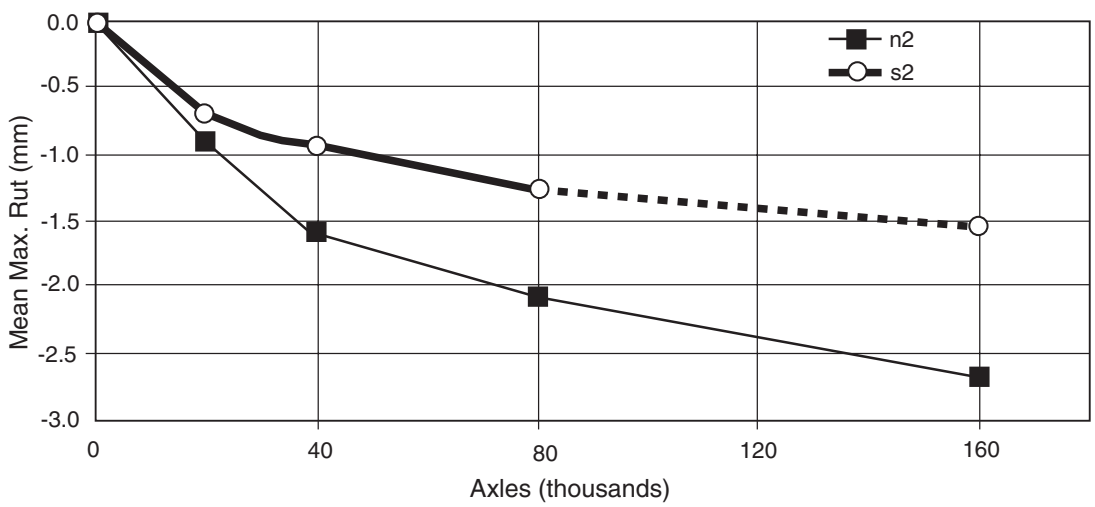
Figure 17: n2 and s2 ruts

The n2 maximum rut after 160k was 2.7 mm, and the s2 160k extrapolated rut was about 1.6 mm (Figure 17). The n2 ruts were higher than those on s2 at all axle counts. After 80k, the rut depth on n2 was 2.1 mm and on s2 was 1.3 mm. On average, n2 had rutted about 1.7 times more than s2.

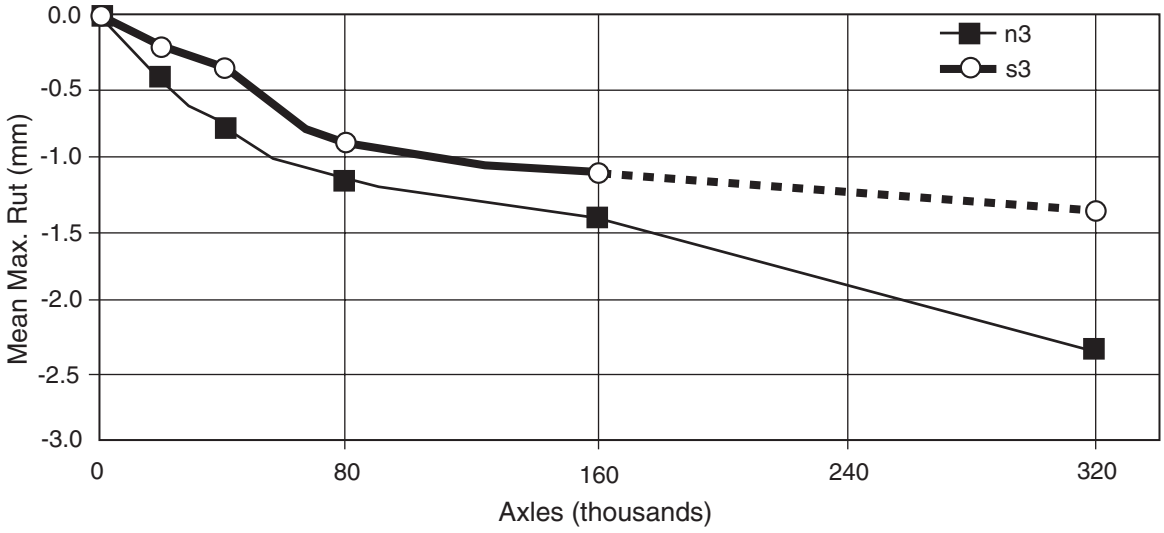
Figure 18: n3 and s3 ruts

As previously shown in Figure 18, the n3 maximum rut after 320k was 2.4 mm, and on s3 the rut depth was about 1.4 mm (extrapolated). Pad n3 rutted about 1.7 times more than s3. The increased rutting experienced on the wet tests was probably due to the increased tire pressure and distress resulting from water pressure on the LWAC.

Eighty-three percent of the 2.4 mm total rutting of pad n3 at 320k axles occurred in the Dustrol layer (~25 mm recycled LWAC plus Reclamite). This effect was probably due to degradation and stripping of the LWAC as a result of water application on the surface. The rest (17%) occurred in underlying layers, with about 8% occurring in the 20 mm in-situ LWAC layer.

Of the 1.1 mm rutting of pad s3, about 42% deformation occurred in the top 10 mm second Remixer layer, which was undergoing stripping and degradation owing to the effects of water. About 38% deformation occurred in the in-situ LWAC and 20% in underlying layers. This effect was probably a result of water damage.

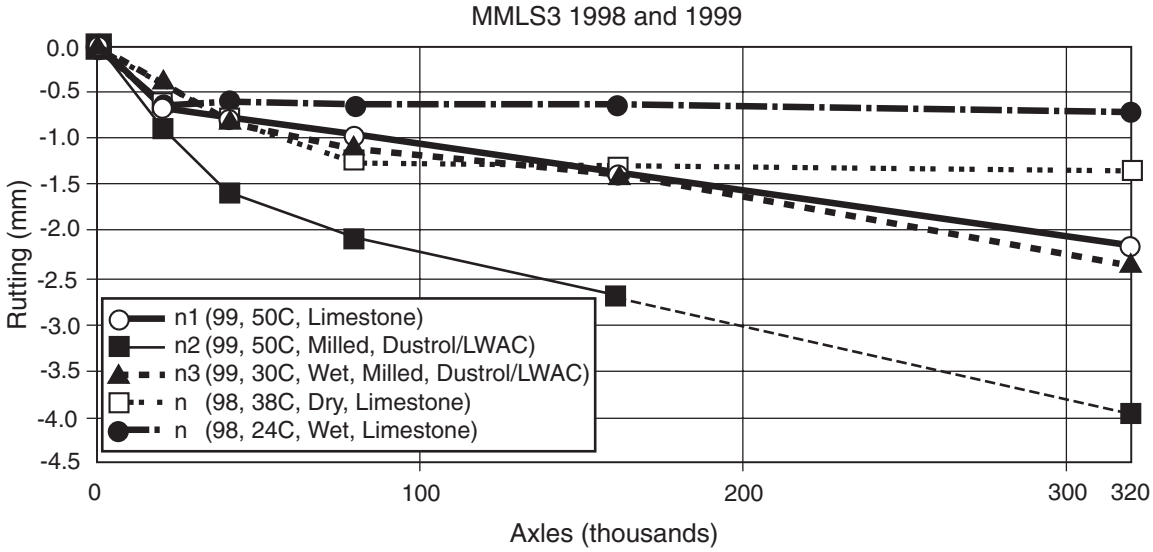
Figure 19: MMLS3-1998 and MMLS3-1999 ruts

Figure 19 showed the plot of the n-dry rut profiles for the 1998 MMLS3 dry test (no temperature control) and the 1999 MMLS3 hot tests. At 320k, the 1999 MMLS3-n1 rut was 2.2 mm, and the 1998 MMLS3 (n-dry) rut was 1.4 mm. The hot test rutting was about 60% greater than that in the 1998 dry test. At the termination of the 1998 dry test at 1.0 million axles, the rut was only 1.8 mm (about 83% of the hot test rut at 320k).

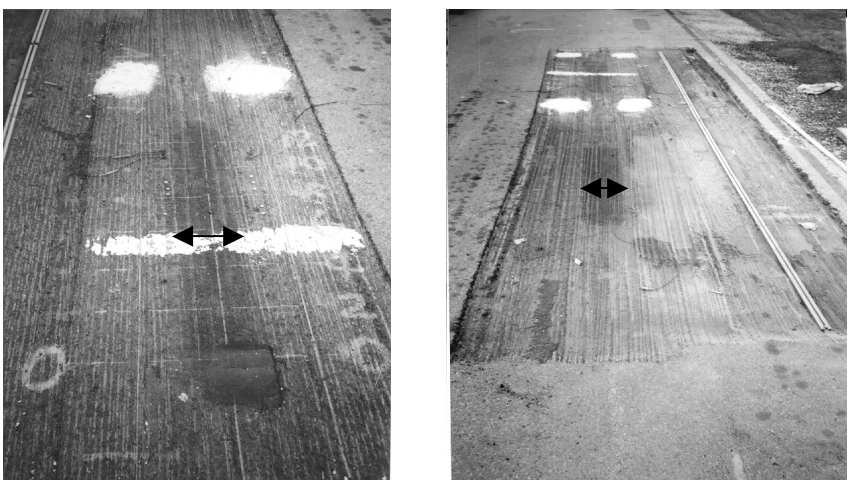
Figure 21: Surface ruts (n2 and n3)

Figure 21 shows the milled pads n2 and n3. The change in tire pressure to 690 kPa could have contributed to the greater rutting in n3 than that in n1. At the same temperature, this would have increased the rutting by more than 60%. However, the lower temperature of pad n3 would have mitigated this effect. Therefore, no correction was made.

(a) n2, 2.7 mm @ 160k *(b) n3, 2.4 mm @ 320k*

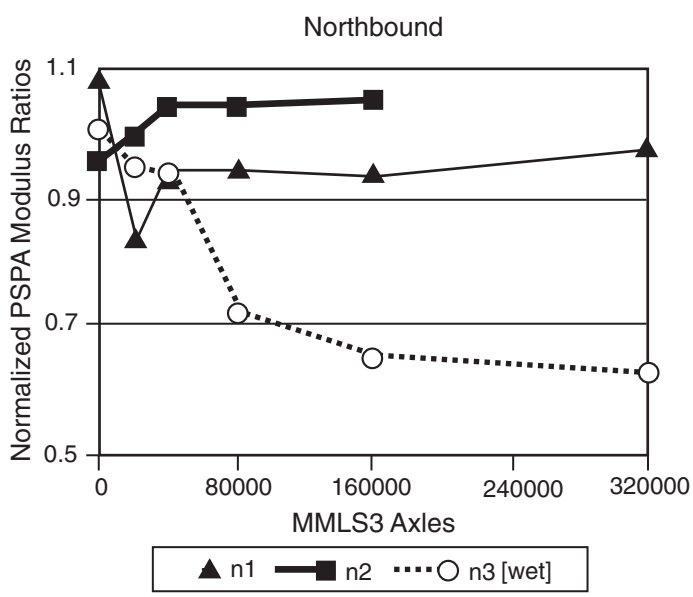
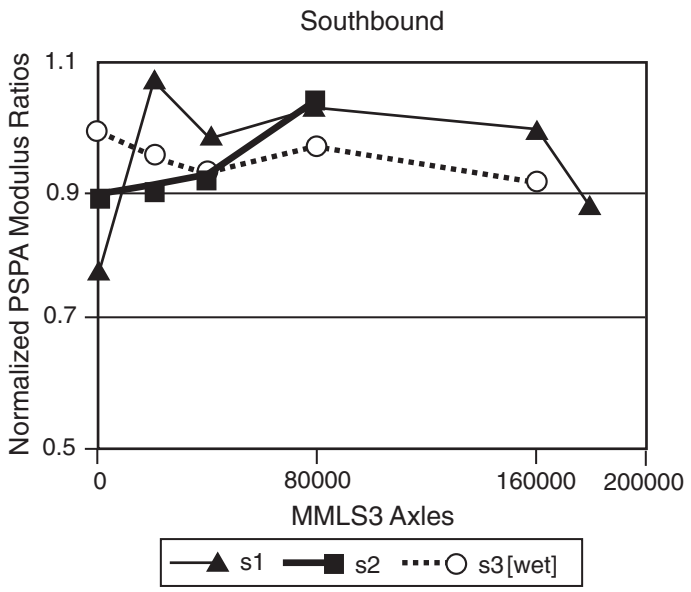
Figure 23 (a): Normalized PSPA moduli (25 °C, 30 Hz)

Figure 23 shows that there was a decrease in pavement AC moduli in pads n1, n3, and s3 with MMLS3 trafficking. In pads s1, n2, and s2 there was an increase. As a result of anticipated traffic damage, the moduli would normally be expected to decrease with trafficking. However, material densification resulting from traffic may offset the effects of traffic damage, as was evident in pads s1, n2, and s2. Tangella (1990) and Raithby and Ramshaw (1972) have also reported this phenomenon.

The decrease in AC pavement moduli on both the wet tests (n3 and s3) suggests water damage (AC degradation and stripping). There was a loss in stiffness of about 37% in the northbound structure and about 8% in the southbound structure owing to MMLS3 trafficking in the presence of water.

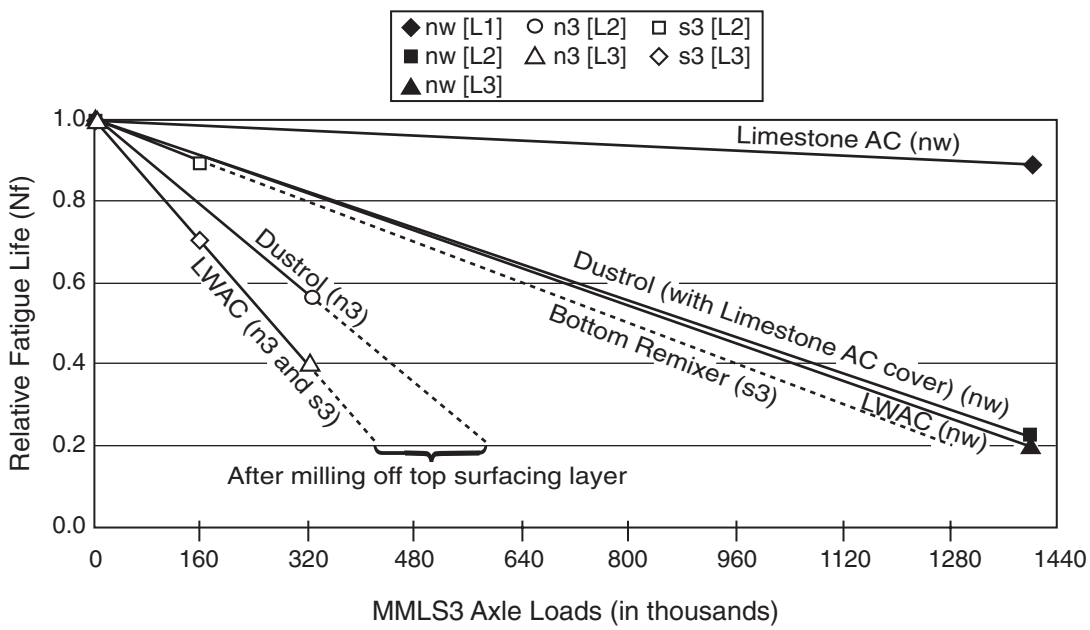
Figure 24: Relative indirect tensile fatigue life (Nf) after MMLS3 wet trafficking

The wet pads showed a reduction in fatigue life relative to the virgin asphalt as well as in comparison with the heated pads n1, n2, s1, and s2. Figure 24 shows these results graphically. The Dustrol on pad n3 had a reduction of about 43% (after 320k), while the reduction for the bottom Remixer on pad s3 was about 10% (after 160k). These reductions were due to the damaging effects of water. The LWAC on the southbound section had a loss of about 30% after 160k, and the northbound had a loss of 60% for the LWAC after 320k. Figure 24 shows that these changes fall on the same line and thus exhibit a degree and extent of water damage similar to the amount they would have exhibited had they been subjected to the same number of MMLS3 traffic axles. This finding was not surprising since it is virtually the same material. The damage under extended trafficking for both the Dustrol and LWAC was far greater, as evident from the 21% residual fatigue life of nw after 1.4 million load applications (Table 7[a] and Figure 24). However, the slope of the 1998 Dustrol and LWAC graphs (Figure 24) is not as steep as that of the corresponding 1999 graphs. This difference is

an indication that the progression of water damage was not as rapid and as intensive as that in the 1999 wet tests owing to the limestone AC cover in the 1998 test. It should be remembered that the top 25 mm of limestone AC was milled off in the 1999 wet tests. If MMLS3 trafficking had continued in the 1999 wet tests, the bottom Remixer, the Dustrol, and the in situ LWAC would have been reduced to about 21% residual fatigue life after about 1,226k, 585k, and 455k, respectively. The damaging effect of wet axles is apparent, and it is clear that the number of axle loads that can be carried is significantly reduced under wet conditions, even under the light wheel loads of the MMLS3. In fact, because the south- and northbound LWACs (L3) were found to be equally susceptible to water damage, both pavement structures would probably perform the same under wet trafficking, especially if water could gain access to the LWAC layer through cracks or through a porous surface.

Both Table 7[a] and Figure 24 indicate that the upper limestone AC on the northbound structure appeared to be less affected by water; it had a residual fatigue life of about 89% of the original asphalt after 1.4 million MMLS3 axle loads. This finding is contrary to the prediction in terms of the American Association of State Highway and Transportation Officials (AASHTO) T283 test results.
