EFFECTIVENESS OF BASE TYPE ON THE PERFORMANCE OF PCC PAVEMENT ON ERI/LOR 2

INTERIM REPORT

CONTINUED MONITORING OF INSTRUMENTED PAVEMENT IN OHIO – State Job No. 14652(0)

April 2000

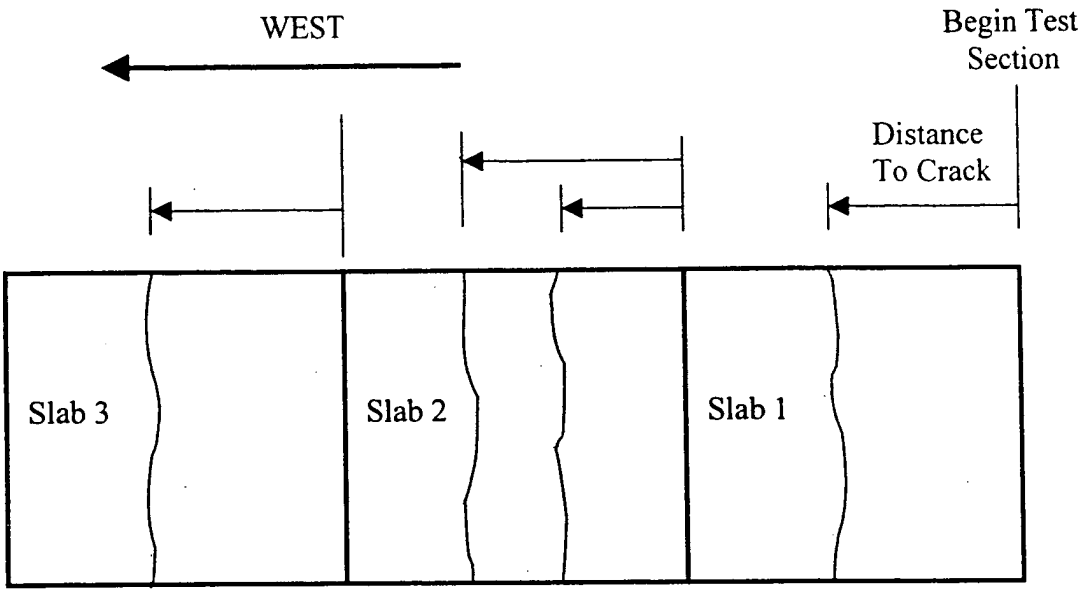
RT. 2 - CONCRETE CRACK LOCATIONS

Slabs numbered from east to west
Transverse cracks measured from east end of slab
Slabs shaded in table have longitudinal cracks
