DOT/FAA/AR-97/9

An Acoustic Emission Test for Aircraft Halon 1301 Fire Extinguisher Bottles

April 1998

Final Report

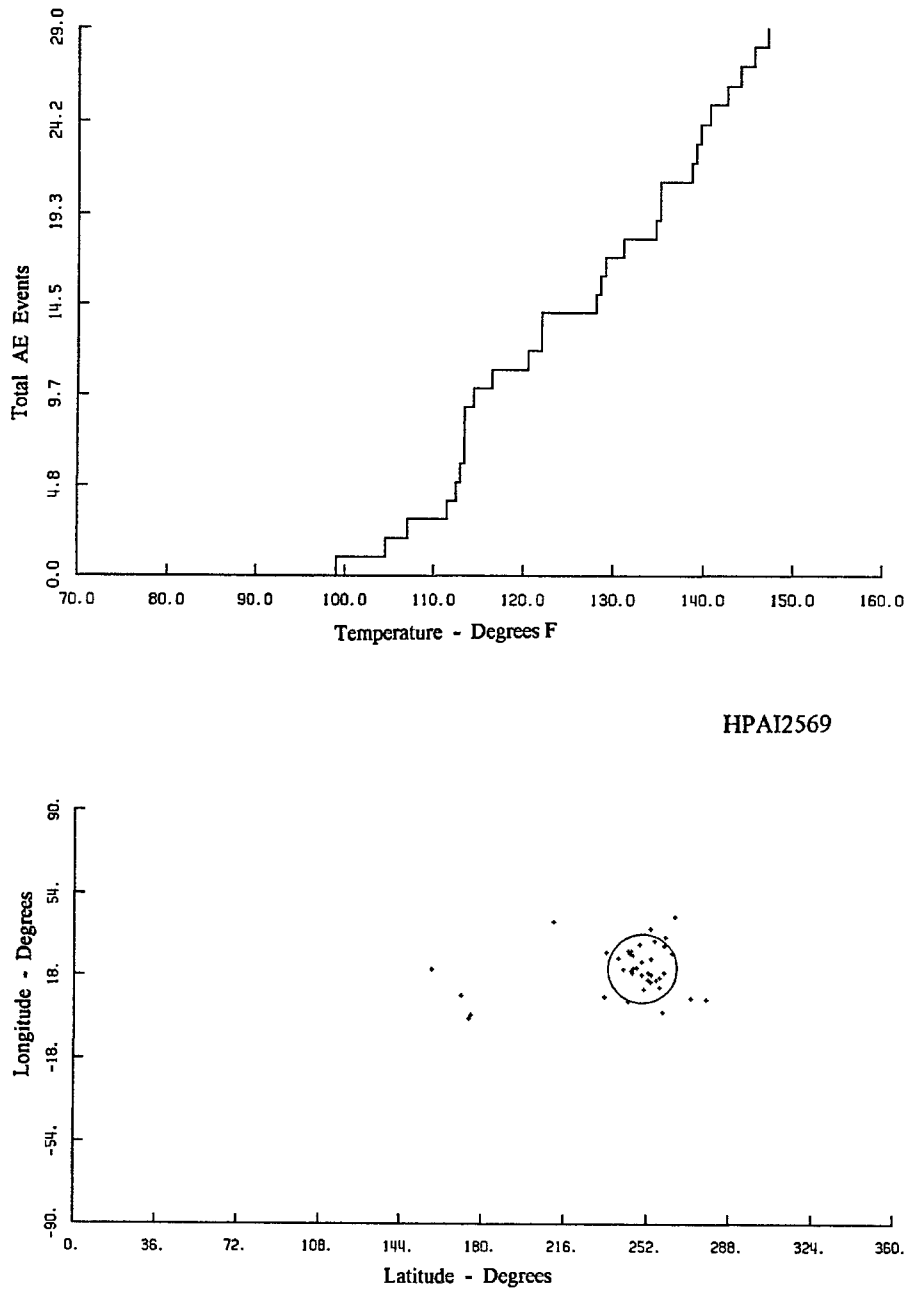
Location diagrams and event versus temperature data are shown in figures 4 and 5. In figure 4, a serious appearing cluster containing 29 events is shown on the location plot. However, the event rate is constant as the temperature, and thus the pressure, increases. In contrast, figure 5 shows a

FIGURE 4. EVENT VERSUS TEMPERATURE CURVE AND LOCATION PLOT. The slope of the event curve for the cluster is constant with increasing temperature.

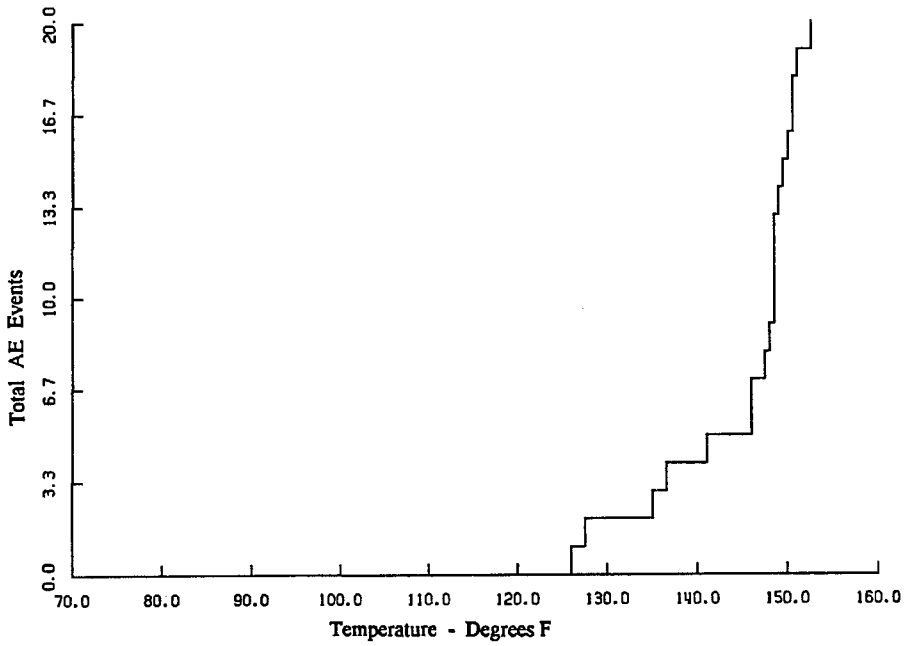
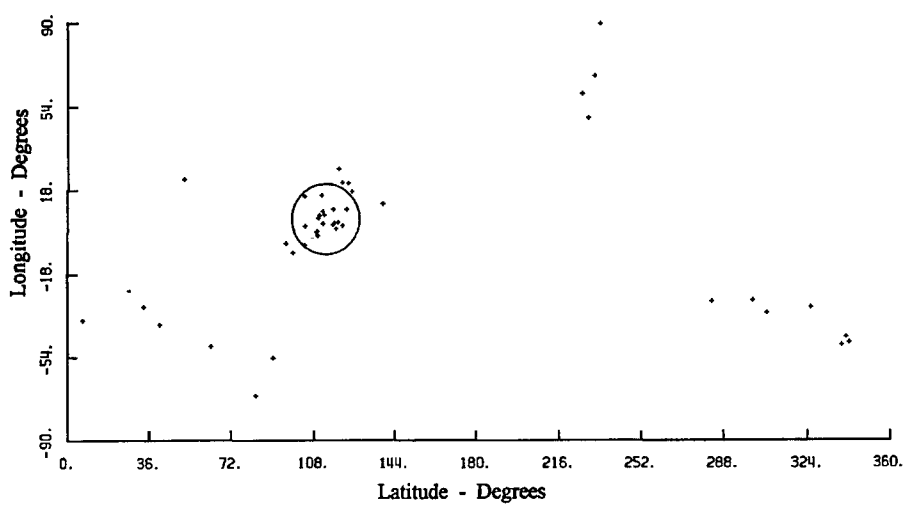
cluster containing 20 events, but 18 of the 20 events occurred above 130°F. The cluster in figure 5 is located partially over a doubler plate on the bottle. An x ray of this plate showed a tungsten inclusion in the fillet weld holding the plate on the bottle. The fact that the emission did not start until a relatively high temperature and the rapid emission rate above 148°F is strong evidence that a crack is propagating in the weld, starting from the tungsten inclusion. Because

FIGURE 5. EVENT VERSUS TEMPERATURE CURVE AND LOCATION PLOT. The slope of the event versus temperature curve for the cluster shows a significant increase at high temperatures.

the bottle passed a hydrostatic test, the crack is probably not in the vessel wall but instead is propagating within the doubler plate fillet weld parallel to the wall. Thus, it is a real flaw but one which may not result in the failure of the bottle.
