A CASE STUDY OF THE DESIGN, INSTALLATION, AND EARLY PERFORMANCE OF A NINETEEN-MILLIMETER SUPERPAVE MIX

VTRC VDOT VAA SUPERPAVE

July 1999
VTRC 00-R2

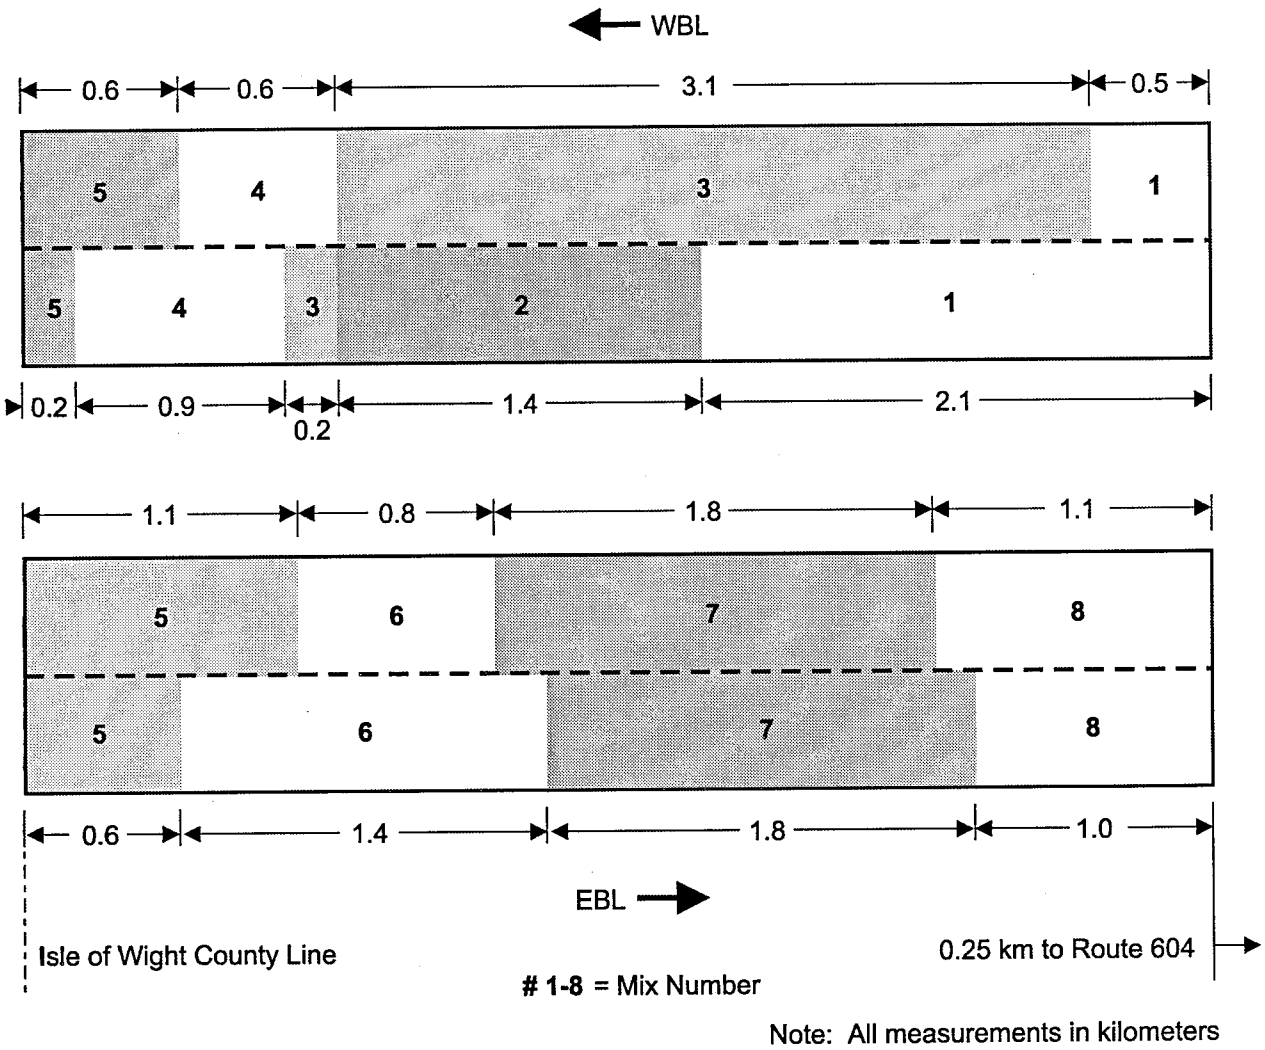
Figure 1. Test Section, Route 460

Several changes in the blends and asphalt contents were made during the project in an attempt to refine the mix design, which resulted in the production of eight mixes (see Figure 1).

However, the problems with low voids in lab specimens and tenderness during field compaction were not solved. Texas also reported tenderness problems, especially with 19.0-mm mixes (Tahmoressi, 1997), and other states have reported at unrecorded meetings that some 19.0-mm mixes are tender during compaction. It has been observed by others that a temperature zone exists where the mix is tender during compaction. They found it necessary to roll the mix while it was hot, stop rolling as the mix temperature was in the tenderness zone, and complete the rolling when the mix cooled below the tenderness zone (Deahl, 1999). Although the tenderness zone was observed on the Route 460 project, the rolling technique described was not known at that time and, therefore, was not used.

Mix 5 was placed in the eastbound and westbound traffic lanes (see Figure 1). The average rut depth of 3.3 mm and 5.8 mm in the eastbound and westbound traffic lanes, respectively, was significantly different when analyzed with a *t* test at 95 percent confidence limits. The test results (volumetrics and gradation) of samples from both sections revealed no obvious reasons for the difference. Also, the rut depth of other mixes placed in the westbound lane was obviously not larger than that of mixes in the eastbound lane, which does not indicate a difference in traffic loading in the two directions.

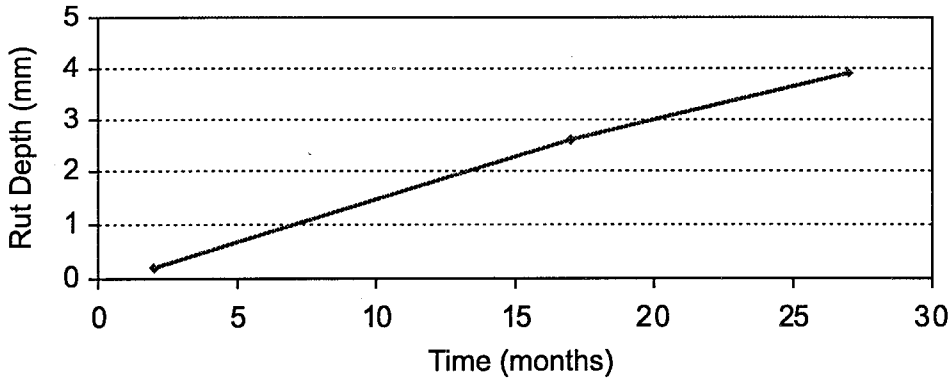
Figure 2. Average Rut Depth of Mixes in Outside Traffic Lanes

Density (voids) and rut depth field tests were performed. The results are shown in Table 7. Also, the change of rut depth with time is shown in Figure 2. Rutting has progressed approximately at a linear rate since construction with a total average rut depth of approximately 4 mm after slightly more than 2 years. Although the total rut depth is not excessive, it is hoped

that the rate of development will decrease. Some of the rutting can be attributed to consolidation, but calculations for the 1.2 percent decrease in pavement voids can account for only about 0.5 mm of the rutting. Most of the rutting is probably the result of aggregate particles reorienting themselves to a more stable state. If adequate density could have been achieved during construction, the particles would have been in a more stable position and this initial rutting should have been less.
