DOT/FAA/AR-99/11

Large Engine Uncontained Debris Analysis

May 1999

Final Report

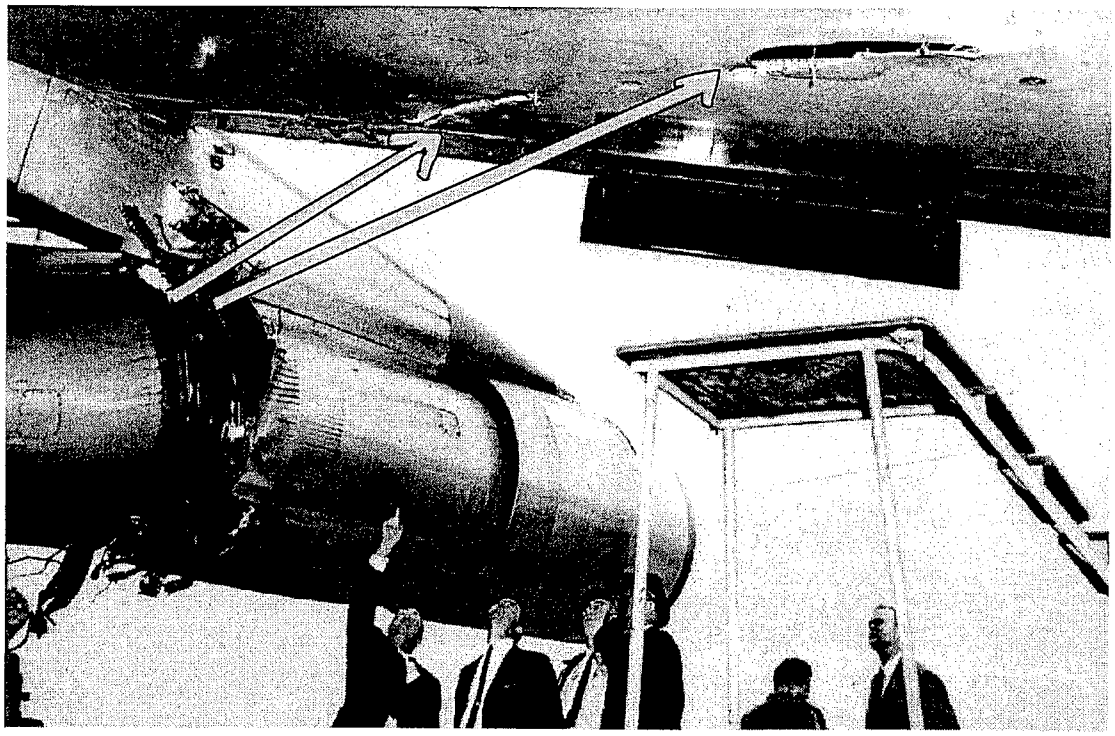
Uncontained gas turbine engine events, figure 1-1, are a basic threat to aircraft safety. To better defend against this threat, debris characteristics must be accurately defined. Debris characterization includes defining debris size, mass, velocity, trajectory angles, and number of fragments per event type. This report defines these characteristics for different engine types and failure modes. Recommendations for future analysis are also provided.

FIGURE 1-1. UNCONTAINED TURBINE DISK EVENT

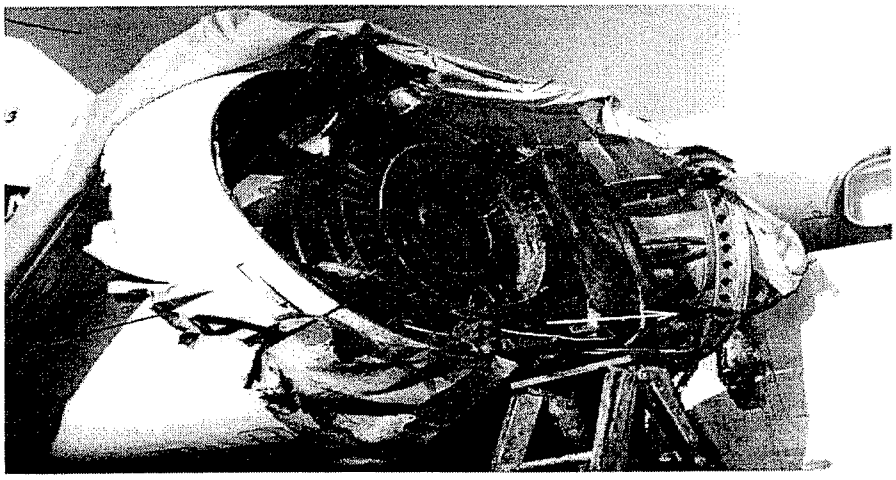
For fan disk damage from a disk failure (shown in figure 4-12), figure 4-13 shows the basic trajectory angles to range from +5 and -5 degrees. A 100% normalized disk fragment is used to model fan disk debris. Initial energy levels are near 100,000 ft lbf.

FIGURE 4-12. FAN DISK DAMAGE

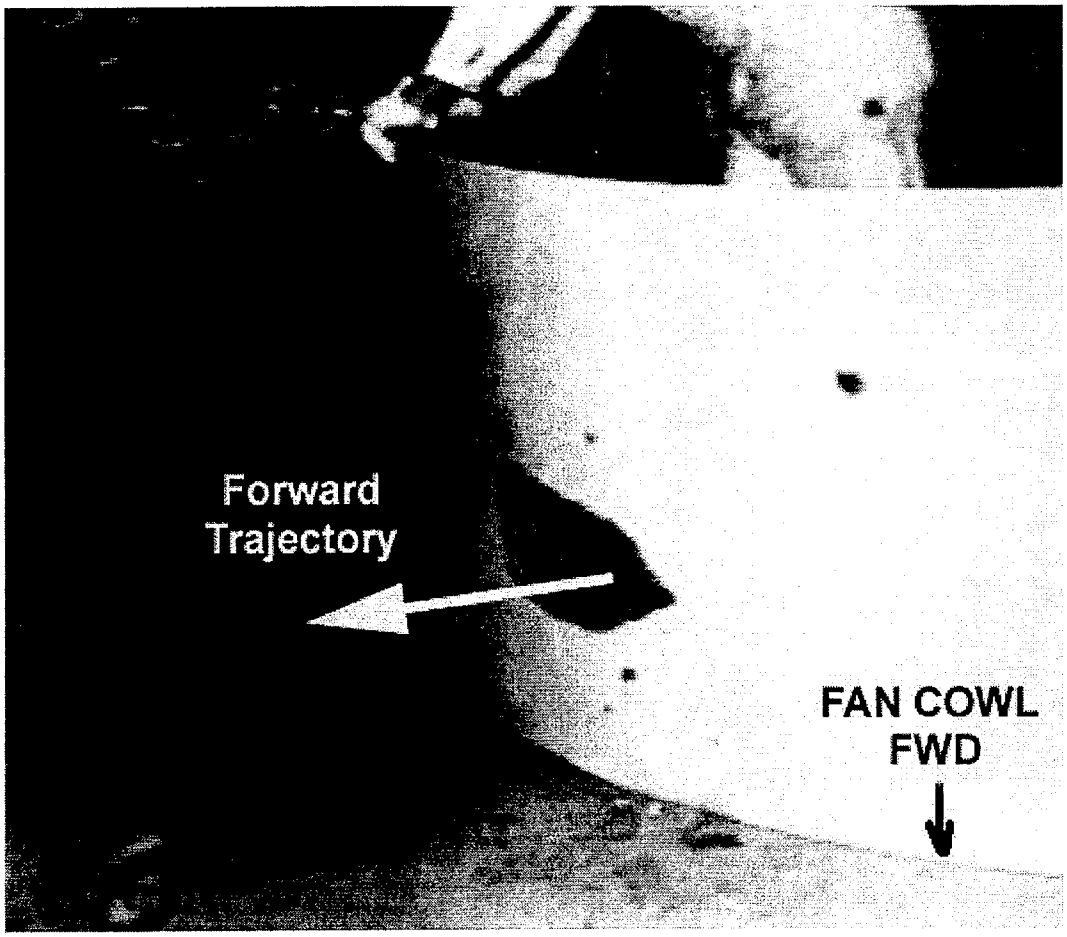
FIGURE 4-21. BLADE DEBRIS EXIT AND COWL DAMAGE

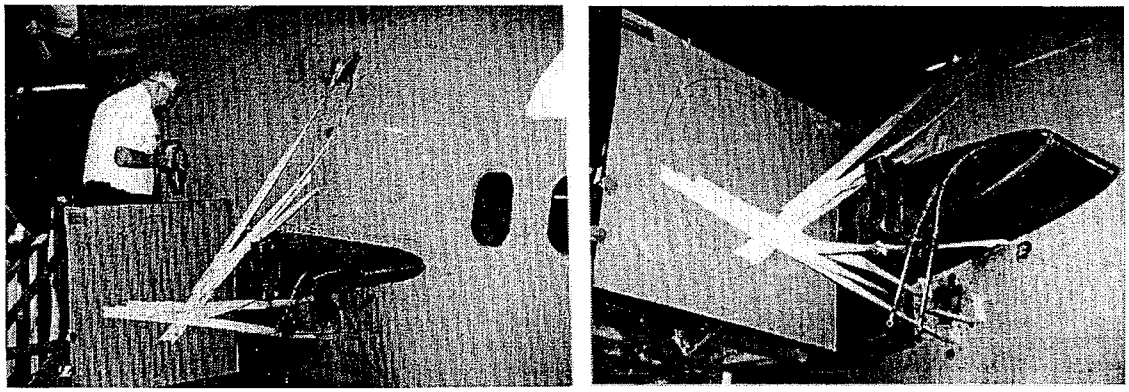
FIGURE 4-25. DISK AND BLADE DAMAGE FROM COMPRESSOR DISK EVENT

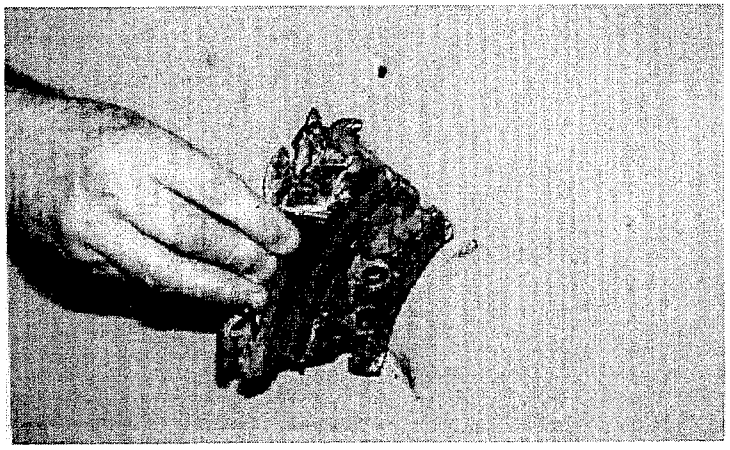
Figure 4-28 shows a compressor disk fragment after passing through the fuselage. Figure 4-29 shows a very tight trajectory band of 5 to -5 degrees for disk debris. Initial energy levels are near 25,000 ft-lbf. These levels are similar to the fan blade energy levels presented earlier (figure 4-6). Disk pieces, however, often enter the fuselage edgewise making them far more likely to penetrate aircraft structure.

FIGURE 4-28. COMPRESSOR DISK FRAGMENT AFTER PASSING THROUGH THE FUSELAGE

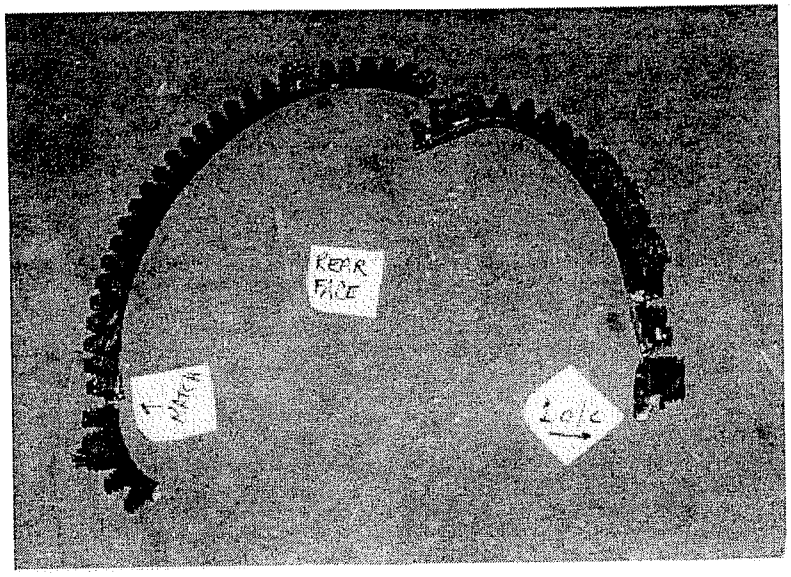
FIGURE 4-48. TURBINE RIM FRAGMENTS FROM RIM PEAL EVENT

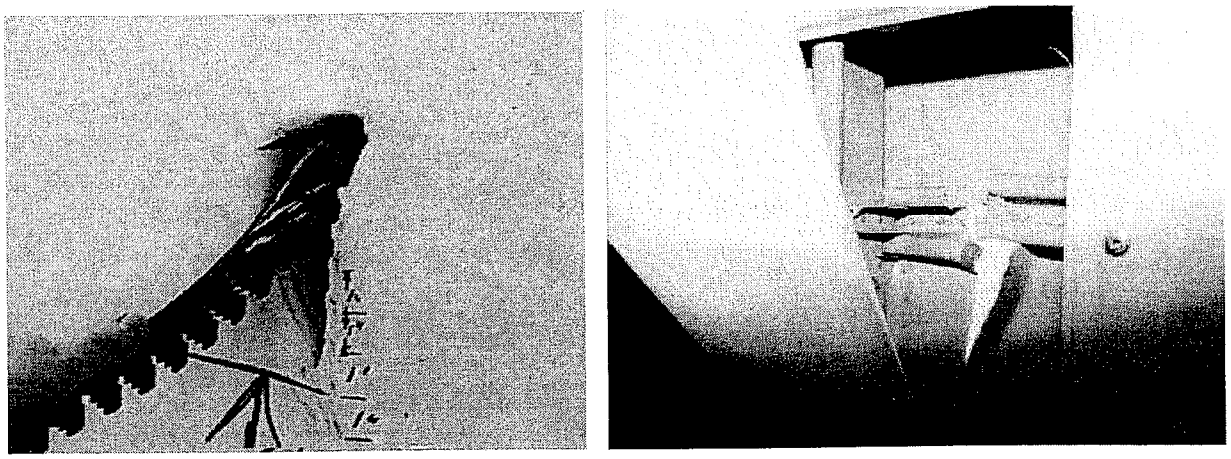
FIGURE 4-50. FUSELAGE DAMAGE FROM TURBINE RIM DEBRIS

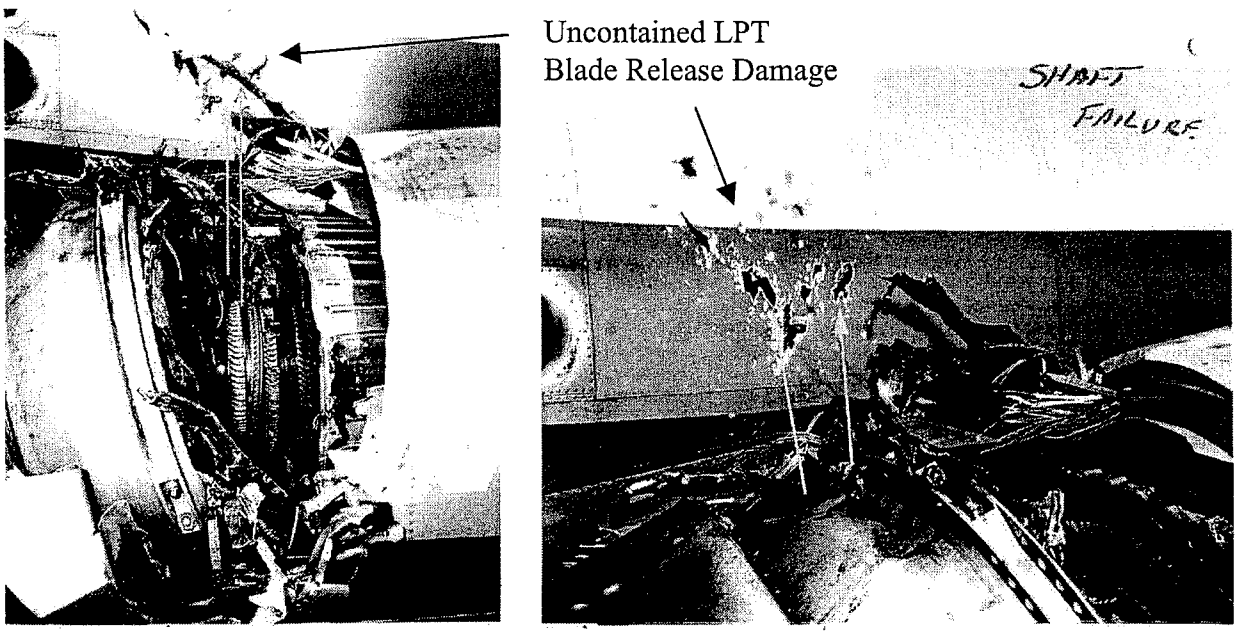
FIGURE 4-59. TURBINE OVERSPEED RESULTING IN UNCONTAINED LPT BLADE RELEASE (NEAR-FIELD FUSELAGE DAMAGE)
