Report No. CG-D-01-99, I

Investigation of Fuel Oil/Lube Oil Spray Fires On Board Vessels

Volume I

FINAL REPORT
NOVEMBER 1998

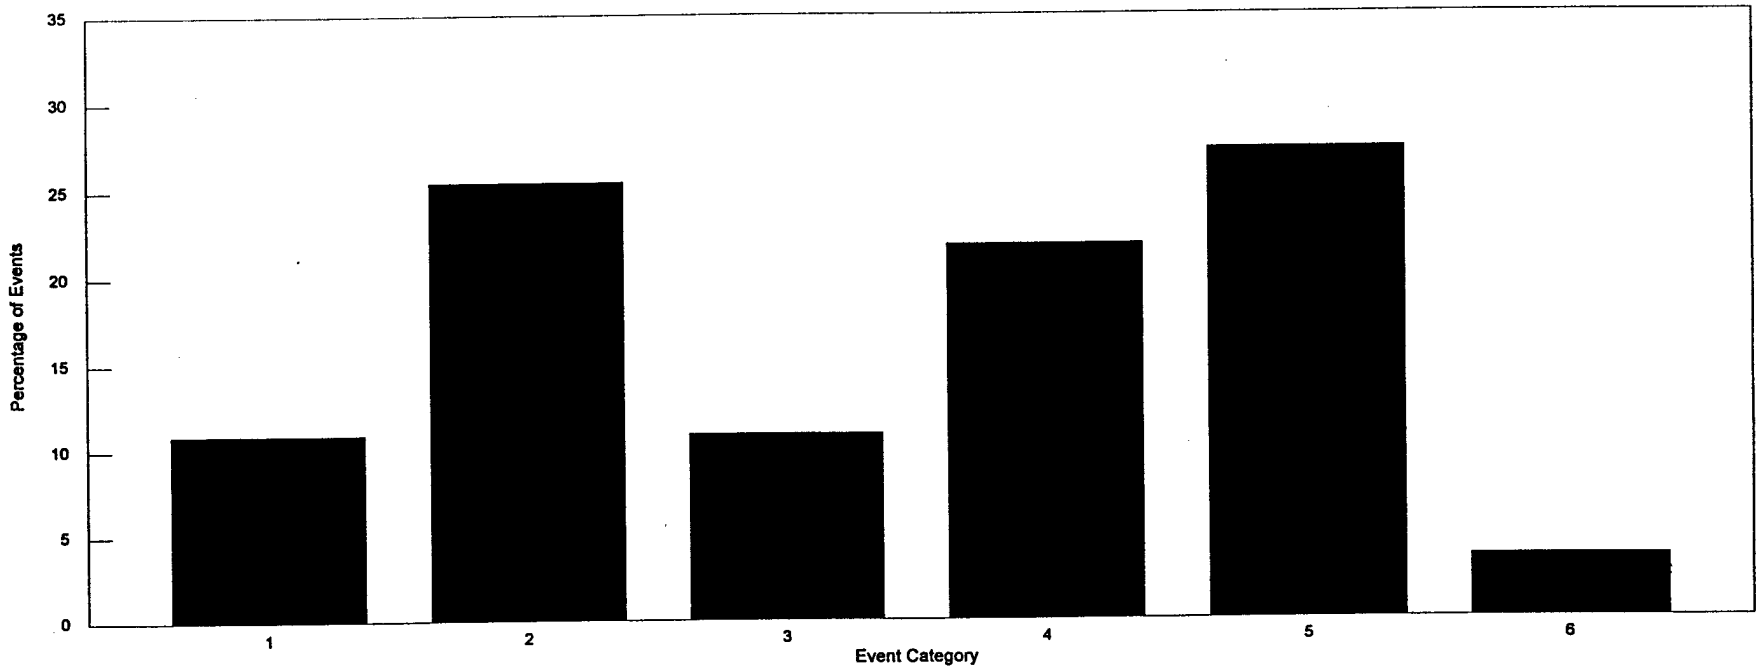
Figure 3.1 General Categories of Causes of Fuel Oil/Lube Oil Spray Fires

Spray fires have occurred because of a variety of human-related and/or equipment-related causes. Although each incident is unique regarding the specific cause of failure, it is convenient for the purpose of discussion to assign them to one of six general categories of causes of failure. Figure 3.1 presents the percentage of incidents that resulted from each general category. Next we discuss and illustrate each category.

In addition, Figure 3.1 shows that 20% of the releases were attributed to incorrect design, deficiencies in manufacturing, and/or errors during installation. One might expect that these types of causes of fires would affect newer ships more than older ships. Thus, it would appear that the frequency of these fires should decrease with the ship's age. However, several spray fires were attributed to incorrect design, deficiencies in manufacturing, and/or errors during installation deficiencies *following ship modifications* (not following initial design and commissioning). That is, ship modifications allow these types of deficiencies to be introduced throughout the life of a ship, thereby helping explain the lack of correlation between the number of spray fires and the ship's age.

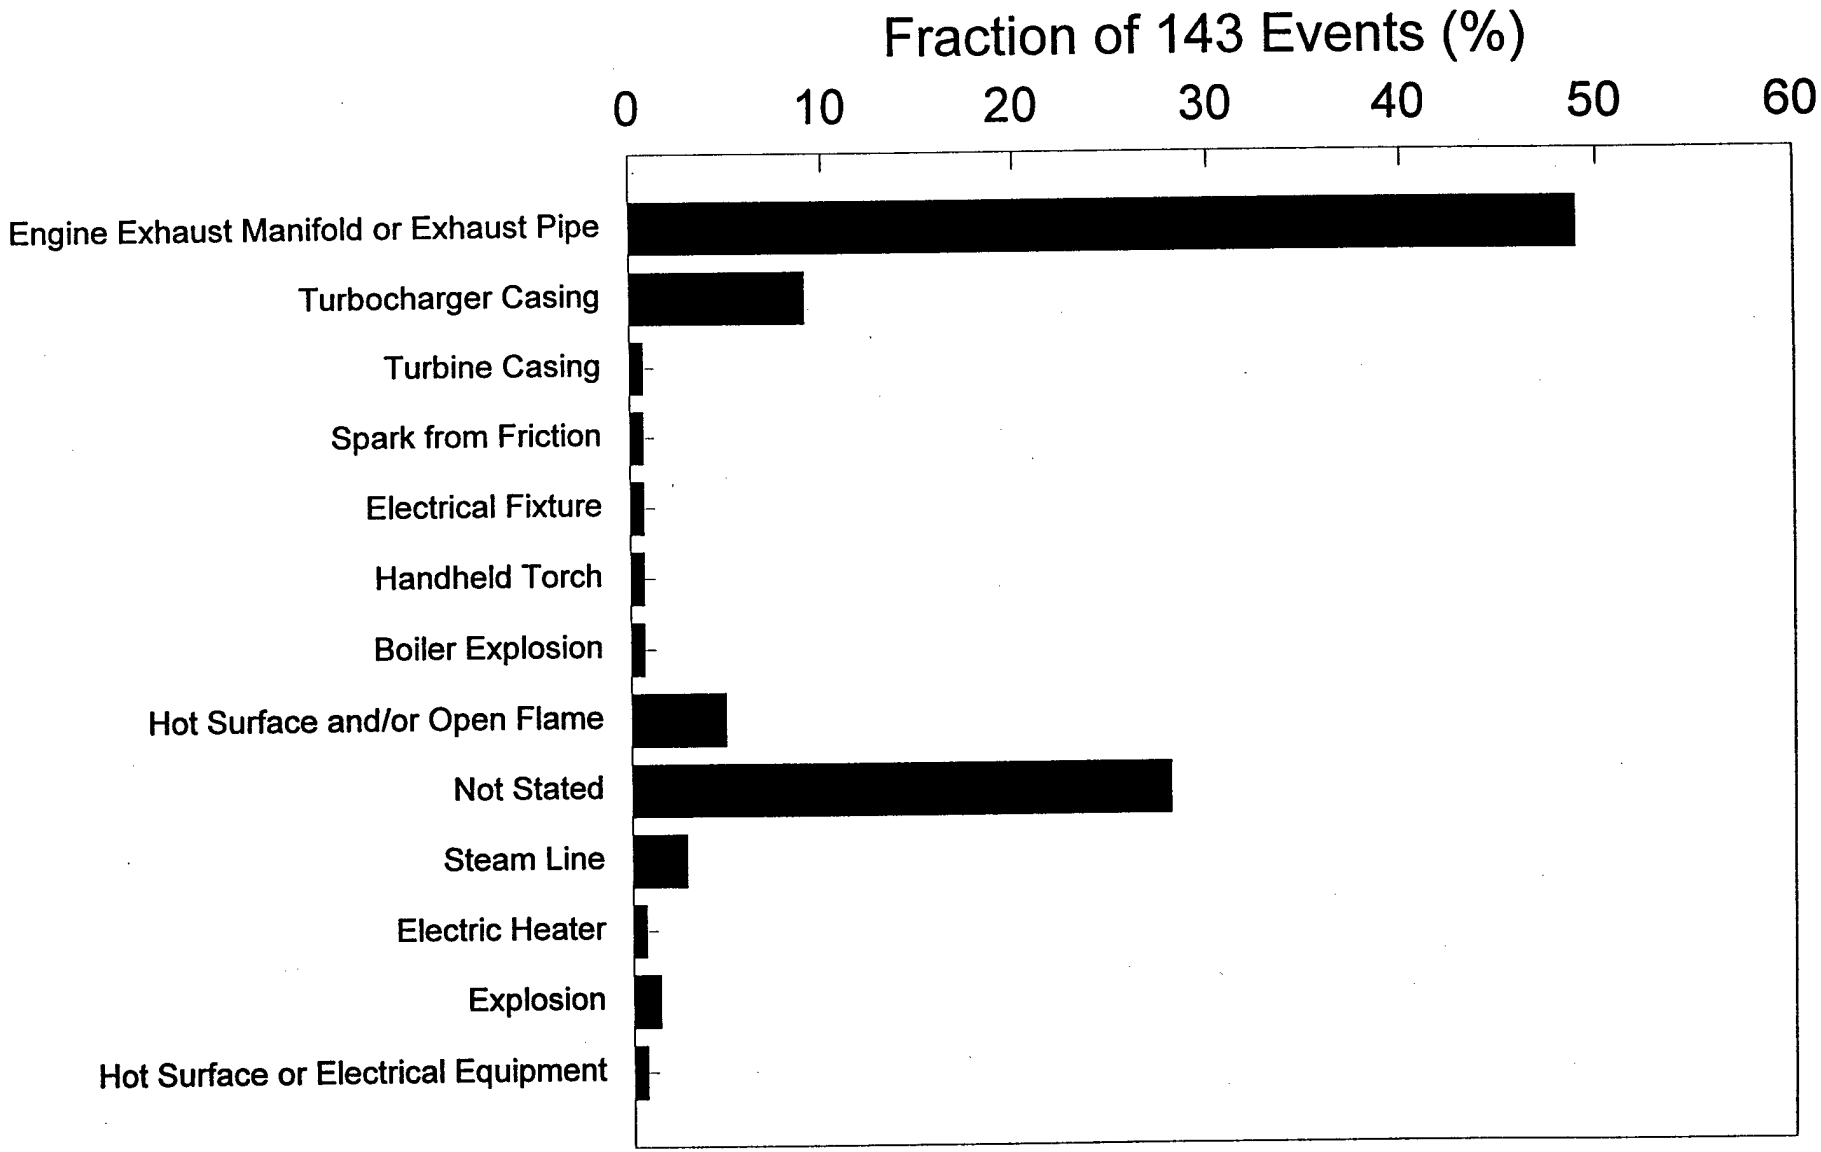
Figure 3.2 Source of Ignition: All Oil Fires

3.2 Sources of Ignition of Fuel Oil/Lube Oil Spray Fires — Figures 3.2 through 3.4 show the sources of ignition for the 143 spray fires, 17 spray fires with injury or fatality, and 9 spray fires with fatality, respectively. "Engine Exhaust Manifold or Exhaust Pipe" is by far the most common source of ignition (almost 50% of all fires in Figures 3.2 and 3.3 and about 22% of all fires in Figure 3.4). The "Not Stated" category is also an important contributor in all cases, particularly in Figure 3.4, are "Turbocharger Casing" and "Steam Line." It is clear that hot surfaces dominate risks of ignition within engine rooms on board ships.

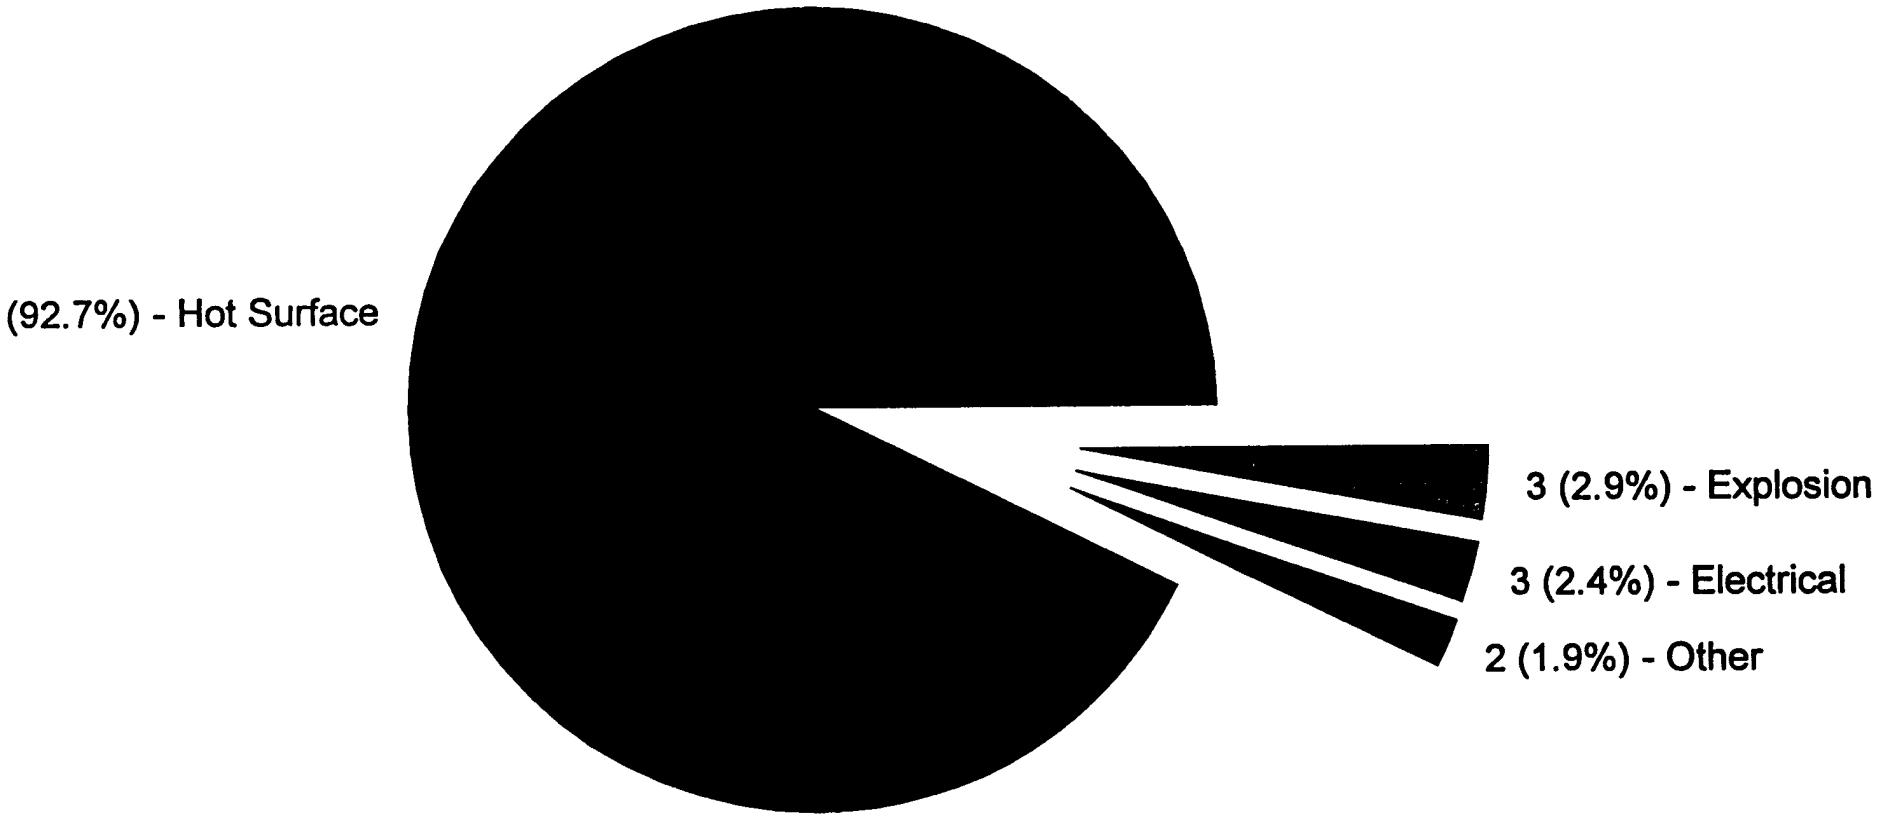
Figure 3.5 Sources of Ignition by Categories: All Oil Fires

To further illustrate the dominance of hot surface, Figures 3.5 through 3.7 show the relative contribution of categories of sources of ignition, defined in Table 3.1.

The category "Hot Surface" is responsible for the ignition of about 93% of all fires, 93% of all fires with injury or fatality, and about 86% of the fires with fatality. For the latter (fires with fatality), the one incident ignited by a handheld torch represents about 14% of all fires because there are only seven fatal fires in which the source of ignition has been determined and documented.

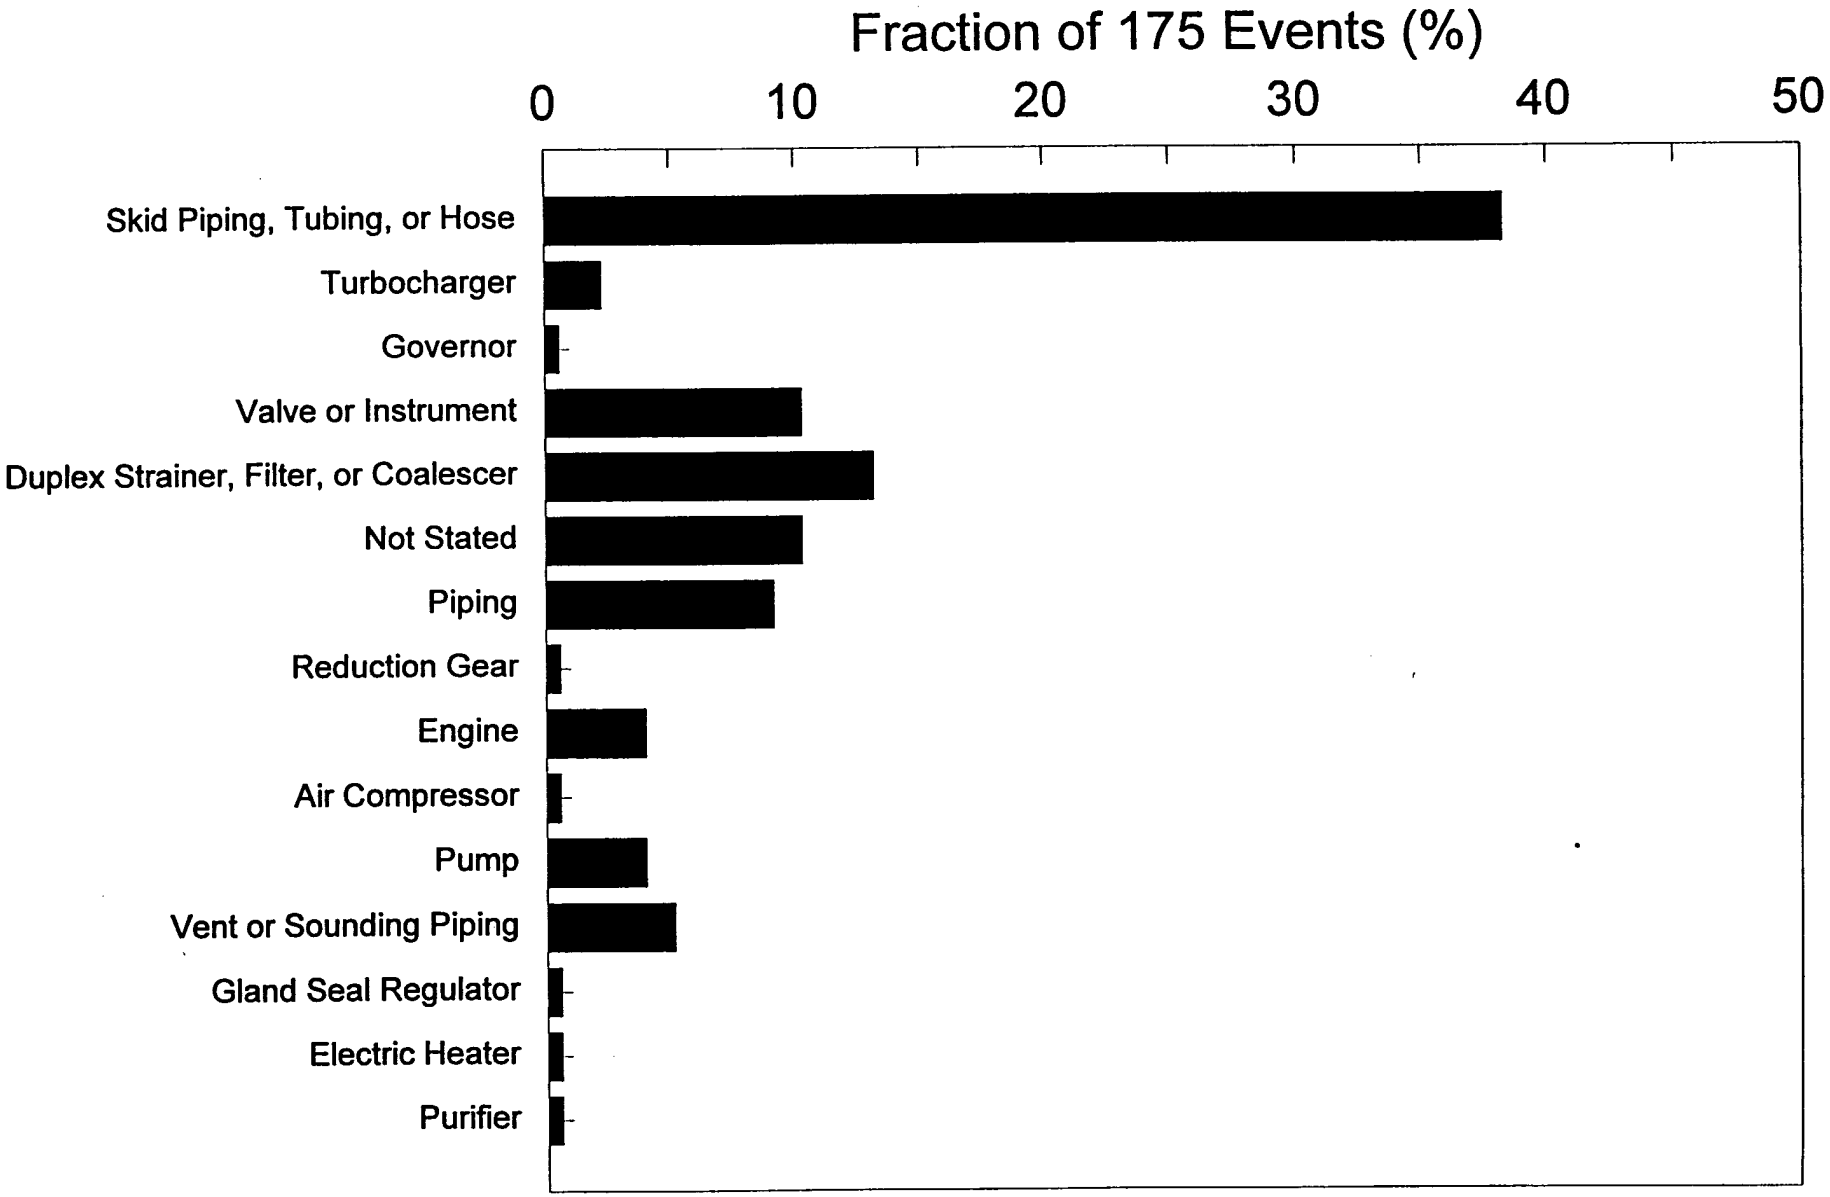
Figure 3.8 Equipment Involved in the Release: All Oil Releases

3.3 Equipment Involved in Fires Caused by the Release of Fuel Oil/Lube Oil — Figures 3.8 through 3.10 show the equipment involved in the release of fuel oil/lube oil and its contributions to all fire incidents (Figure 3.8), all fires with injury or fatality (Figure 3.9), and all fires with fatality (Figure 3.10), respectively. "Skid Piping, Tubing, or Hose" dominates risks in Figures 3.8 and 3.9, and it is important in Figure 3.10. (The piping outside the engine or pump skid [e.g., piping from oil tanks to strainers and piping from strainers to diesel engines] is considered separately in the category "Piping.") These results are interesting because skid piping/tubing/hose is usually under the control of the manufacturer (i.e., the piping/tubing/hose that comes with an engine skid or pump skid), and it is generally not subject to regulations and standards that are in place for piping outside the engine/pump skid.

However, the equipment category "Duplex Strainer, Filter, or Coalescer," which is the second most prevalent in Figures 3.8 and 3.9, dominates risks in Figure 3.10. *That is, spray fires involving "Duplex Strainer, Filter, or Coalescer" have been more fatal than fires involving other types of equipment.* In fact, the equipment category "Duplex Strainer, Filter, or Coalescer" is responsible for 55% of all fuel oil/lube oil spray fires with fatality (Figure 3.10).

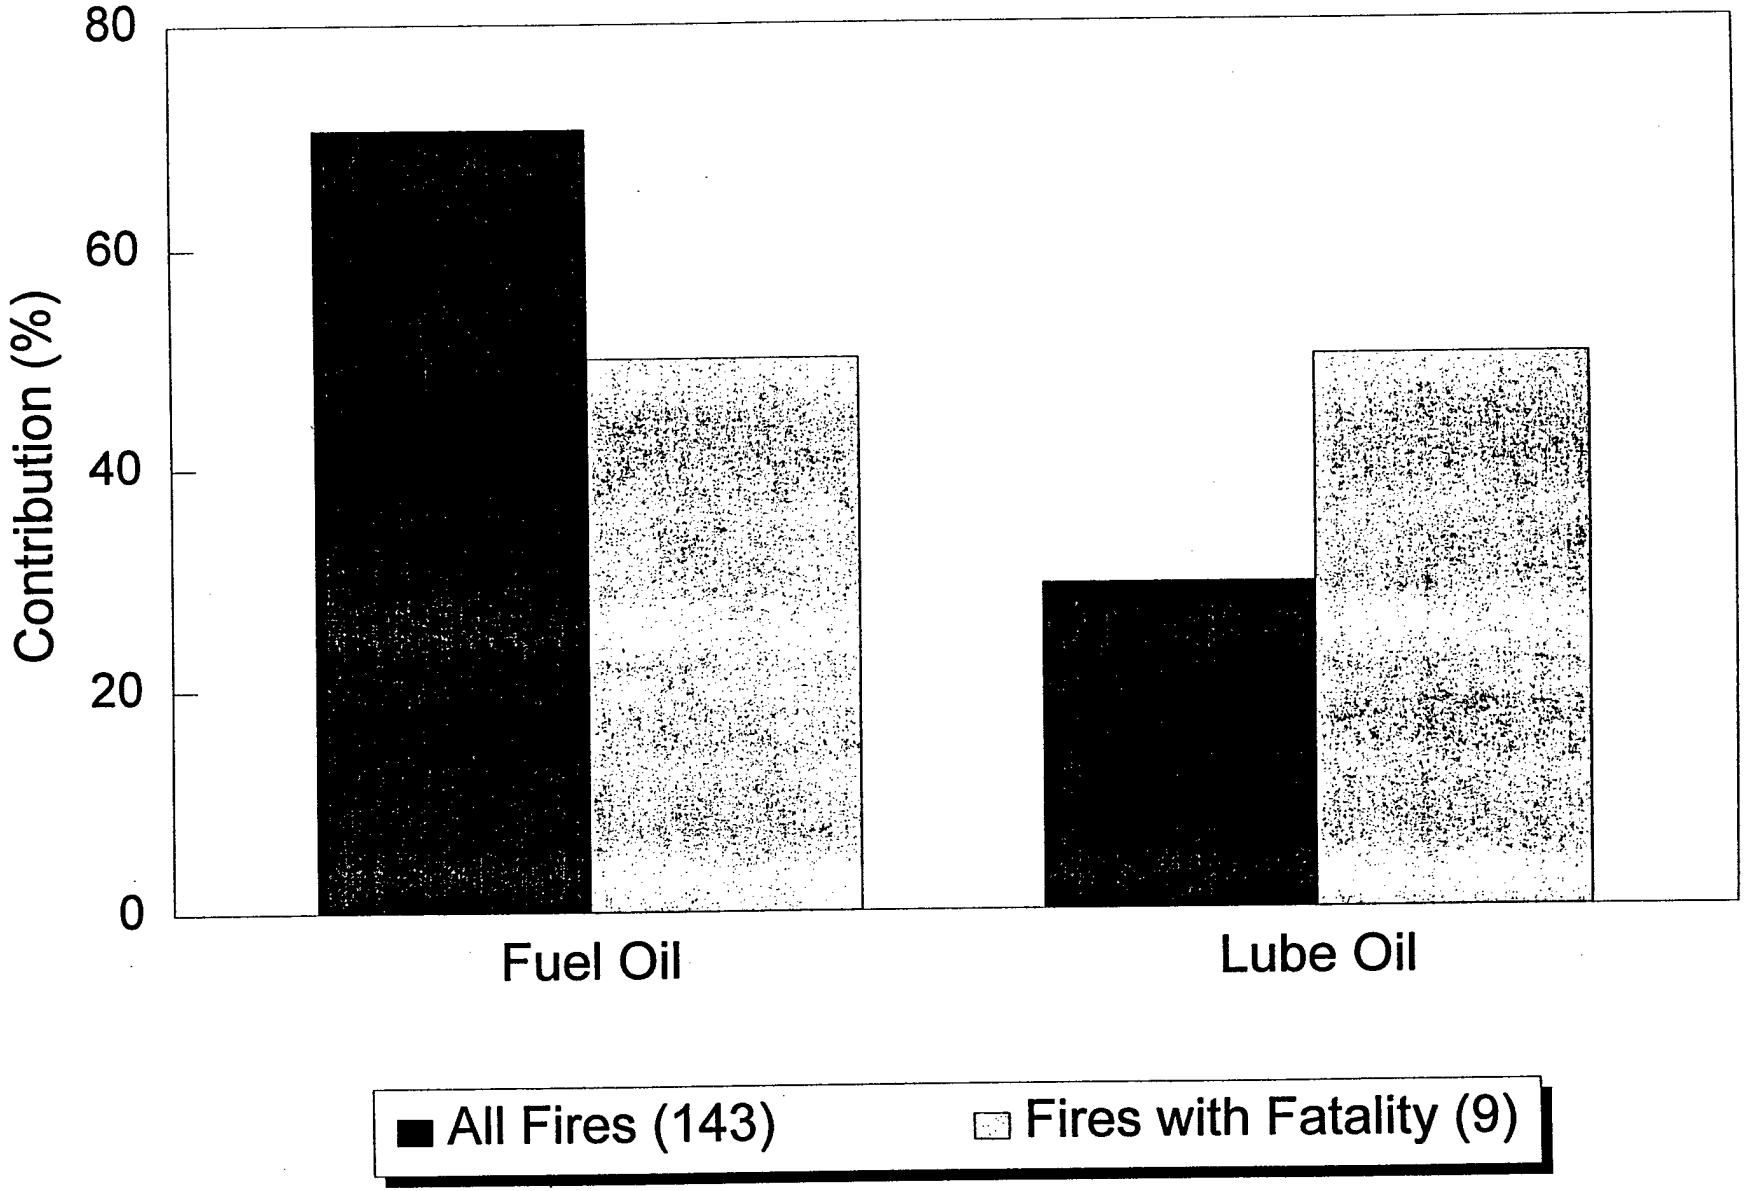
Figure 3.11 System Involved in the Fire

3.4 System Involved in Fires Caused by the Release of Fuel Oil/Lube Oil — Figure 3.11 shows that fuel oil systems account for about 70% of all oil fires while lube oil systems account for about 30%. However, when fires with fatality are considered, these contributions are 50% for fuel oil systems and 50% for lube oil systems. This indicates that while fuel oil fires occur more often (about twice as much) than lube oil fires, the fewer lube oil fires have caused as many fatal incidents as fuel oil. Figure 3.12 further illustrates this point. The probability of a fatality given a fuel oil fire is about 4% while the probability of a fatality given a lube oil fire is about 10% (more than twice as much). *Therefore, lube oil fires are less frequent than fuel oil fires, but they tend to be more fatal when they do occur.*

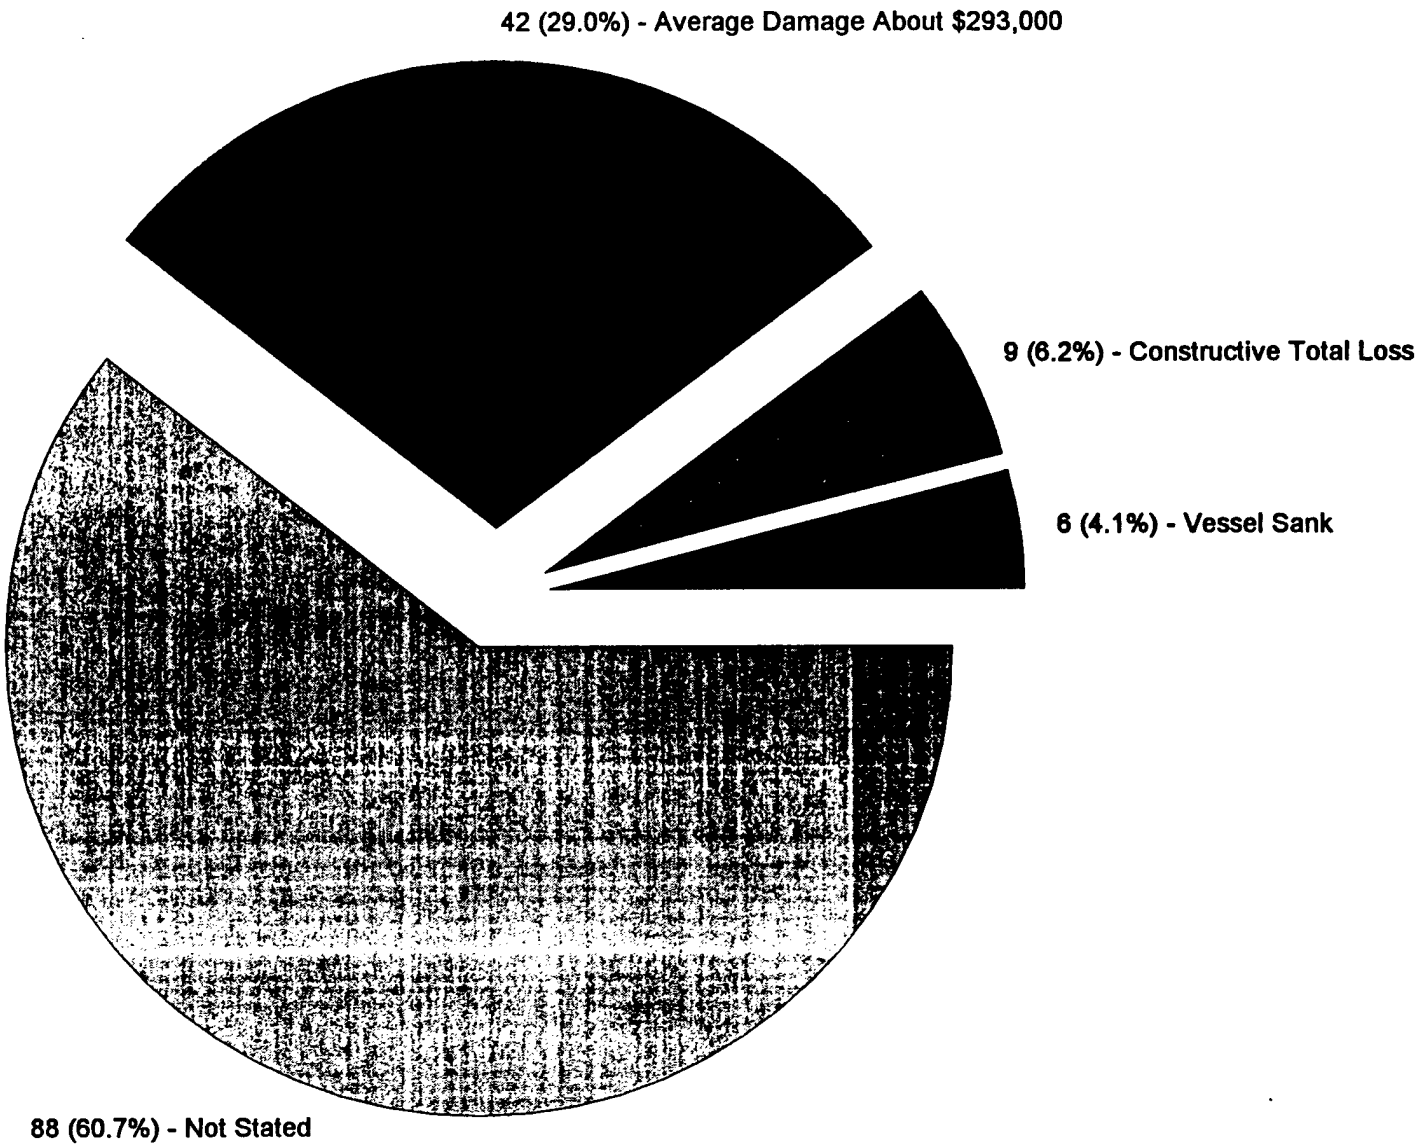
Figure 3.13 Damage Characterization

3.5 Damage Characterization — Figure 3.13 shows that the damage incurred in many spray fires (about 61%) was not stated in the incident reports. However, damage information was available in 57 incident reports, and Figure 3.13 shows that it is extensive.[h] The vessel sank in 6 of the incidents, incurred constructive total loss in 9 of the incidents, and incurred an average of about $293,000 in the remaining 42 incidents.

[h]In addition to the 55 incident reports in Appendixes A through G that provided damage information, Figure 3.13 considers the damage from two other incidents: *Fire on Board the Bahamian Passenger Ship THE SCANDINAVIAN STAR in the Gulf of Mexico, March 15, 1988*, NTSB/MAR-89/04, National Transportation Safety Board, Washington, DC, July 1989, and *Engineroom Fire Aboard the U.S. Tankship CHARLESTON in the Atlantic Ocean About 35 Miles off the South Carolina Coast, March 7, 1989*, NTSB/MAR-90/06, National Transportation Safety Board, Washington, DC, October 1990. These two incidents were not included in the appendixes because these reports became available after the hazard evaluation described in Step 7 in Section 2. We considered them in Figure 3.13 because they were among the most expensive engine room fires for the shipping industry.

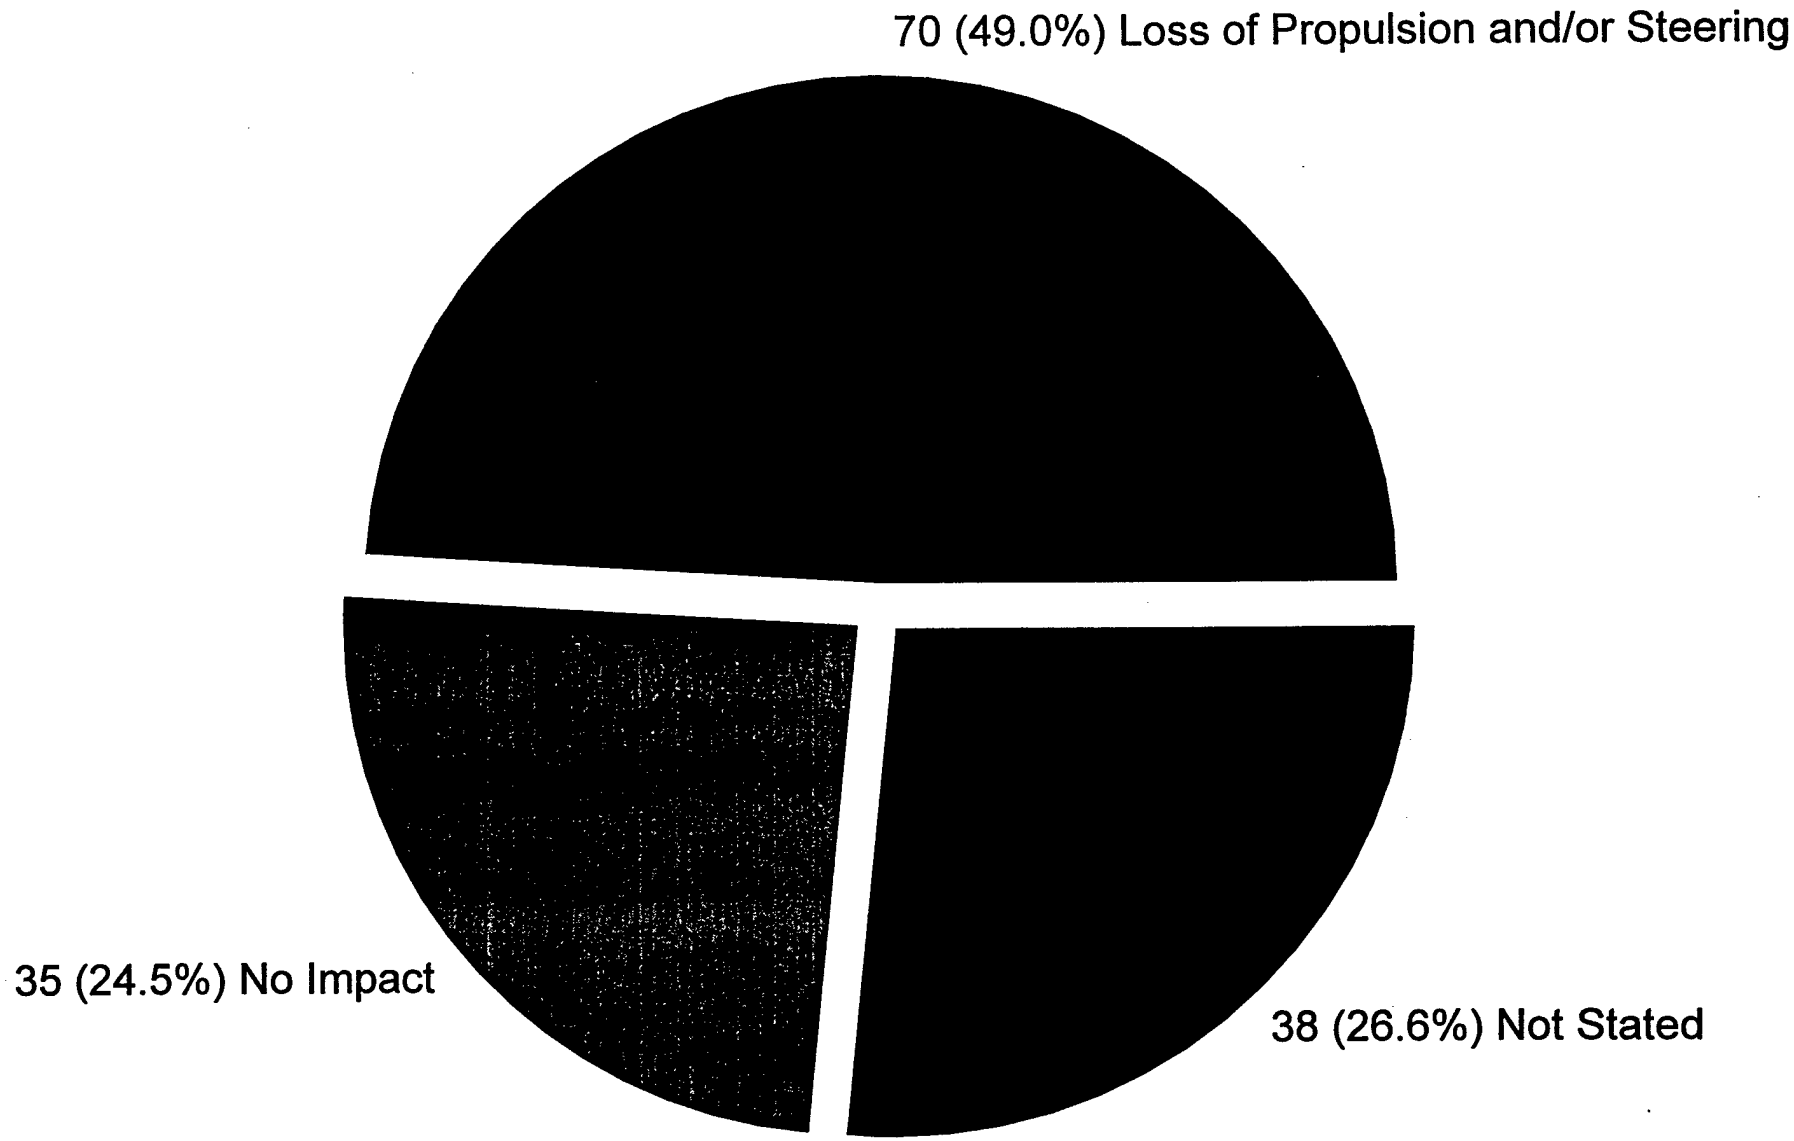
Figure 3.14 Impact on Propulsion/Steering: All Oil Fires

Figure 3.14 shows that vessels experienced loss of propulsion and/or steering in 70 incidents and were able to maintain these functions in 35 incidents. (These are important statistics because loss of propulsion and/or steering can lead to other incidents such as grounding and collision.) These numbers indicate that the probability of loss of propulsion and/or steering is about twice the probability of not losing these functions during spray fires.

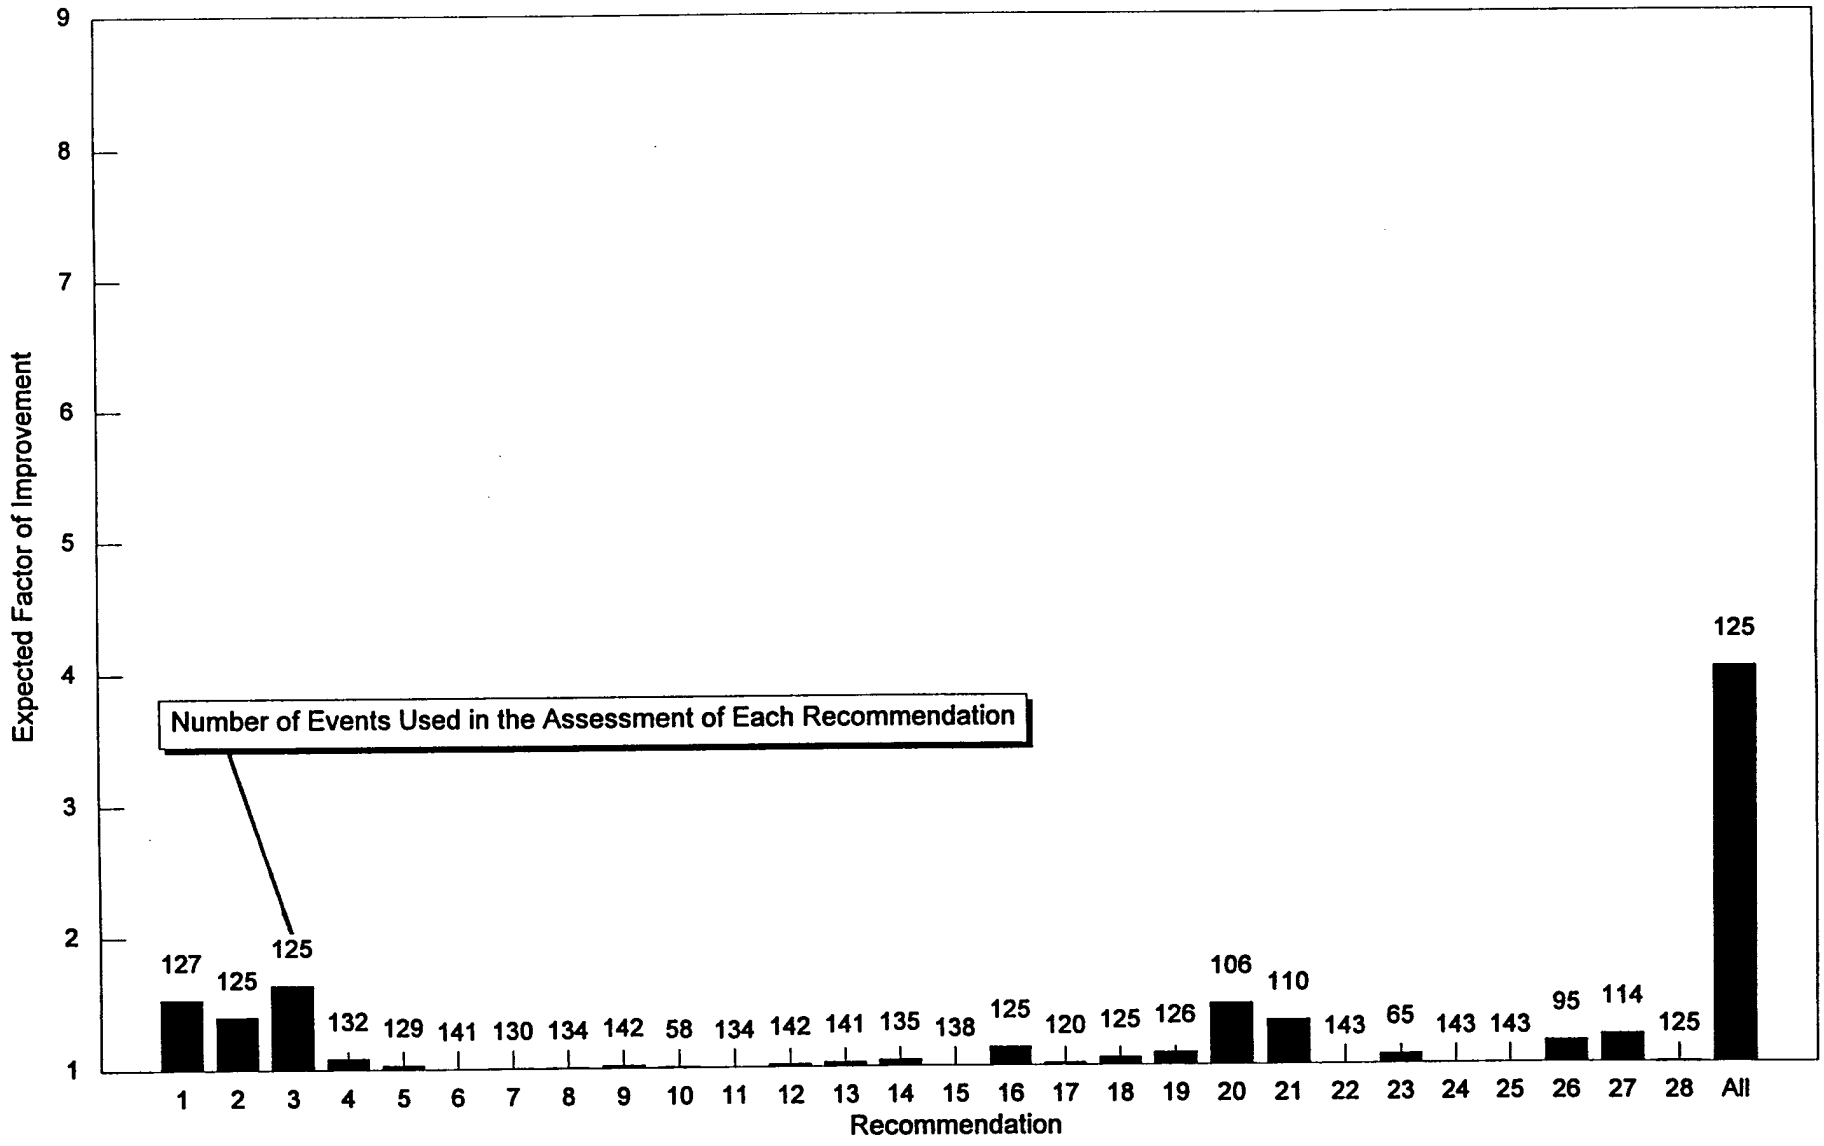
Figure 3.15 Expected Factors of Improvement for Preliminary Recommendations (All Oil Fires)

3.6 Impact of Preliminary Recommendations — Figures 3.15, 3.16, and 3.17 show the expected factors of improvement for each preliminary recommendation (1 through 28) and for all preliminary recommendations combined (All) for all oil spray fires, all fires with injury or fatality, and all fires with fatality, respectively. In Figure 3.15, no single preliminary recommendation provides significant improvement (e.g., a factor of 2 improvement) by itself. (A factor of 2 improvement implies a 50% reduction of the frequency of incidents.) However, several preliminary recommendations (i.e., 1, 2, 3, 16, 20, 21, 26, and 27) do provide some improvements. The combined impact of all preliminary recommendations is a factor of 4 improvement (reduction of the frequency of incidents to 25% of its frequency without the benefits of these recommendations), primarily because of preliminary recommendations 1, 2, 3, 16, 20, 21, 26, and 27.

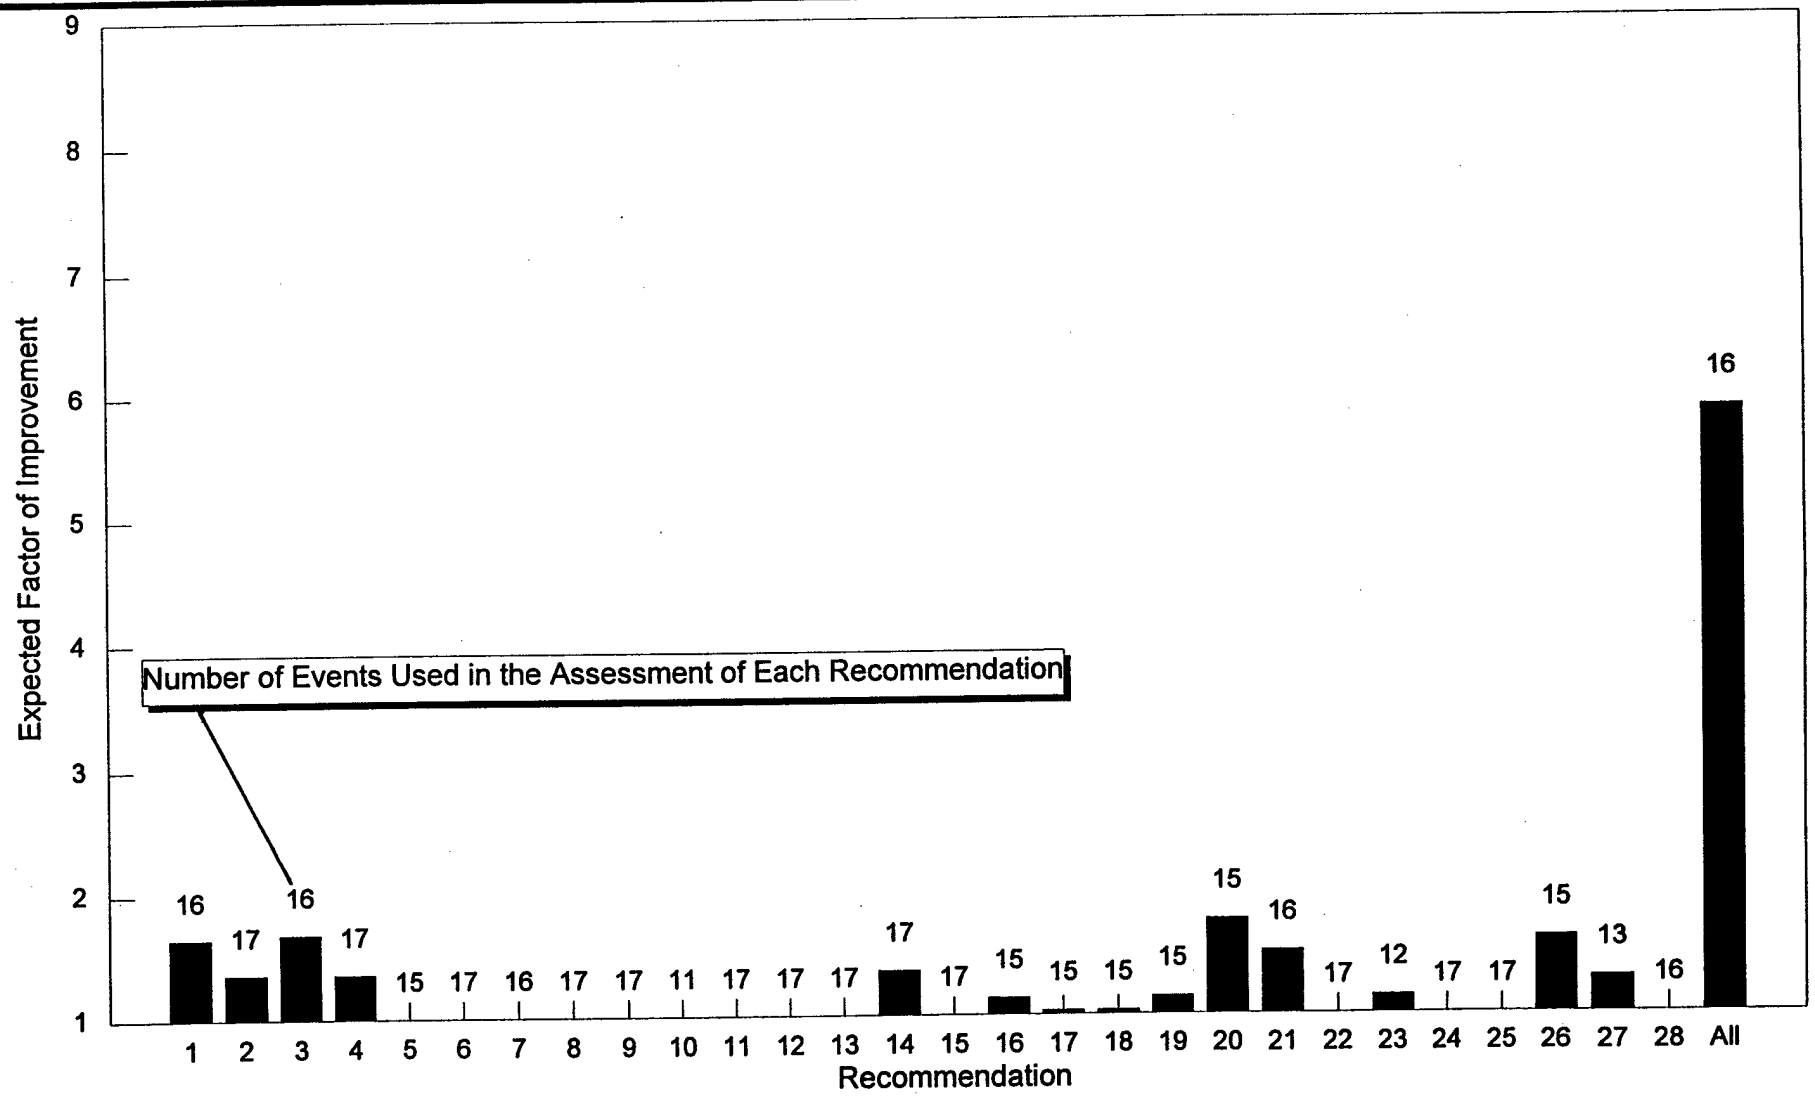
Figure 3.16 Expected Factors of Improvement for Preliminary Recommendations
(All Fires with Injury or Fatality)

Figure 3.16 shows similar results for the impact of preliminary recommendations on fires with injury or fatality. However, the individual impact of several recommendations is higher in Figure 3.16. Also, some preliminary recommendations (i.e., 4 and 14) that had little or no impact in Figure 3.15 show some benefits in Figure 3.16. The combined impact of all preliminary recommendations is a factor of about 6 improvement (reduction of the frequency of incidents to 17% of its frequency without the benefits of these recommendations), primarily because of preliminary recommendations 1, 2, 3, 4, 14, 16, 19, 20, 21, 23, 26, and 27.

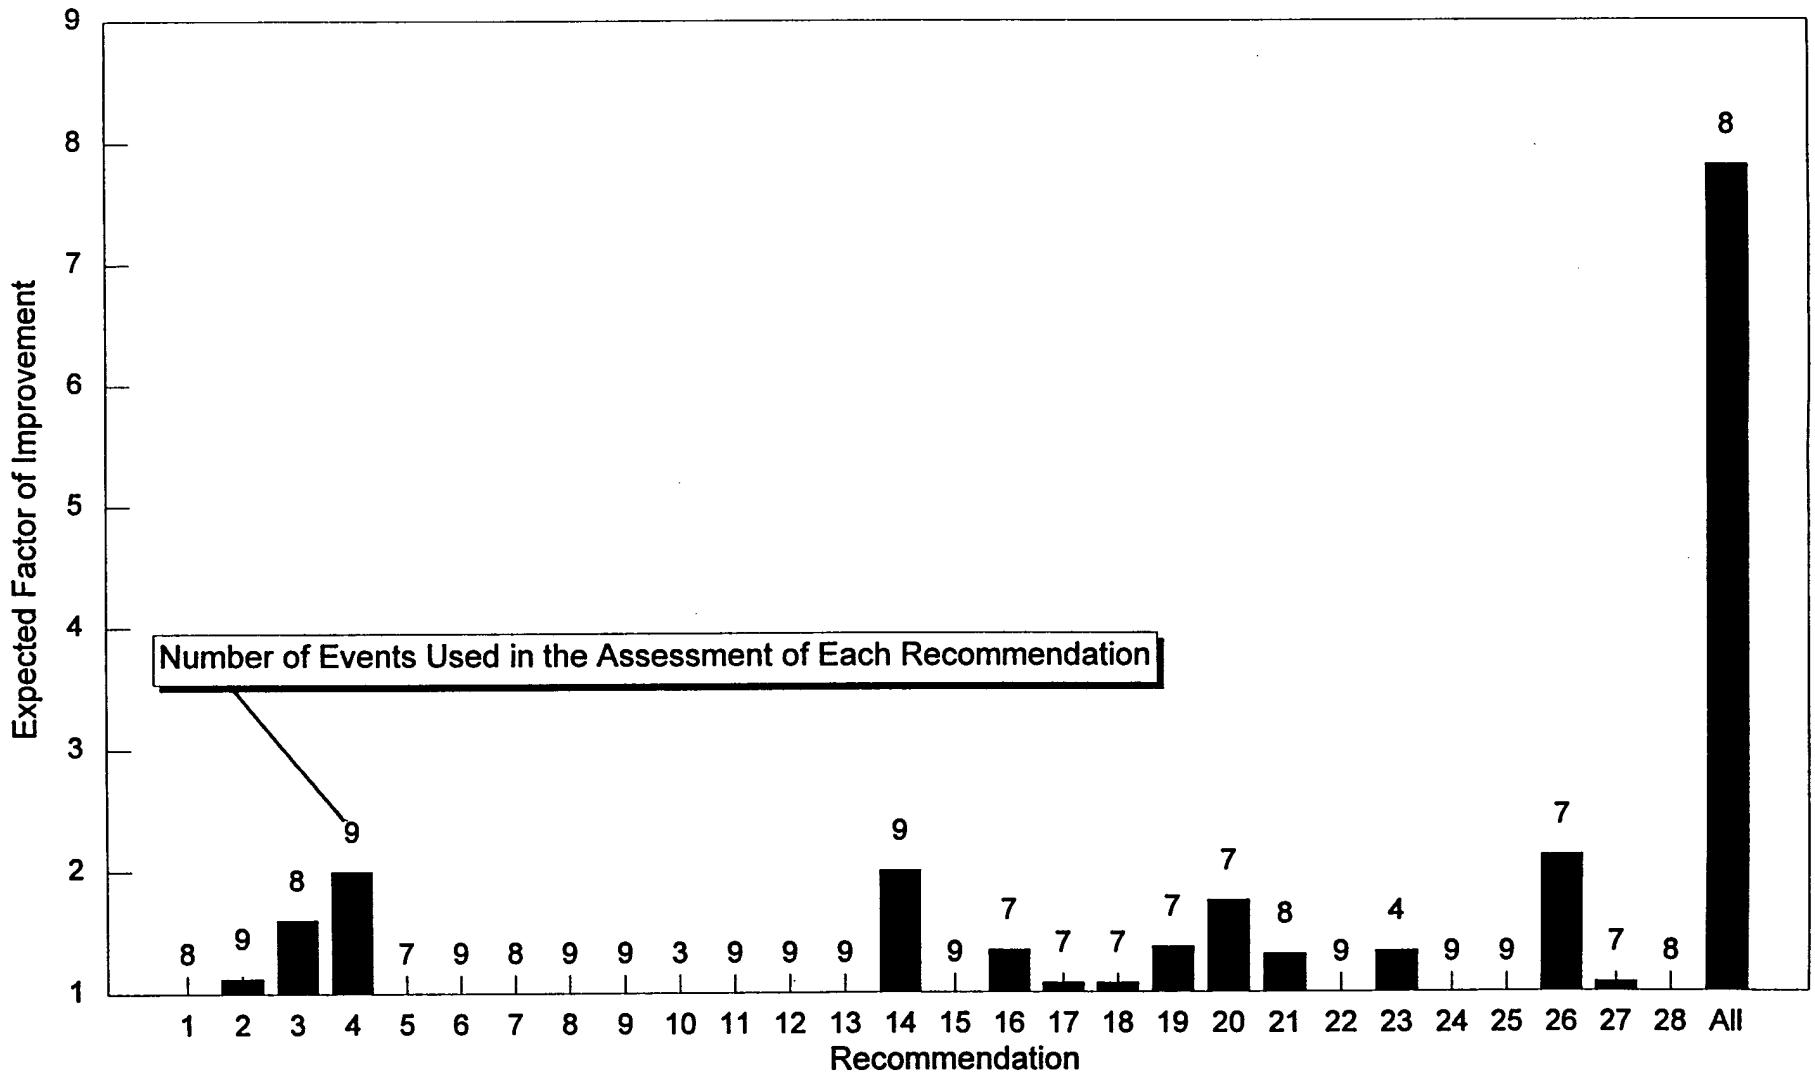
Figure 3.17 Expected Factors of Improvement for Preliminary Recommendations (All Fires with Fatality)

Figure 3.17 shows similar results for the impact of preliminary recommendations on fires with fatality. In this case, the individual impact of some of the preliminary recommendations (i.e., 4, 14, and 26) is about 50% reduction in the frequency of fatal fires (factor of 2 improvement). Also, the combined impact of all preliminary recommendations is a factor of about 8 improvement (reduction of the frequency of incidents to 13% of its frequency without the benefits of these recommendations), primarily because of preliminary recommendations 3, 4, 14, 16, 19, 20, 21, 23, and 26.
