MILLABRADING TEST EVALUATION

Norwood Road – M.P. 287.02
(Southbound Interstate 5)

Construction Report

FHWA-OR-RD-00-02

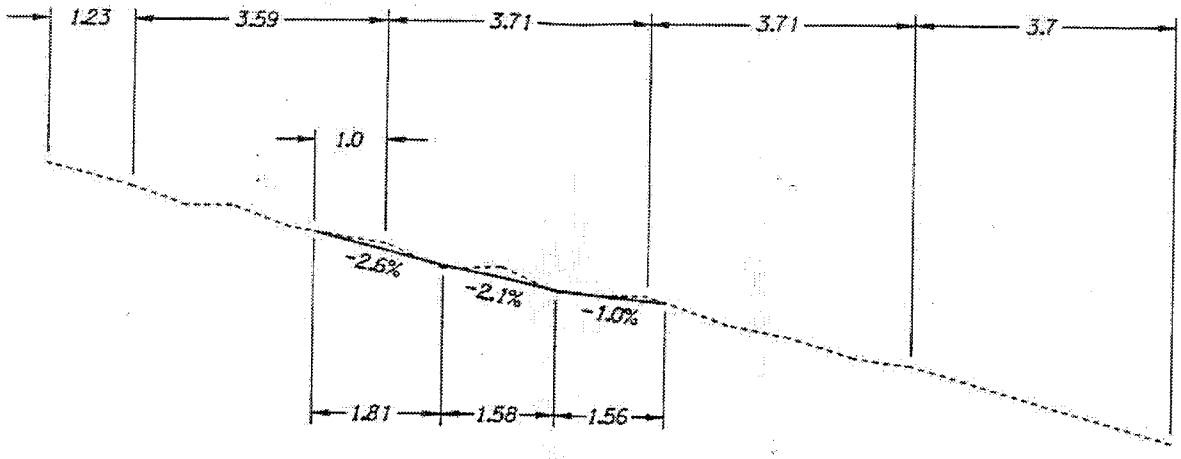
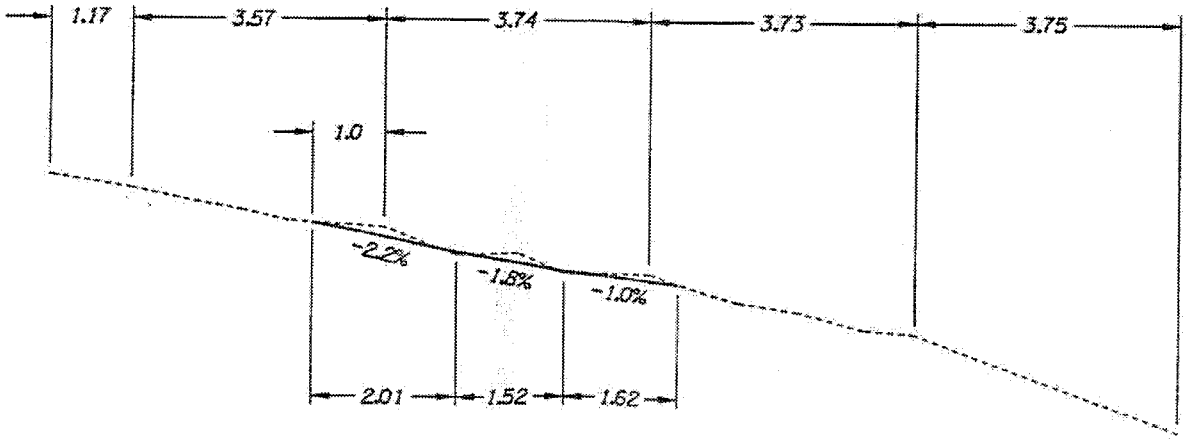
Figure 2.3: Design Cross Sections

The design cross sections are shown in Figure 2.3. A minimum cross slope of 1% was set to maintain drainage. A maximum cross slope of 3% was allowed. Approximately 16 mm of PCC pavement would be removed. Project monitoring included identifying any impacts associated with creating a broken slope in the middle lane. Would the different slopes affect automobile handling and/or increase accident frequency?

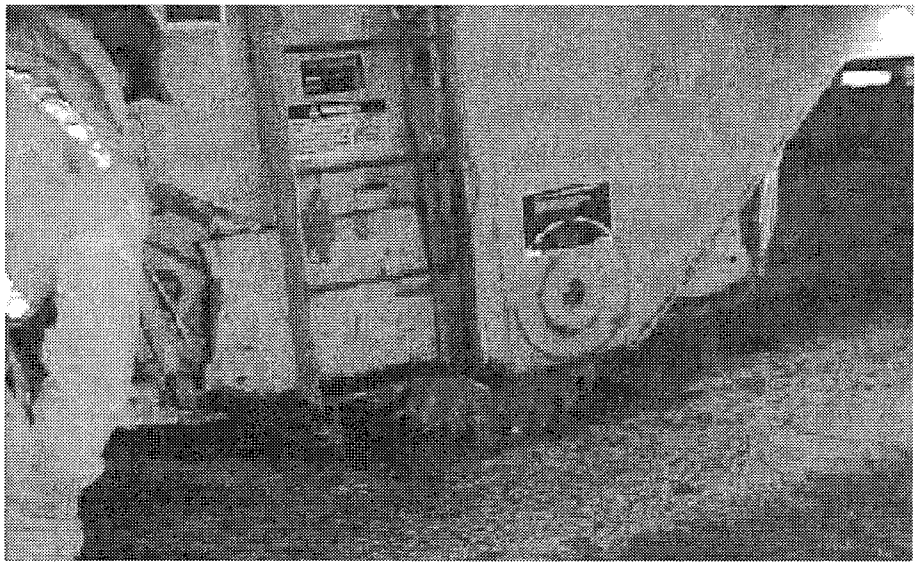
Figure 3.1: Modified Rotomill Drum

The milling process utilized a rotomill built by CMI out of Oklahoma City, model PR-800-7. The machine weighed 33.6 Mg and operated at 597 kW. Modifications to the unit included a modified drum speed, automated grade control skis, and a custom built drum. MillCo, also out of Oklahoma City, manufactured the drum. The 2.1 m wide drum provided a tooth spacing of 4.5 mm *(Halton 1999).* The rotomill is reported to operate at about 6 m/min over a 2.1-m wide path. Based on discussions with the contractor, machine weight and drum speed, along with tooth spacing were found to be critical to the effectiveness of the milling. Figure 3.1 includes a photograph of the modified drum.

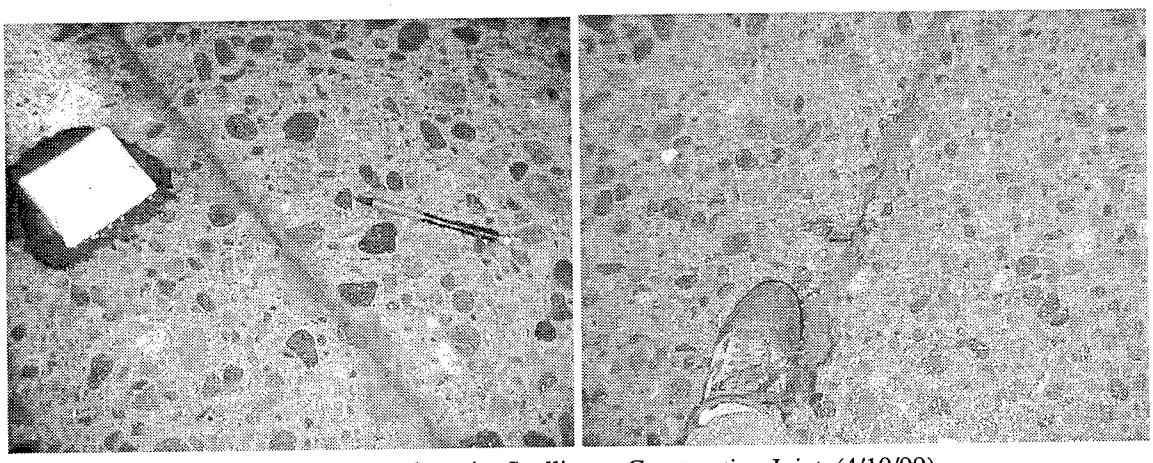
Figure 4.2: Low Severity Spalling at Construction Joint (4/10/99)

The sawcut joint between the fast and middle lane appeared more spalled than the construction joint between the middle and truck lane. The spalling noted for both longitudinal joints would be classified as low severity as defined by the *SHRP Distress Identification Manual for the Long-Term Pavement Performance Project (SHRP 1993)*, however, it was more apparent than before milling. Figure 4.2 shows the spalling observed between the fast and middle lane sawcut joint at two locations.

- Crack filling using proprietary filler or other slurry type material should be investigated to reduce spalling of longitudinal joints.

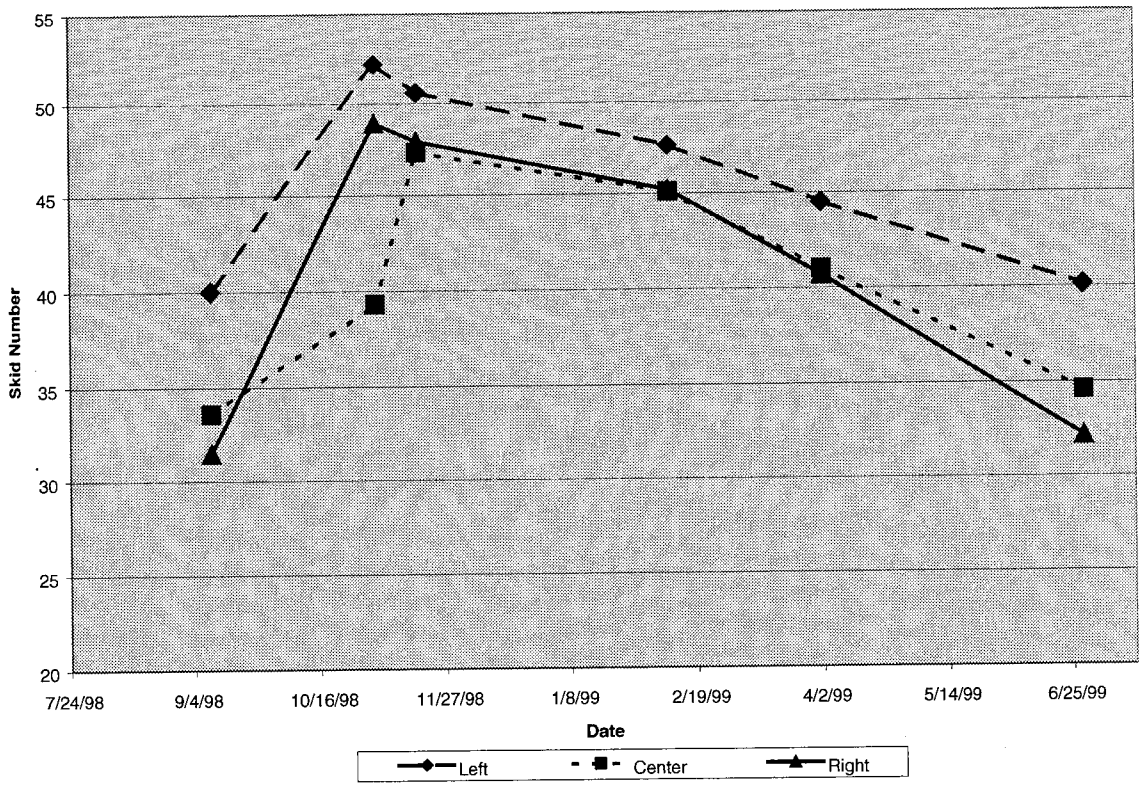
Figure 4.3: Friction Testing Results

All friction testing was done at speeds near 64 km/hr in the left wheel path of all three lanes using a K.J. Law trailer. The data from the tests were converted to standard 64 km/hr friction numbers using correlation equations. Skid testing was performed before the milling and then several times after project completion. One skid test was done after the milling but prior to the shot blasting in the middle lane. The average skid numbers for the three lanes are shown in Figure 4.3.

The November 3, 1998 friction testing includes results for shot blasted sections (fast and slow lanes) and a section with only milling (center lane). The milling increased the skid number from 34 to 39 in the center lane. With the shot blasting, the center lane skid number increased from 39 to 47. Skid numbers, however, have continued to decline, returning to near the preconstruction skid numbers.
