# LTPP Pavement Maintenance Materials: PCC Partial-Depth Spall Repair Experiment, Final Report

PUBLICATION NO. FHWA-RD-99-153

OCTOBER 1999

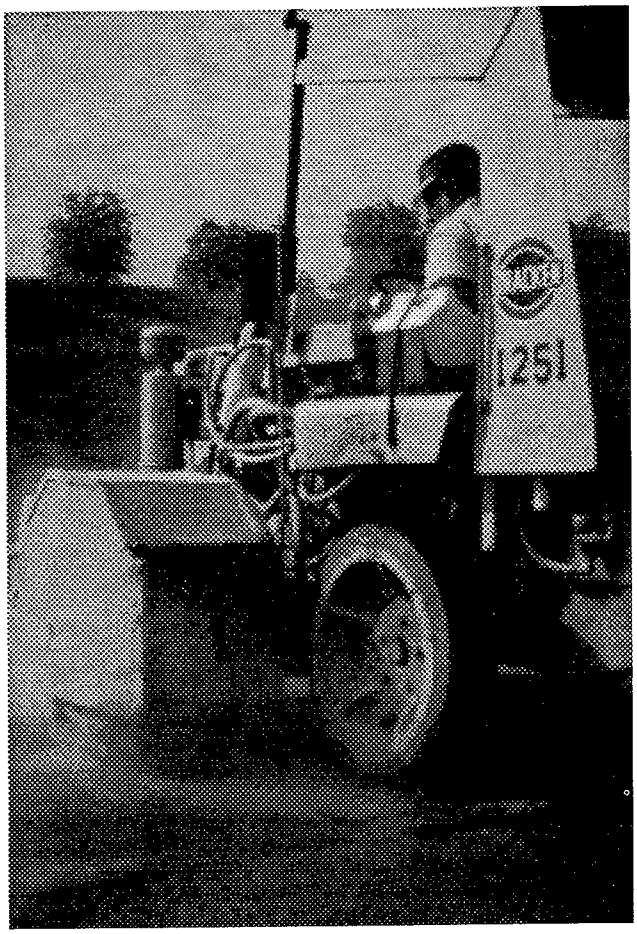
Figure 7. Carbide-tipped, cold-milling machine.

milling machine is shown in figure 7. Milling proceeded in such a manner as to produce vertical edges at the patch boundaries. A small amount of sound material at patch corners could not be removed by milling from any direction. This material was removed by light chipping hammers, as shown in figure 8. Care was exercised to minimize spalling the sound concrete at the patch boundaries.

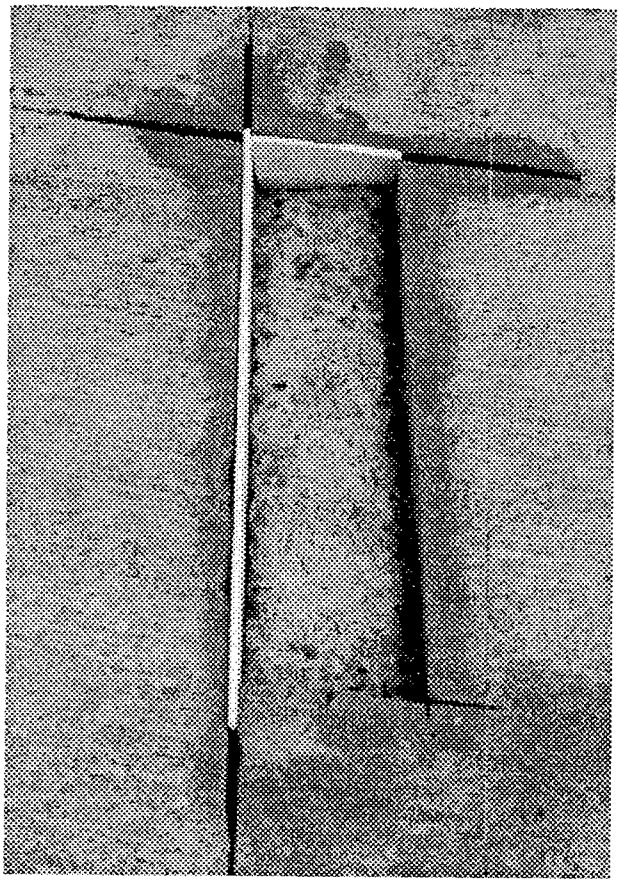
Figure 10. Joint bond-breaker installed at patch edges.

Following the cleaning operation, a joint bond-breaker was placed full-depth in the joints adjacent to repair areas that were to be patched with nonflexible repair materials (i.e., Type III PCC, Duracal, Set-45, Five Star HP, MC-64, SikaPronto 11, and Pyrament 505), as shown in figure 10. The joint bond-breaker consisted of a 102-mm-high, 13-mm-wide, closed-cell polystyrene foam board that was slightly wider than the saw cut. In back-to-back repair areas at a joint, difficulty was encountered in maintaining a true, straight joint line. In locations deeper than 102 mm, it was also difficult to stack the joint bond-breaker to the desired height. Latex caulking was used occasionally to seal any irregularities or gaps between the joint bond-breaker and joint opening in order to prevent repair material from flowing into the joint or crack opening below the bottom of the patch. A joint bond-breaker was not installed in repair areas that would be patched with Percol FL, Penatron R/M-3003, UPM High Performance Cold Mix, AMZ, or Rosco.

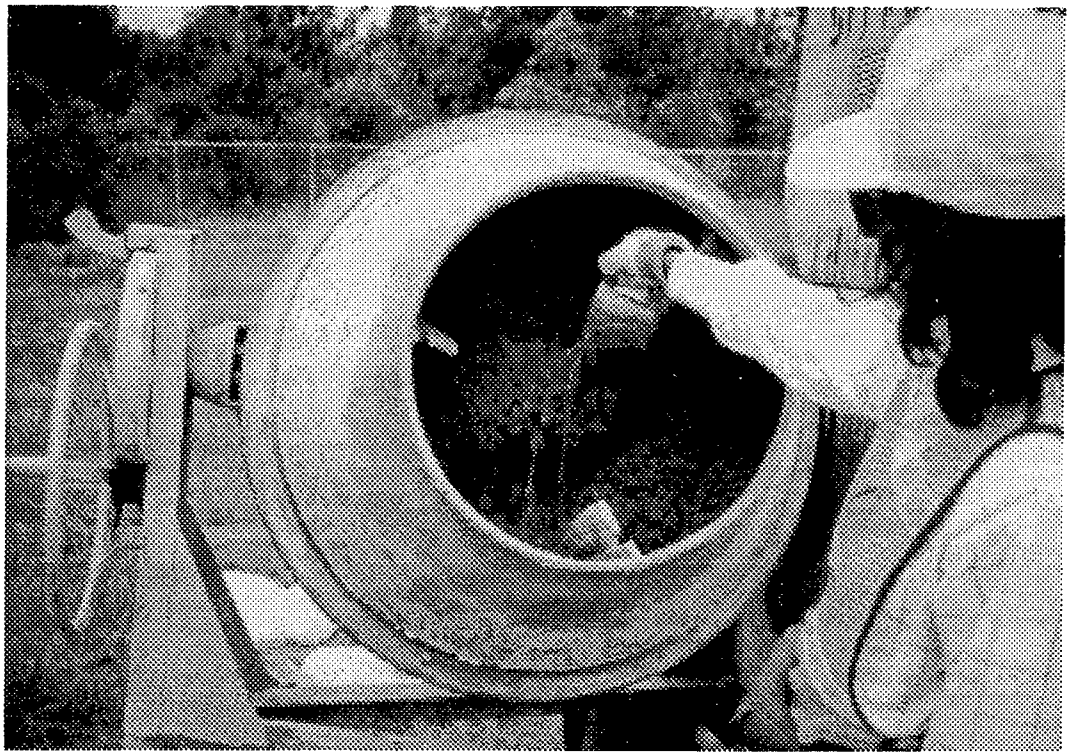
Figure 11. Type III PCC mobile drum mixer.

The Type III PCC mix was prepared in a mobile 2.3-$m^3$ drum mixer, as shown in figure 11. First, the water (11.4 L) was added to the mixer, followed by the coarse aggregate (100 kg), the air-entraining agent (30 mL), and the fine aggregate (50 kg). This combination was allowed to

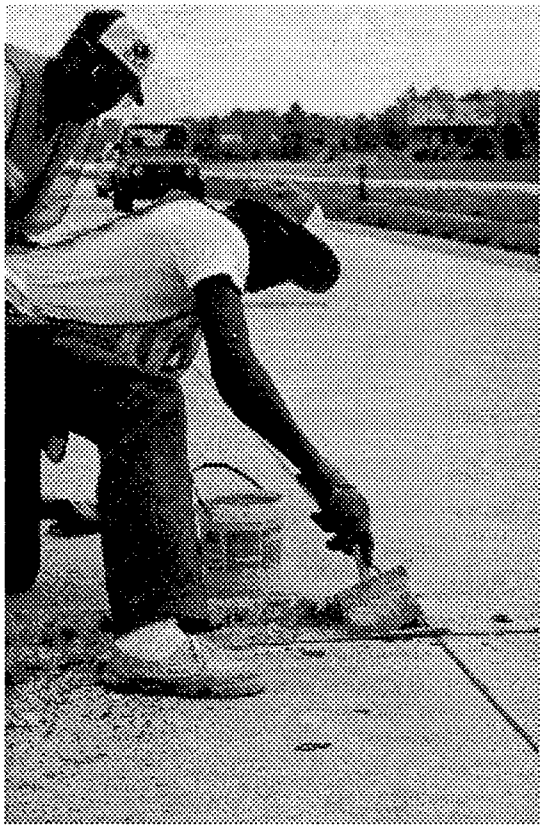
Figure 12. Application of epoxy bonding agent.

The Type III PCC repair material required that the bottom and sides of the repair area be primed with a medium-viscosity epoxy bonding agent. The bonding agent was prepared by mixing part B with part A for 3 minutes, using an electric drill with a Jiffy mixer. A paintbrush was used to apply the epoxy evenly to the repair surfaces, as shown in figure 12. While the epoxy was still tacky, the prepared Type III PCC mix was shoveled into the repair area and vibrated using a pencil vibrator.

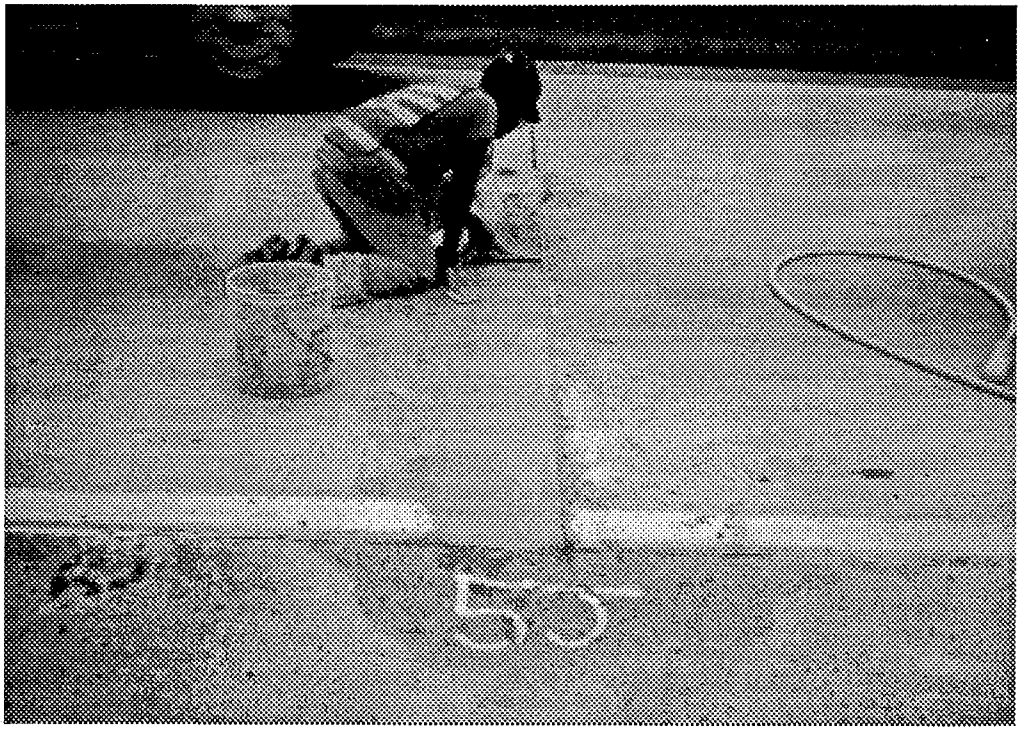
Figure 13. Troweling/finishing of Type III PCC patch.

After vibration, the surface of the patch was troweled level with the surface of the pavement and finished with a float, as shown in figure 13. The mix was sometimes stiff to work with and vibration was essential to make the work finishable. A curing compound was applied after 1 to 2 minutes and, if necessary, the patch was covered with an insulating blanket.

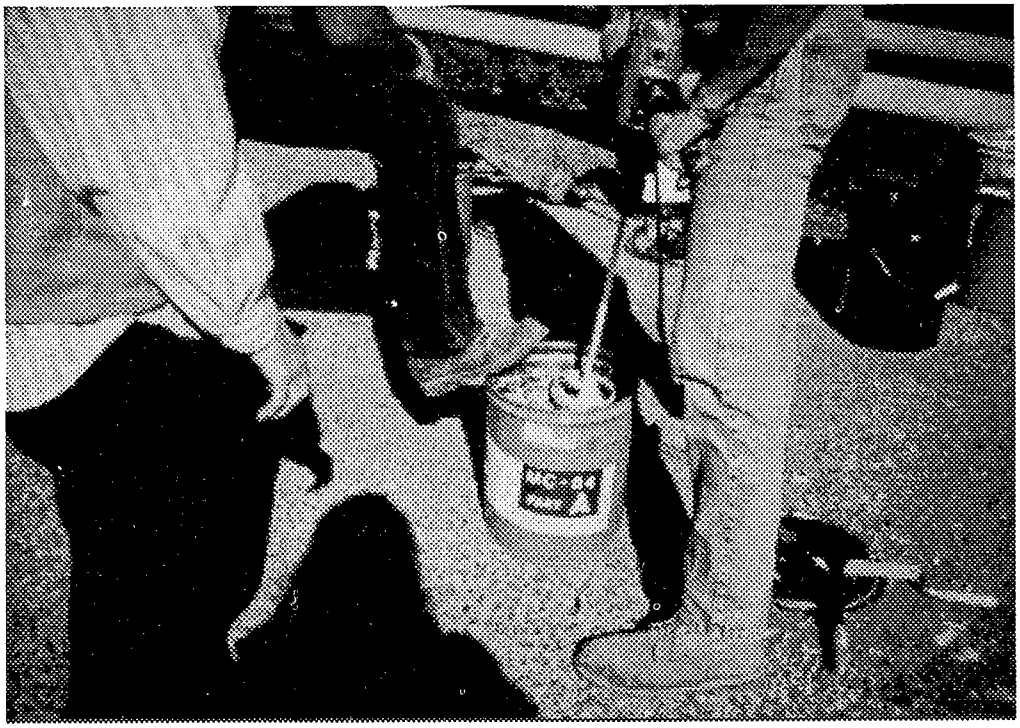
Figure 15. Mixing of MC-64.

MC-64, a two-component epoxy, comes prepackaged with long-grain rubber aggregate in two 19-L buckets. One bucket contains a premeasured amount of resin A, and the other contains a premeasured amount of resin B. These two components were first mixed individually for 3 minutes, then part B was added to part A and the combination was mixed for 5 more minutes. Timers were used to keep track of mixing times. Stainless steel 530-mm Jiffy mixers, powered with 19-mm drill motors, were used for mixing the components, as shown in figure 15.

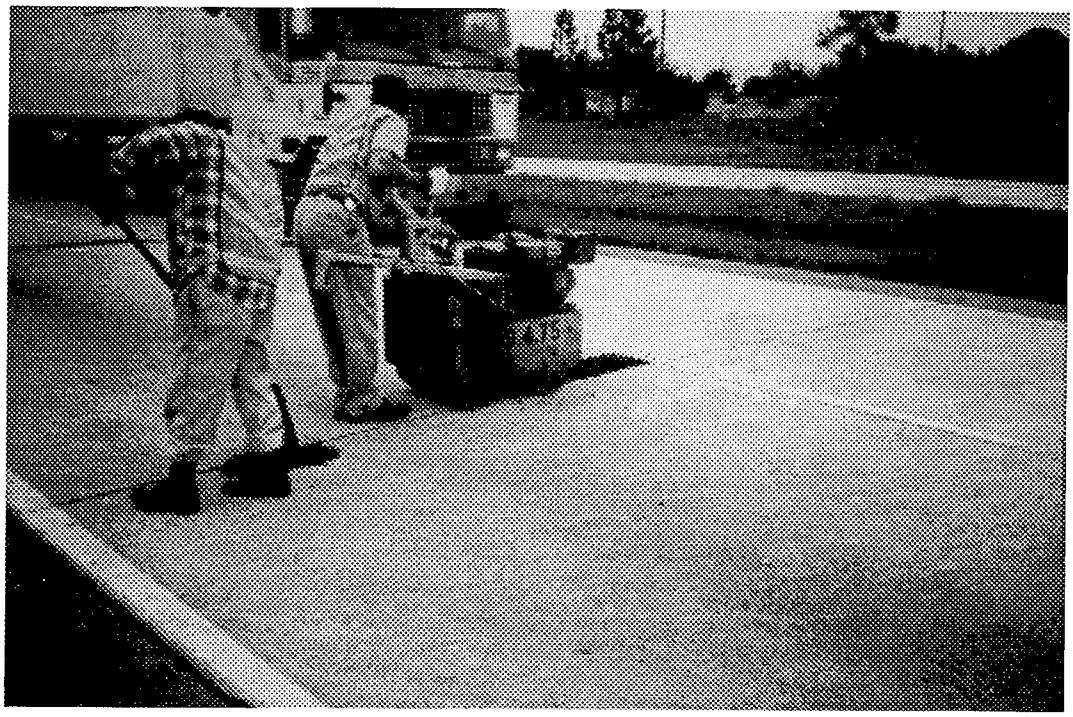
Figure 16. Compaction of UPM repair.

UPM High Performance Cold Mix is a premixed bituminous material. It was shoveled directly from 208-L drums into the repair areas with no additional preparation. The repair areas were overfilled and then compacted using a vibratory roller or plate until the patches were level with the pavement, as shown in figure 16.

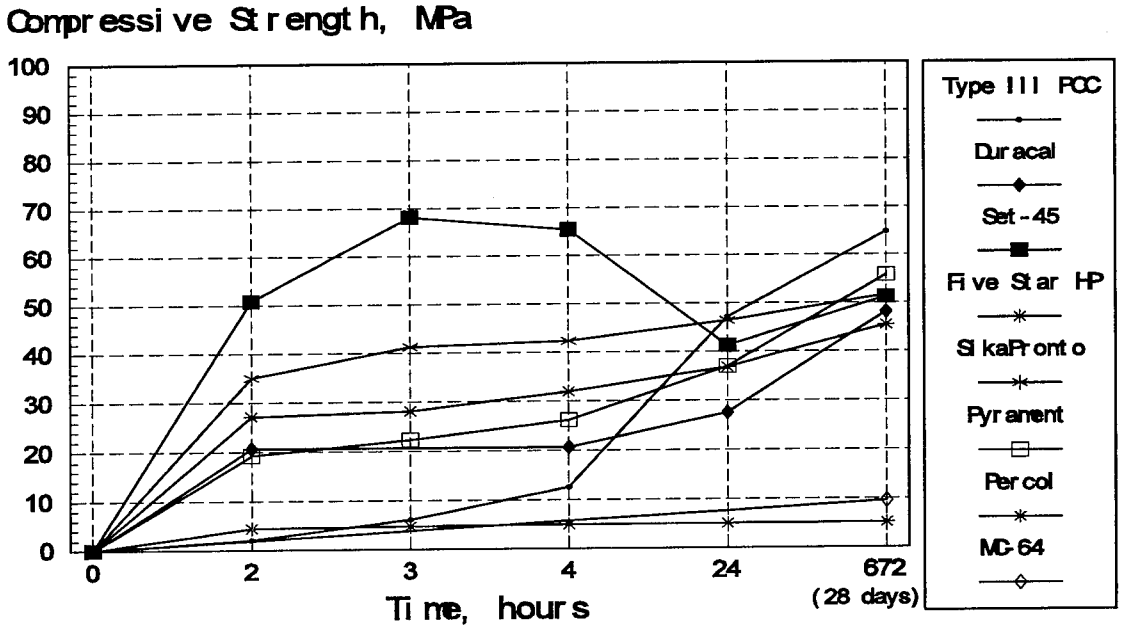
Figure 18. Compressive strengths of spall repair materials.

Compressive strength is often used for specifying and evaluating cementitious spall repair materials. For rapid repairs, early strength gain is of interest. Figure 18 shows the strength-gain curves for the spall repair materials that were tested. It is interesting to see that materials with the highest early strengths were not necessarily those with the highest ultimate strength. The unusual strength-gain curve for Set-45 could not be explained. Based on the Least-Squares Difference T-test and a confidence level of 95 percent, at 2 hours, Set-45 was significantly stronger than the other materials, and Percol FL and Type III PCC were significantly weaker than the others. However, at 28 days, Type III PCC was significantly stronger than all other materials, with Pyrament 505 having the next highest compressive strength. MC-64 and Percol FL were significantly lower in compressive strength than all other materials at 28 days. Set-45, Five Star HP, and Duracal were not significantly different in terms of compressive strength at 28 days.

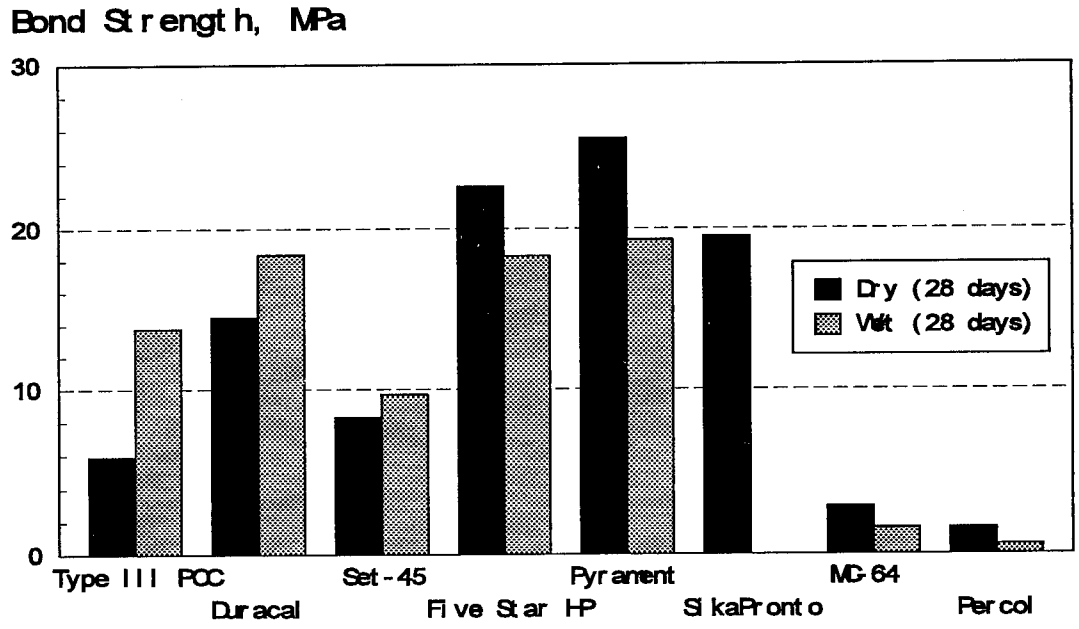
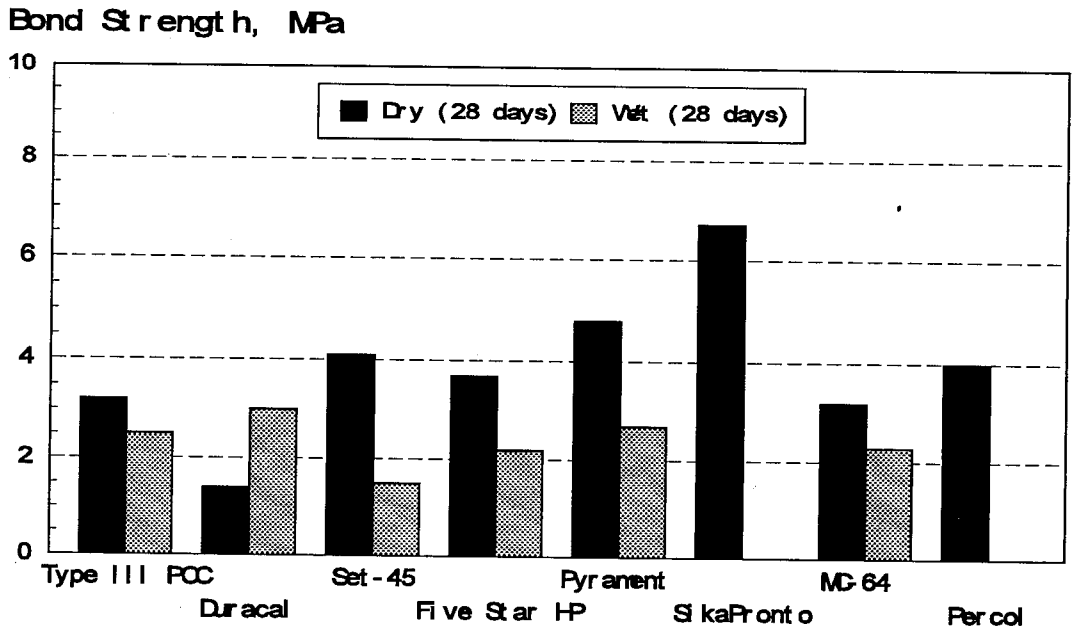
Bond strength is thought to be an important factor in determining field performance. The bond strengths of the spall repair materials are shown in figures 19 and 20. It is interesting to note that, in general, the bond strengths of the materials that were specified to be installed wet decreased when tested using a dry substrate, and materials that were specified to be installed dry lost bond strength when tested using a wet substrate.

Several exceptions to that statement should be noted. Percol FL, whose manufacturer claims that the material is moisture-tolerant, lost strength significantly when applied to a wet substrate. Also, Five Star HP and Pyrament 505 manufacturers recommended that their materials be applied to a saturated, dry (SSD) surface. The slant-shear and center-point bond strength tests indicated that the bond strength was weaker when applied to a wet substrate. It can also be seen that some materials were more tolerant of changed conditions than others. A partial listing of the results of the tests for the cementitious and polymeric materials is given in table 11. Table 12 gives the results of the tests on the bituminous materials when tested using a wet substrate.

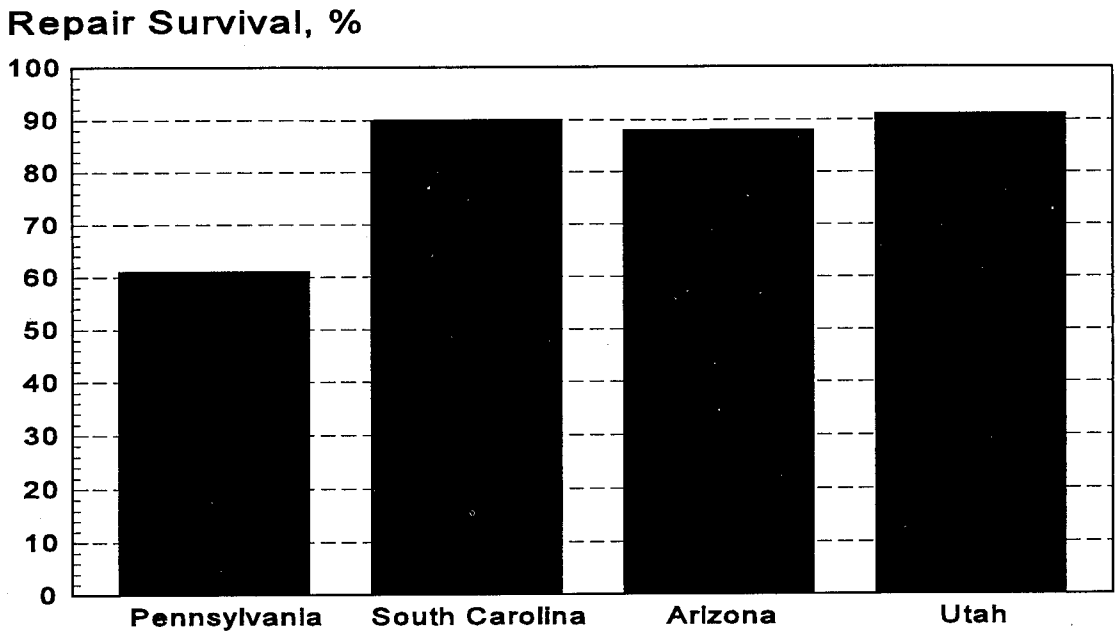
Figure 21. Percentage of surviving patches by test site.

Conceptually, a patch is considered failed if it can no longer service traffic safely. As seen in figure 21, as of the final evaluations, 39 percent of the patches were failed at the Pennsylvania test site, 12 percent were failed at the Arizona test site, 10 percent were failed at the South Carolina test site, and 9 percent were failed at the Utah test site.

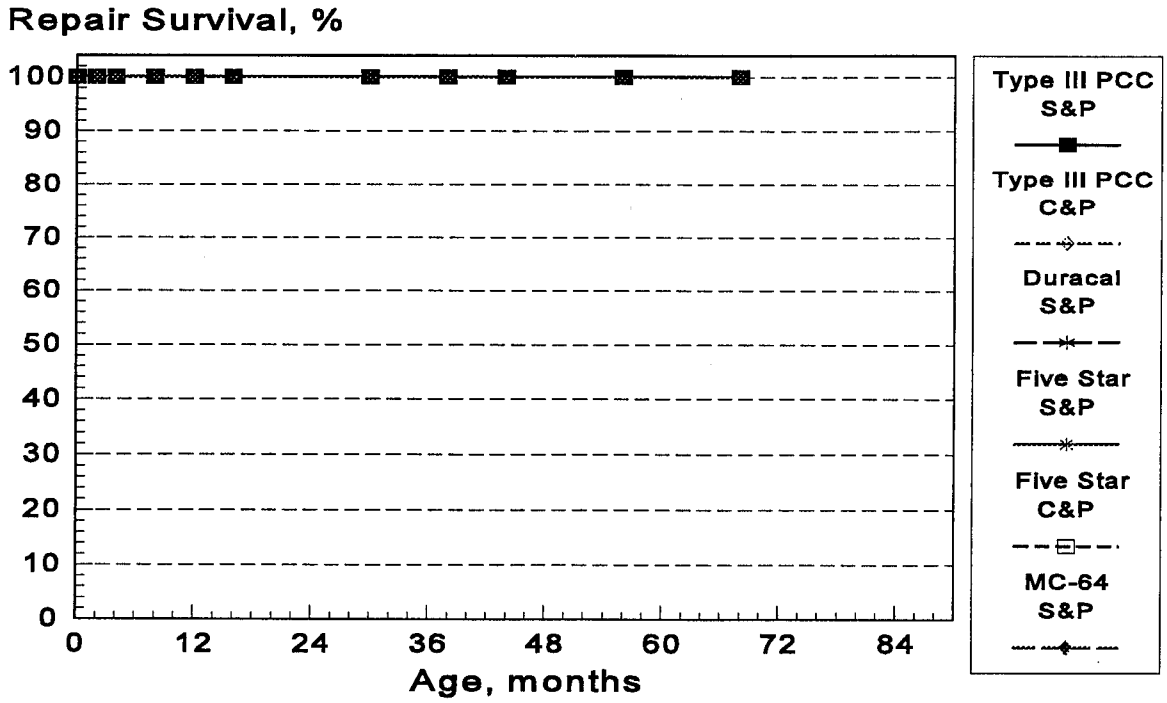
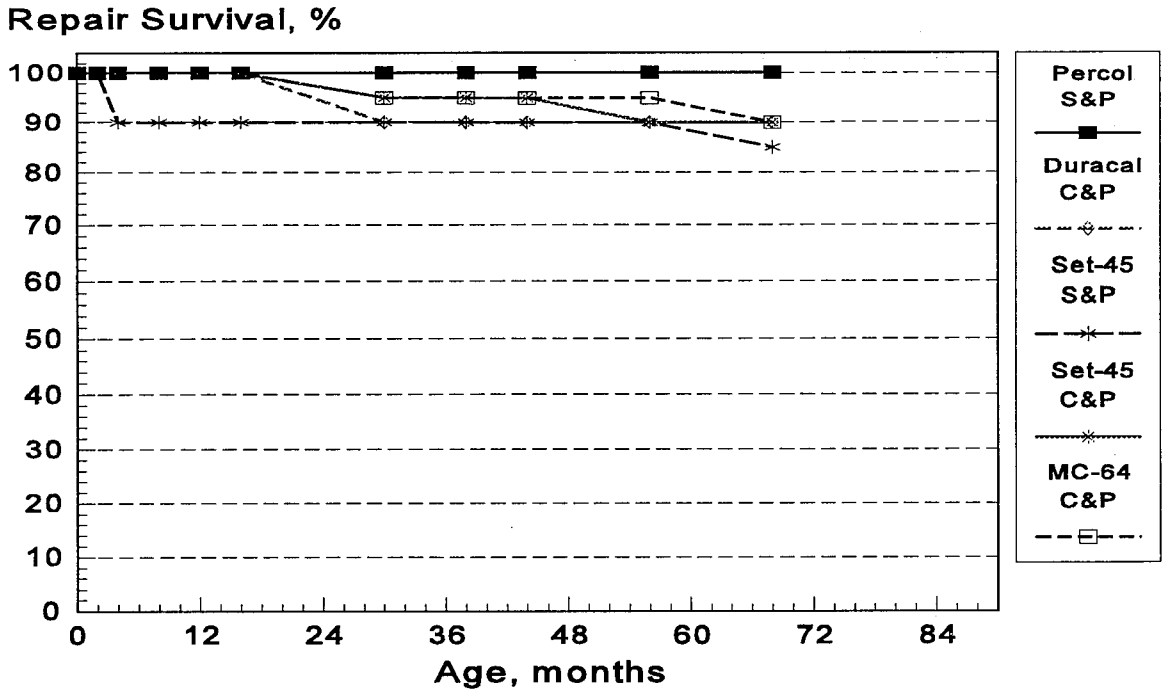
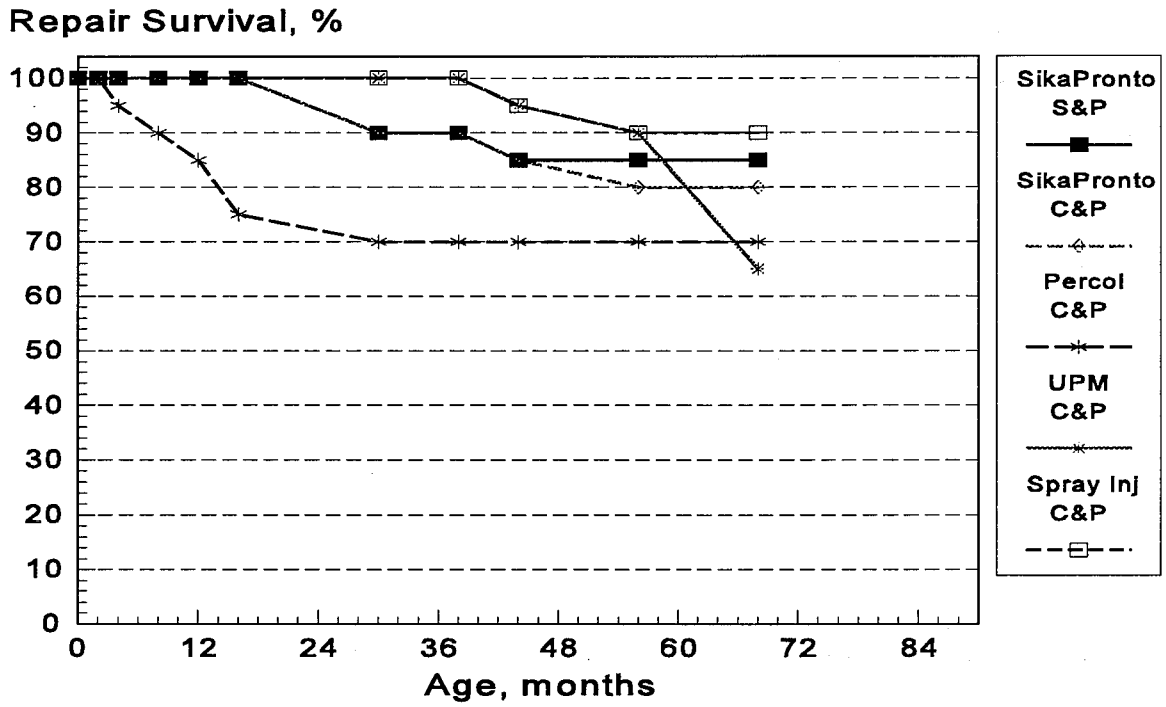
Figure 24. Spall repair survival at South Carolina test site.

The distresses most often observed during the field inspections of the spall repair test sites consisted of cracking of the patches and delamination of the rigid and two-part epoxy repairs from the underlying PCC material. Deterioration of repair edges, aging and raveling of material, cracking, and loss of material pieces were the predominant distresses observed for the bituminous repairs. In many instances, the distresses developed during the initial year after placement and continued to worsen over time as climate and traffic continued to wear on the repairs.

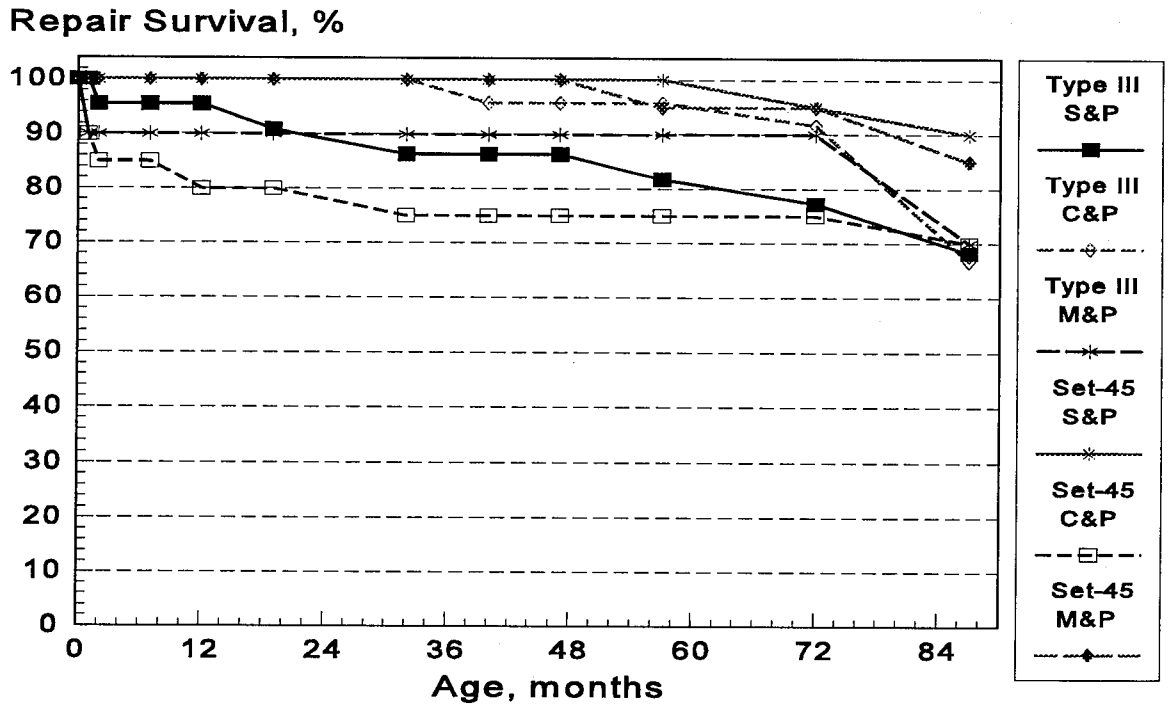
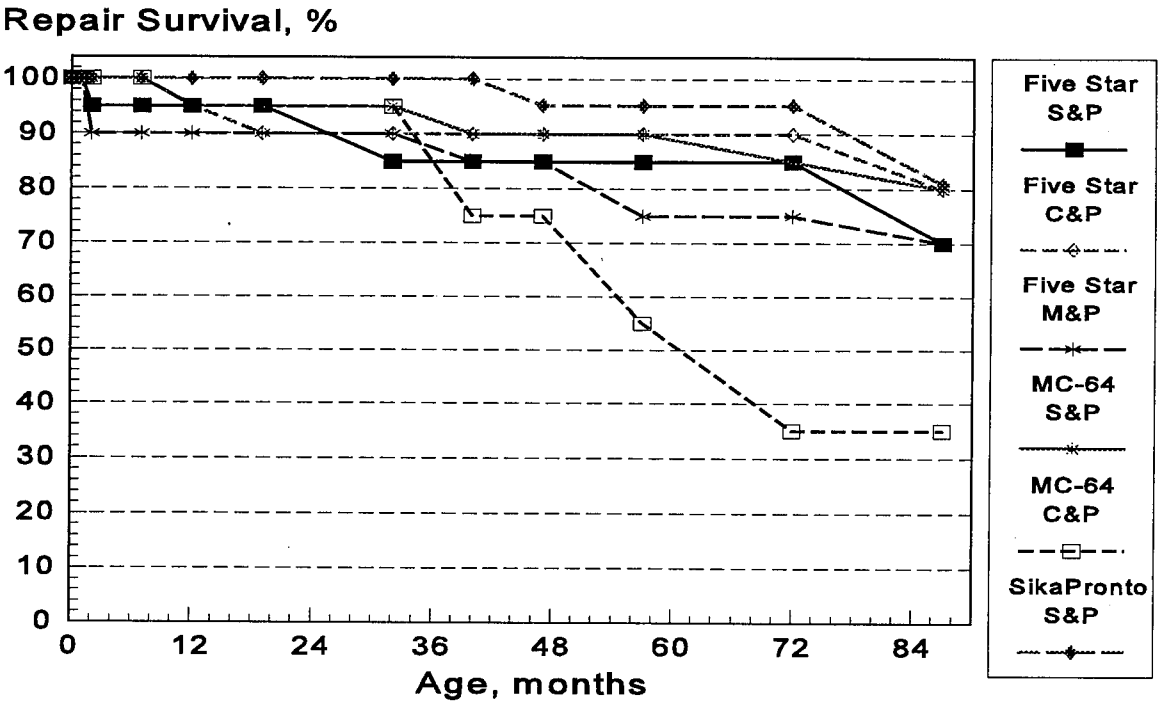
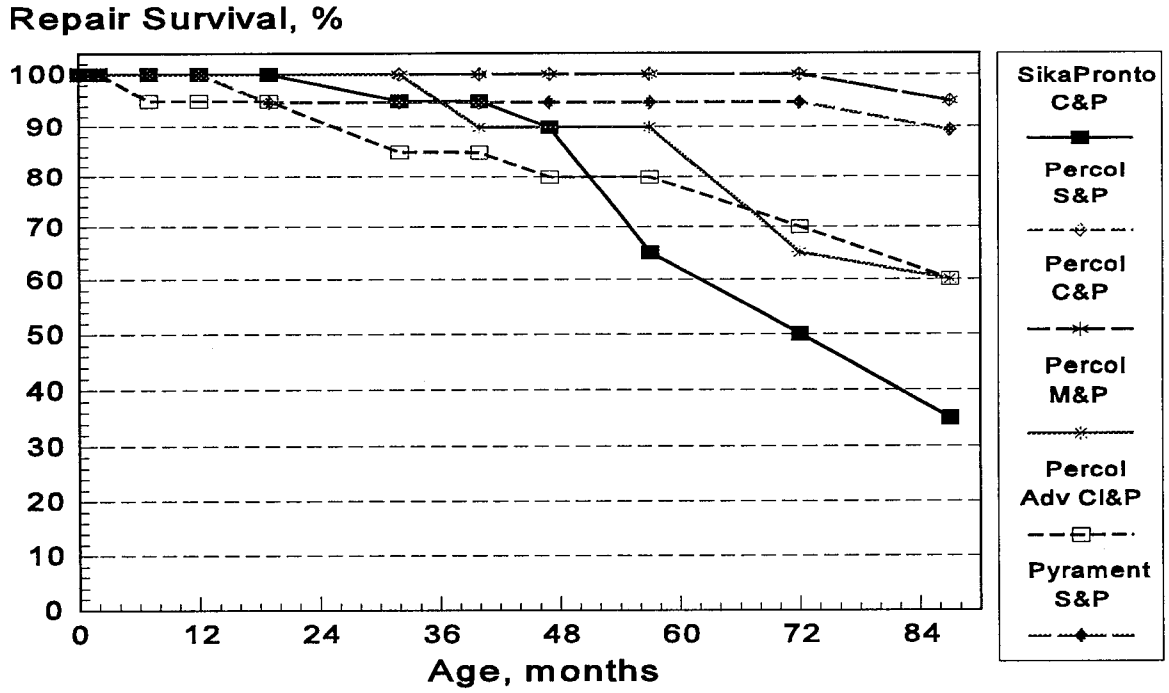
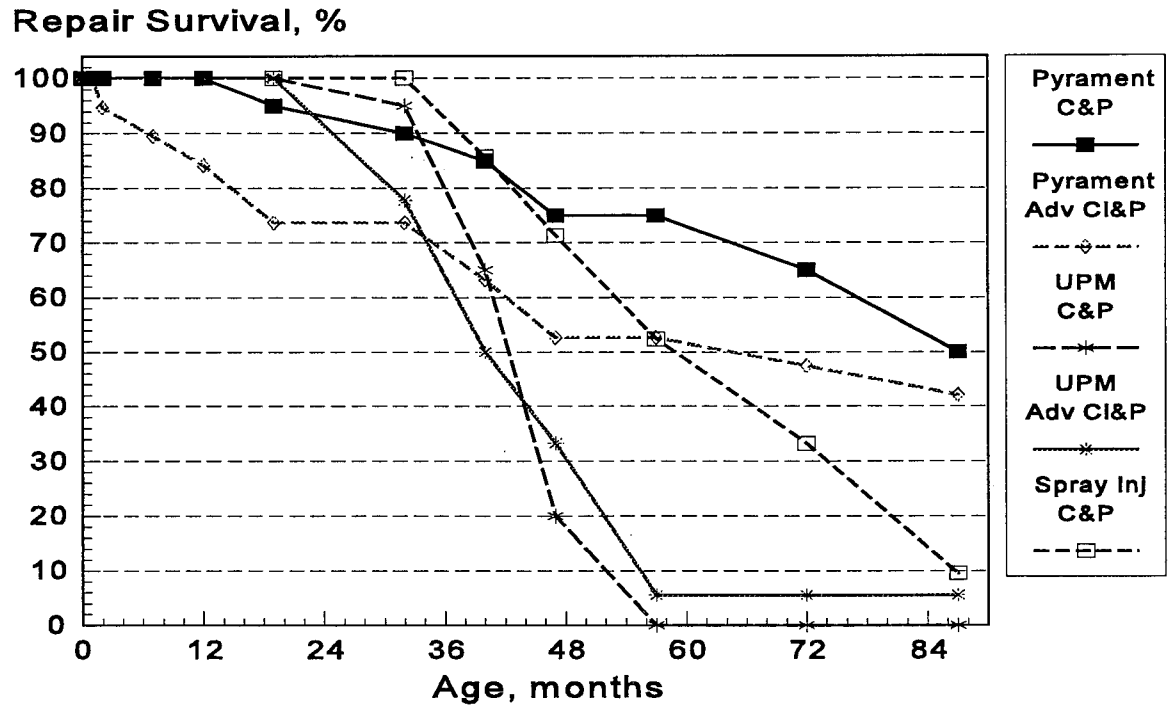
Figure 26. Spall repair survival at Pennsylvania test site.

There was extensive spalling in parts of the test section, often with more than one spall per joint. When the test site was first inspected, the spalls were judged to be limited to the upper one-third of the pavement (coring was not performed). This was confirmed during the installation of the adverse-condition test sections. However, when the remainder of this test site was installed and more rigorous concrete removal techniques were employed, the spalls appeared to extend deeper into the pavement, and dowels often were exposed. Due to limited resources and other constraints, there were no departures from the procedures outlined for the experiment. This site was in the SHRP region that experiences the most severe climatic conditions—both significant precipitation and freezing temperatures. The climate and the fair amount of salt deposited on this route each year may have contributed to the depth of the spalling found there.
