Final Report 2000-31

Asphalt Overlay Cost-Effectiveness

Manitoba TGS and Minnesota SPS-5 Projects
10-Year Ranking of Treatments

Manitoba and Minnesota SPS-5 Projects
10 - Year Ranking of Treatments

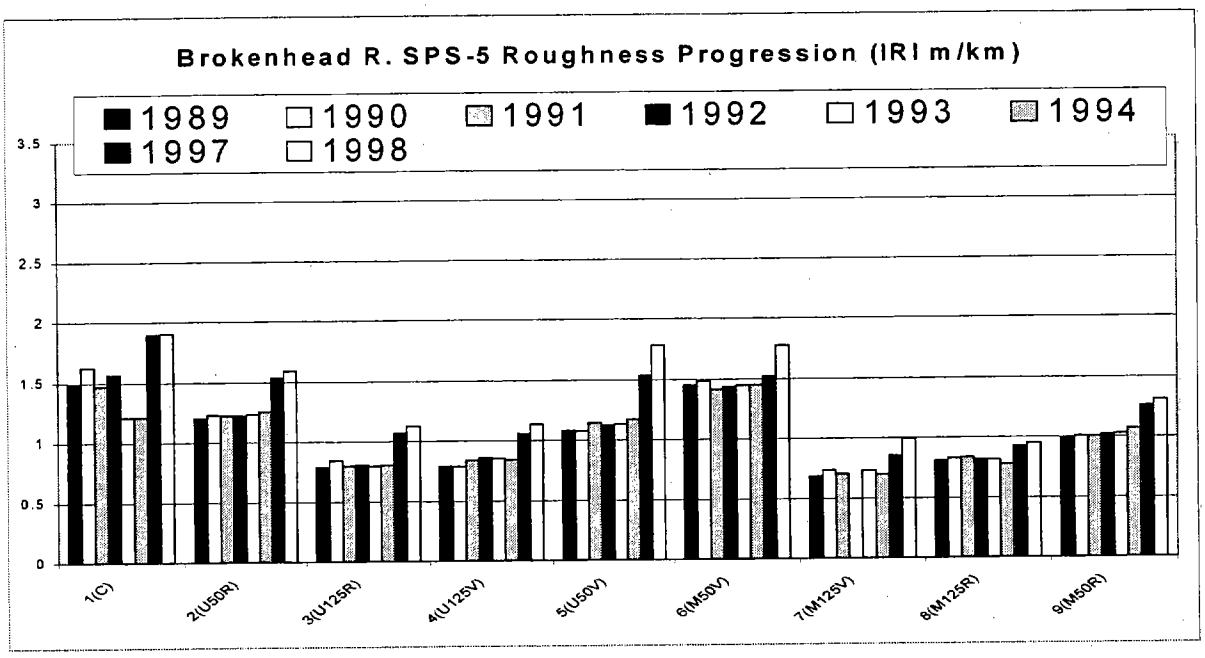
Figure 7 – Brokenhead River Roughness Progression

Figure 7 shows the roughness progression on the Brokenhead River test site. Note that the pre-rehabilitation IRI values were not taken on the Brokenhead River test site and are not shown in this figure. The 125-mm overlays were applied in one more lift than their 50-mm counterparts resulting in significantly lower roughness values (0.2 to 0.8 mm/m IRI) immediately after the paving was completed. Inspection of Figure 7 shows that there is negligible increase in roughness for the cells for the first 6 years of service. Roughness values increase in both 1997 and 1998 at more significant rates. The 1998 values of IRI are all below the 1.9 mm/m IRI value. The 125-mm overlays have lower 1998 roughness values than the 50-mm overlays, and the milled sections with lower roughness than the minimal surface preparation cells. These lower IRI values in 1998 can therefore be attributed to the extra paving lift and its resulting smoother values, the additional structural support of the thicker overlay, and the intensive surface preparation (milling and paving additional layer with fresh asphalt). The roughness on the Brokenhead River site is so low that identifying the sole source is difficult, however the few transverse cracks are not depressed or cupped.

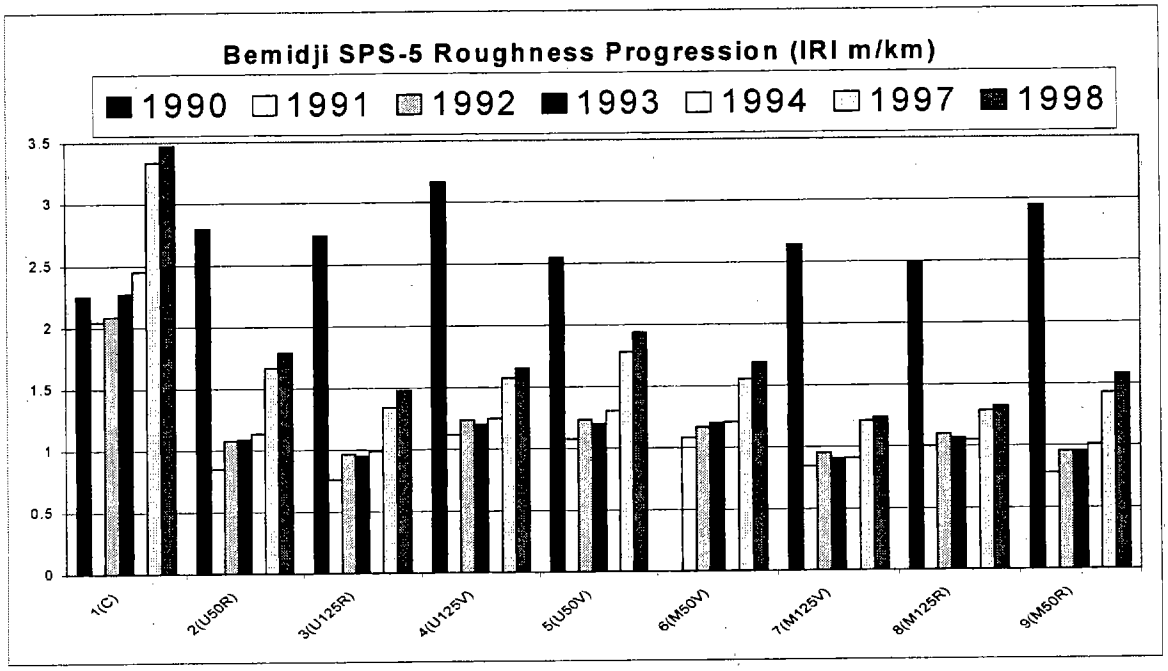
Figure 8 – Bemidji Roughness Progression

It should be noted that the roughness on the Bemidji site is caused by cupped transverse cracks. The survey conducted by the rating crew noted that the surface in between the transverse cracks is relatively smooth.

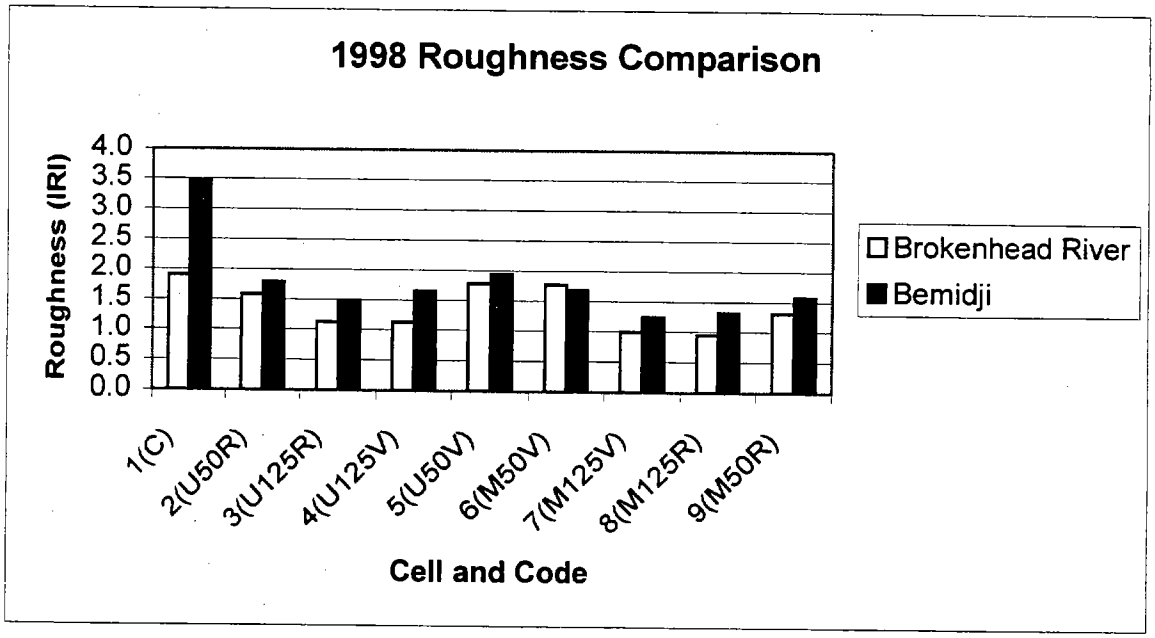
Figure 9 – 1998 Roughness Comparison

Figure 9 allows for direct comparison of the 1998 roughness values on the cells on both sites. All of the Brokenhead River cells have much lower roughness values than their counterparts on the Bemidji site. Note that the low value for roughness on the Brokenhead River Control Section (Cell #1) is attributed to patching that was applied in 1994.

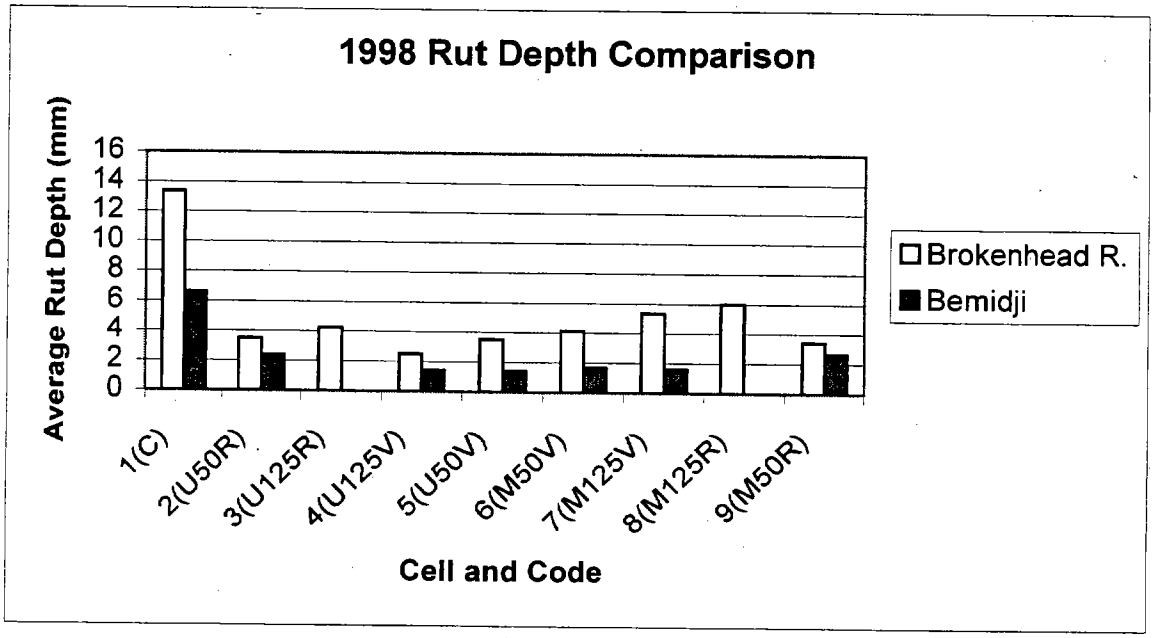
Figure 10 – 1998 Rut Depth Comparison

Table 9 is a list of rut depths measured in 1998, and Figure 10 graphs the results. Rutting values range from 3 to 6 mm and from 1 to 3 on the Brokenhead River and Bemidji cells, respectively. The rutting is lowest on the 125-mm virgin-material overlay with no surface preparation (i.e. no milling). A noticeable trend is that rutting is higher on the milled sections compared to those sections with no milling. No other conclusive trend is noted between the asphalt material type or overlay thickness. The rutting on the Brokenhead River control section has exceeded the tolerable safe limit for rutting set by the agency and was in fact patched in 1994 and again in 1999.

The last trend noted from the data is that in all cases rutting is lower on the Bemidji site when compared to the Brokenhead River site. Note that rutting data for the Bemidji cells numbered 3 and 8 were not available at this time. The rut depths on all of the cells are not considered to be severe enough as of 1998 to require any maintenance intervention.

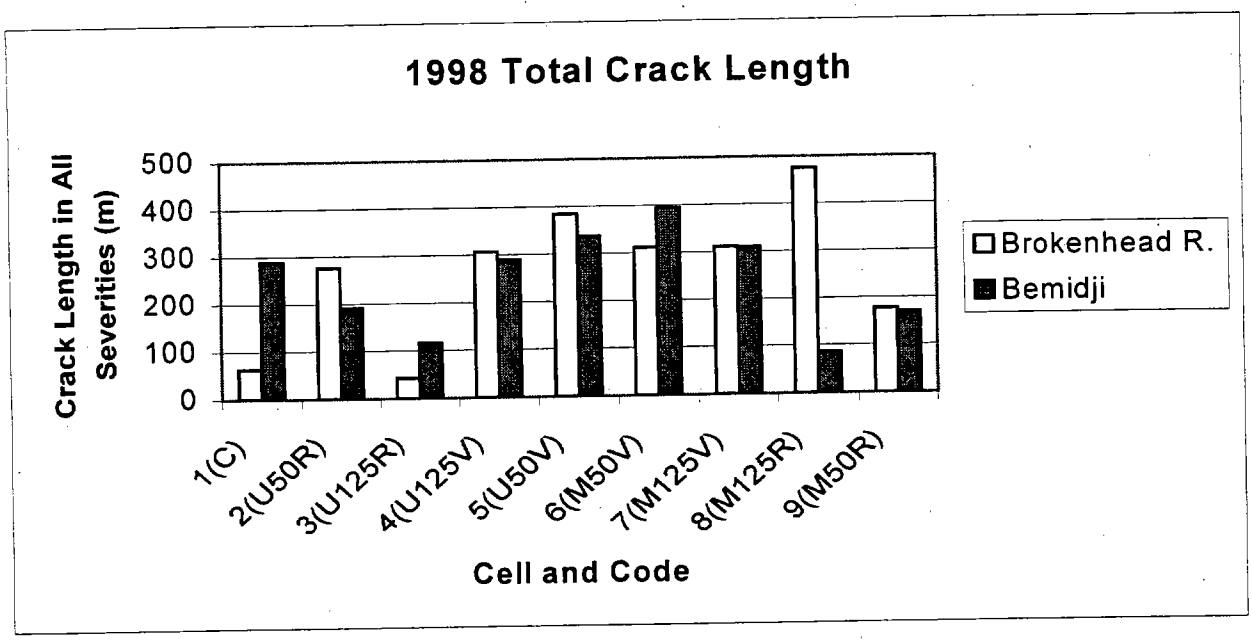
Figure 11 – 1998 Total Crack Length Comparison

Total transverse and longitudinal cracking is summarised for the sites and shown in Figure 11. The lowest amount of cracking is on the Brokenhead River 125-mm thick recycled material overlay with no milling. However, the next lowest amount of cracking is on the Bemidji 125-mm thick recycled material with milling. Cracking is generally higher on the virgin material in all but one Brokenhead River cell. Intensive preparation of the surface (milling) has not significantly reduced the amount of cracking on the surface. Lower levels of cracking are found on the 125-mm thick overlays with one exception on the Brokenhead River site.

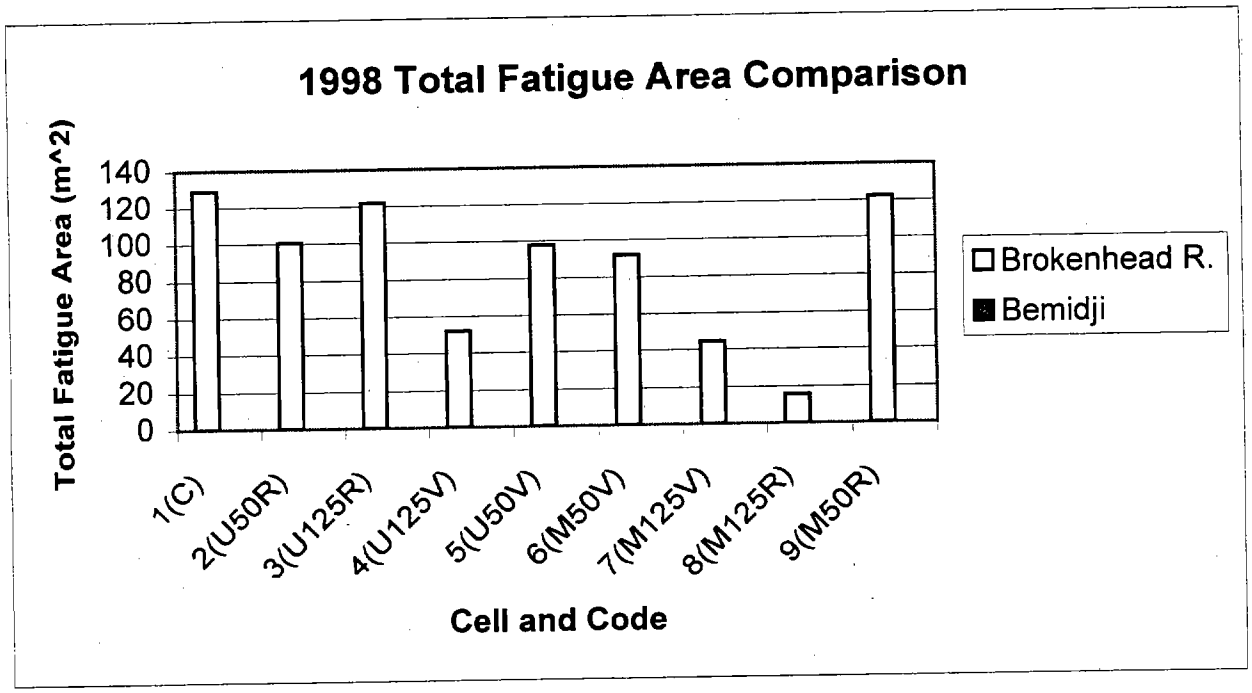
Figure 12 – 1998 Total Fatigue Area Comparison

Surface fatigue area in square metres is plotted as Figure 12. The most noticeable fact is there is no fatigue cracking in evidence on any of the Bemidji cells. The Bemidji site has a much thicker structure and lower traffic that are the probable causes of this difference.

General fatigue cracking trends on the Brokenhead River test site are the 125-mm virgin material overlays with milled surface preparations have less fatigue area than their respective counterparts. The recycled material cells exhibit generally higher fatigue area measurements than the virgin material cells. The additional thickness provided by the 125-mm overlays seems to be limiting fatigue cracking when compared to the 50-mm overlays. The cells with milled surface preparation do not exhibit lower fatigue areas than the unmilled surface cells.

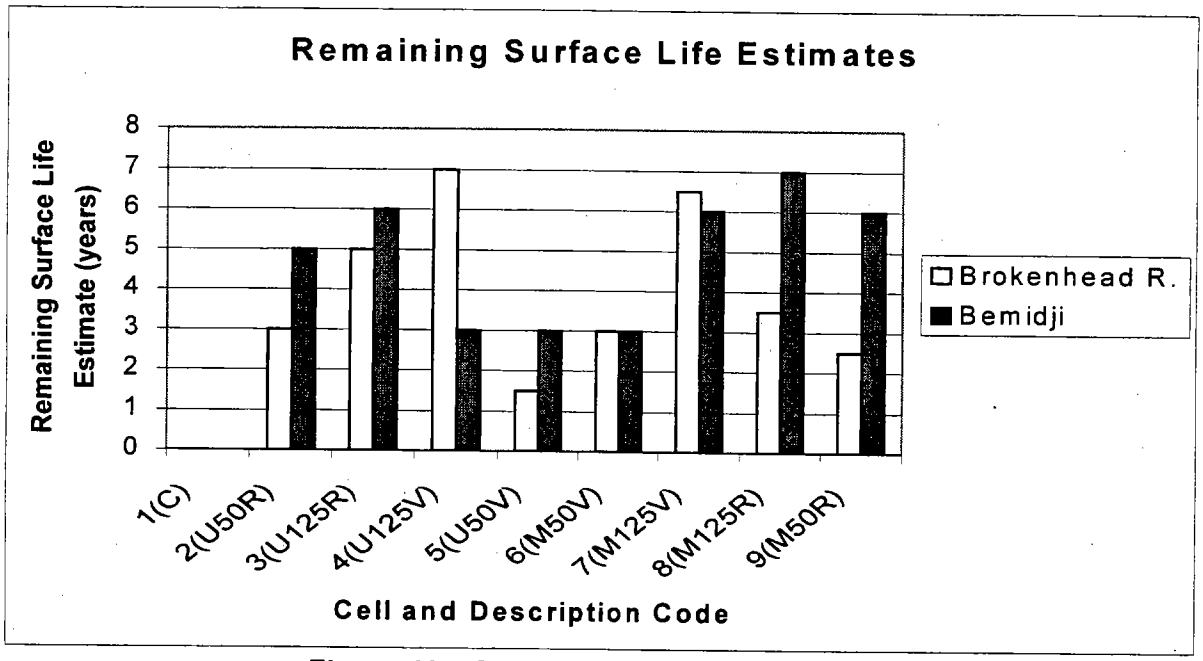
Figure 13 – Remaining Surface Life Estimates

The panel of raters that surveyed the sites in 1999 made estimates of the remaining life of the surfaces on each cell. Figure 13 and Table 13 detail the estimate from some of the Raters. The Rater's opinions varied on the estimates and no agreement could be found on the remaining life estimates. Therefore, the use of this rating is questionable at best.

With this limitation on the remaining life estimates in mind, the data still show that the Raters expect the remaining life be significantly less on the Brokenhead River site. The fatigue cracking is the primary surface distress on the site and the severity level is beginning to exhibit block and even alligator cracking in some locations. These distresses were felt to indicate that the site is going to require extensive maintenance intervention such as a mill and overlay in as little as 3 to 5 years from 1999.

The Bemidji site exhibits a high level of roughness at the transverse joints requiring maintenance intervention to smooth the surface. However this maintenance intervention would not require a complete new surface such as that at Brokenhead River. The Raters felt that once the transverse crack roughness was corrected the Bemidji site cells would not require major surface repairs for quite some time. This is the reason for the lower remaining surface life estimates for the Brokenhead River site.

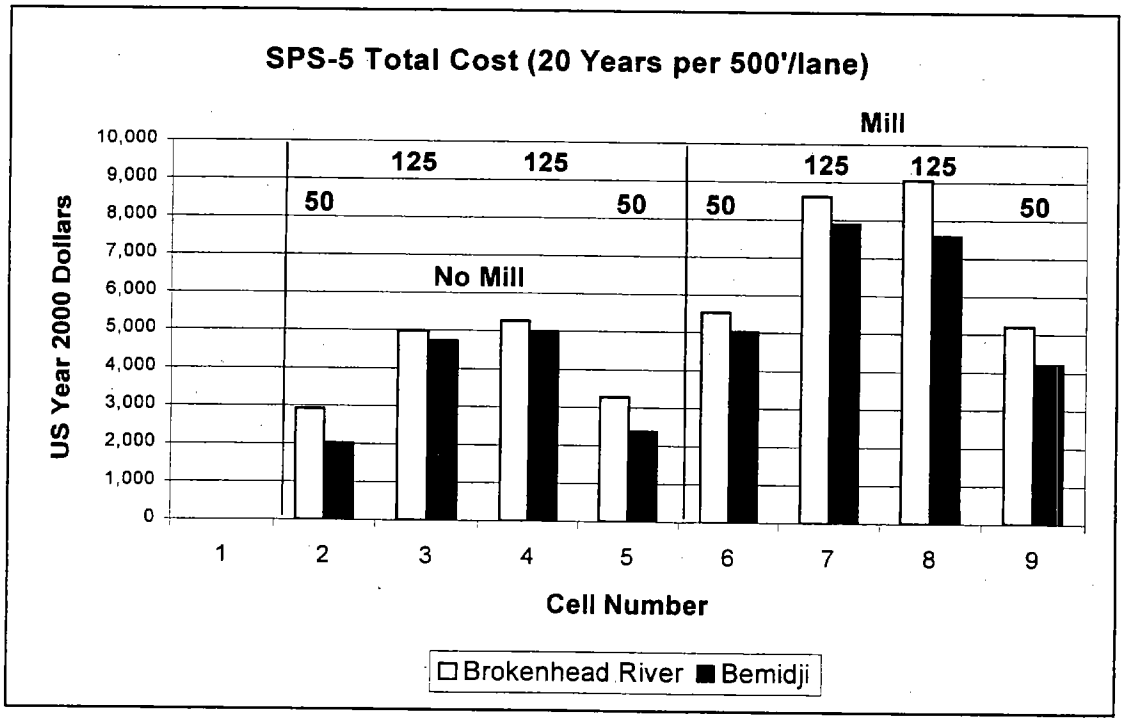
Figure 14 – Total Costs per SPS-5 Treatment

Using the remaining life / distress types along with the estimated maintenance events / costs a total cost for each section is calculated and is summarized in the third part of Tables 15 and 16 as "Cost Summary" for each project. The total 20-year costs are summarized in Figure 14. This shows the most cost-effective SPS-5 treatment consists of a no mill - 50-mm recycled overlay for both Bemidji and Brokenhead River at this time. It also shows that the extra cost to mill a pavement may not be cost-effective for pavements in the poor to fair original condition as these two sites were. The cost comparisons will be confirmed as further reviews are done in the upcoming years.

Currently after 10 years all sections, excluding the control section, still are performing well. As a result at this point, researchers recommended the least costly treatment, 50mm recycled asphalt overlay with no surface preparation, for pavement rehabilitation.
