SEISMIC PERFORMANCE AND RETROFIT OF MULTI-COLUMN BRIDGE BENTS

WA-RD 449.1

Final Report
August 1998

Washington State Department of Transportation

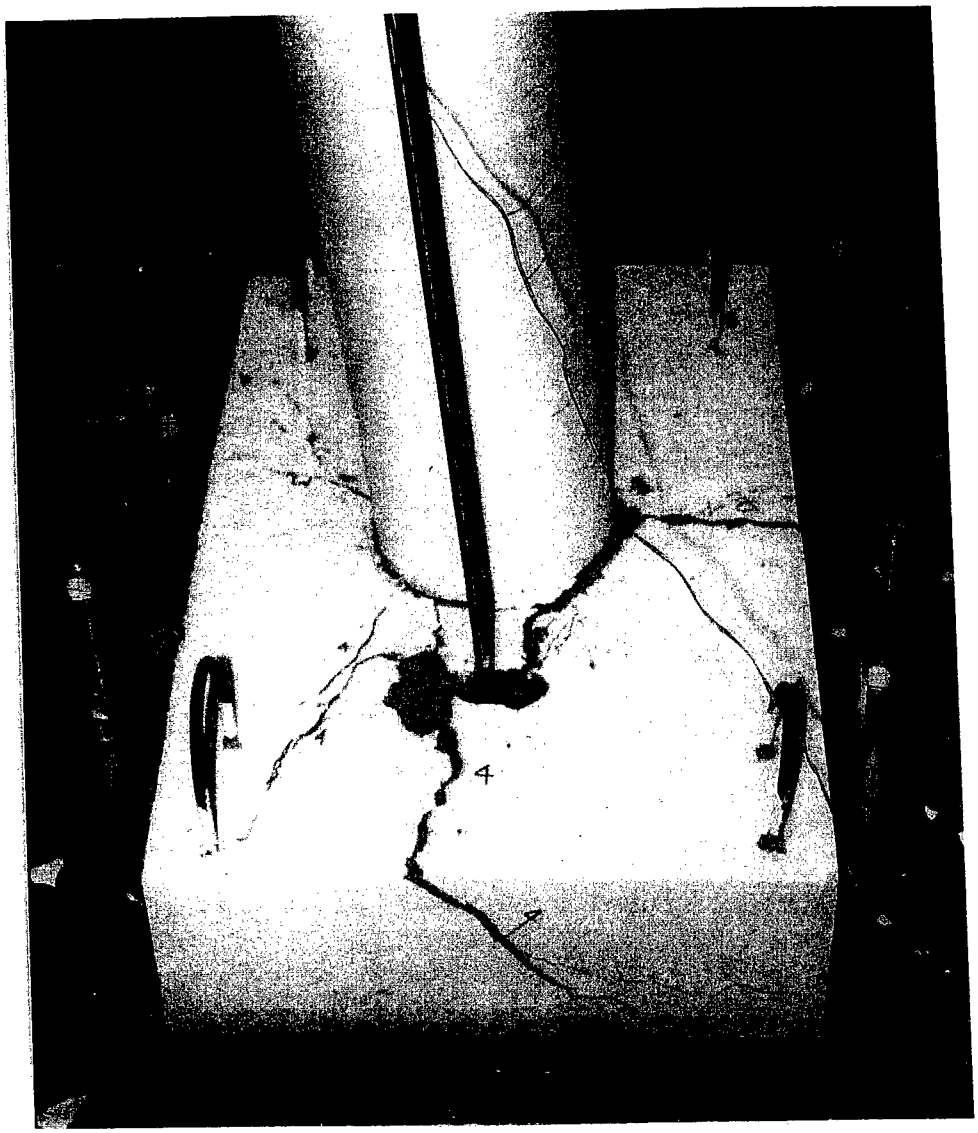
Two major damage mechanisms were observed in both the as-built specimens. During loading to the 5 cm (2 in.) displacement level, cracks developed in the footings radiating outward from the column, in directions both perpendicular to and in line with the load. By the end of the test, all of the footings were severely cracked, as shown in Figure 7. Through careful examination of the cracking patterns in the footings, and from experience with similar damage observed in the footings of single-column bent specimens (McLean, et al, 1995; Xiao, et al, 1994), it was concluded that the damage was a result of joint shear distress in the column/footing connection. Principal tension stress values within the joint region were calculated using the approach suggested by Priestley (1991) for assessing joint shear and were found to exceed the recommended allowable stress values, supporting the conclusion that a joint shear failure in column/footing connection was the failure mechanism.

Figure 7 Cracking in the footings of Specimen No. 2.

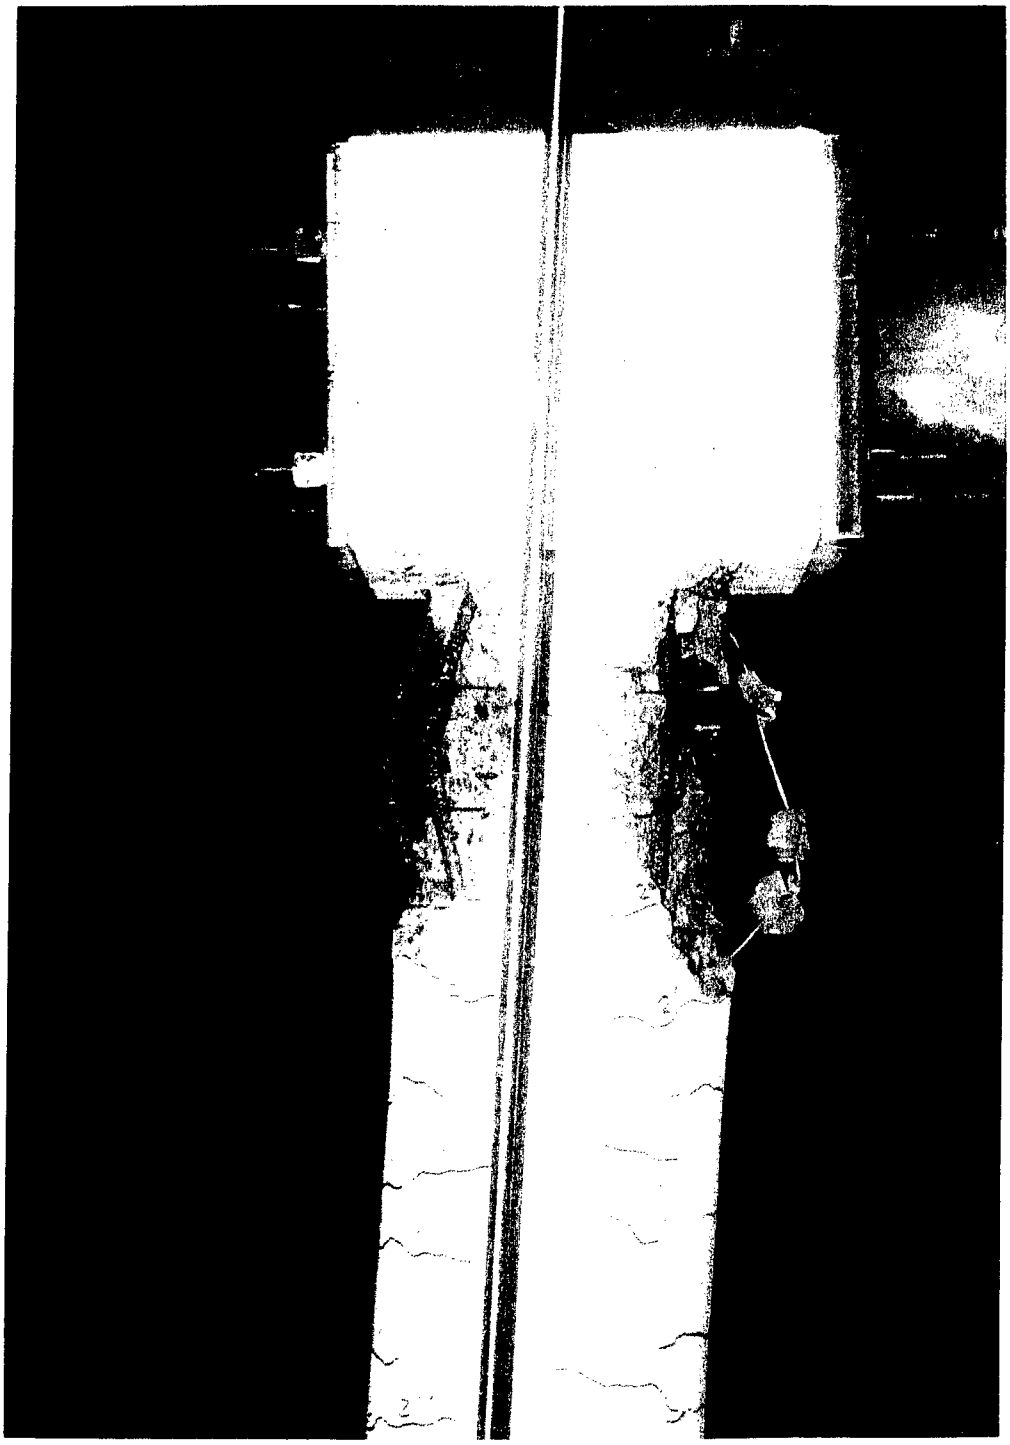
The second damage mechanism observed in the tests was the degradation of the hinging regions in the columns. Since the footings experienced cracking and rotated during testing, no damage or plastic hinge formation occurred at the bottoms of the columns. Significant flexural cracking occurred at the tops of the columns during loading to the 2.5 cm (1 in.) displacement level. Spalling of the cover concrete in the top hinging regions occurred at approximately 7.5 cm (3 in.) displacements. Due to lack of proper confinement, the longitudinal reinforcement began to buckle within the plastic hinge regions, beginning at a displacement level of 10 cm (4 in.). This led to degradation of the concrete core, as shown in Figure 8, and eventual failure of the specimens.

Figure 8 Damage in the top hinge regions of the columns of Specimen No. 2.

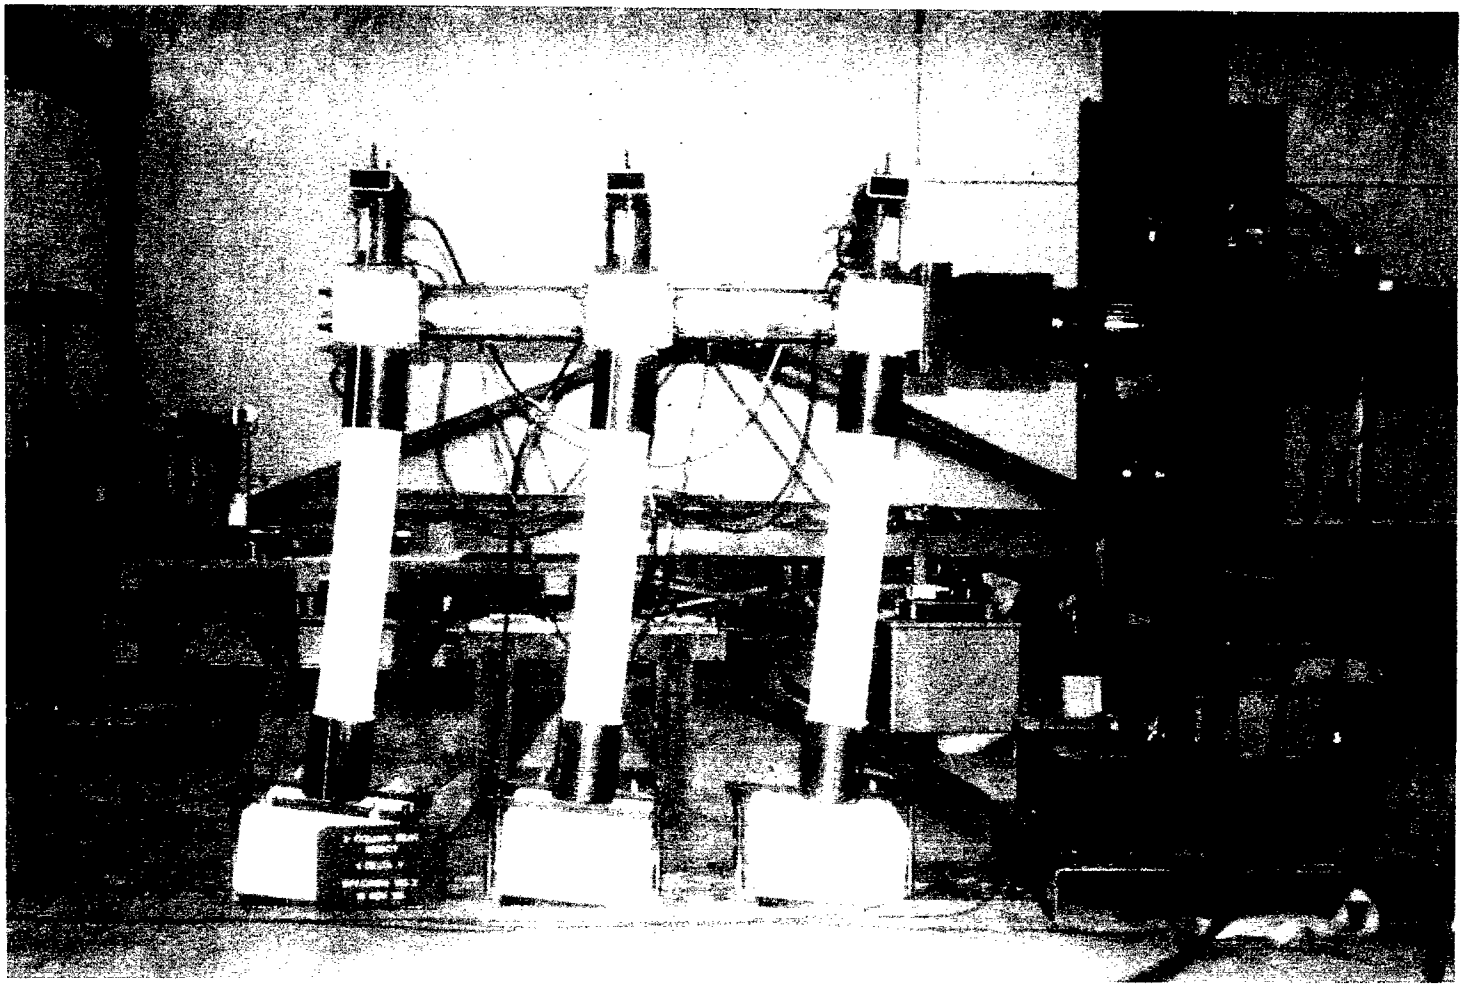
During testing, all three retrofitted columns developed minor flexural cracking just below the jackets in the upper hinge regions. The retrofitted footings rotated, resulting in some pinching of the hysteresis curves, but did not develop any significant cracking. A photograph of Specimen No. 3 during testing is shown in Figure 11. Failure occurred in the specimen due to a longitudinal column bar fracturing within the retrofitted top hinging region

Figure 11 Specimen No. 3 during testing.

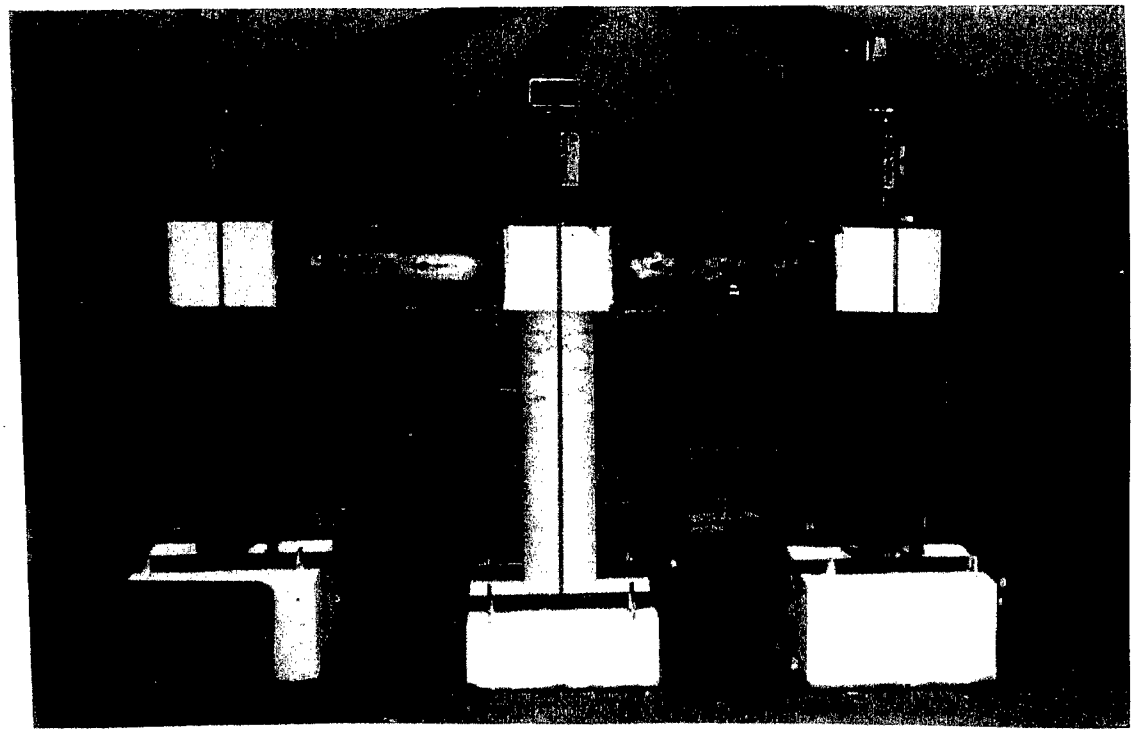
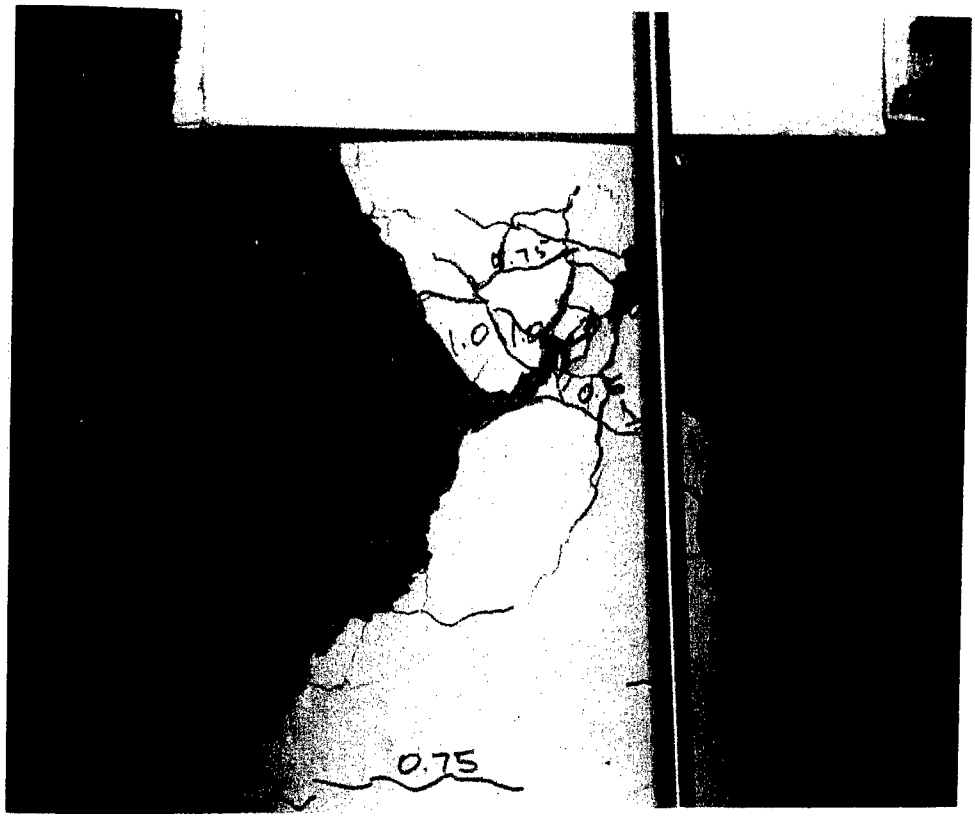
While loading the system to a displacement level of 1.2 cm (0.5 in.), horizontal (flexural) and inclined (shear) cracks were observed in the top hinging region of the unretrofitted center column. During loading to a displacement level of 7.5 cm (1.5 in.), the shear cracks increased in size. The top hinge region eventually failed in shear, resulting in a significant drop in load-carrying capacity of the bent, at a displacement level of 12.3 cm (2.5 in.). The maximum value of applied shear in the center column was 39 kN (8.8 kips). The retrofitted outer columns continued to carry load even after the center column completely failed and lost all of its core concrete. No cracks were observed in the footings during testing. A photograph of Specimen No. 6 during testing along with a closeup of the damage in the center column are shown in Figure 16.

Figure 16 Photographs of Specimen No. 6 during testing.

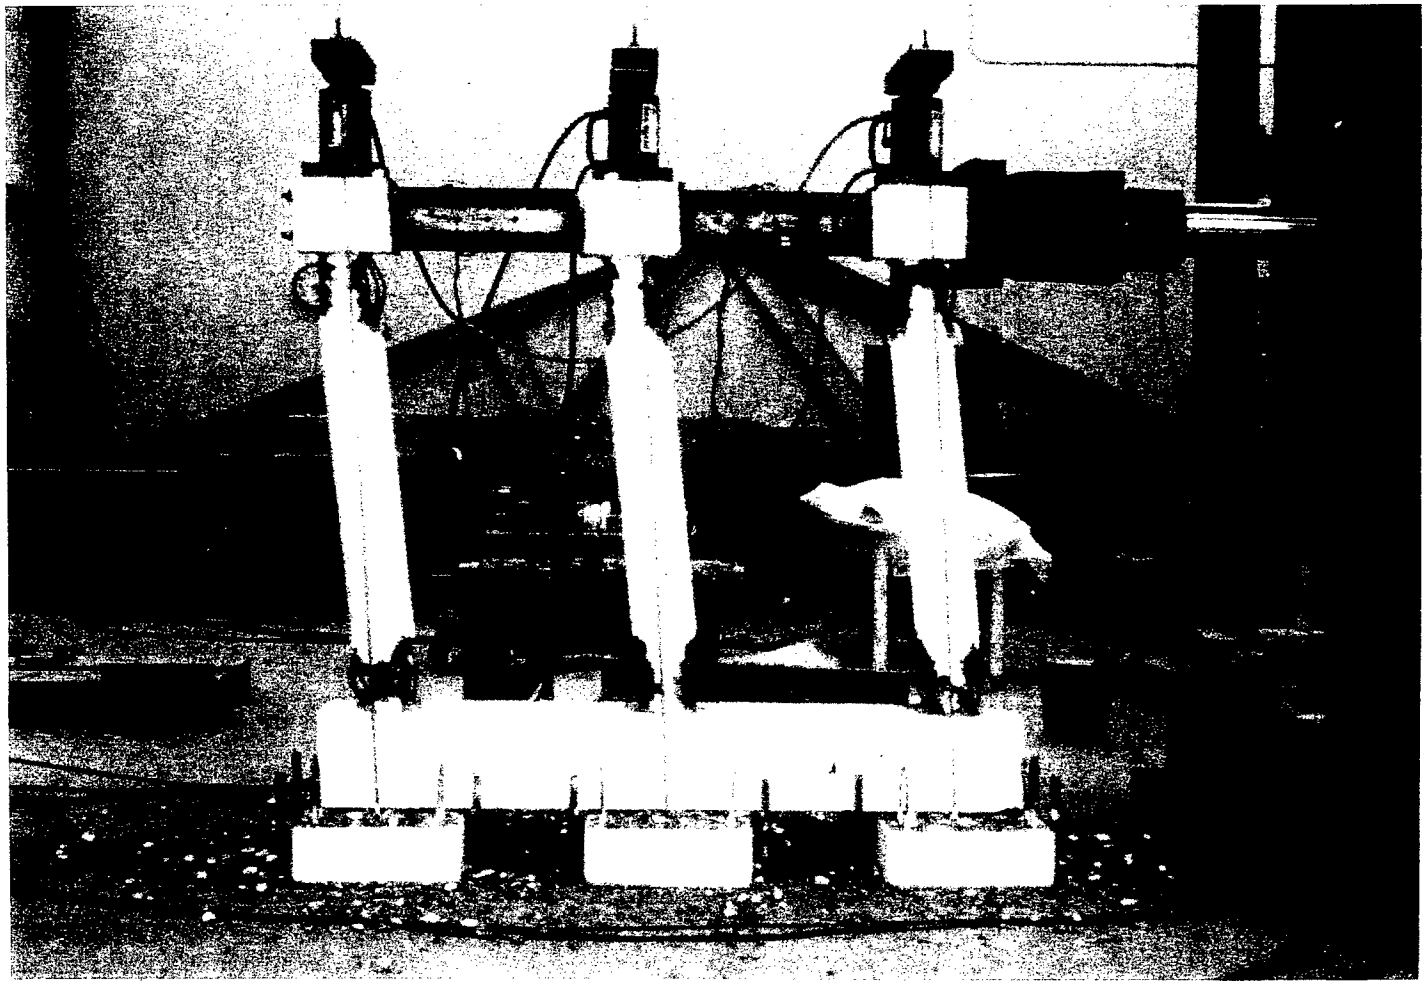
The addition of the link beam resulted in plastic hinges forming in both the top and bottom regions of the columns. During loading to a displacement level of 7.6 cm (3 in.), significant concrete spalling occurred followed by longitudinal bar buckling within the hinging regions. No footing rotation or cracking was observed in the footings during the test. Some minor cracking occurred in the link beam around the column/beam joint. A photograph of Specimen No. 7 towards the end of testing is shown in Figure 19.

The link beam retrofit was effective in preventing damage to the footings during testing. Because no column jacketing was used, failure was caused by degradation within the unretrofitted plastic hinging regions. Based on experience with the previous tests with jacketed columns, it would be expected that, had column jacketing been used, the response of the specimen with the link beam retrofit would have been improved even further.

Figure 19 Photograph of Specimen No. 7 during testing.
