Case Studies of Two Non-Overlay Cathodic Protection Systems For Bridge Decks

RESEARCH REPORT 149

Final Report on Research Project 181-1
Conducted in Cooperation With
The U.S. Department of Transportation
Federal Highway Administration

Research Report 149
March 1990

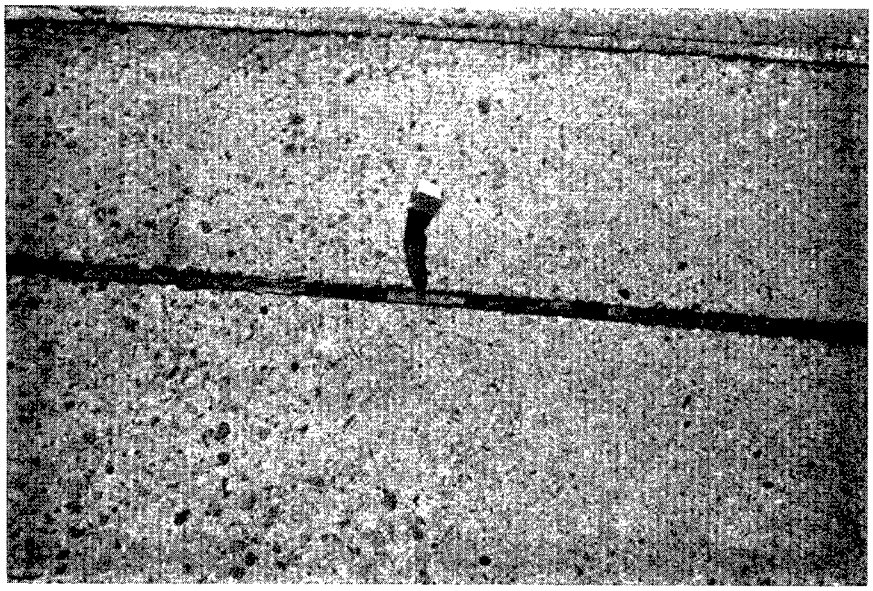
Figure 1. Typical anode grout distress.

Anode-grout debonding was first observed immediately after exposing the anodes to traffic. Small isolated areas of grout were repaired by the contractor in October 1983. After acceptance of the contract and one winter in service, larger areas of anode-grout distress appeared. By October 1984, about 200 lin ft had debonded or cracked (Fig. 1). Grout distress increased to 600 lin ft by the spring of 1985.

The anode-grout used here proved unsuitable for this task. Laboratory testing and field observations showed that grout shrinkage on setting usually caused it to crack along one vertical face of the sawcut slot. Traffic action, along with differential stresses between the grout and concrete substrate due to temperature changes, caused rapid deterioration of the anode matrix. In design of the system, close anode spacing was selected so that if minor breaks occurred in one anode, current from adjacent functioning anodes would help protect the steel near the broken anode.

Repair involved removing defective grout sections by air-chipping, and then hand-tooling the ends of each section of remaining sound grout so that about 1/2 in. of carbon filament conductor was exposed. The slots were cleaned by sand and air blasting. New carbon-filament conductors were then placed in the cleaned slots, overlapping the exposed existing carbon filaments. The slots were then backfilled with grout repair material and sprinkled with silica sand. About 3 cu ft of anode-grout and 1200 ft of carbon anode conductor were required to complete the repair work. By the beginning of October, all anodes were repaired and all zones were energized and fully operational. By the summer of 1986, a survey showed that though repaired anode-grout areas were still well bonded, an additional 150 lin ft of original anode-grout had debonded.

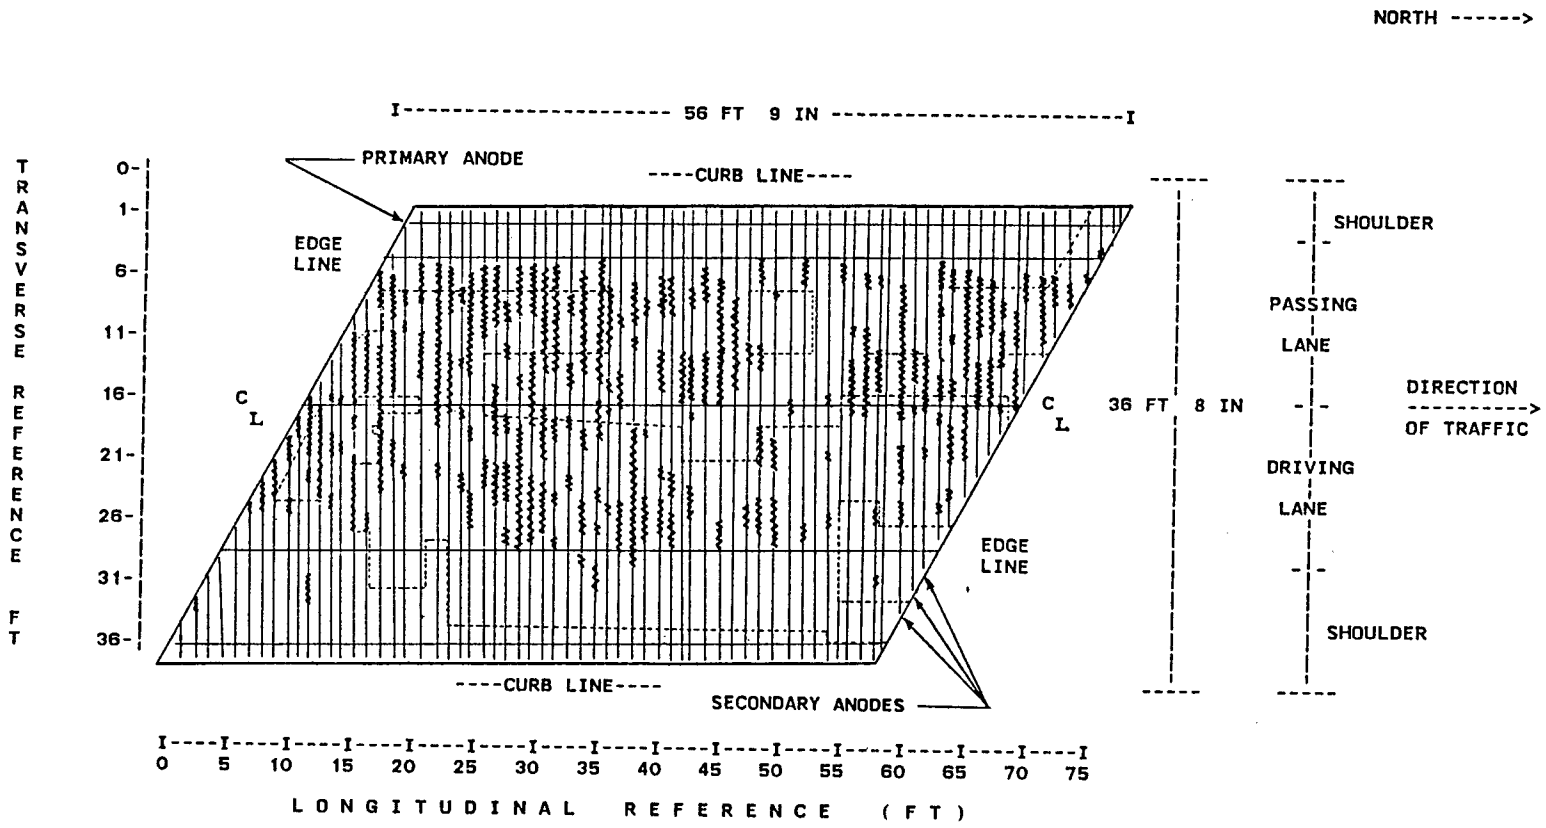
ANODE GROUT DISTRESS SURVEY
MAY, 1986
SPAN NO. 1 (ER&DB)
~~~~

Anode-grout distress was described earlier. A total of 750 lin ft or about 12.5 percent of original grout failed by summer 1986, when it was last measured. As anode deterioration progressed, it was noted that a dark orange to brown discoloration was forming at the grout-concrete interface of the anodes. This is a characteristic stain caused by acid generation, which became pronounced as fewer and fewer anode paths were available to carry the zone current. The stain was noticeably absent from broken and isolated sections of anode-grout not energized.

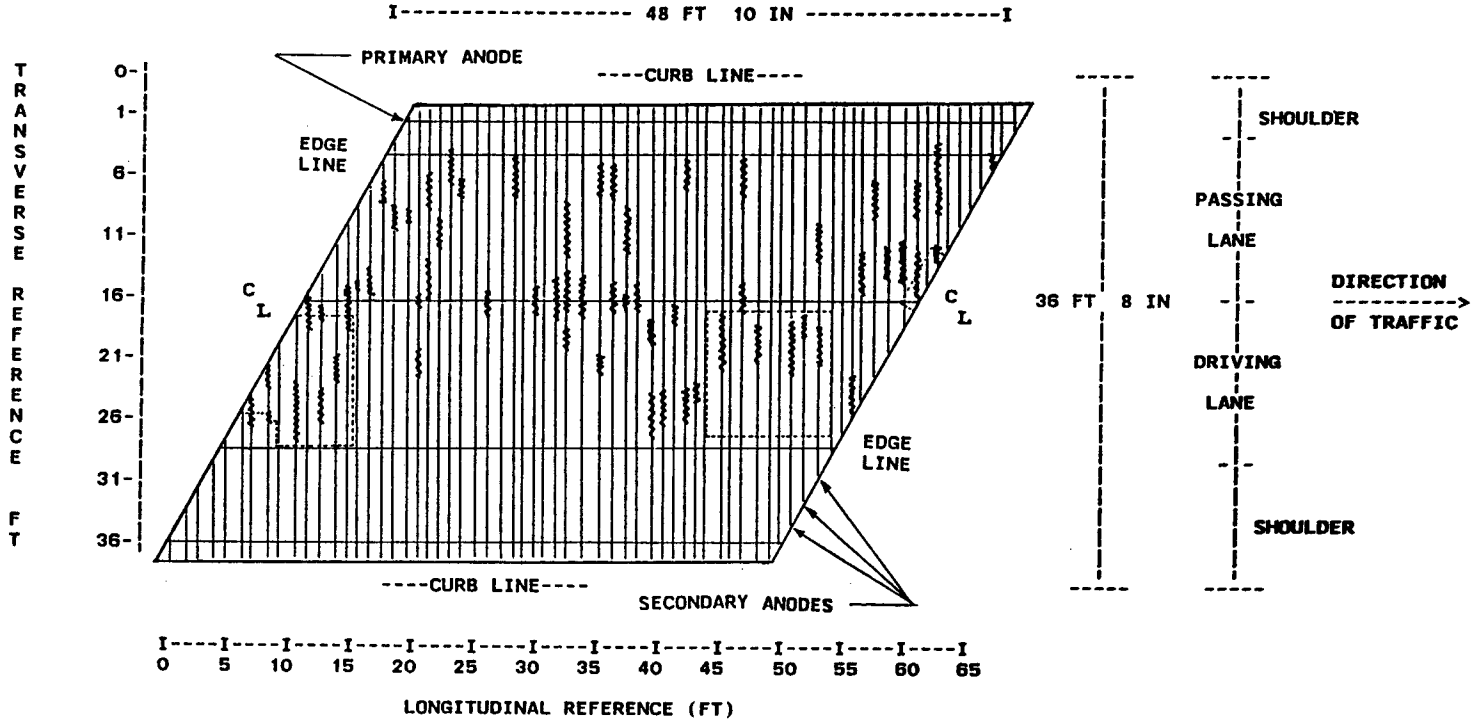
NORTH ------>
I---------- 48 FT 10 IN ----------I
PRIMARY ANODE
----CURB LINE----
EDGE LINE
C L
C L
EDGE LINE
----CURB LINE----
SECONDARY ANODES
TRANSVERSE REFERENCE FT
0-
1-
6-
11-
16-
21-
26-
31-
36-
I----I----I----I----I----I----I----I----I----I----I----I----I----I----I----I----I
0 5 10 15 20 25 30 35 40 45 50 55 60 65
LONGITUDINAL REFERENCE (FT)
36 FT 8 IN
SHOULDER
PASSING LANE
DRIVING LANE
SHOULDER
DIRECTION OF TRAFFIC ---------->
LEGEND
GROUT DISTRESS
CONCRETE PATCH
ANODE GROUT DISTRESS SURVEY
MAY, 1986
SPAN NO. 3 (ER&DB)

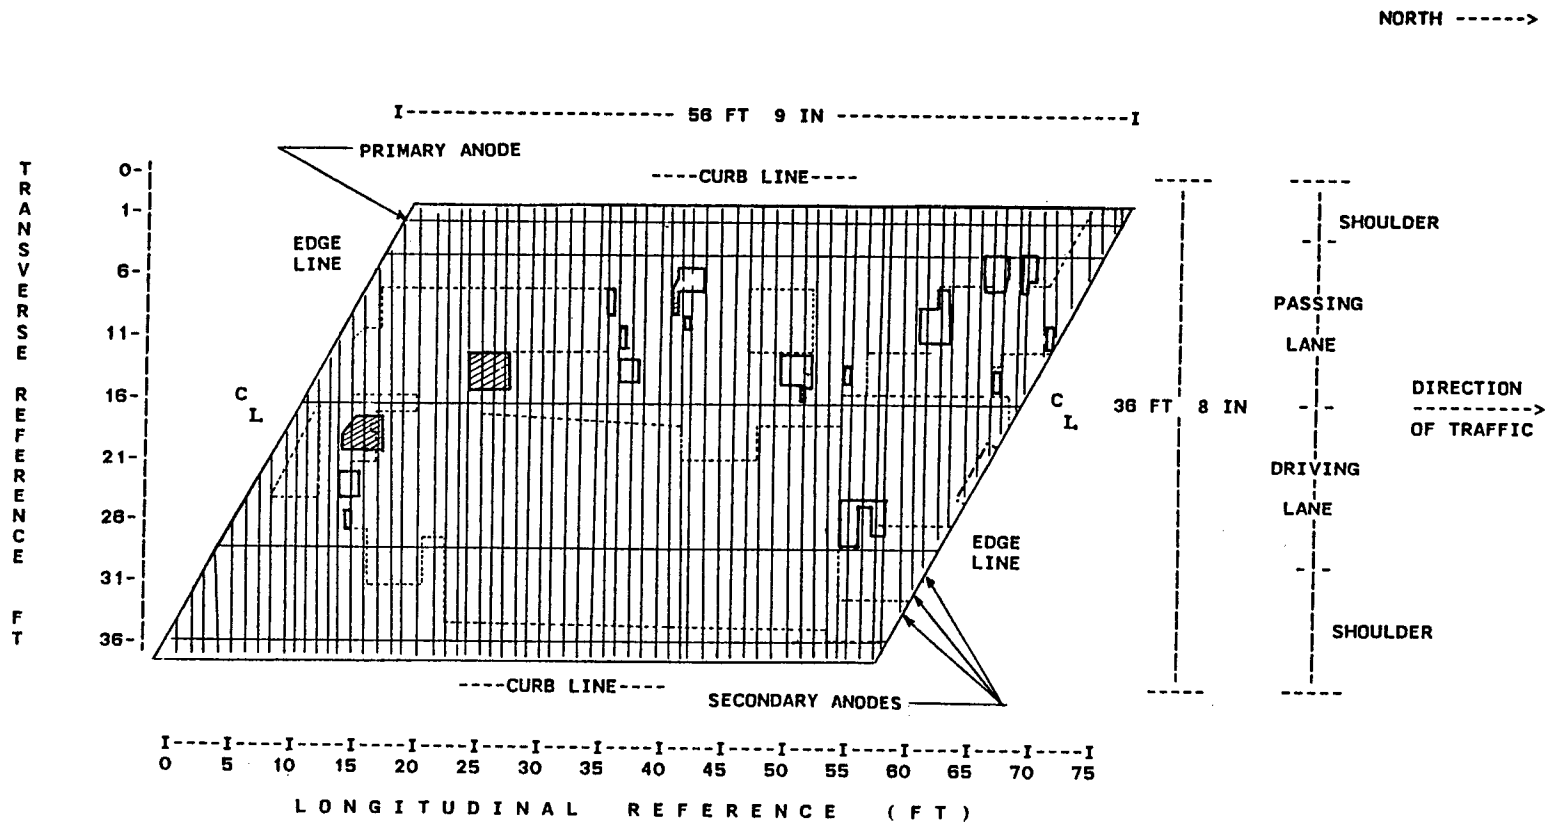
SPALL & DELAMINATION SURVEYS
MAY, 1987
SPAN NO. 1 (ER&DB)

In 1985, it became apparent that the bridge deck surface was experiencing surface distress in the form of spalling. Spalling and delamination were surveyed in May 1986 and again in May 1987. The pattern of distress was progressive and tended to occur in the travel lanes adjacent to concrete patch areas. Appendix D shows the spall and delamination survey results taken in May 1987. These data are summarized in Table 5.

Concrete deck distress at Whitney Point, first measured in May 1986, involved 1.2 percent of the deck area. Surveyed a year later, deck distress had doubled (Table 5). All spalls and delaminations detected were found in old concrete adjacent to deck surface areas patched before the system was installed. Since these areas previously seemed "sound" when the deck was surveyed for delaminations in 1983, distress formed either as a result of the rapid deterioration process described earlier, or existed before CP installation as corrosion-induced microcracks, not detectable using standard delamination-survey techniques.
