EVALUATION OF THE INSTALLATION AND INITIAL CONDITION OF LATEX-MODIFIED AND SILICA FUME CONCRETE OVERLAYS PLACED ON SIX BRIDGES IN VIRGINIA

INTERIM REPORT

March 1999
VTRC 99-IR2

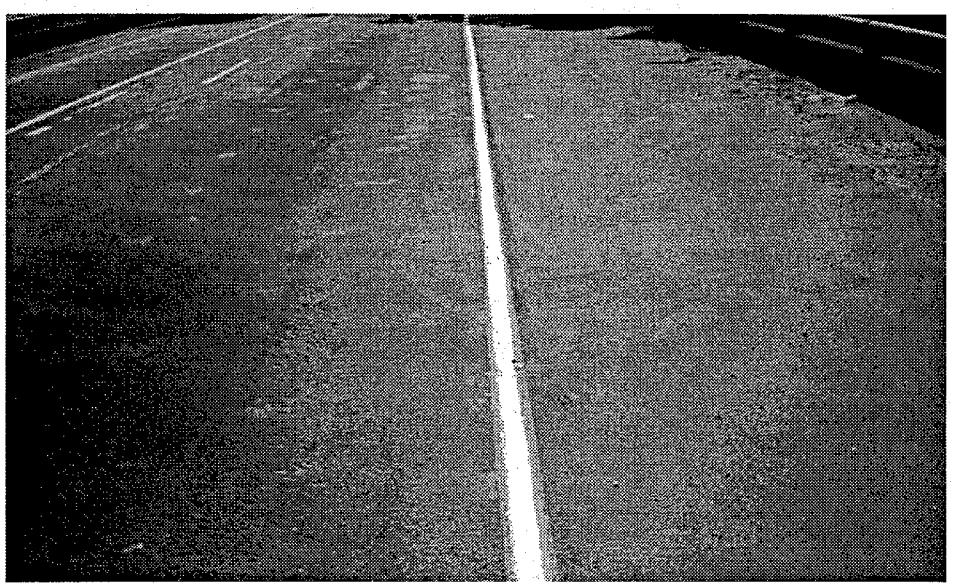
Figure 2.2. Bridge 1 prior to overlay placement. The surface has been milled.

Figure 2.3. Bridge 2 prior to overlay placement. The modified EP5 epoxy overlay is in excellent condition.

Figure 2.4. Bridge 3 prior to overlay placement.

Figure 2.5. Bridge 4 prior to overlay placement. The wet spots are locations where half-cell potential measurements were taken.

Figure 2.6. Bridge 6 prior to overlay placement. The Class I waterproofing was worn off much of the travel lane.

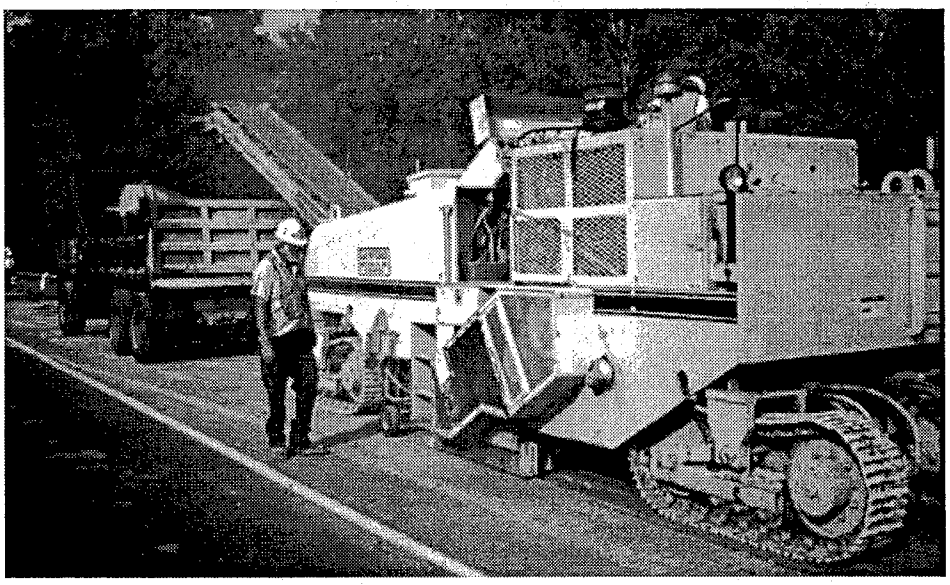
Approach slabs and decks were milled to remove the epoxy overlays and the top 13 mm (0.5 in) of the concrete (see Figure 3.1). The milled surface was chain dragged to identify delaminated areas. Concrete was removed to one half the deck thickness at three locations on Bridge 1 because a chain drag of the milled surface identified delaminations. The total area of concrete removed for patching on Bridge 1 was approximately 1.67 m^2 (2 yd^2). Concrete was removed in an area approximately one half the deck thickness by 15 cm (6 in) wide along each side of the joints on all six bridges.

Figure 3.1. Milling machine removing the top 13 mm (0.5 in) of Bridge 4.

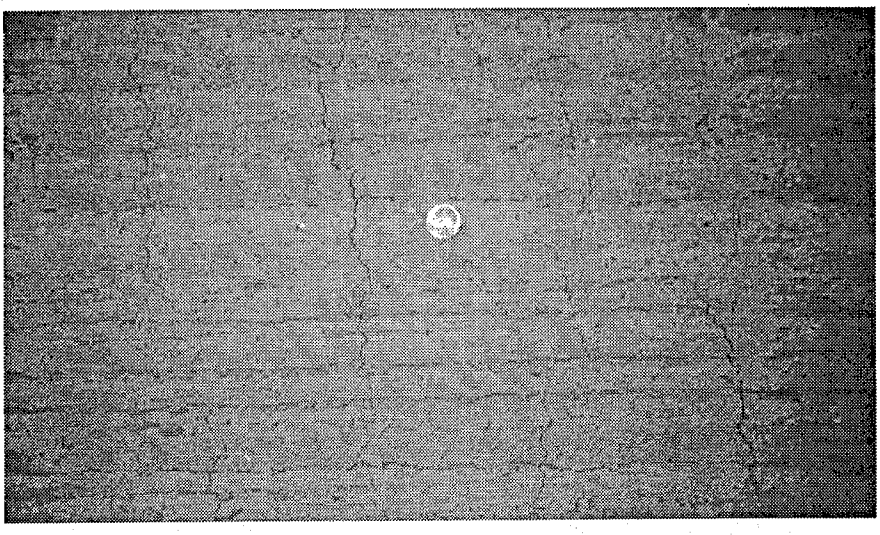
*The first overlay placed on Bridge 1 was removed because it developed many full-depth plastic shrinkage cracks that appeared to be initiated as screed tares.
**Third span of outside lane is ML; inside lane is LMC.

Figures 5.1 and 5.2 show the severe case of plastic shrinkage cracking initiated by screed tares that occurred in the overlay placed on the outside lane of Bridge 1. The overlays on the approach slabs were not cracked, which suggests that a possible explanation for the cracking was the rapid cooling of the hot overlay concrete, which was placed in the evening as temperatures dropped. The concrete in the approach slabs was insulated by the subgrade. Figure 5.3 shows the excellent condition of the SF overlay in the outside lane of Bridge 1 that replaced the cracked overlay. Figure 5.4 shows the relative dark color of Span 3 of Bridge 2. Span 3, which was overlayed with ML, was full of plastic shrinkage cracks, which were later treated with high-molecular-weight methacrylate, causing the darker color. Spans 1 and 2 are in excellent condition. Figures 5.5 and 5.6 show the excellent condition of Bridges 3 and 4, the early-strength concretes that were opened to traffic at 24 hours of age. Figure 5.7 shows the ML overlay of Bridge 5, which was full of plastic shrinkage cracks that were subsequently treated with high-molecular-weight methacrylate. Figure 5.8 shows the excellent condition of the LMC overlay on Bridge 6. Cracking on the decks is illustrated in the next section.

Figure 5.1. Plastic shrinkage cracking in Bridge 1R. The cracks are parallel with the axis of the rotating drums on the screed. The SF overlay was removed.

Figure 5.2. Bridge 1R after SF overlay placement. Core shows plastic shrinkage cracks are full depth.

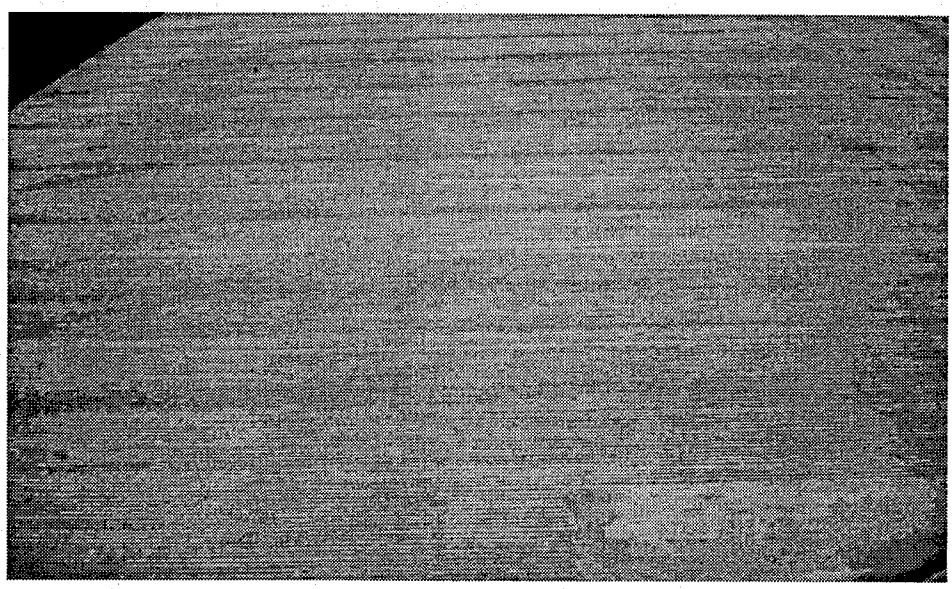
Figure 5.3. Outside lane and shoulder of Bridge 1 after SF overlay placement.

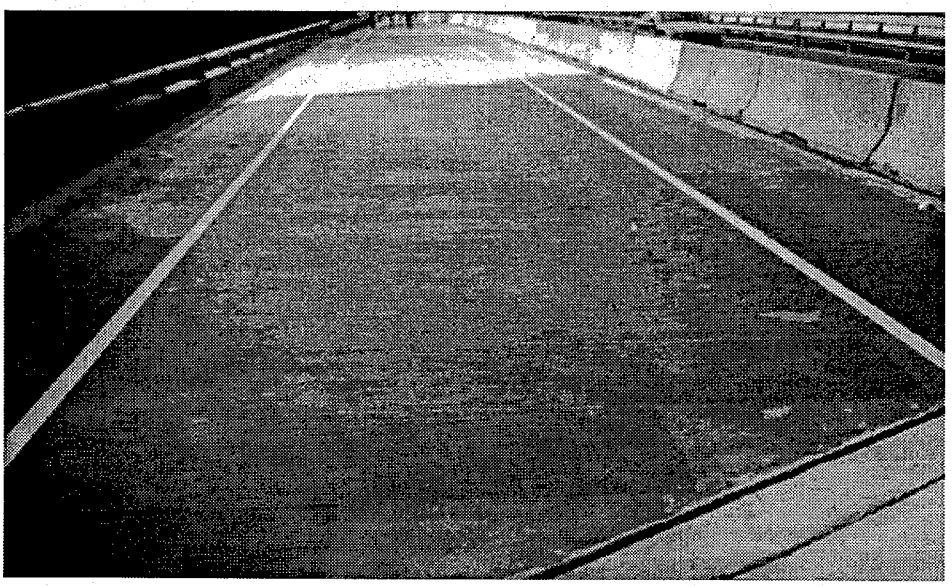
Figure 5.4. Outside lane and shoulder of Bridge 2 after MMLMC and ML overlay placement.

Figure 5.5. Outside lane and shoulder of Bridge 3 after LMCHE overlay placement.

Figure 5.6. Outside lane and shoulder of Bridge 4 after SFHE overlay placement.

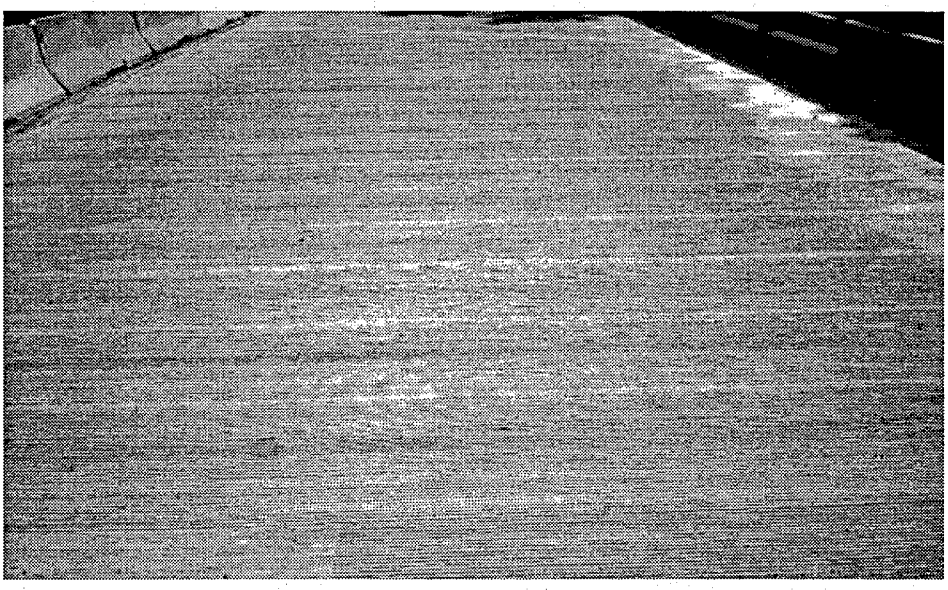
Figure 5.7. Outside lane and shoulder of Bridge 5 after ML overlay placement.

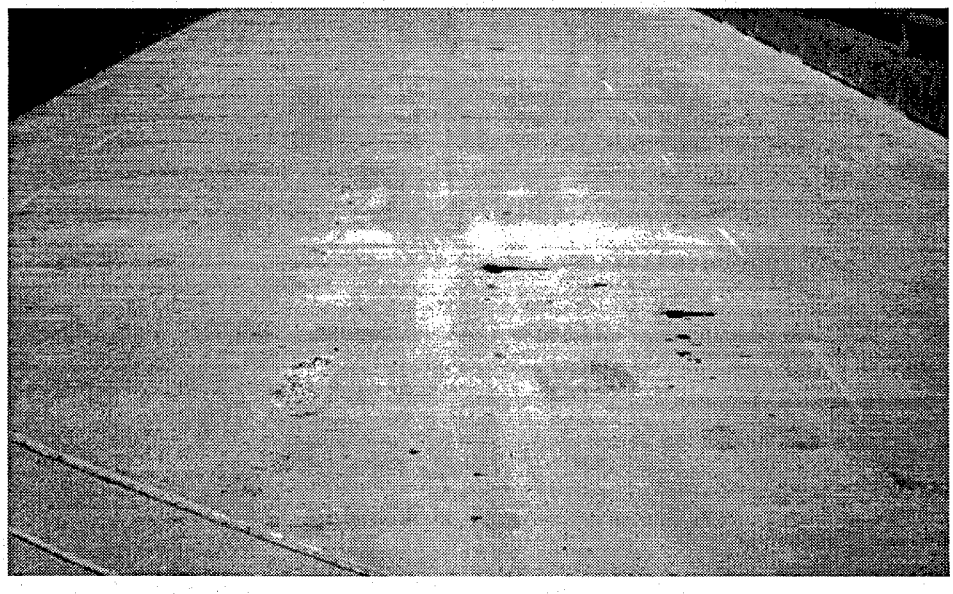
Figure 5.8. Outside lane and shoulder of Bridge 6 after LMC overlay placement.

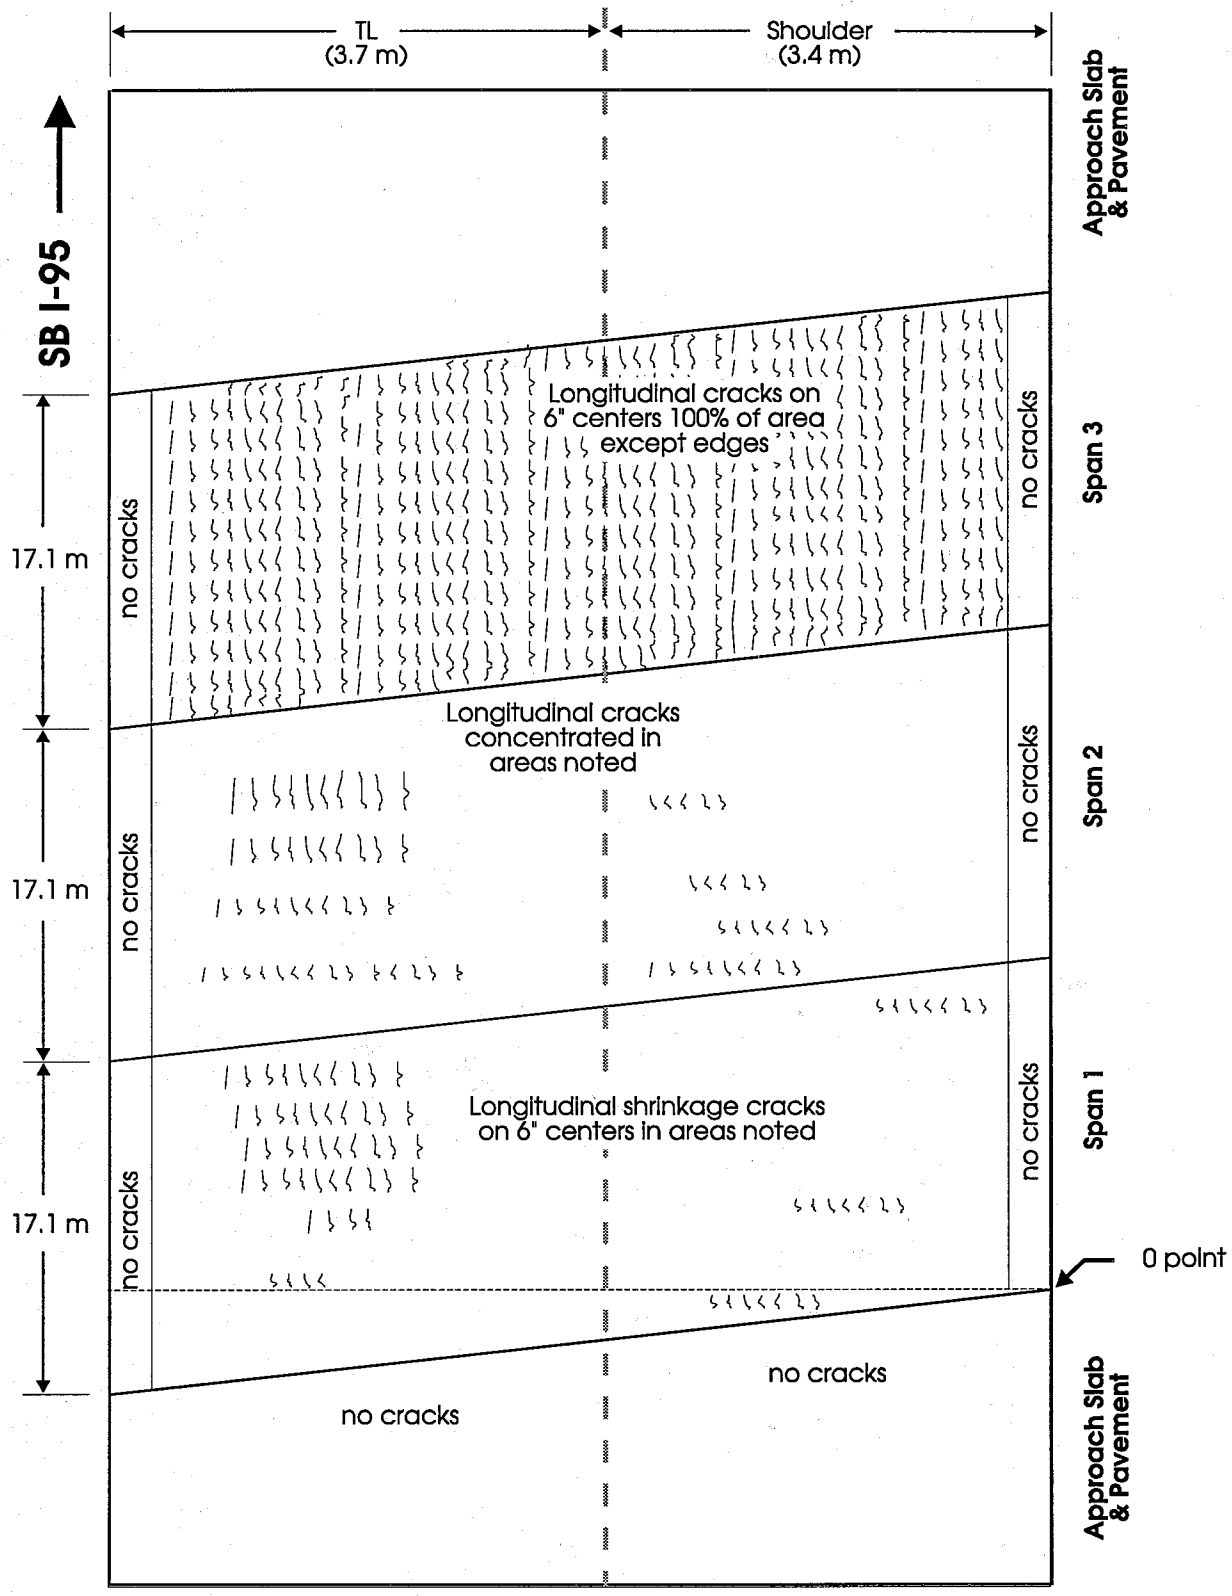
Table 5.5 is a summary of the cracks and patches in the outside lane and shoulder of the six bridge overlays. The overlays on Bridge 1 (1R) were removed because of the plastic shrinkage cracks initiated by screed tares. The overlays on Bridge 5 and Span 3 of Bridge 2 were treated with high-molecular-weight methacrylate to seal the plastic shrinkage cracks. Only the overlays on Bridge 2 had to be patched, and the delaminated area was small. The cracks and patch are shown in Figures 5.9 through 5.15.

Figure 5.9. Cracks and delaminations in Bridge 1 SBL, TL and shoulder (removed).

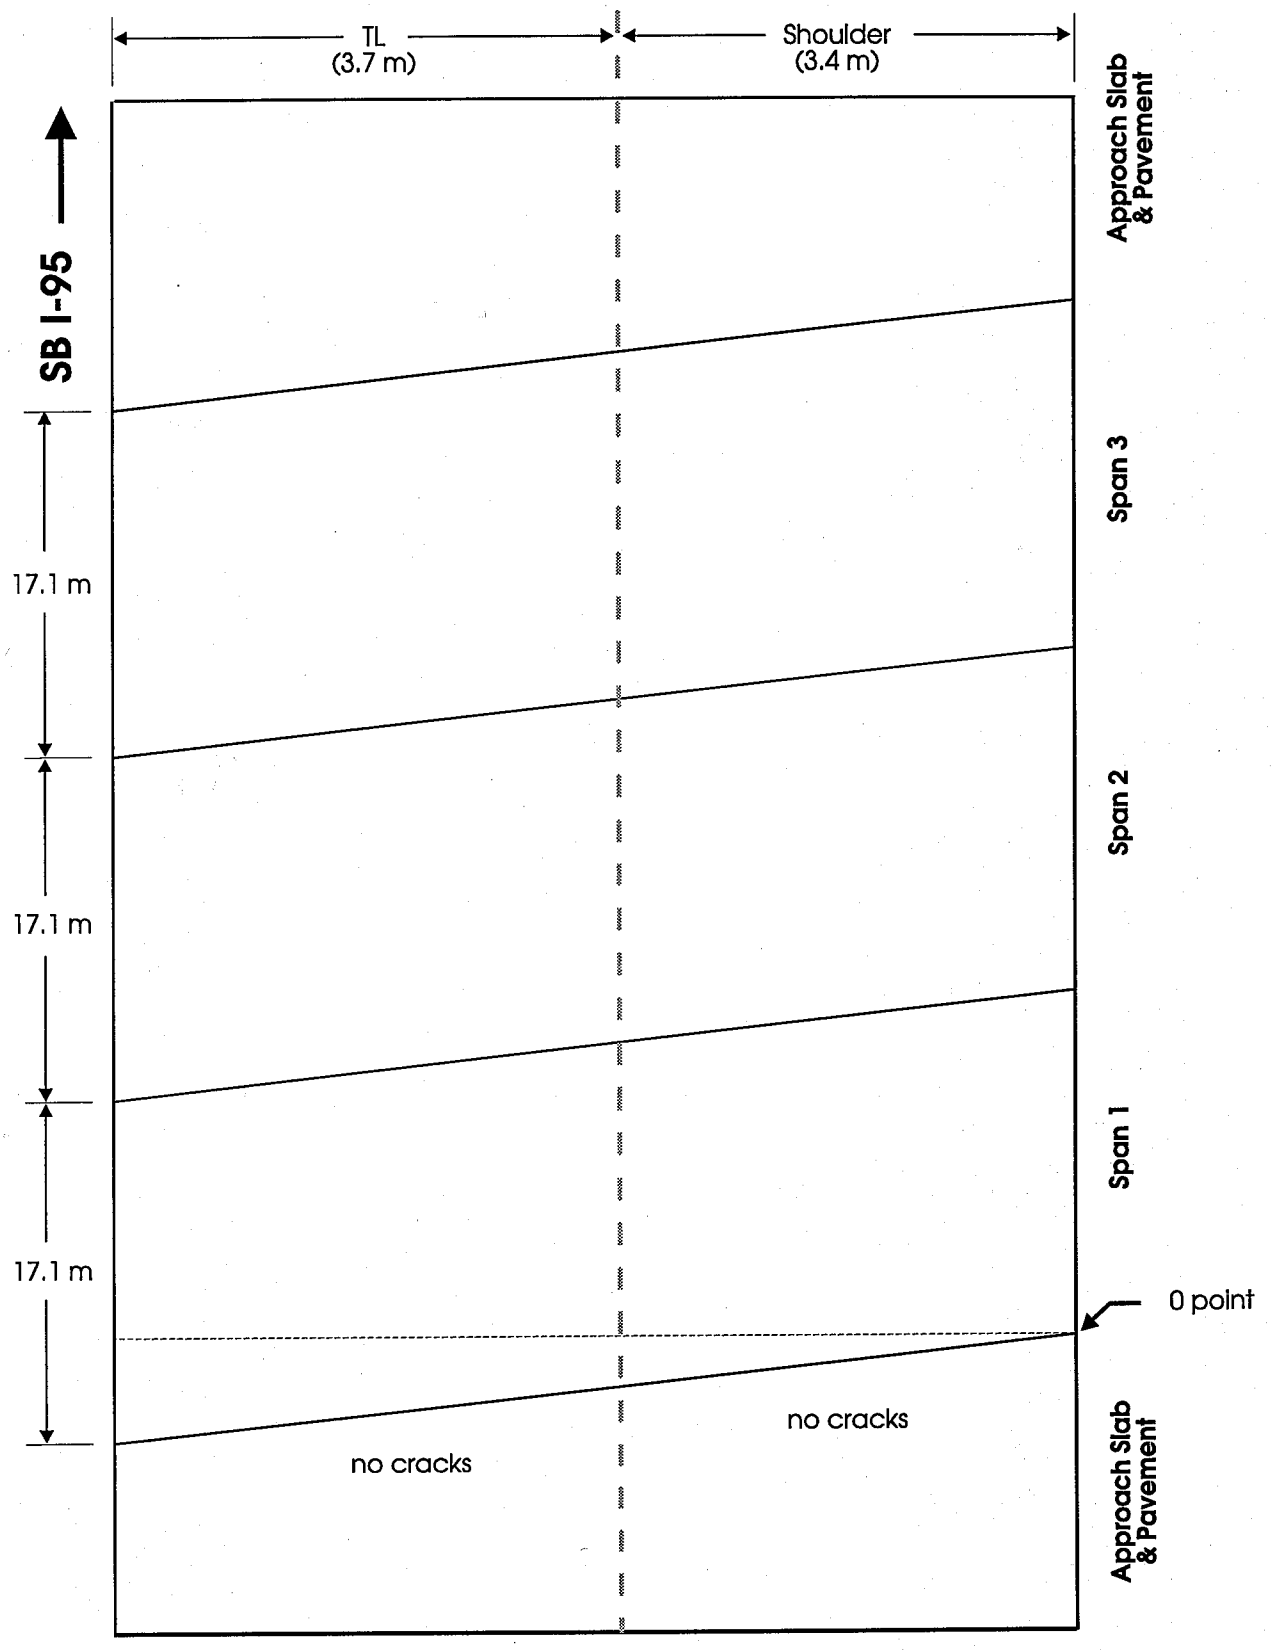
Figure 5.10. Cracks and delaminations in Bridge 1 SBL, TL and shoulder.

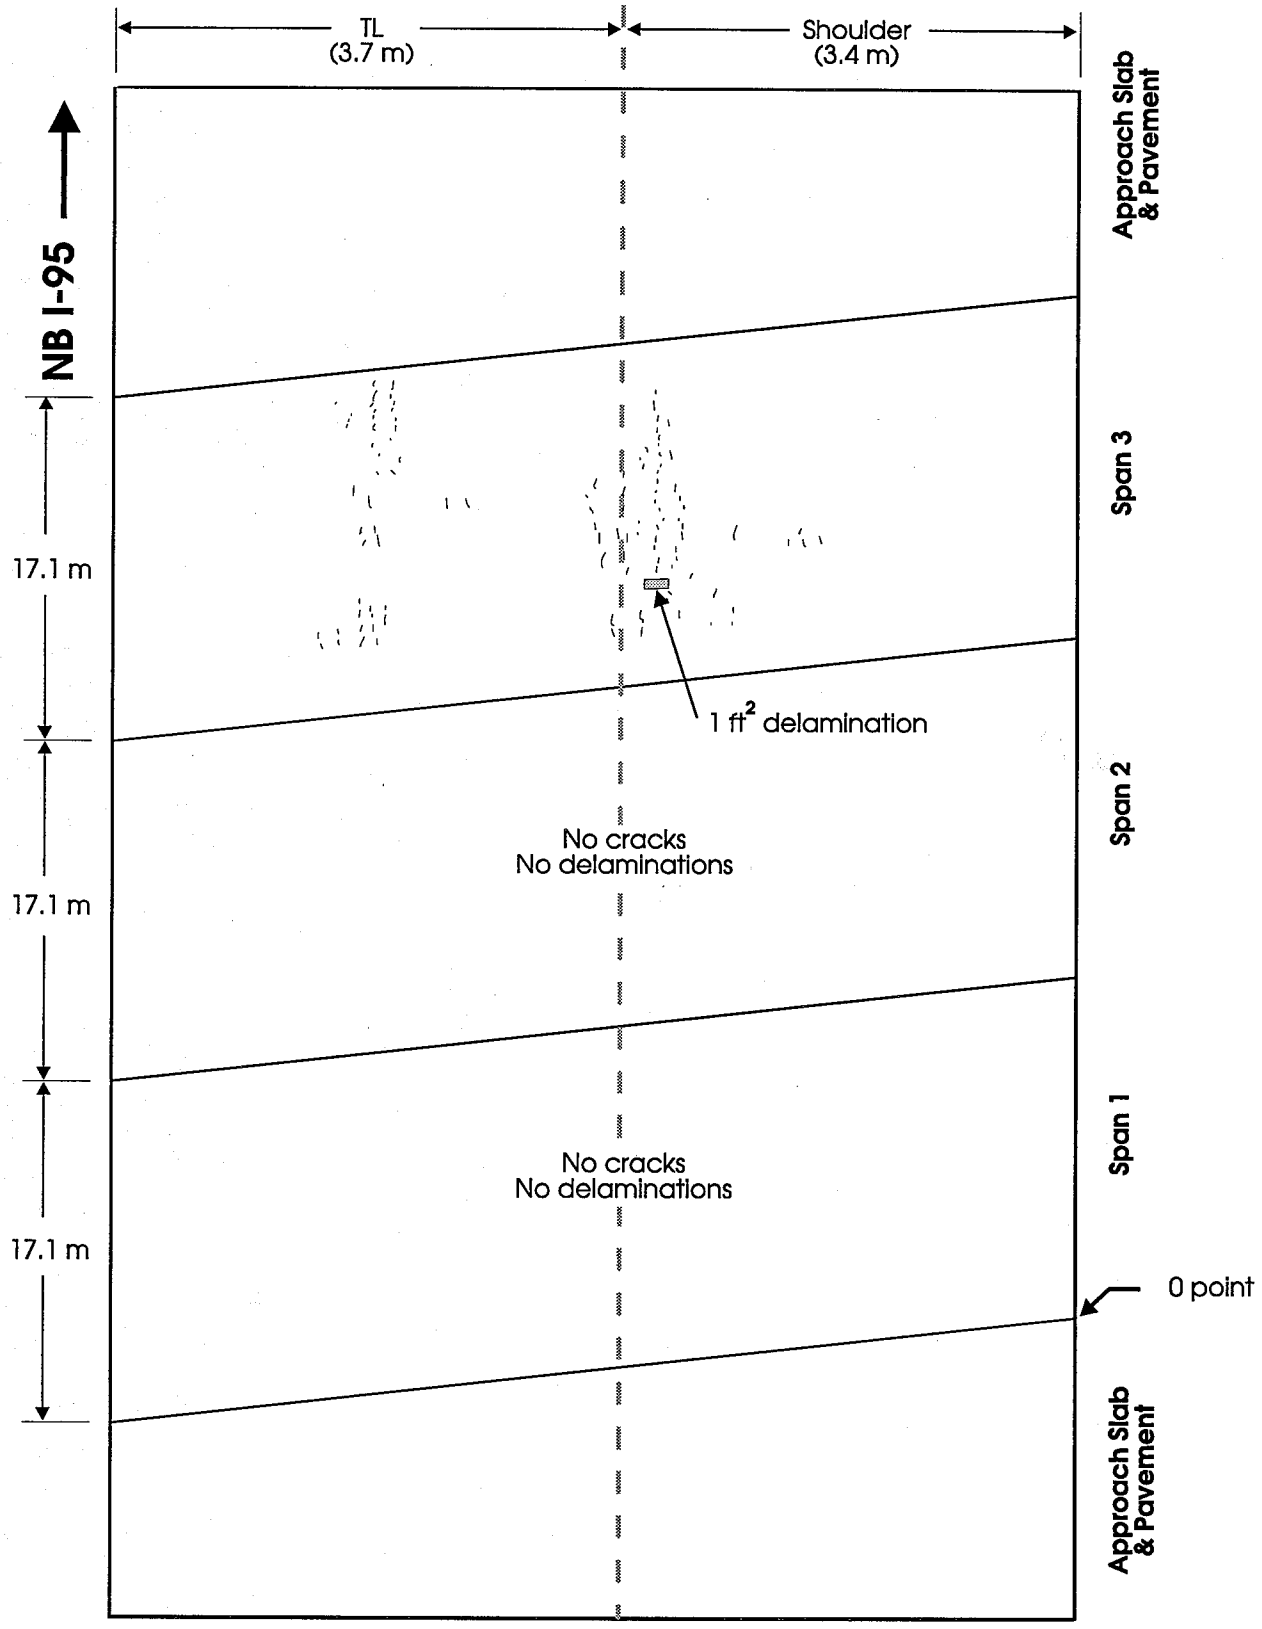
Bridge 2 had 0.093 m^2 (1 ft^2) of delamination. Otherwise, no delaminations were found.

*Span 3 with ML had numerous plastic shrinkage cracks.

Figure 5.11. Cracks and delaminations in Bridge 2 NBL, TL and shoulder.

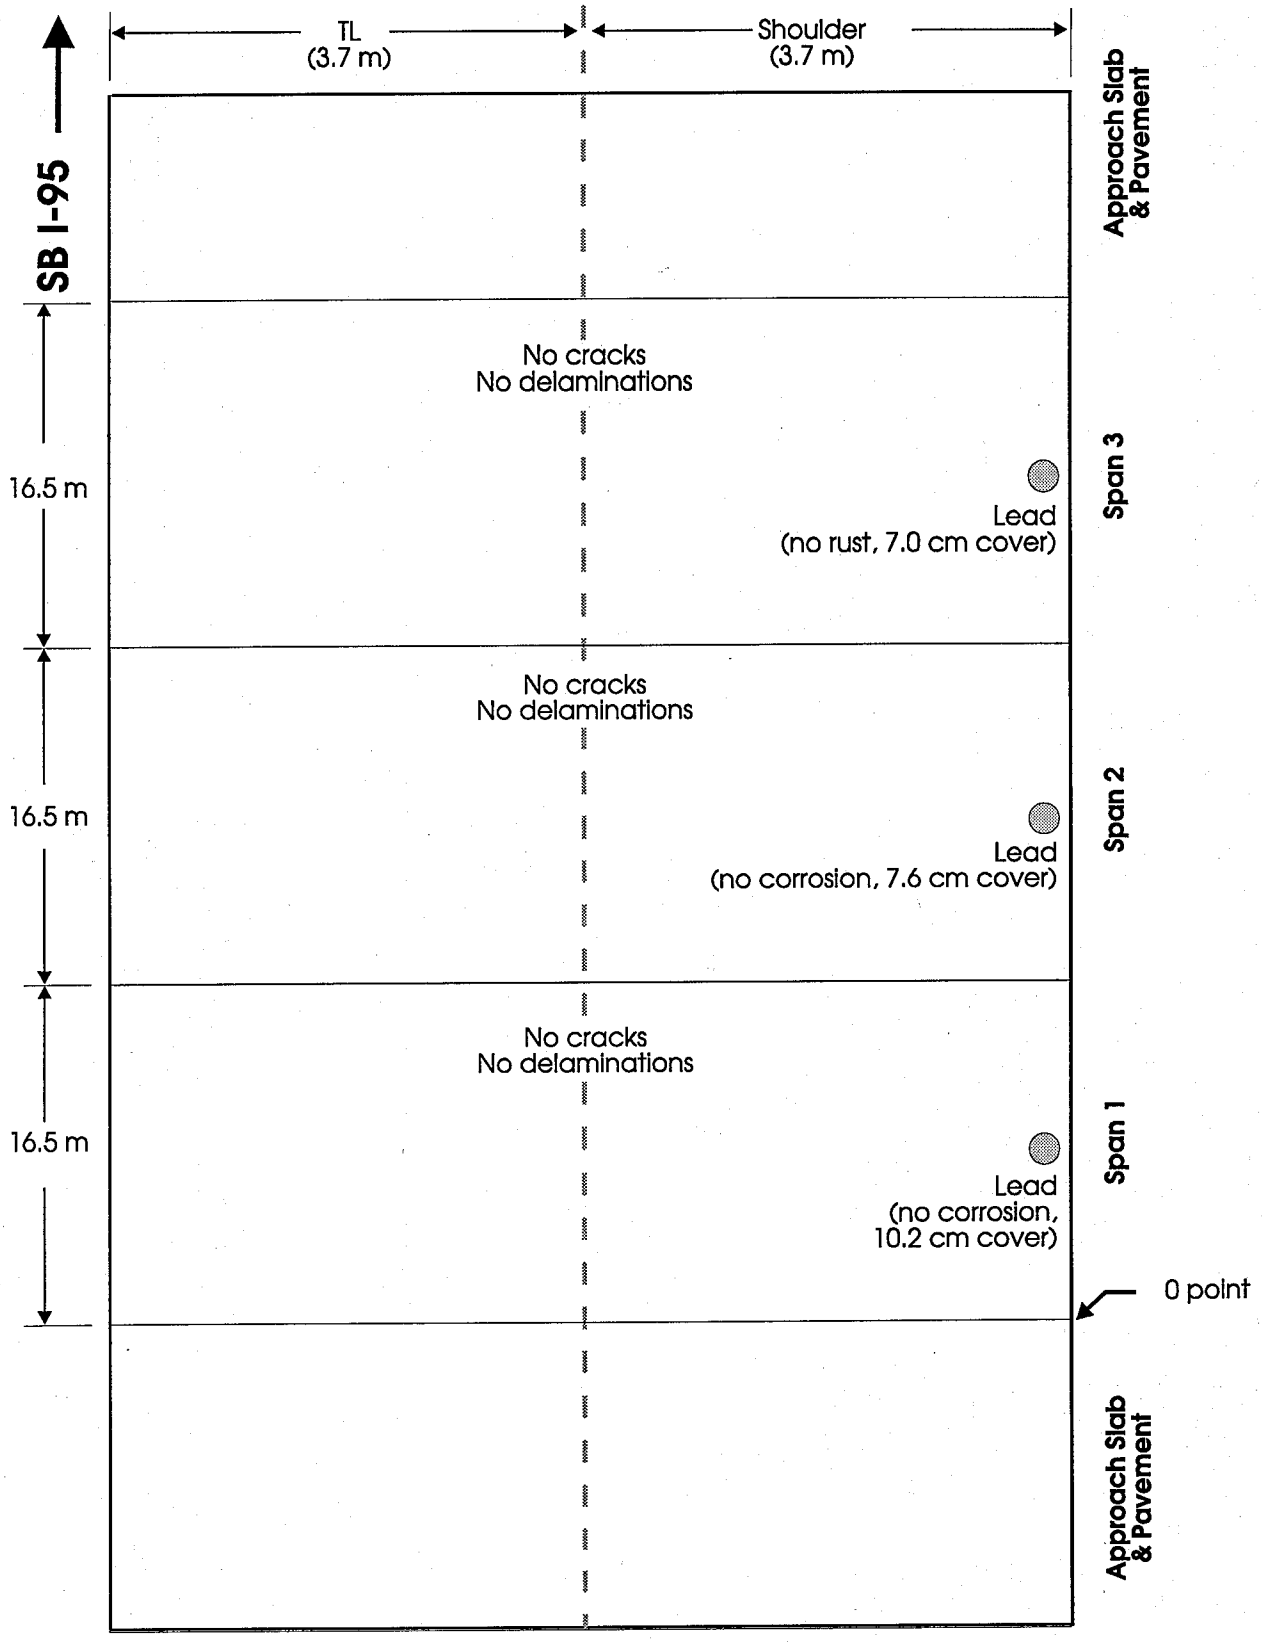
Figure 5.12. Cracks and delaminations in Bridge 3 SBL, TL and shoulder.

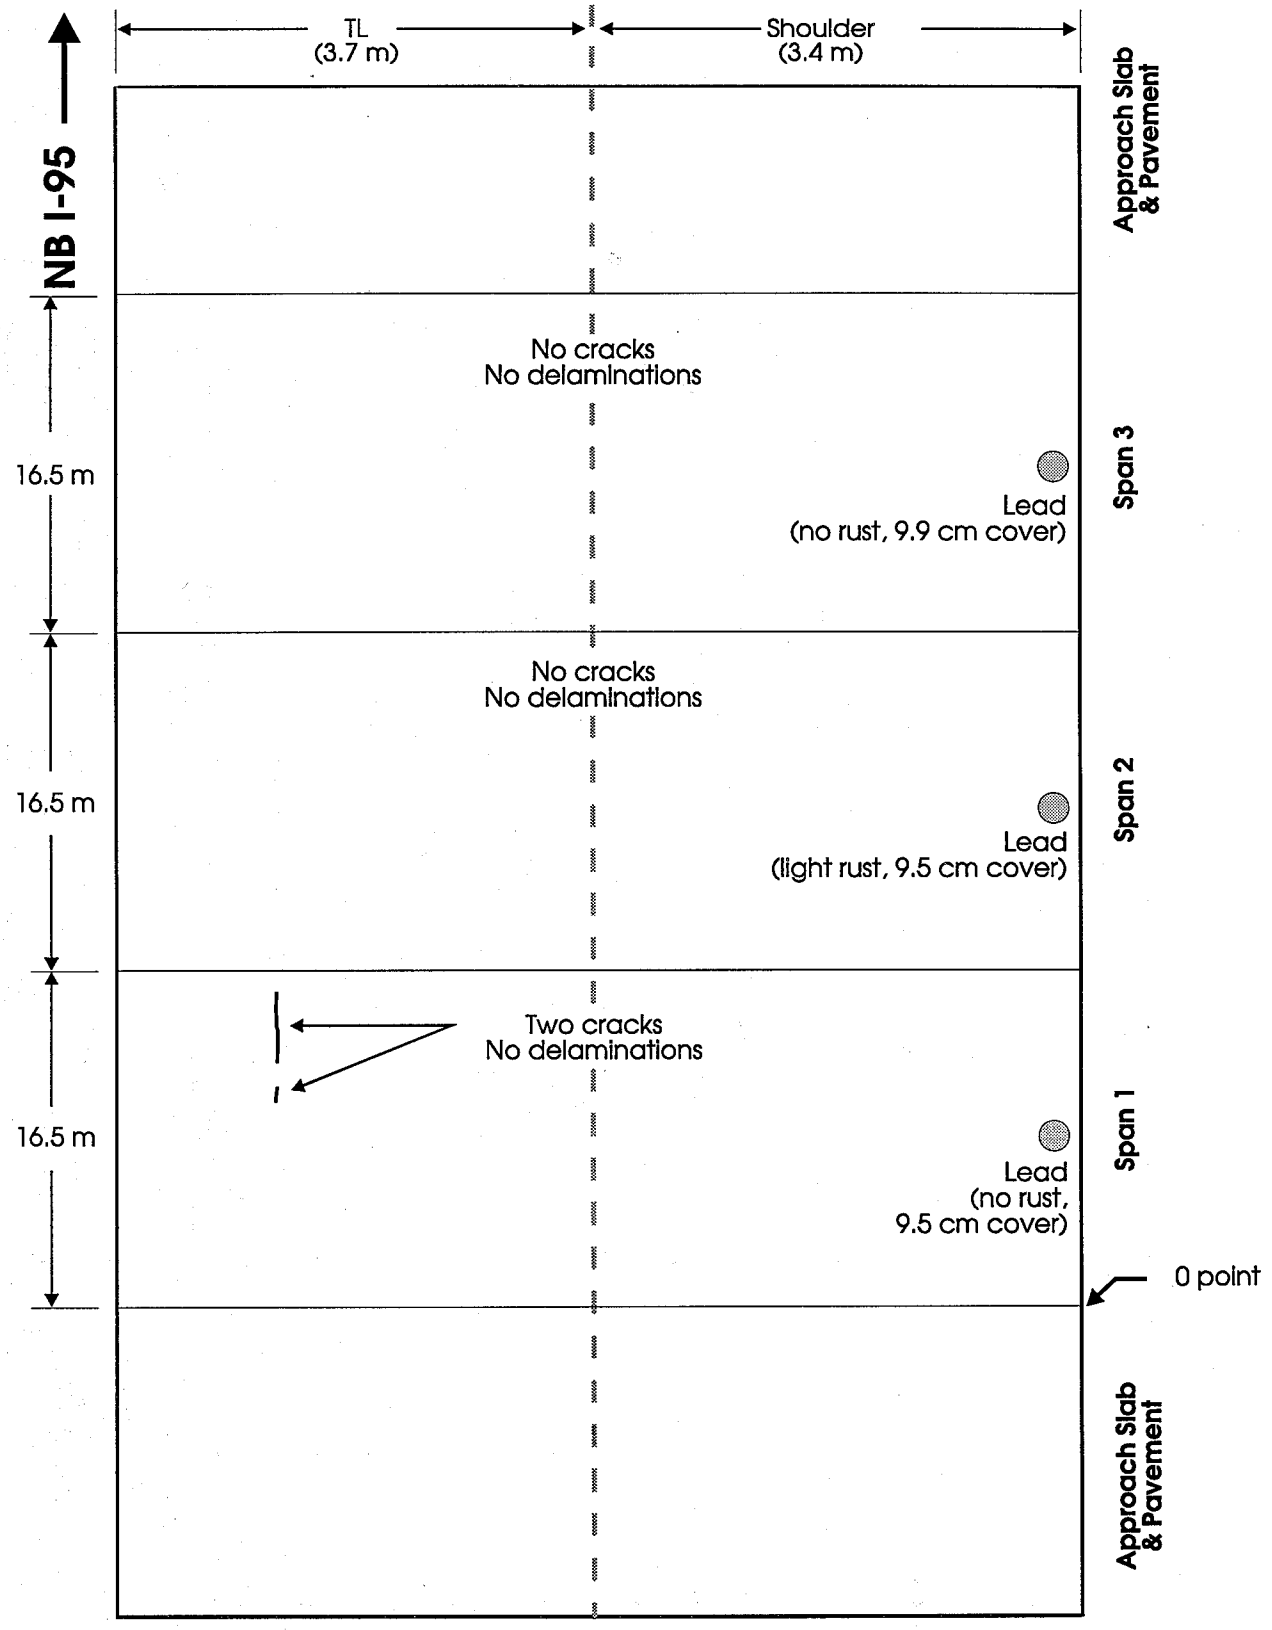
Figure 5.13. Cracks and delaminations in Bridge 4 NBL, TL and shoulder.

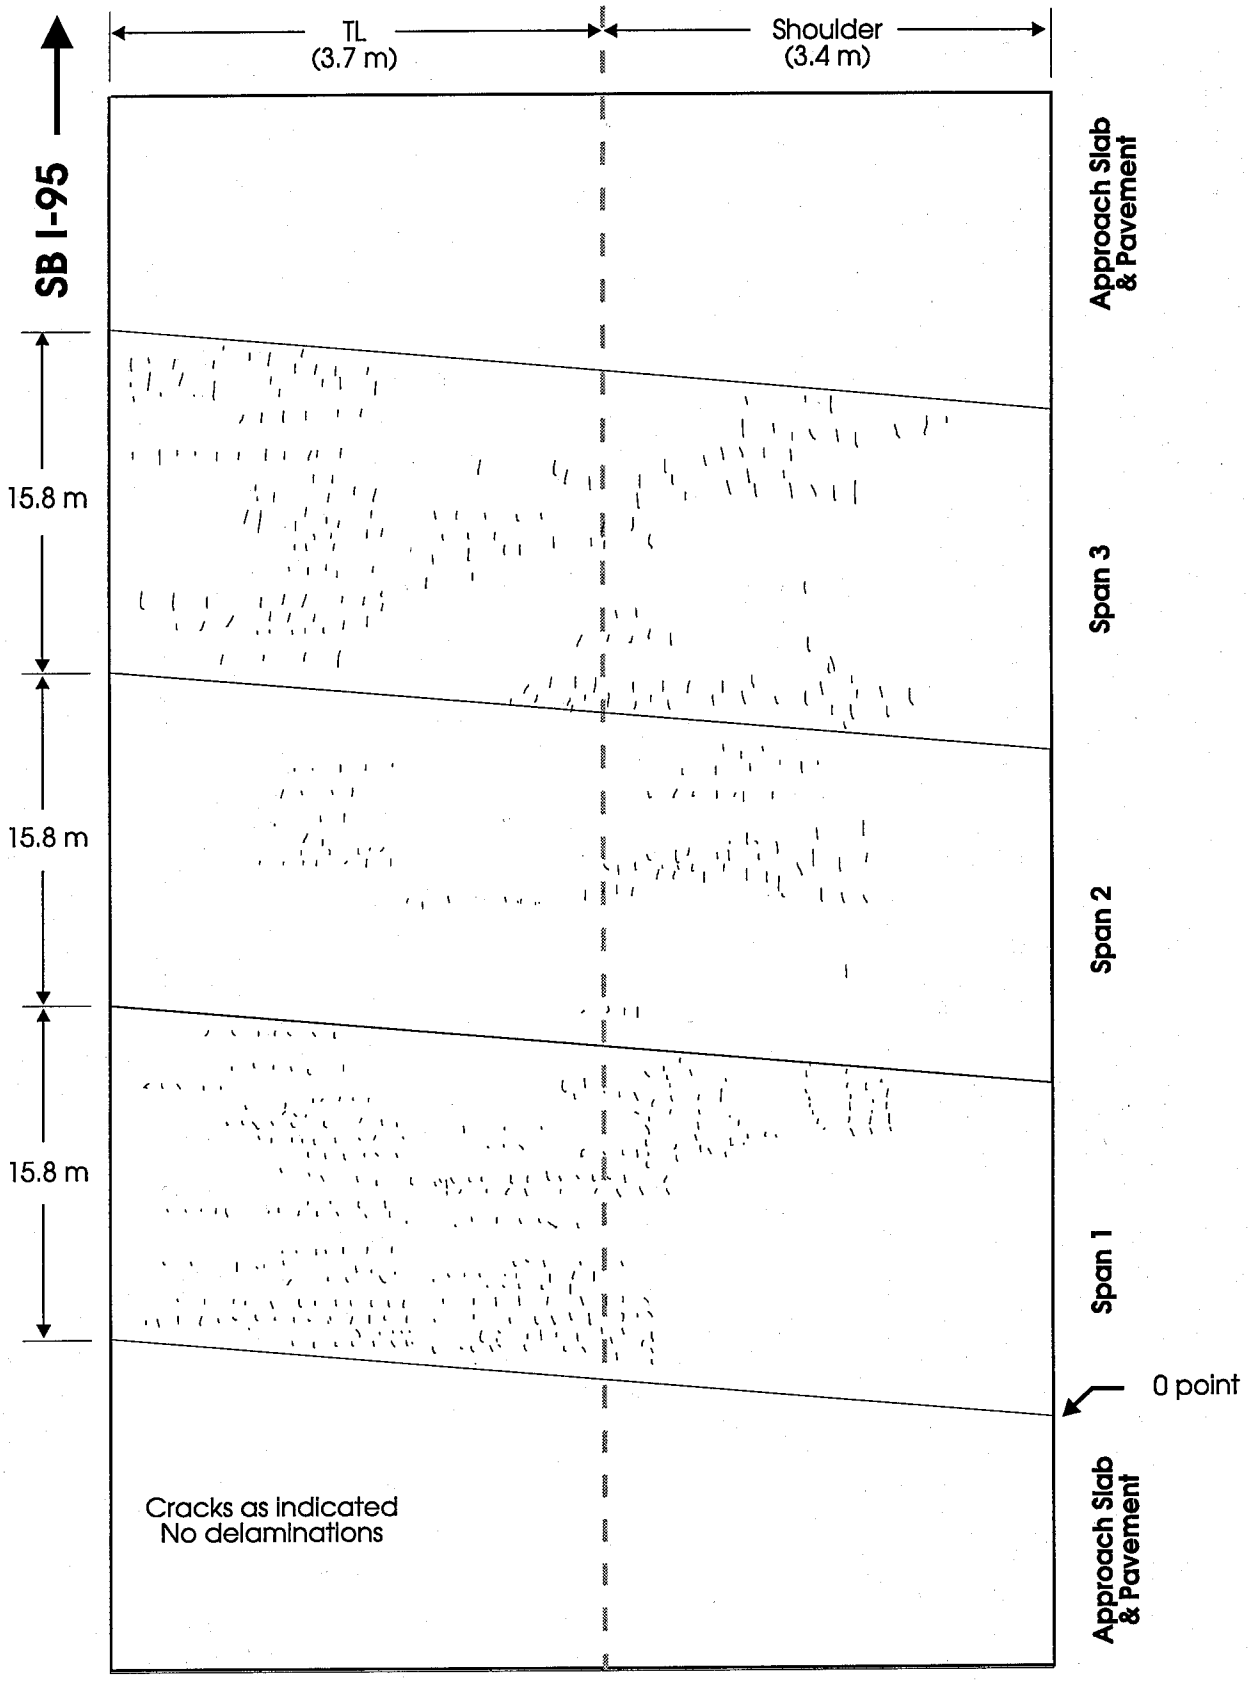
Figure 5.14. Cracks and delaminations in Bridge 5 SBL, TL and shoulder.

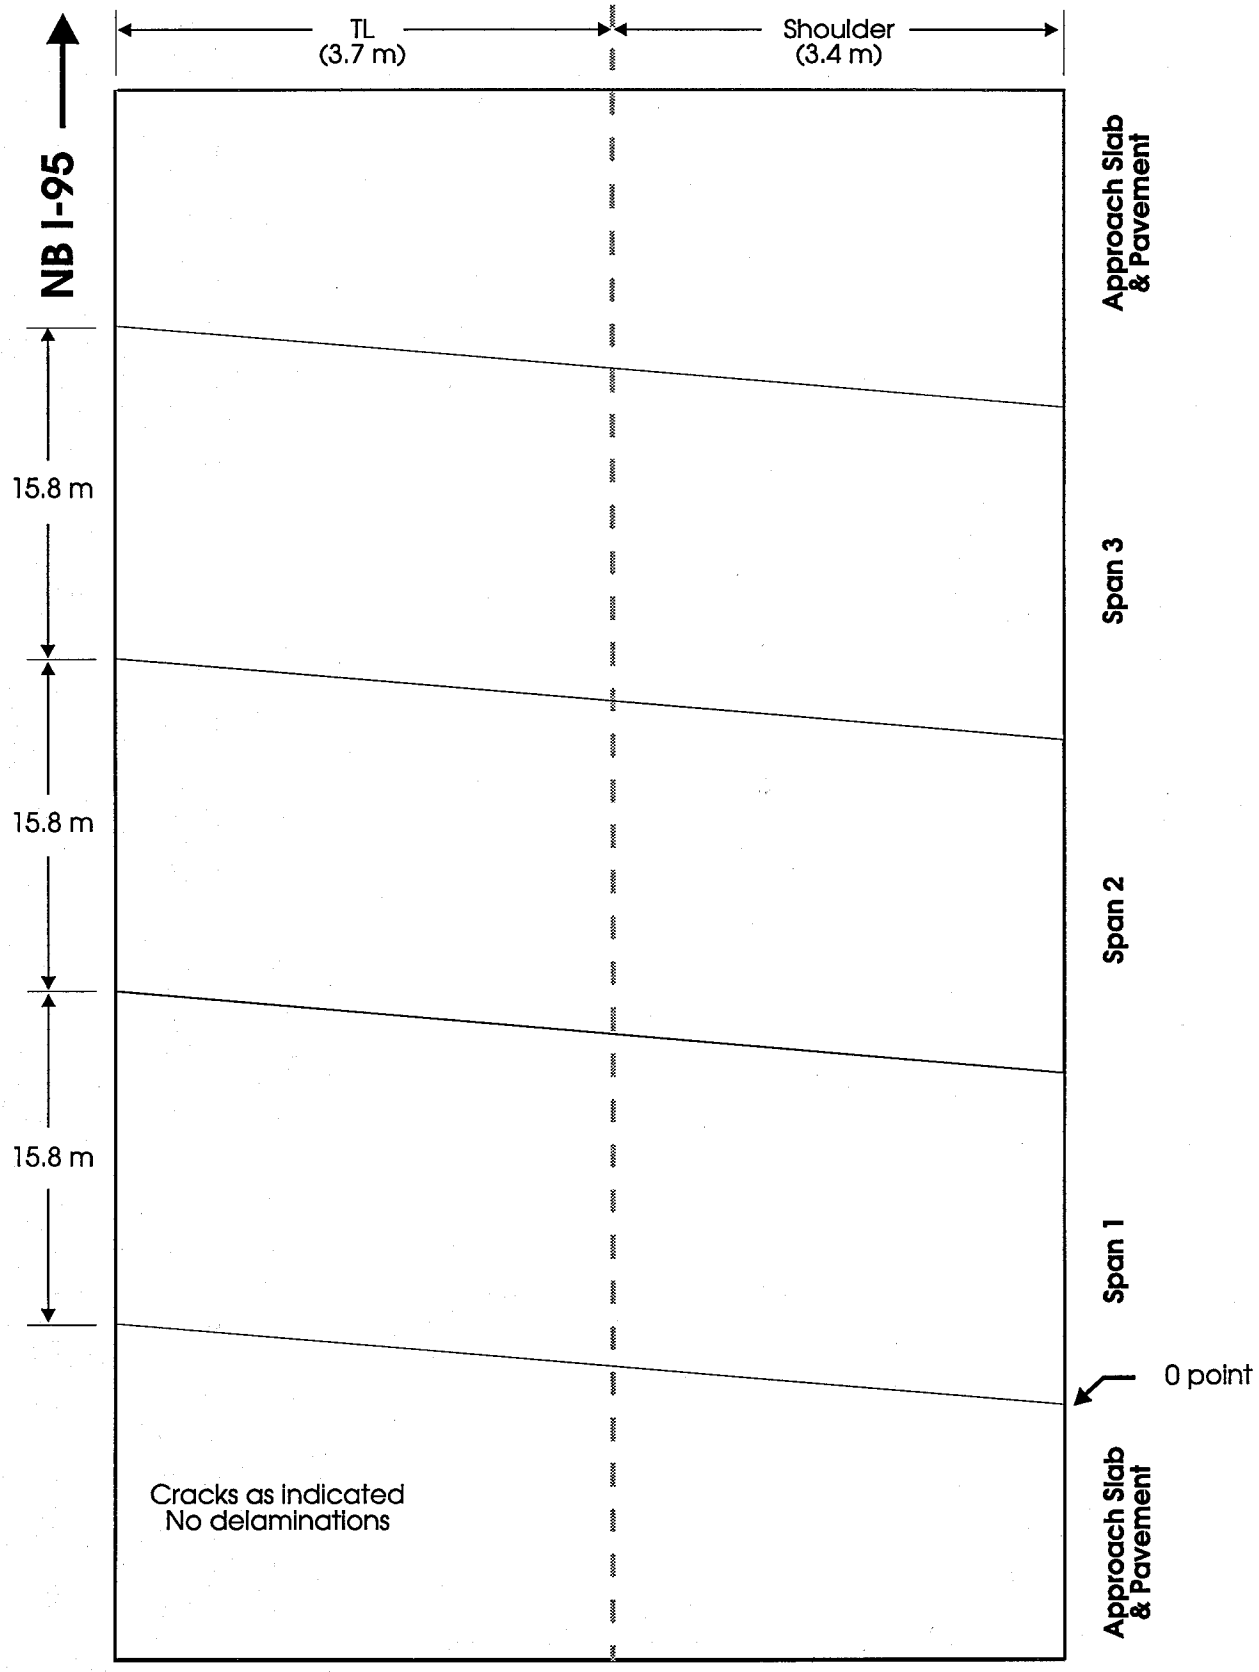
Figure 5.15. Cracks and delaminations in Bridge 6 NBL, TL and shoulder.
