Long-Term Monitoring of Pavement Maintenance Materials Test Sites

PUBLICATION NO. FHWA-RD-98-073 JUNE 1998

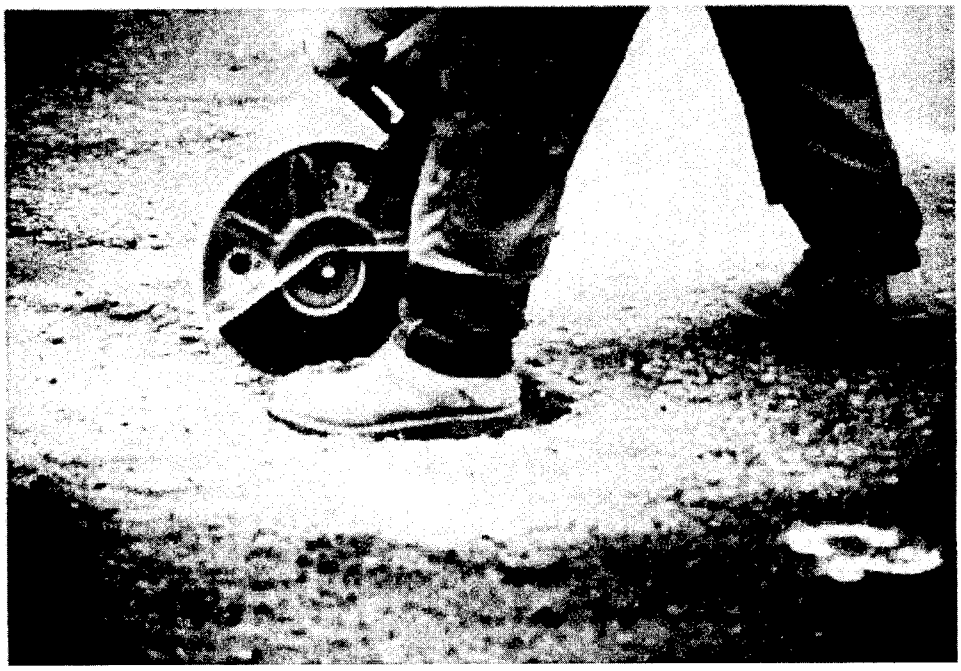
Figure 15. Straightening sides using pavement saw.

1. Remove all water and debris from pothole by using compressed air, brooms, shovels, or other available equipment.
2. Square up the sides of the pothole so they are vertical and have sound pavement on all sides (it is not necessary to create a square or rectangular area as long as the sides are vertical). The squaring up can be achieved by using either a jackhammer equipped with a spade bit or a pavement saw, as seen in figure 15.

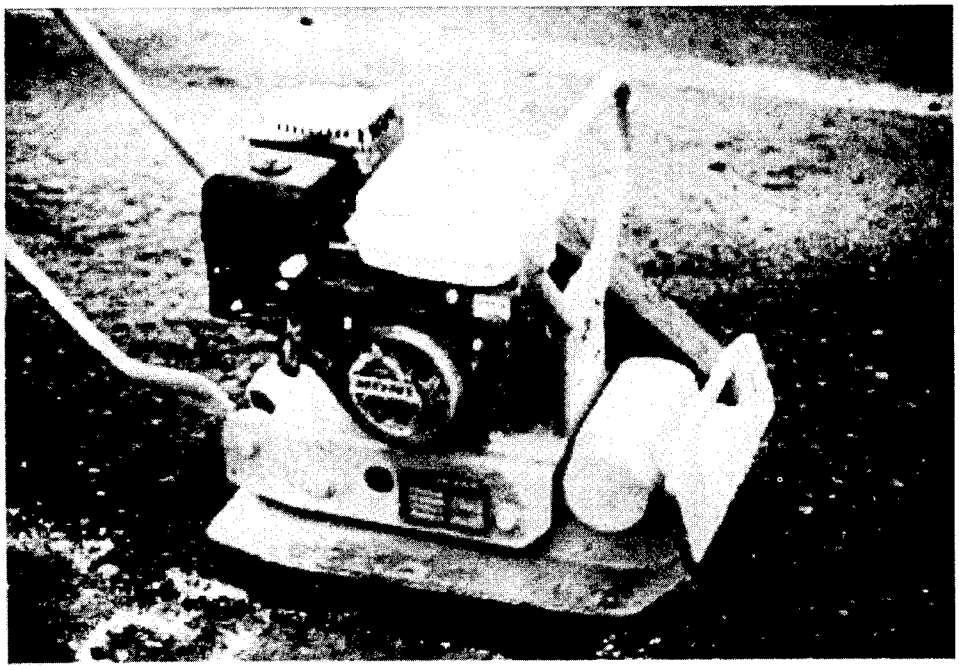
Figure 16. Compaction using vibratory plate compactor.

4. Compact the material starting in the center and working out toward the edges, which will cause the material to pinch into the corners. A one-man compaction device, such as a single-drum vibratory roller or vibratory plate compactor, as shown in figure 16, should be used.

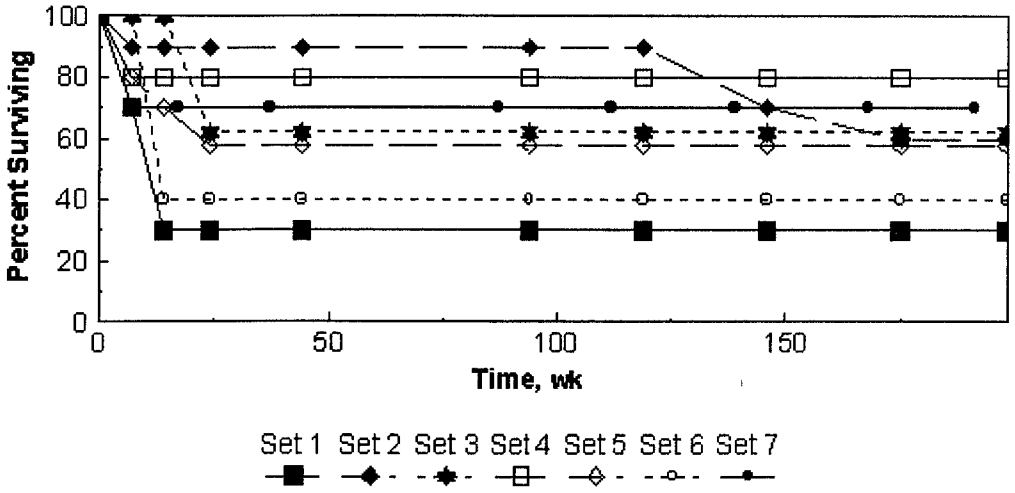
Figure 29. Survival of pothole repairs for control patches-Ontario test site.

One of the reasons that the analysis has concentrated on the differences within the groups is the variability of the performance observed from one set of control patches to the other. Figure 29 illustrates the survival plots for each of the seven sets of control patches placed at the Ontario test site. The percentage surviving after 198 wk varies from 30 to 80 percent, although the materials, placement procedure, and compaction were the same. The most likely source of the variability is differences in the pavement support, drainage, and other in-situ factors, which would have been similar for the rest of the repair types. Comparisons between different patch types at different locations throughout the test site would be irrelevant due to the differences in performance caused by site-specific factors.

Comparison among different sets of control patches within test sites did show differences in survival throughout the same site. An example of these differences can be seen in figure 29 for the control patches at the Ontario test site. These differences indicate that the performance of the control patches was affected by site-specific factors, such as underlying support and drainage, since the material, placement procedure, and compaction effort were the same for each set.

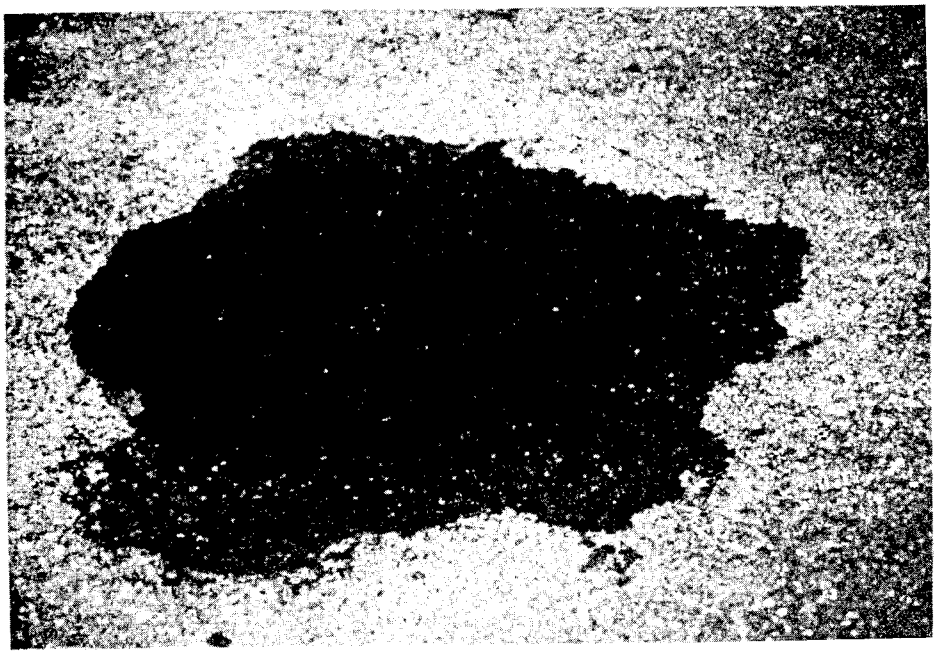
Some of the more significant distresses noted at the test sites were dishing, raveling, and edge disintegration. However, bleeding was prevalent among the PennDOT 486 patches but was not widespread among the other patches placed. Figures 30 through 34 show examples of bleeding, shoving, cracking, raveling, and edge disintegration as they were noted in the field.

Figure 30. Example of bleeding distress.

Figure 31. Example of shoving distress.

Figure 32. Example of cracking distress.
