Methods for Preventing ASR in New Construction

Results of Field Exposure Sites

December 2013

U.S. Department of Transportation
Federal Highway Administration

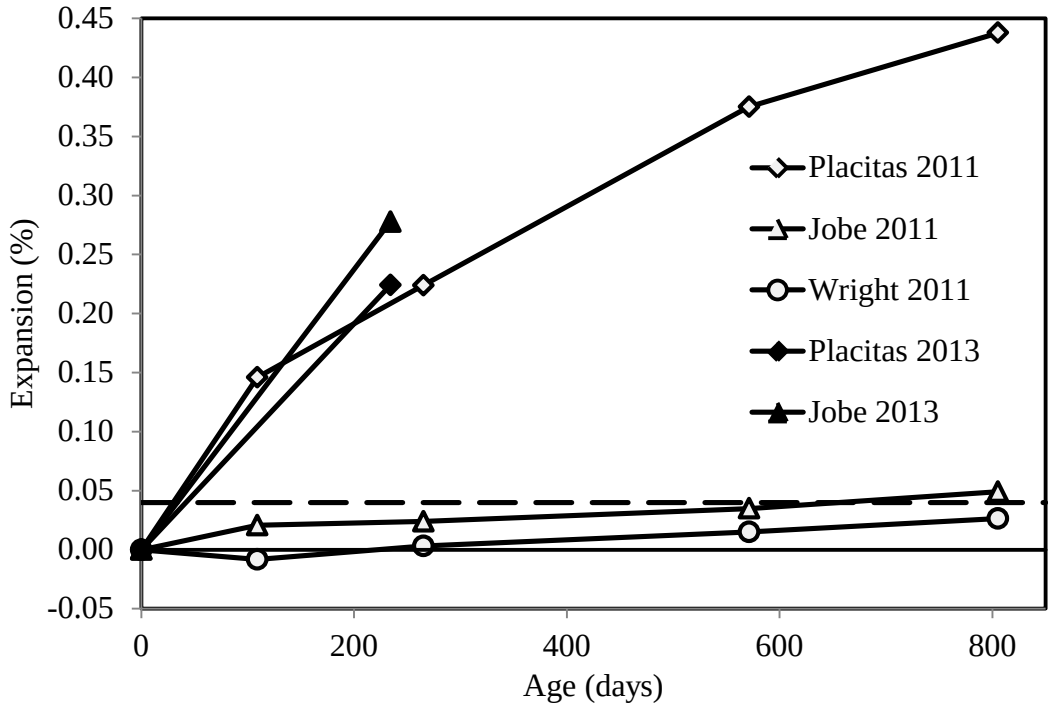
Figure 5. Expansion of Blocks with Imported Known Reactive Aggregates

Figure 5 shows the expansion of blocks containing the "imported" known reactive aggregates from Texas (Jobe and Wright) and New Mexico (Placitas). Of the blocks manufactured in 2011 only the block with Placitas (Mix 4) showed rapid expansion and cracking, and this is consistent with behavior observed for this aggregate on other exposure sites. The block containing Wright sand has not yet expanded, and this is not unexpected as this sand is more slowly reactive than the Jobe and Placitas. The behavior of the block with Jobe is surprising as this sand has produced very rapid expansion when combined with high-alkali cement in blocks on other exposure sites. To further investigate this apparent anomaly additional blocks were cast with Jobe and Placitas in January 2013. The data in Figure 5 show both blocks to expand rapidly this time, and the magnitude and rate of expansion of the 2013 Placitas block is very similar to the 2011 Placitas block. A corner of 2011 Jobe block was removed using a concrete saw and examined in the

laboratory; this confirmed that the sand was indeed Jobe. It is suspected that an error occurred during the batching of the 2011 Jobe block and that low-alkali cement was inadvertently used instead of high-alkali cement. If this is indeed the case the block is expected to start expanding at some point in the future and, at that time, consideration will be given to removal of another small sample from this block for the purpose of determining the alkali content of the concrete.

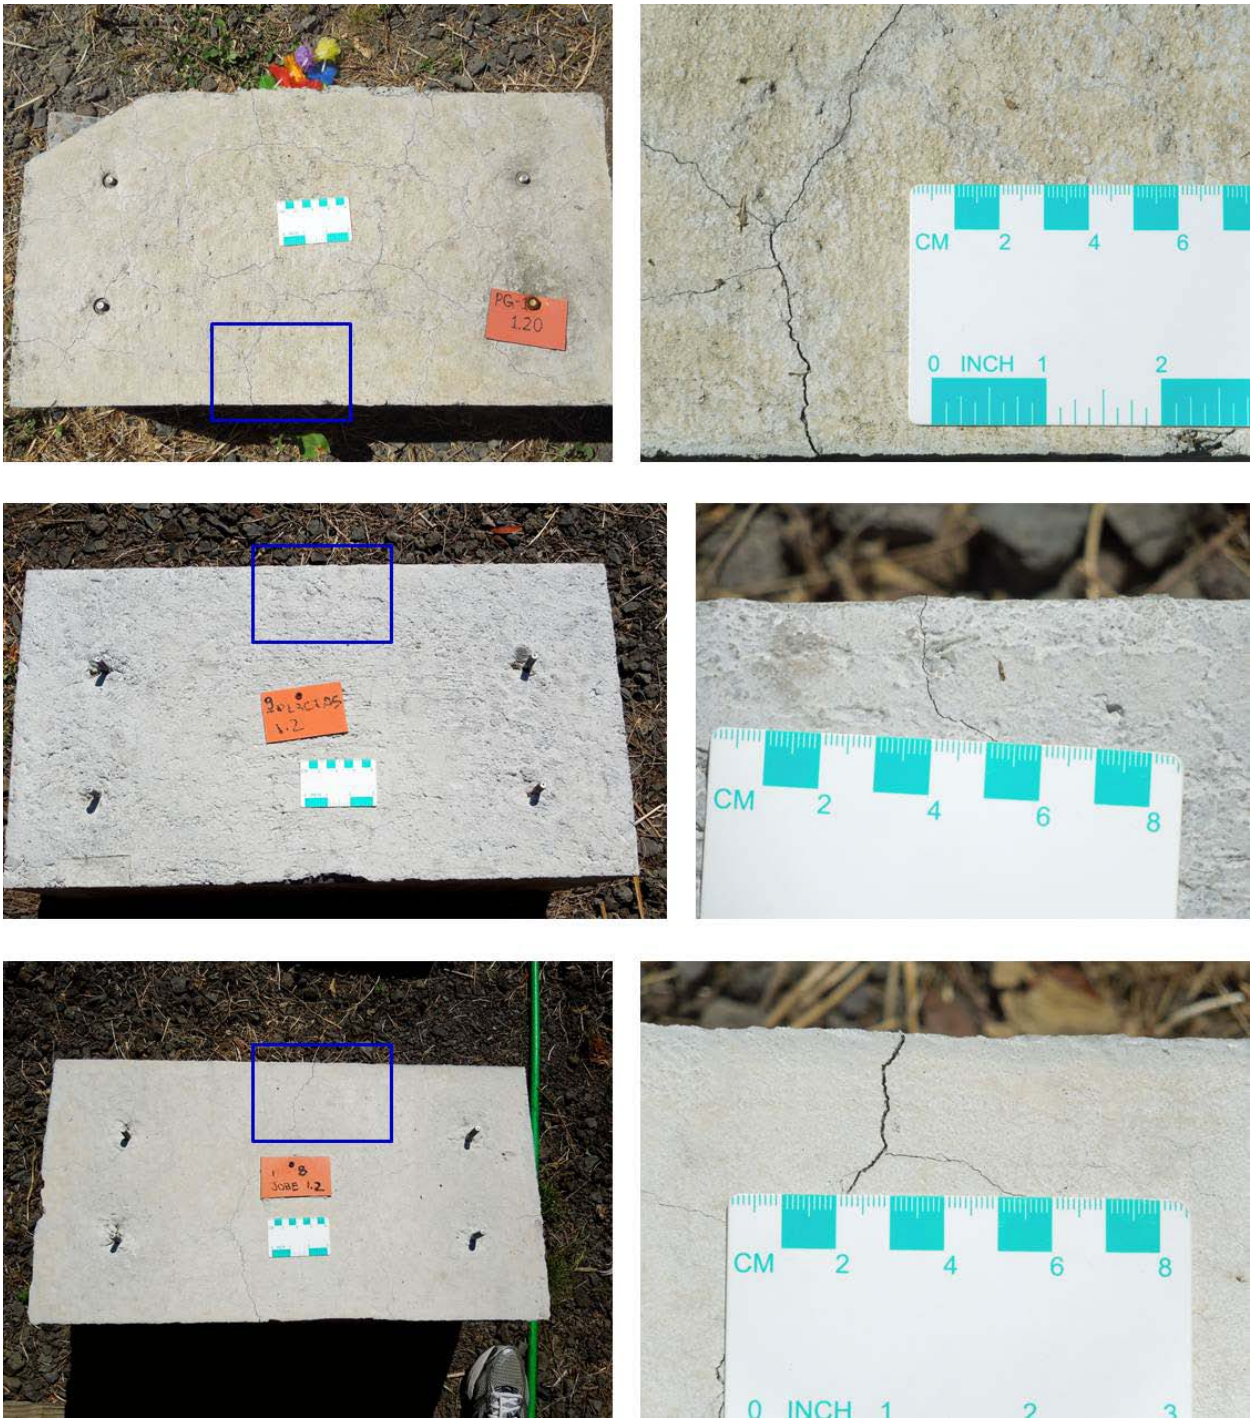
Figure 6. Photographs of Cracked Blocks with Placitas Aggregate Cast in 2011 (top) and 2013 (middle) and Jobe Sand Cast in 2013 (bottom)
(Photos on right are enlargements of areas in blue box on left)

Figure 6 shows the condition of some of the blocks with known reactive aggregates. The photographs were taken in August 2013 when the 2011 blocks were at an age of 805 days and the 2013 blocks were just 234 days old. The cracking exhibited in the blocks constructed with Placitas (2011 and 2013) and Jobe (2013) is symptomatic of ASR.

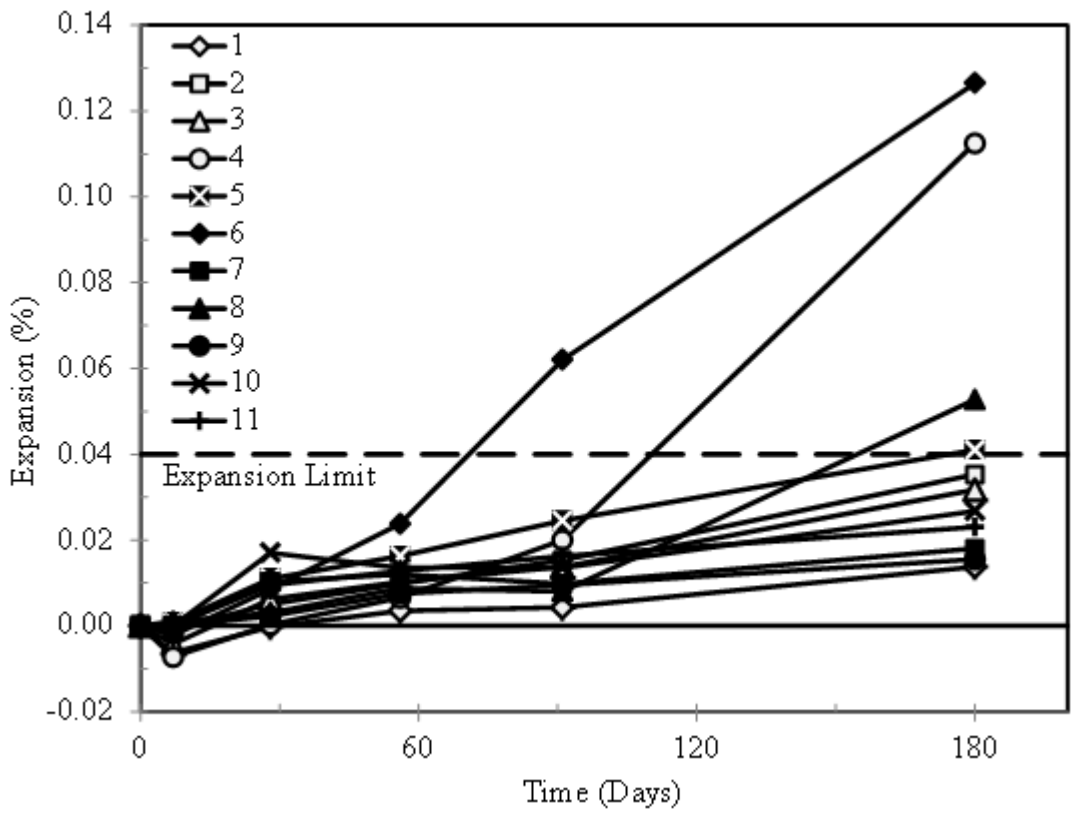
Figure 9. Expansion of Local Aggregates Tested in Concrete Prism Test (ASTM C 1293) – Data to 180 days only (Note: specified test duration is 1 year)

At the time of writing, the CPT was not complete; this is a 1-year test and only 180-day expansion data are available. However, the data available do confirm that aggregates 4, 5, 6, and 8 are deleteriously reactive as the 180-day expansion value already exceeds the 1-year expansion limit of 0.040%. Both aggregates 2 and 3 show expansion values in excess of 0.030% at 180 days and, based on experience, it is highly likely that these aggregates will exceed the 0.040% limit at 1 year. One or more of the other local aggregates will probably exceed the limit at one year also.

The relationship between expansion and time for the 11 aggregates tested in the CPT are presented in Figure 9. Although the tests are not sufficiently advanced for definitive statements to be made regarding the reactivity of the aggregates, the spread of data do confirm that the 11 aggregate samples selected represent a wide range in terms of alkali-silica reactivity (as intended).

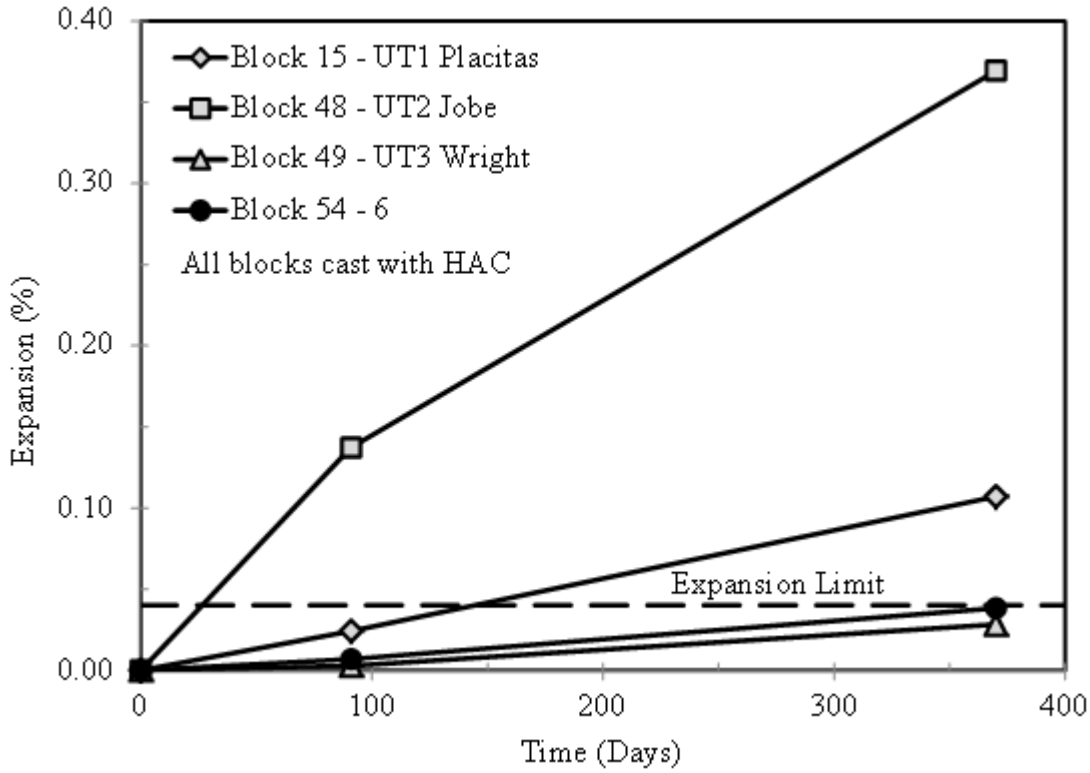
Figure 10. Expansion of Blocks on Exposure Site in Lawrence, Massachusetts

The expansion values for the concrete blocks after three months and one year on the exposure site are presented in Table 8. Figure 10 shows the expansion versus age for the three known reactive aggregates together with aggregate 6. Aggregate 6 was selected because it shows the highest expansion among the 11 local aggregates and has been implicated as a contributor to ASR in a number of structures in New England. The Jobe aggregate, which is considered to be one of the most, if not the most, reactive aggregates in North America, produces expansion in excess of 0.040% after just 91 days on the exposure site. After 1 year, the Placitas aggregate has also produced expansion in excess of 0.040%, but none of the other blocks have reached this level of expansion at this age. However, the block with aggregate 6 and high-alkali cement has expanded by 0.038% at 1 year. Significant expansion of the blocks produced with local aggregates is not expected after one year. Damaging expansion and cracking due to ASR often takes 5 to 10 years, and sometimes even longer, to occur under field conditions. Indeed in many cases the blocks exhibit shrinkage (negative values in Table 8) during the first year, and this is expected behavior.

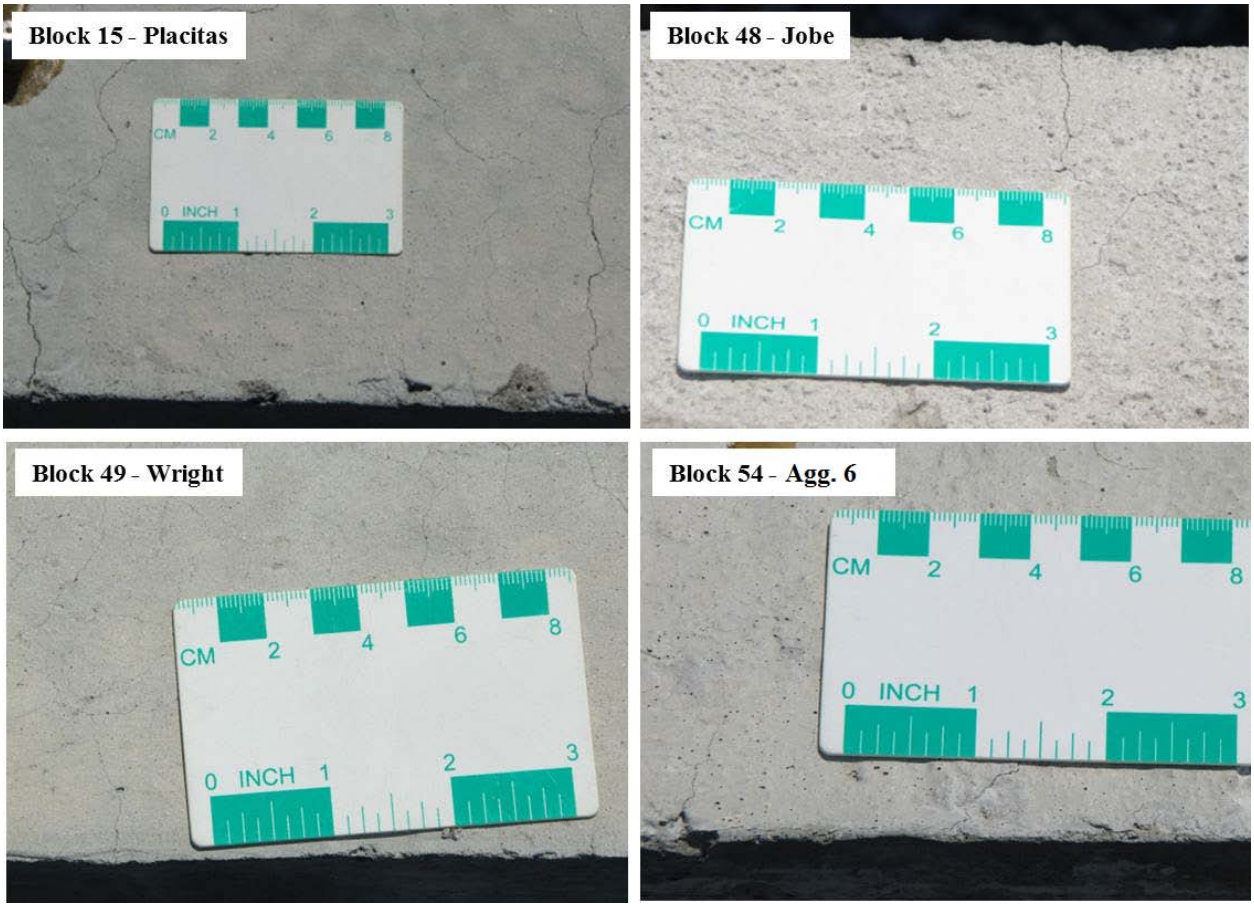
Figure 11. Cracking in Blocks on Exposure Site after One Year

Visual inspection of the blocks at one year revealed significant cracking in four blocks (Figure 11); these were: Block 15 with Placitas, Block 48 with Jobe, Block 49 with Wright, and Block 54 with aggregate 6. Note that at 91 days only Block 48 with Jobe showed any signs of cracking. All of these blocks were produced with the high-alkali cement (HAC) without either SCM or lithium.
