STATE OF CALIFORNIA  
**DEPARTMENT OF TRANSPORTATION**  
ENGINEERING SERVICE CENTER,  
DIVISION OF MATERIALS ENGINEERING AND TESTING SERVICES

**COMPLIANCE CRASH TESTING OF K-RAIL USED IN  
SEMI-PERMANENT INSTALLATIONS**

1. REPORT NO. FHWA/CA/OR-99/07	2. GOVERNMENT ACCESSION NO.	3. RECIPIENT'S CATALOG NO.	
4. TITLE AND SUBTITLE COMPLIANCE CRASH TESTING OF K-RAIL USED IN SEMI-PERMANENT INSTALLATIONS		5. REPORT DATE October 1999

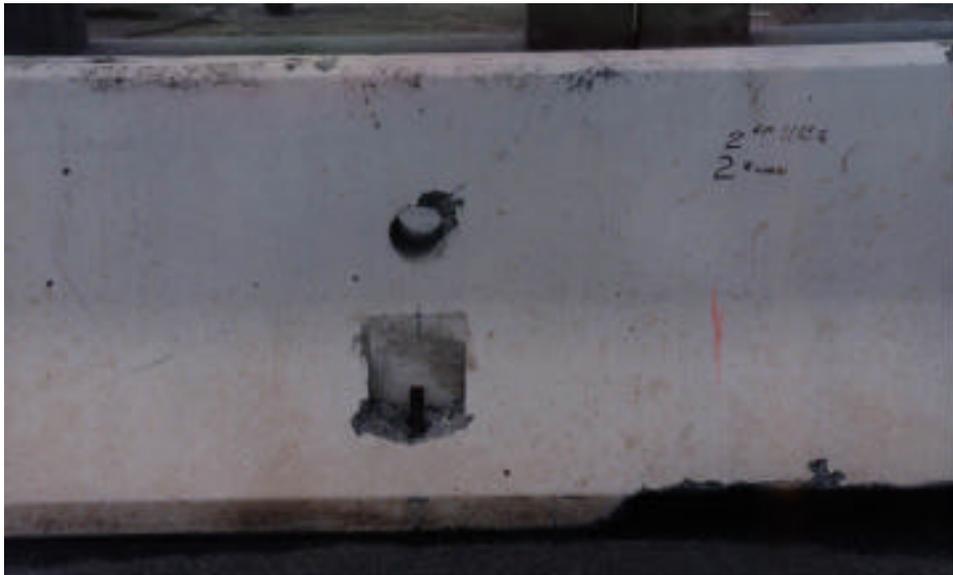
Figure 2-2 - View of  
Anchor Stake in  
Barrier

Construction of the barrier consisted of obtaining the K-rail, clearing the holes for the stakes, placing and connecting the rail elements, and staking the individual elements to the AC pavement (see Figure 2-2). The final test barrier length was 48.77 m.

Note: Due to a misinterpretation of the original design, the stakes were cut to 610 mm instead of 1000 mm. The error in length was not discovered until the barrier was being constructed. It was decided that the shorter stakes would only make the test more conservative, so they were not replaced with the longer ones.

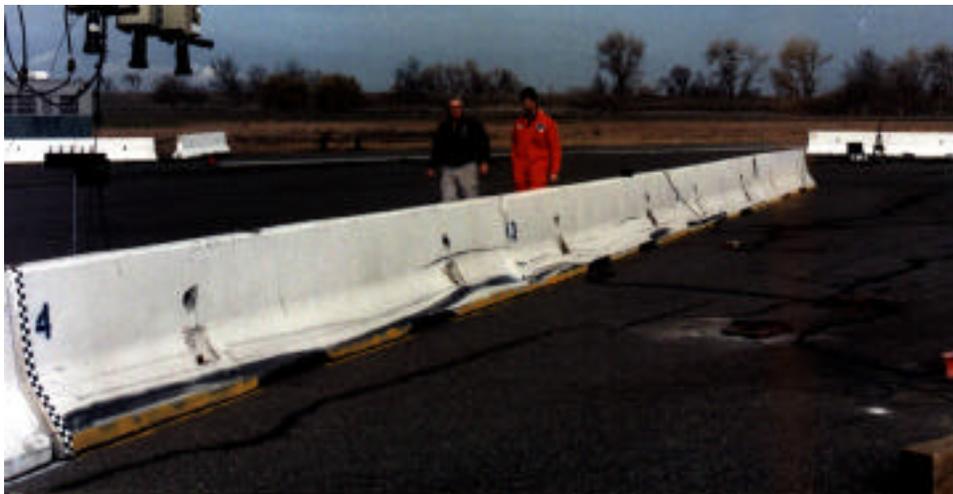
Figure 2-4 -  
Assembled Barrier

The barrier was assembled one segment at a time. The elements were placed using a 3600-kg capacity forklift. Pins were placed in the pin-and-loop connections by hand. Those segments that had spalled during the stake-hole clearing were placed at the ends of the test barrier. The barrier was not pulled tight to take up slack in the pin-and-loop connections (see Figure 2-4).

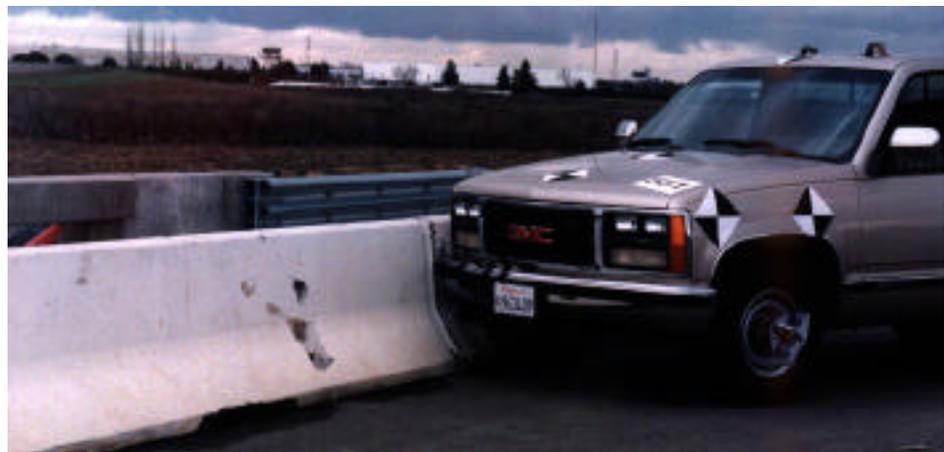
Figure 2-6 - Vehicle 551 At Barrier

The vehicle impact speed and angle were 100.6 km/h and 25 degrees, respectively. Impact occurred at the joint between the fourth and fifth segments (see Figure 2-6). As the vehicle hit the barrier, it yawed left until the entire right side of the vehicle was in contact with the face. At 0.2 seconds the vehicle started to ride upward. All four wheels lost contact with the ground as the front bumper reached the next segment (about 6 m downstream). The vehicle touched down 12 m further downstream. As the front left tire hit the ground, the roll and pitch were measured to be 12.8° and 25°, respectively. The vehicle immediately started to right itself and was stable about 4 meters past the end of the barrier (about 16 m downstream of the point of impact). The exit speed and angle were 82 km/h and 6 degrees respectively. The 6-degree exit angle is well within the 60% limit of Report 350.

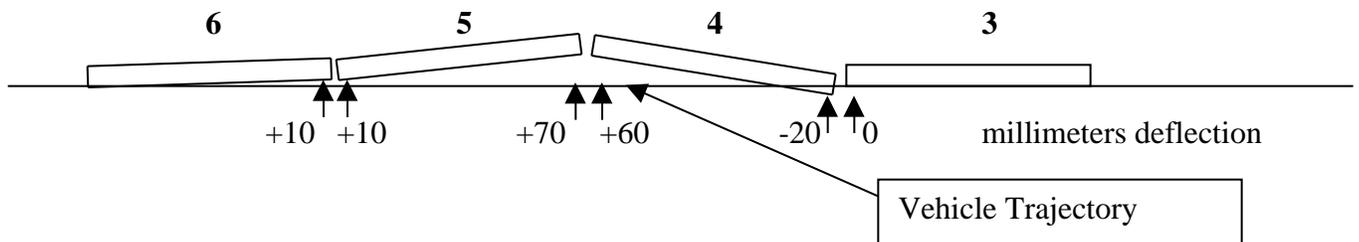
The barrier underwent some permanent deflection:

Damage to the barrier was minimal (Figure 2-11 through Figure 2-15). The connecting pin-and-loop at joint 4-5 bent enough that it caused minor spalling and the pin had to be cut before the barrier could be moved. The maximum lateral displacement measured at the top of the barrier was 260 mm during impact. There was also some minor spalling of anchor stakes in segments 4 and 6.

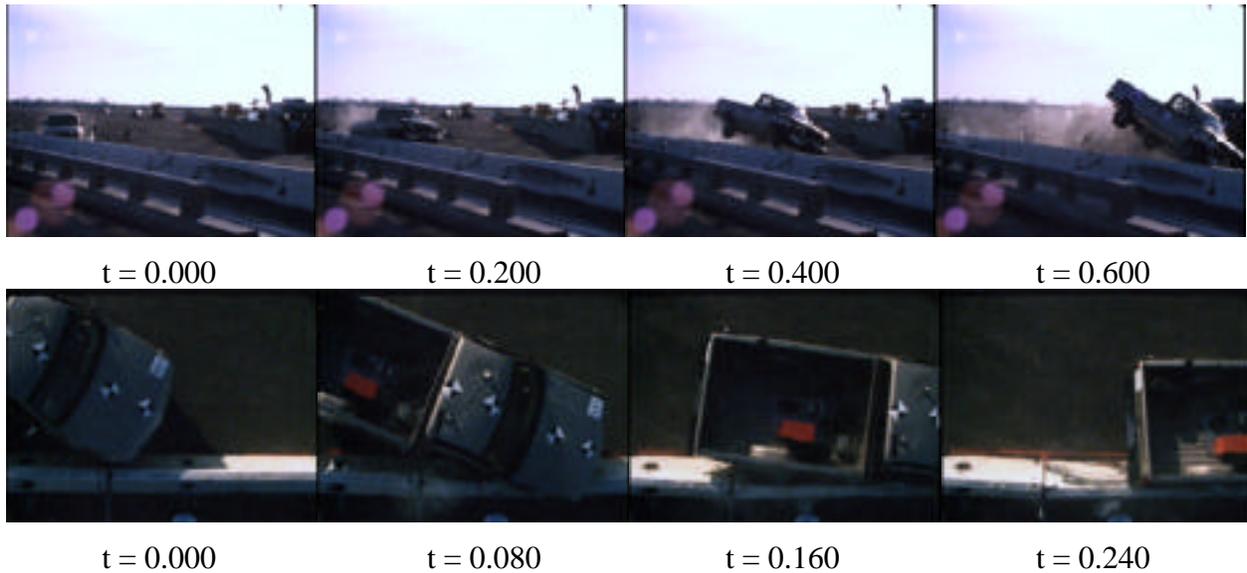
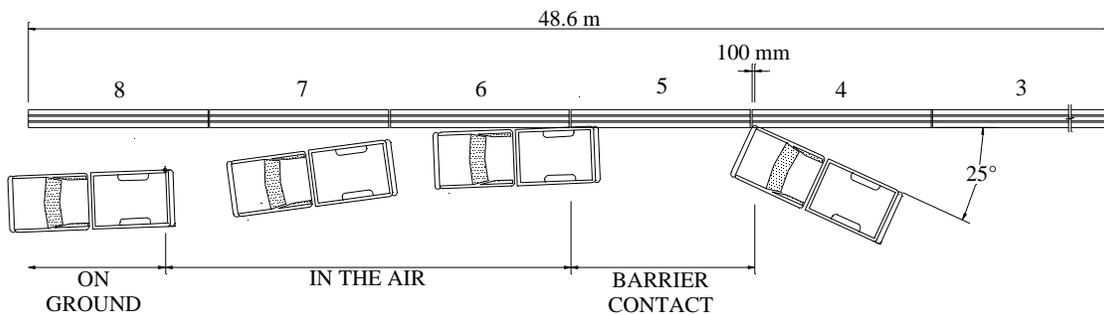
Figure 2-16 - Test 551 Data Summary Sheet

Spalling at the pin-and-loop  
 connection at point of  
 impact, also at some of the  
 anchor stakes. Superficial  
 scuffing

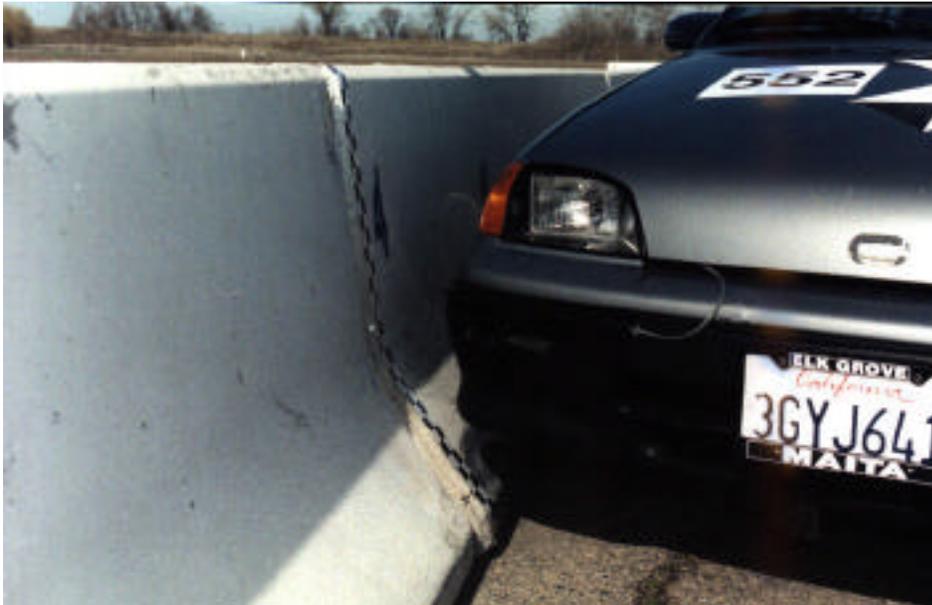
Figure 2-17 - Vehicle 552 At Impact Point

The vehicle impact speed and angle were 101.7 km/h and 20 degrees, respectively. Impact occurred at the joint between the fourth and fifth segments (see Figure 2-17). Within the first 3 m of barrier contact, the vehicle rotated 20 degrees to the left, the rear hatch opened up and all four wheels left the ground. Contact with the barrier continued for about 8 m while the vehicle rose. The vehicle stayed level while rising to an ultimate height of 630 mm. The vehicle came back down 15 m downstream of the impact point (see Figure 2-21 through Figure 2-23).

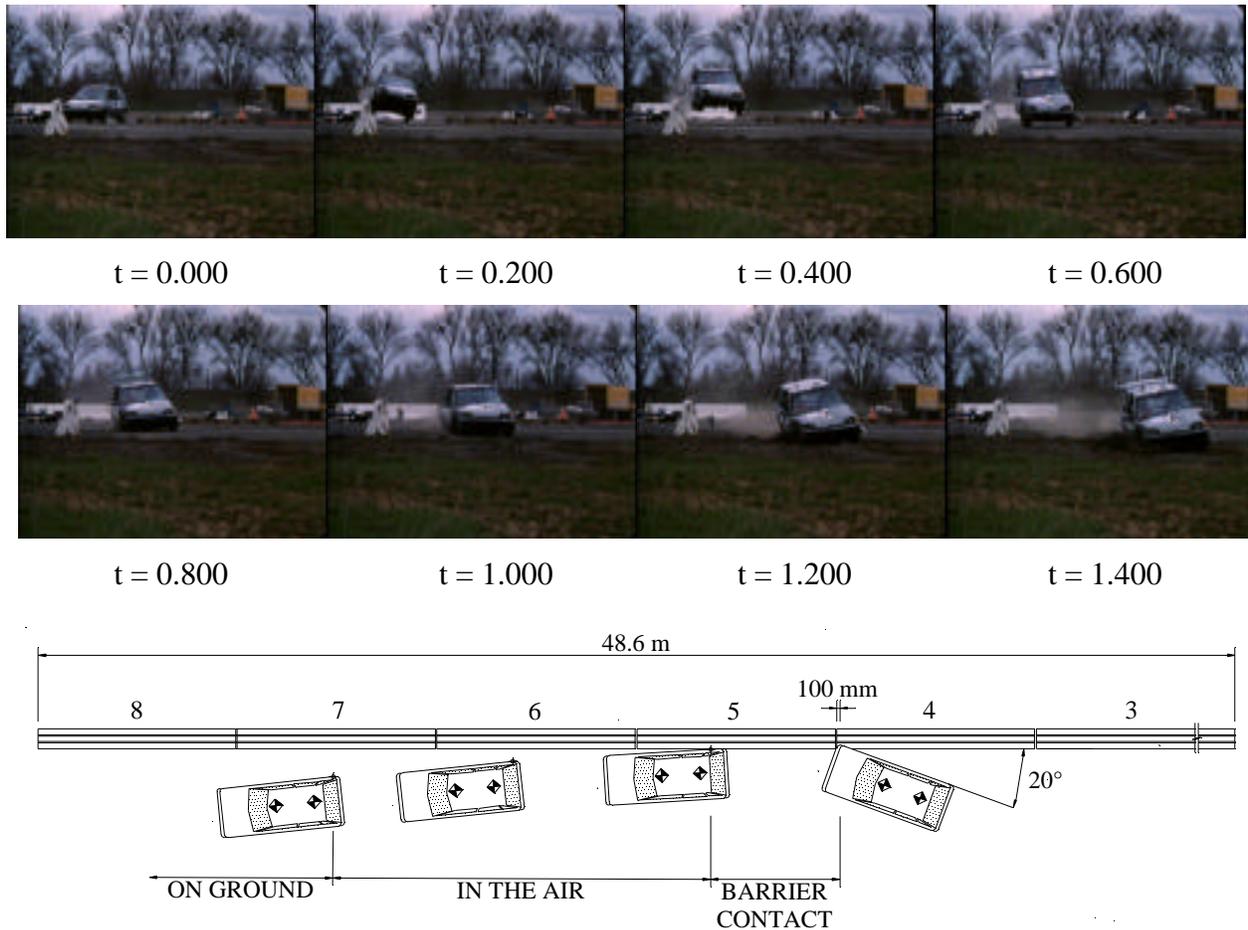
Figure 2-27 - Test 552 Data Summary Sheet

Damage occurred only on the front of the barrier. Vehicle contact was limited to segments 4 and 5, where the barrier received superficial scuffing (see Figure 2-27). The K-rail cracked around several of the stake holes, but they all retained their integrity. The barrier rotated back approximately 30 mm during impact, but righted itself as the vehicle lost contact with the barrier.

Segment 4 had a permanent deformation of 25 mm, with the front edge of the barrier raised about 10 mm. The loop connections did not incur any damage.
