**EPOXY COATED
REINFORCEMENT STUDY**

Final Report

STATE RESEARCH PROJECT #527

Oregon Department of Transportation
Research Group
200 Hawthorne SE, Suite B-240
Salem OR 97301-5192

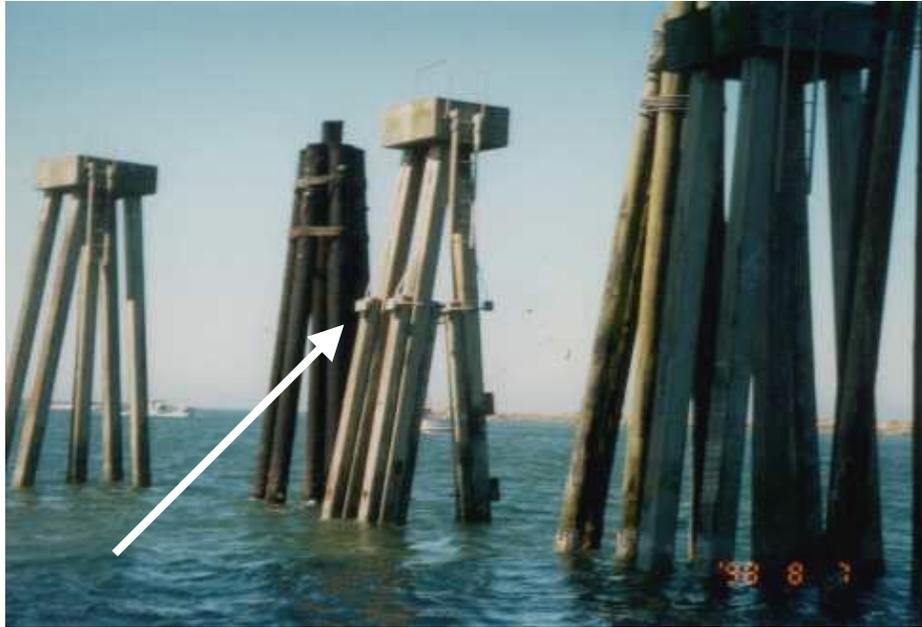
Figure 1.3: Concrete Beams Attached to the Dolphin in the Middle of the Picture

As seen in Figure 1.3, there are junction boxes at the top of each of the beams. The beams were pre-wired for taking half-cell potential measurements. The beam dimensions are 200 mm x 200 mm x 6.1 m. They were attached to the dolphin at a location where part of the beam was always in the water, another section was always exposed to the air and the middle section was in the tidal zone between the low and high tide levels of Yaquina Bay.

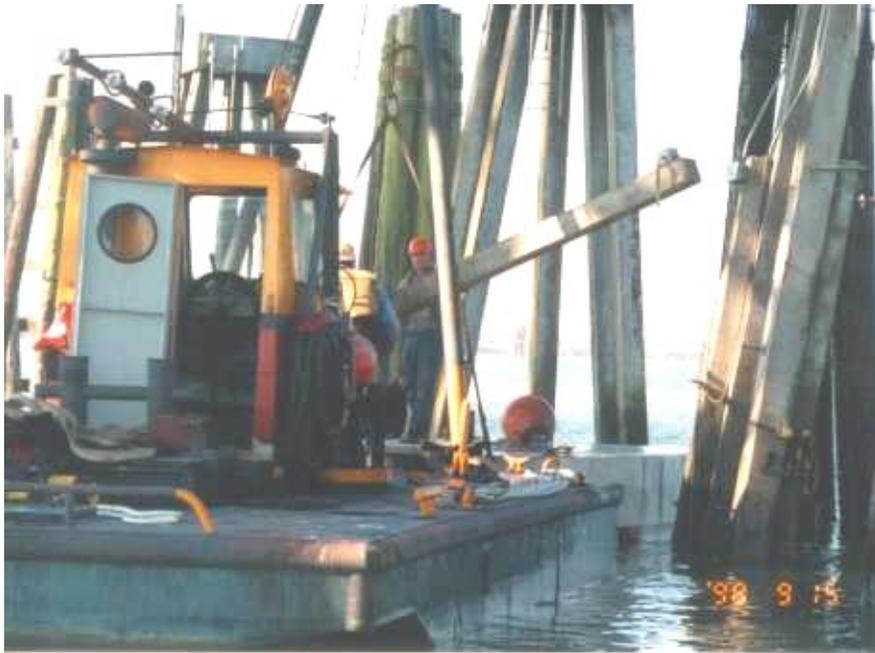
Figure 4.1: The Test Beam being Lifted onto the Barge.

After removing the barnacles and surface buildup along the beam's exterior, the beam was examined for surface cracking. Considering the long-term exposure to the harsh environment of the Oregon Coast, the beam appeared to be in relatively good condition.

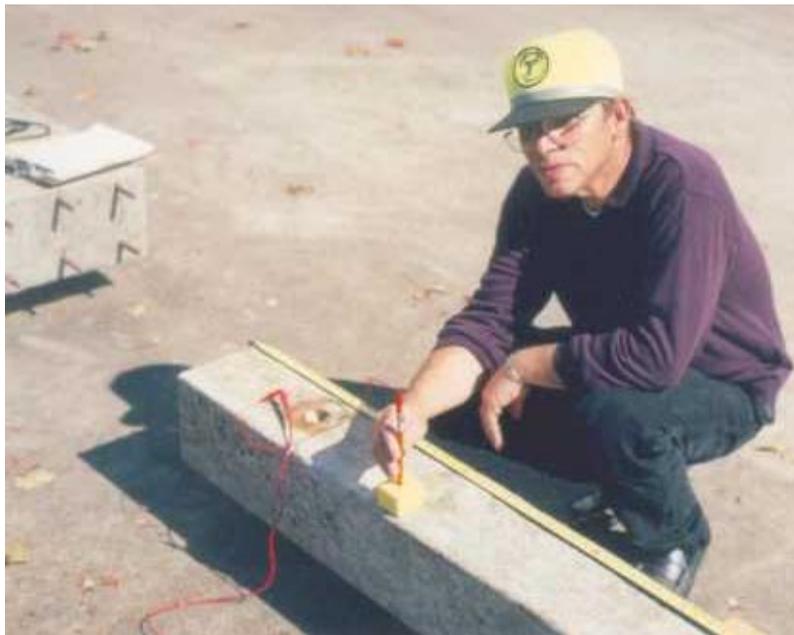
Figure 4.6: Half-Cell Potential Measurements Using Copper-Copper Sulfate Electrode

After the crack locations were recorded, half-cell potential measurements were taken. The beam had been cast with built in junction boxes and electrical connections to the reinforcing steel to facilitate the half-cell testing. The testing was done for each exposed face of the beam from the bottom to the top at approximately 150 mm intervals (Figure 4.6). The north face was not considered since this face abutted the concrete dolphin in Yaquina Bay. The half-cell measurements were made using a battery operated voltmeter and a copper-copper sulfate reference electrode.

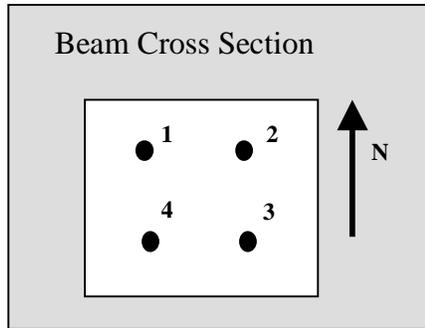
Figure 4.7: Cross Section of the Test Beam Relative to the Top End of the Beam

For reference, Figure 4.7 shows the cross section of the beam and the rebar numbering layout for the rebar relative to the top end of the beam.
