CRASH TEST OF TYPE III BARRICADES

FINAL REPORT

FEBRUARY 2000

By M. El-Gindy, A. Scanlon, and R. Tallon

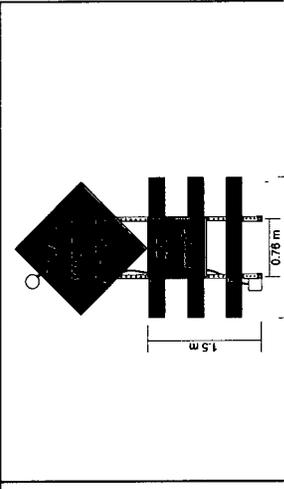
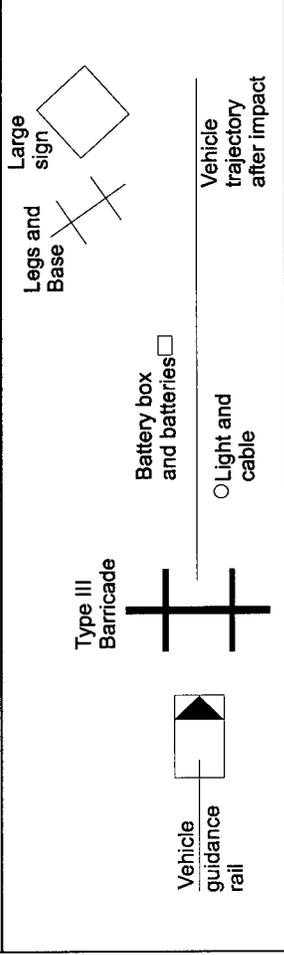
Figure 9. Crash Test #1: Type 3 barricade head-on test (November 3, 1999).

In both the head-on test and the edge-impact test, the Type III barricade was essentially destroyed with debris coming to rest at the locations shown in *Figures 9 and 10*. The final condition of each test article after the test can be seen in *Figures 11 and 12*.

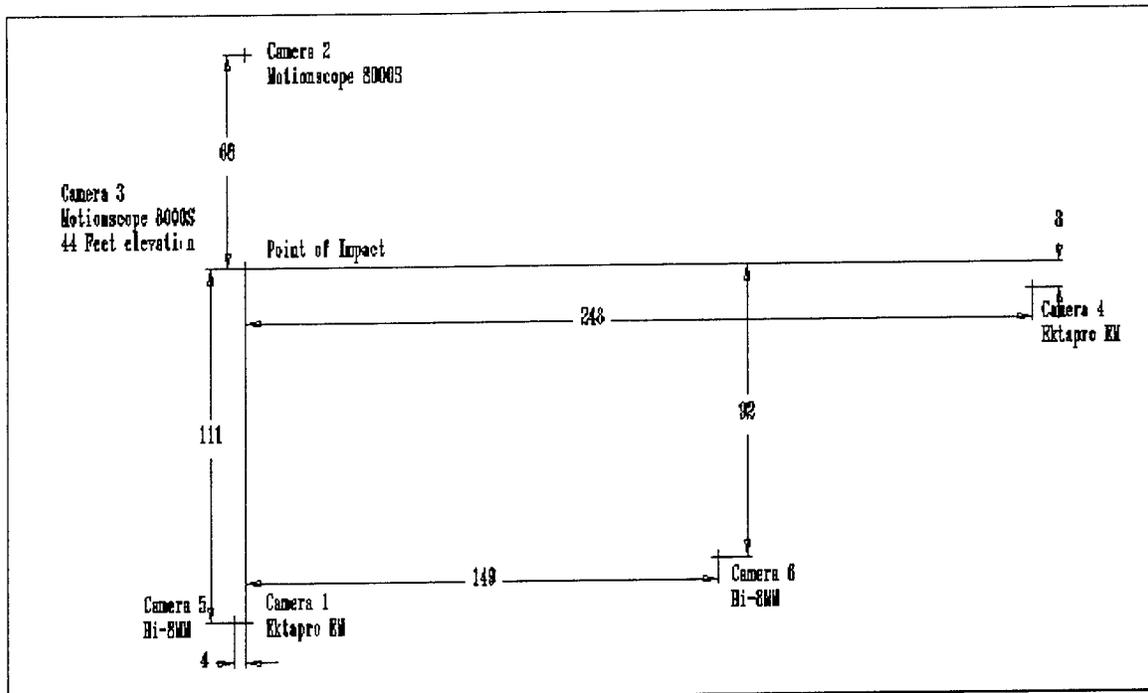
Figure B1. Diagram of camera placement (test #1).

Due to an equipment malfunction just prior to the first test, camera 4, the Ektapro TR, was not functional for the first test. PTI investigators decided to continue the first test without this camera. This problem was subsequently resolved and the camera functioned for the second test.
