Research Report
KTC-00-8

LONG-TERM MONITORING OF EXPERIMENTAL FEATURES, SUBTASK 2
Alexandria-Ashland Highway (KY 9) Pavement Performance
Monitoring

June 2000

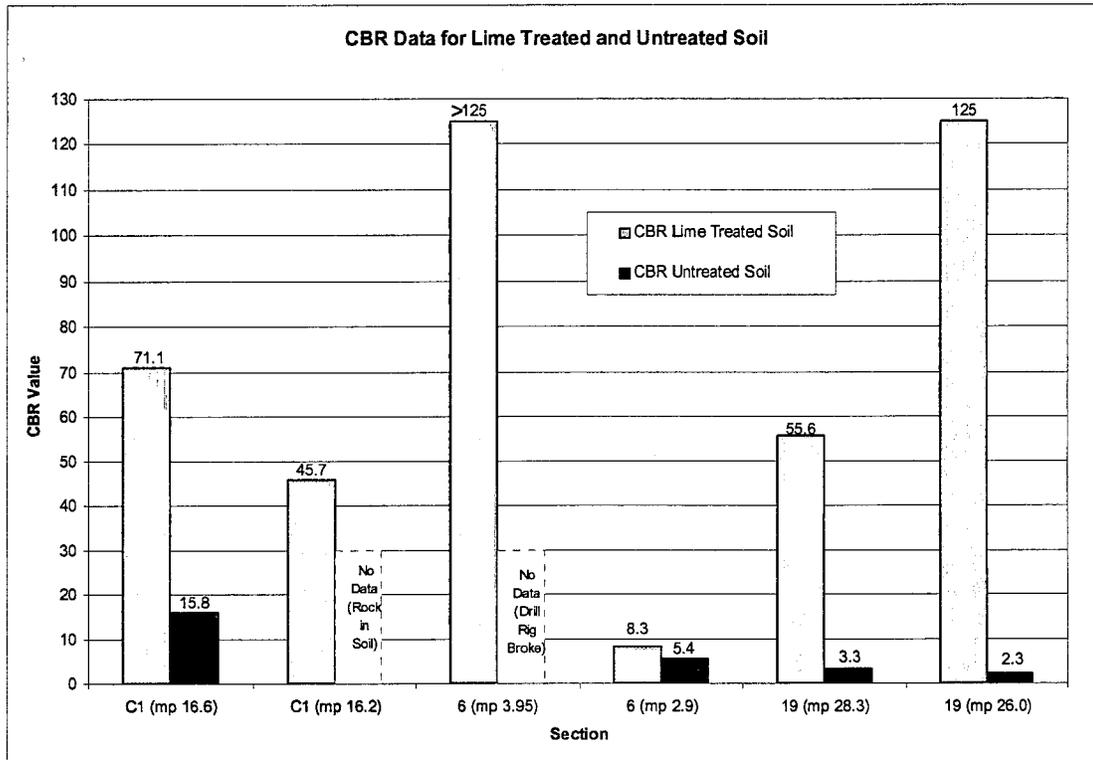
The subgrade in 10 of the 23 design sections was chemically stabilized with hydrated lime. The lime was added to a depth of six or nine inches with a four to six percent ratio. In-place California Bearing Ratio (CBR) tests were conducted on the stabilized soil and further down in the untreated (unstabilized) soil for comparison. CBR tests were conducted in three of the sections (C1, 6, and 19). Tests were conducted at two different locations in each section. In Section C1 (milepost 16.2) and Section 6 (milepost 3.95), no data were collected on the untreated subgrade due to rocks in the subgrade and mechanical problems with the drill rig, respectively. The field testing data are summarized in Table 4 and shown graphically in Figure 1. As shown in Table 4, the average CBR value of the untreated subgrade was 6.6 and the average CBR value after lime stabilization was 71.7. On average, the strength of the subgrade was increased by 76 percent (based on sites where both untreated and treated soils were tested).

Figure 1. Unstabilized versus Stabilized Soil.

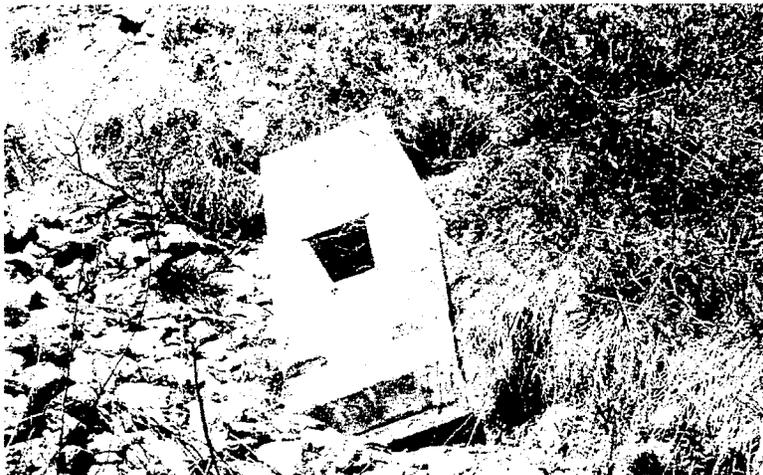
In July 1999, the edge drain headwalls were visually inspected in order to evaluate the overall effectiveness of the drainage systems. A select number of headwalls were inspected in the 22 different pipe-drained sections. A total of 64 headwalls were inspected. Of the 64 inspected, 76 percent of the headwalls were clean, 13 percent were partially covered, 6 percent were entirely covered, and 5 percent were plugged (Figure 2). Headwalls placed in shallow ditchlines appeared to have the most debris in them (Figures 3 and 4). The foundation of a headwall in Section 19 had been severely eroded (Figure 5).

Figure 5. Erosion under Headwall (Section 19).

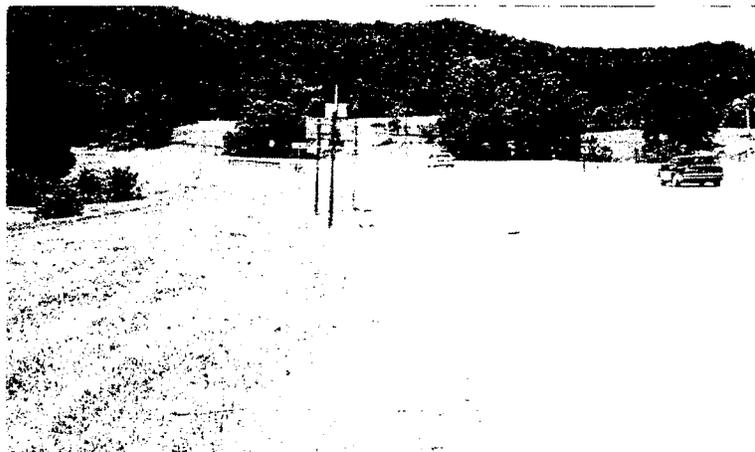
Section 21A was the only section that contained a drainage blanket but no edge drains. This is referred to as a daylighted section. The daylighted section was inspected in August 1999. Vegetation had grown over the edges of the drainage blanket and onto the less permeable granular shoulder material (Figure 9 - 11). Several inspection trenches were excavated through the aggregate shoulder directly against the paved shoulder and down to the drainage blanket. The blanket appeared to be clean and open at the edge of the paved shoulder. The permeability of the blanket was evaluated at two locations. At both locations, water was discharged from a water tank through a 3/4-inch hose into the drainage blanket. The drainage blanket at each location readily accepted the water. The water was held constant for approximately 15 to 20 minutes at each location. No water was observed exiting the edges of the blanket. At one of the two locations, a dye tracer was added to the water and allowed to flow into the blanket for an additional 10 minutes. No signs of water exiting the edge of the blanket were observed. A small hole was excavated at the edge of the blanket which had been over grown with vegetation. The water was observed trapped at the edges of the blanket (Figure 12).

Figure 10. Edge of Drainage Blanket Covered with Vegetation.

It was apparent that neither the pipe collector system nor the daylighted system for the drainage blankets were functioning properly. It was also apparent that both systems must be properly constructed and properly maintained in order to be effective. Edge drain headwalls should be inspected after installation and maintenance should be conducted on the headwalls. Daylighted sections should also be maintained by preventing vegetation growth over the outer edges of the blanket.

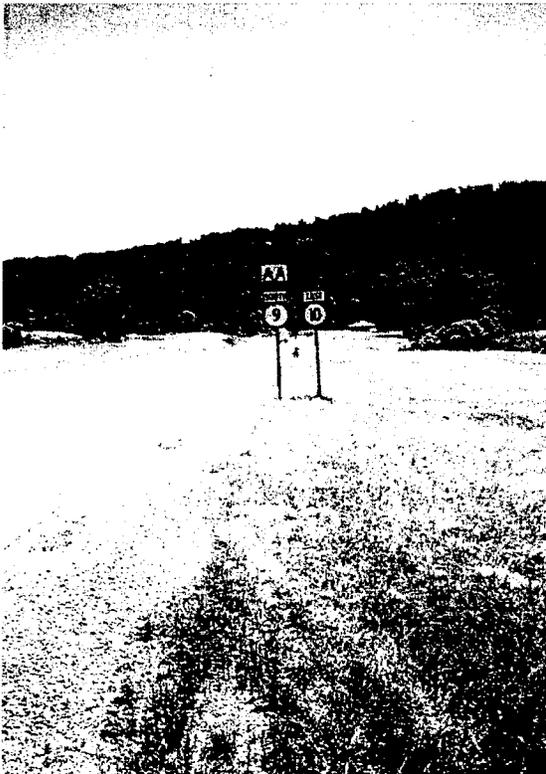
Figure 11. Edge of Drainage Blanket Covered by Vegetation.

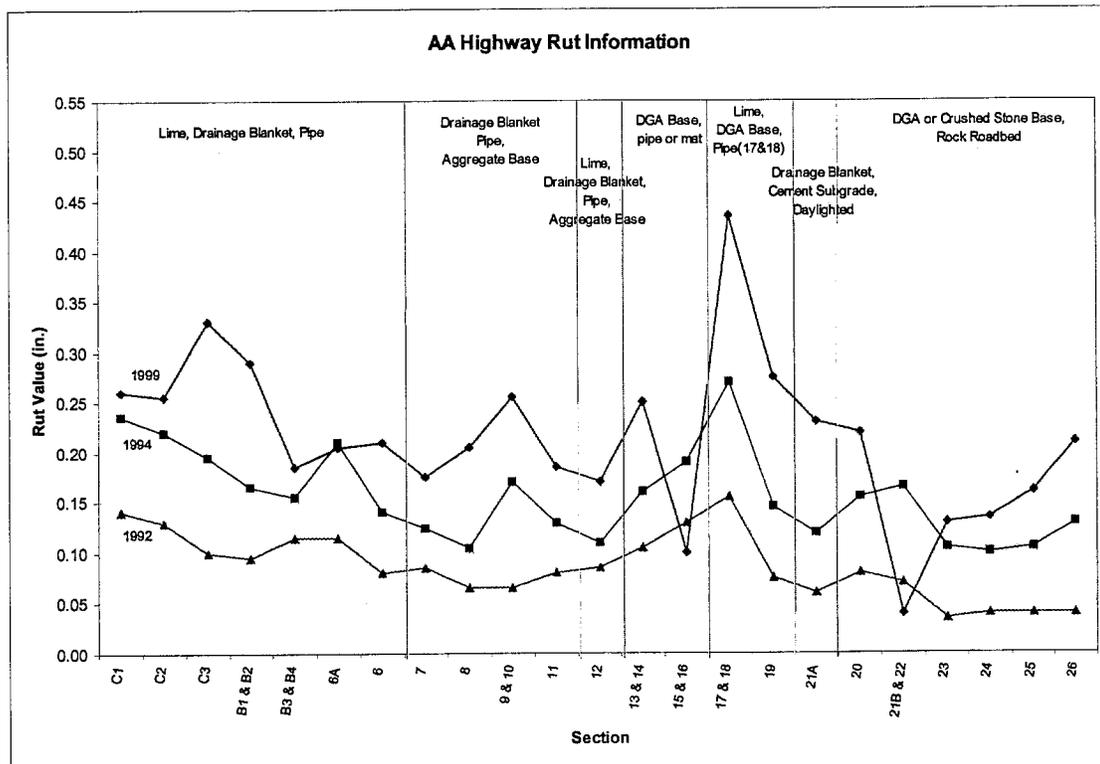
As part of the performance evaluation, rutting measurements were taken every tenth of a mile for each design section. The rutting measurements were taken in 1992, 1994, and 1999. In 1992, the average rut value for the sections was 0.09 inches; in 1994, the average rut value was 0.16 inches; and in 1999, the average rut value was 0.21 inches. The values for all the AA Highway sections are shown graphically in Figure 47. The sections with the crushed stone base and rock roadbed (Sections 20 - 26) had the least amount of rutting over the years. Sections 17 & 18, which appeared to be in fairly good condition, had the highest rutting. The visual distress survey indicated that there was bleeding in areas of Sections 17 & 18. This may be an indication of high asphalt content or low void content in the mixture contributing to the higher rutting values.

It is also interesting to note that Sections 15 & 16 had already been overlaid and Sections 17 & 18 had high rutting values, and both of which were drained by a perforated pipe in a fabric wrapped trench. It is possible that the fabric has become blinded and is causing the subgrade to become saturated.

Figure 47 indicates that not only Sections 15 & 16 were overlaid but also Sections 21B & 22. Both of these sections had river gravel surfaces.

Figure 47. Rutting Per Design Section (1992, 1994, and 1999).
