EXPERIMENTAL INSTALLATION OF LARGE DIAMETER (48 in.) HIGH DENSITY POLYETHELENE CULVERT PIPE (HDPE)

CONSTRUCTION REPORT

CONSTRUCTION REPORT
Report # PE-09-00

Joe Wilson
Wisconsin Department of Transportation
Technology Advancement Specialist

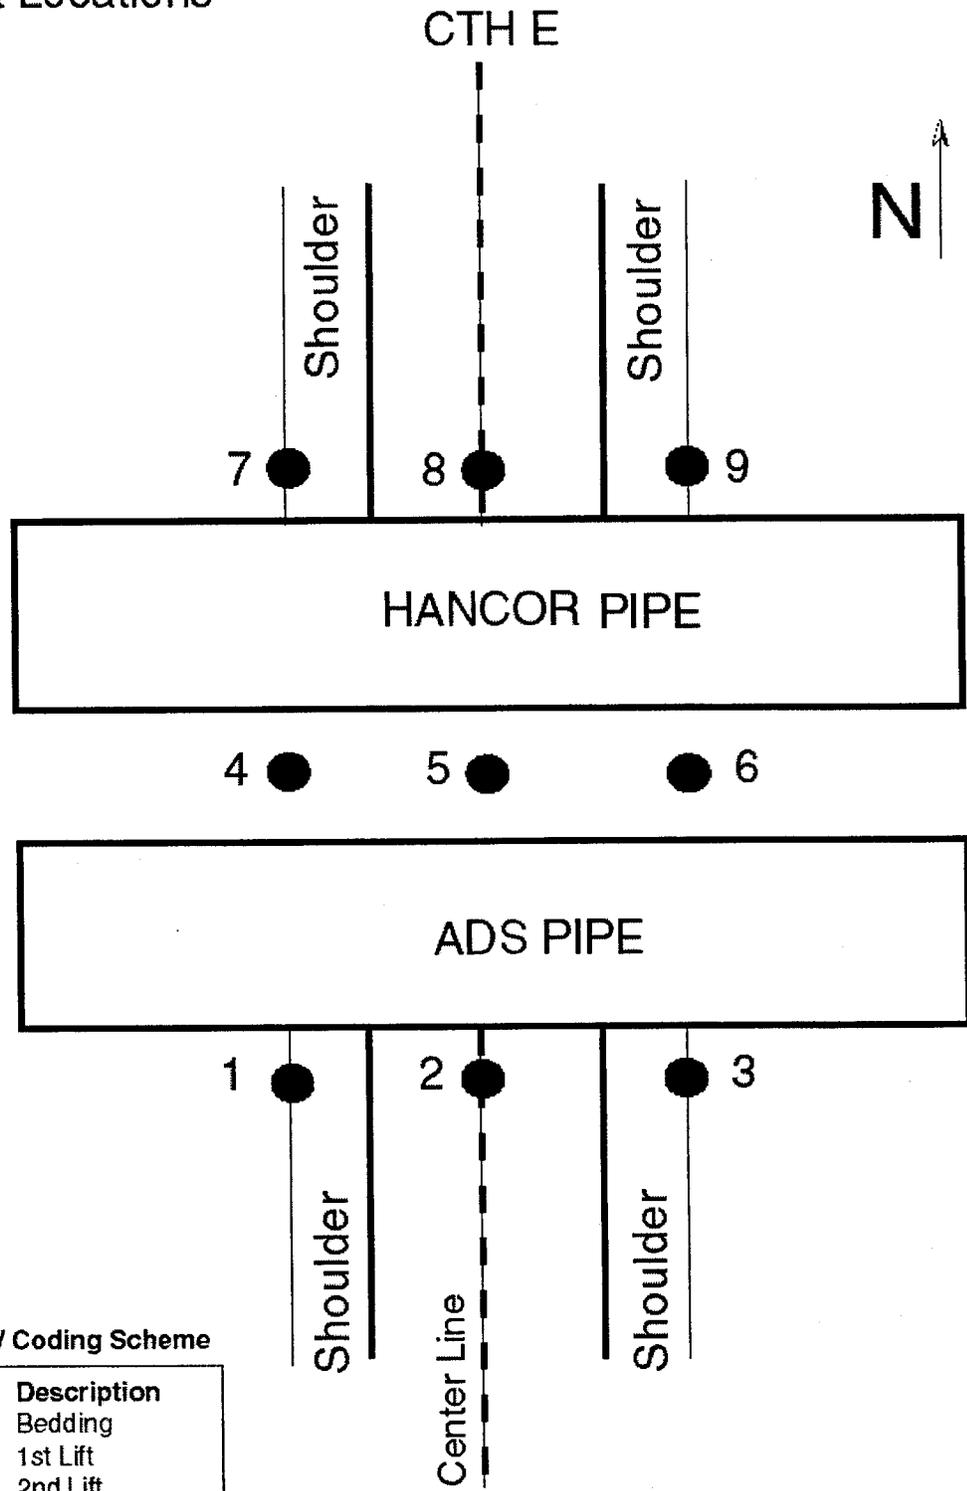
Soil Test Locations

Nuclear density testing was performed at nine different locations as shown in Figure 1 in Appendix A. Tests were conducted at the nine sites for the bedding and then repeated at approximately the same location for each successive lift. A Troxler 3440 nuclear density machine was used for the density tests. The test method was ASTM D2922. The tests were performed by Cooper Engineering Inc.. The results show that the average relative compaction for 51 total tests was 101.7 percent. Table 1 on the following page contains the complete Nuclear Density Data.

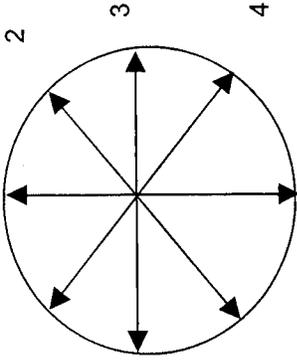
Pipe Deformation Measurements
September 1, 2000

CTH E, Polk County
2 Miles north of McKinley, WI.
Measurements by Ken Lewis (ADS)

1)	48 3/16	48 7/8	48 5/8	48 9/16	48 1/2	48 11/16	48 1/2	48 3/16	48 1/4
2)	47 5/8	48 3/4	47 7/8	48 1/16	47 7/8	48 5/8	48 1/16	47 5/8	47 13/16
3)	47 15/16	47 3/4	47 1/4	48	47 3/8	47 15/16	48 1/4	47 1/2	48 11/16
4)	48 3/8	48 1/4	48 1/16	48 5/8	48 1/16	48 1/4	49 1/16	48 1/2	48 5/8

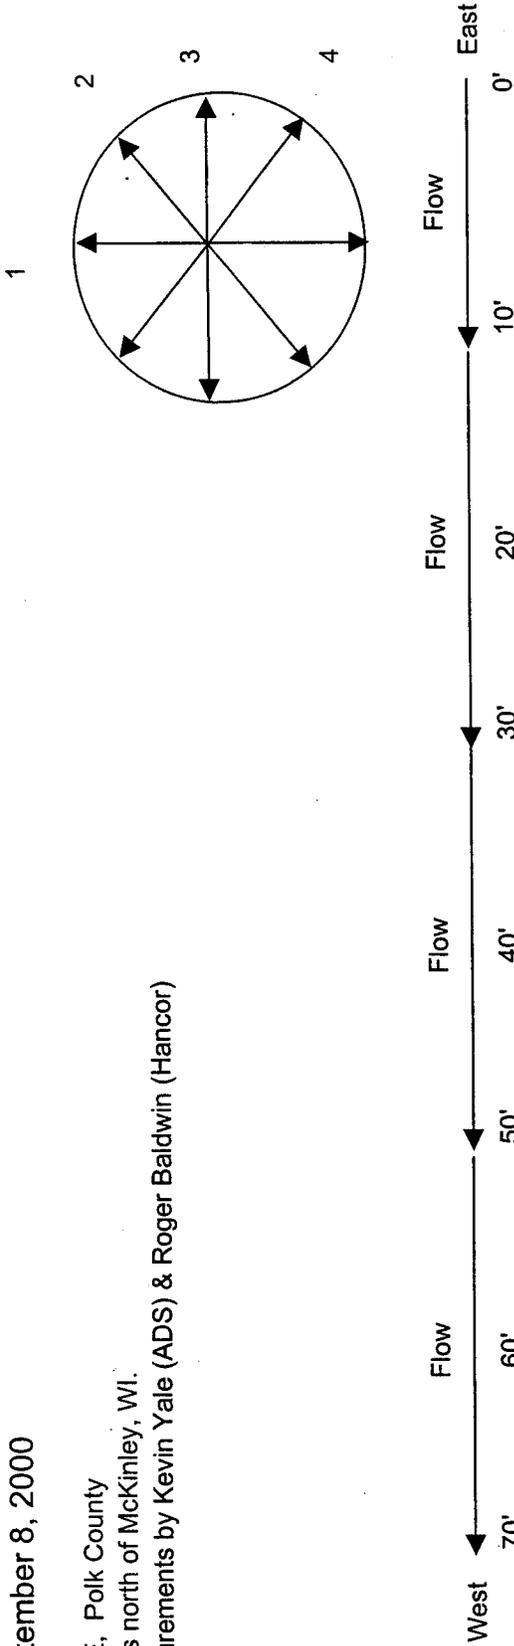
Pipe Deformation Measurements
September 8, 2000

CTH E, Polk County
2 Miles north of McKinley, WI.
Measurements by Kevin Yale (ADS) & Roger Baldwin (Hancor)

Spigot	Hancor - 1	Bell Spigot	Hancor - 2	Bell Spigot	Hancor - 3	Bell Spigot	Bell
1)	48 5/8	48 5/8	48 5/8	48 7/16	48 1/2	48 1/2	48 1/4	48 11/16
2)	47 7/8	48 9/16	47 1/2	47 3/4	47 9/16	48 3/8	47 1/2	48 1/4
3)	46 7/8	47 11/16	46 15/16	48	47 7/16	47 7/8	47 3/8	48 1/8
4)	48 5/8	47 15/16	48 1/4	48 1/4	48 5/8	48 1/4	48 11/16	48

Spigot	ADS - 1	Bell Spigot	ADS - 2	Bell Spigot	ADS - 3	Bell Spigot	Bell
1)	47 5/8	47 1/2	47 3/8	47 3/16	47 1/16	47 3/4	47 15/16	47 3/8
2)	47 1/4	46 7/8	46 3/4	46 5/8	46 7/8	46 3/4	46 11/16	46 7/8
3)	46 1/4	46 9/16	46 1/4	46 3/16	46	46 1/4	45 15/16	46 1/4
4)	46 11/16	48	46 15/16	46 7/8	46 5/8	46 3/4	46 13/16	46 1/2

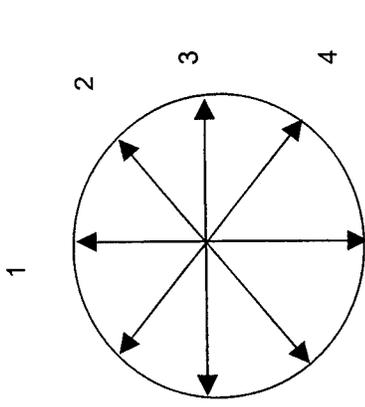
Pipe Deformation Measurements
October 4, 2000

CTH E, Polk County
2 Miles north of McKinley, WI.
Measurements by Robert Reukema (WisDOT) & Roger Baldwin (Hancor)

Spigot	Hancor - 1	Bell Spigot	Hancor - 2	Bell Spigot	Hancor - 3	Bell Spigot	Bell Spigot	Bell
1)	48 1/4	48 1/8	48 3/4	48 1/2	48 1/2	48 1/4	48 1/4	48 1/4	48 7/8
2)	47 1/2	48 1/4	47 1/2	47 3/4	47 1/2	47 1/4	47 7/8	47 1/2	47 3/4
3)	45 3/4	47 3/4	47	47 3/4	47 1/2	47 1/4	47 3/4	47 1/2	47 3/4
4)	48 3/4	48 1/4	48	48 1/2	48 1/2	48	48 1/4	48 1/4	48 1/2

Spigot	ADS - 1	Bell Spigot	ADS - 2	Bell Spigot	ADS - 3	Bell Spigot	Bell Spigot	Bell
1)	47 7/8	47 3/8	47	47 1/4	47 3/4	47 3/4	47 3/4	47 7/8	47 7/8
2)	47	47 3/8	46 1/2	46 3/4	46 3/4	46 5/8	46 3/4	47	46 7/8
3)	45 1/2	46 1/2	46 1/2	45 3/4	46	46 1/2	45 3/4	46	45 5/8
4)	46 3/4	46 3/4	46 7/8	46 1/2	46 1/2	46 3/4	46 1/2	46 3/4	46 1/2

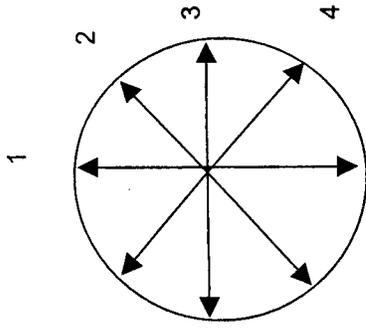
Hancor Pipe Deformation Summary

Pipes were installed on September 1, 2000.
 Sep. 8 measurements were thus 1 week after installation, while
 Oct. 4 measurements were thus 1 month after installation.
 The Values in the table below represent the delta difference from the initial
 measurements taken immediately after installation.

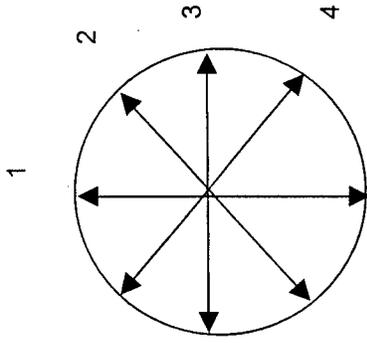
Pipes were installed on September 1, 2000.
 Sep. 8 measurements were thus 1 week after installation, while
 Oct. 4 measurements were thus 1 month after installation.

The Values in the table below represent the delta difference from the initial
 measurements taken immediately after installation.

Spigot	ADS - 1	Bell Spigot	ADS - 2	Bell Spigot	ADS - 3	Bell Spigot	ADS - 3	Bell Spigot	Bell	Spigot	Bell
Sep. 8, 2000	1)	5/8	- 1/8	0	1/16	0	- 1/8	- 3/16	0	0	1/16	5/8
	2)	0	- 1/8	- 1/4	- 5/16	0	1/16	0	- 1/16	3/16	1/8	1/8
	3)	- 15/16	- 1/16	- 1/4	- 1/4	- 1/8	- 1/16	0	- 1/8	1/8	1/16	- 13/16
	4)	- 1/16	7/8	3/16	1/8	- 1/4	0	- 1/8	- 1/8	- 3/8	- 1/4	- 3/8
Oct. 4, 2000	1)	7/8	- 1/4	- 3/8	1/8	0	1/16	- 1/8	0	- 1/8	0	1 1/8
	2)	- 1/4	3/8	- 1/2	- 7/16	- 1/8	- 1/16	- 1/8	- 3/16	1/4	1/8	1/8
	3)	- 1 11/16	- 1/8	0	- 5/16	- 1/4	- 1/16	- 1/8	- 1/8	- 1/16	- 3/16	- 1 7/16
	4)	0	- 3/8	1/8	1/8	0	- 1/8	- 1/8	- 1/8	- 3/8	- 5/16	- 3/8
