**Engineering and Organizational Issues Related to  
The World Trade Center Terrorist Attack**

**Reconnaissance and Preliminary  
Assessment of a Damaged Building  
Near Ground Zero**

**Volume 2:  
Reconnaissance and Preliminary Assessment of a  
Damaged Building Near Ground Zero**

April 2002

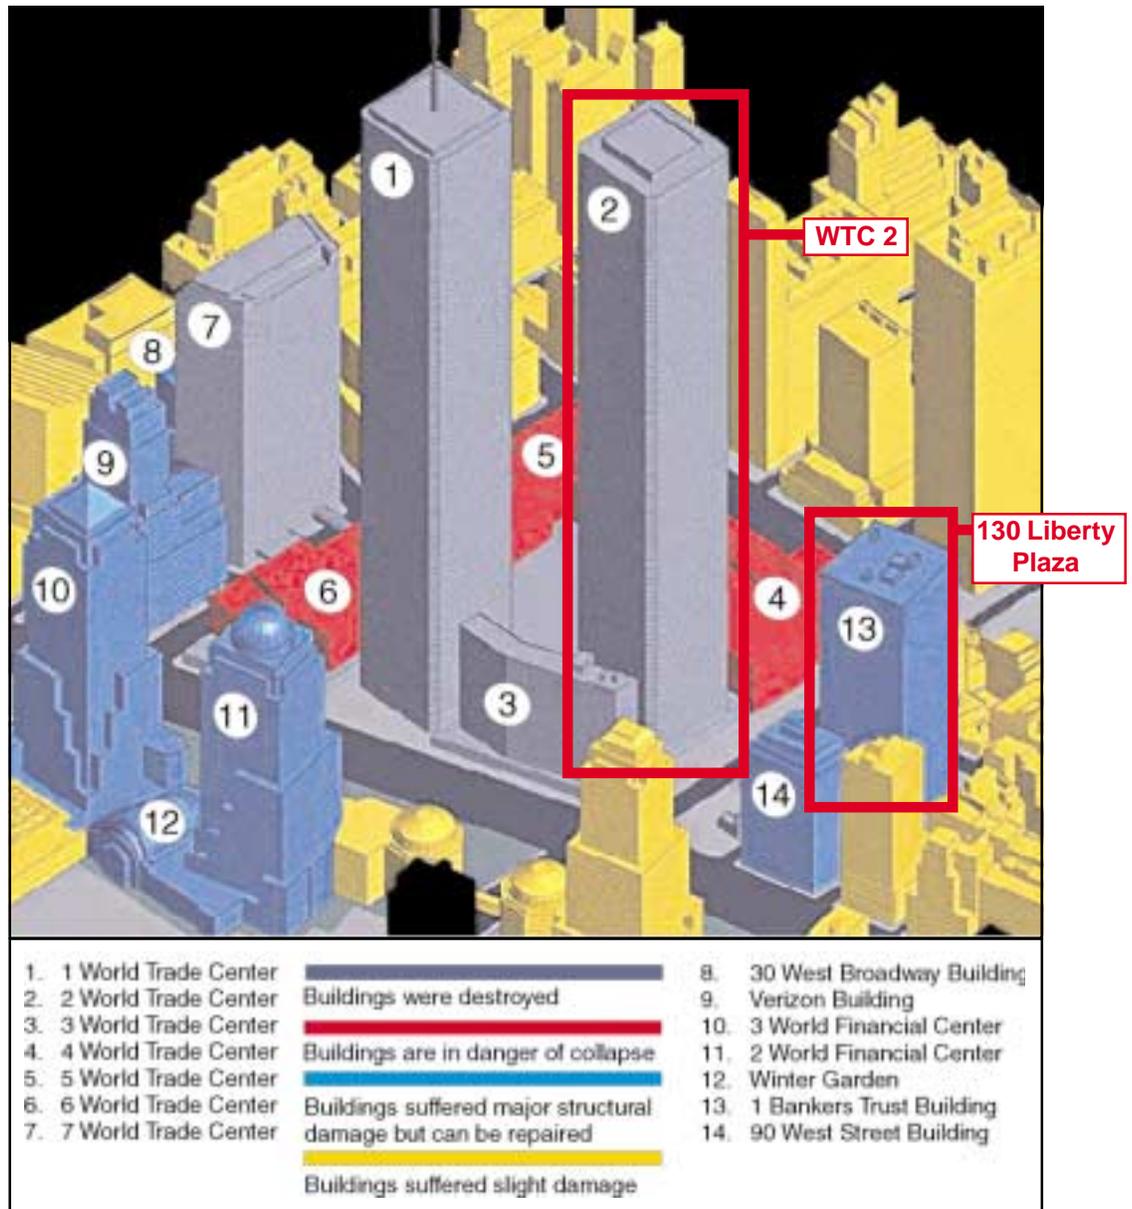
Figure 1.1. Location of subject building with respect to the World Trade Center complex

The Banker's Trust Building is a 39-story office building located at 130 Liberty Plaza in lower Manhattan. The building was located to the immediate south of the WTC 2. Figure 1.1 shows the location of the building with respect to the WTC complex.

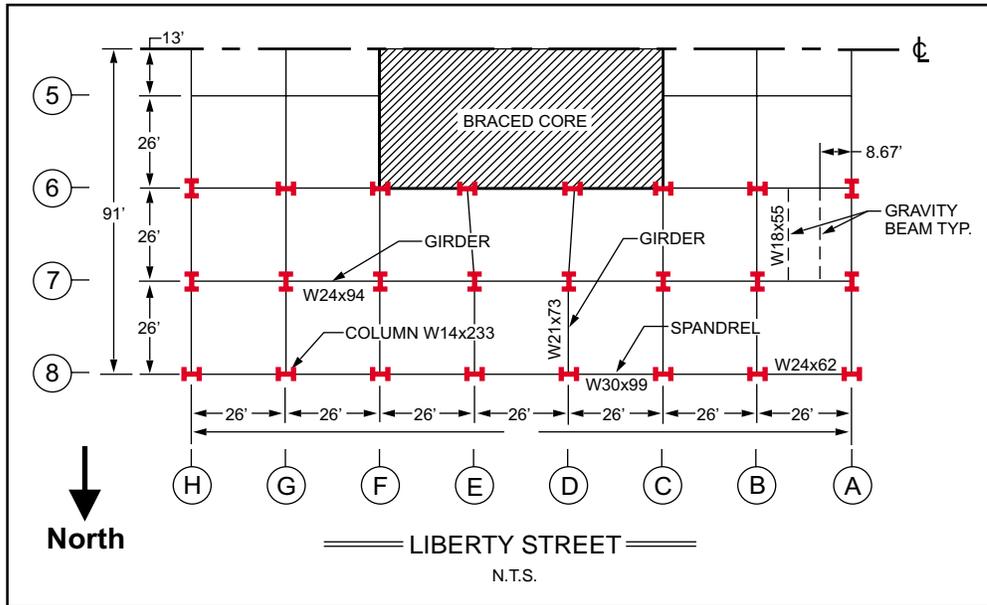
Figure 1.2. Partial plan view of a typical floor with estimated section sizes at Tenant Level 25

Both structural and nonstructural components in the building suffered significant damage, with all of the non-dust and non-mildew related damage above the sixth floor confined to a 2-bay by 2-bay zone contained by Lines 6 and 8 and C and E (see Figure 1.2 for details). Nonstructural damage extended a short distance to the west of Line C and the east of Line E.

To facilitate three-dimensional finite element analysis of the building, section sizes along frame Lines 6 and 7, including intermediate perpendicular framing, were determined based on: (1) information from the September 23, 2001, reconnaissance visit; and (2) gravity load considerations. The resulting column and beam sections at TL 25 are shown in Figure 1.2 for one half of a typical building floor plan.

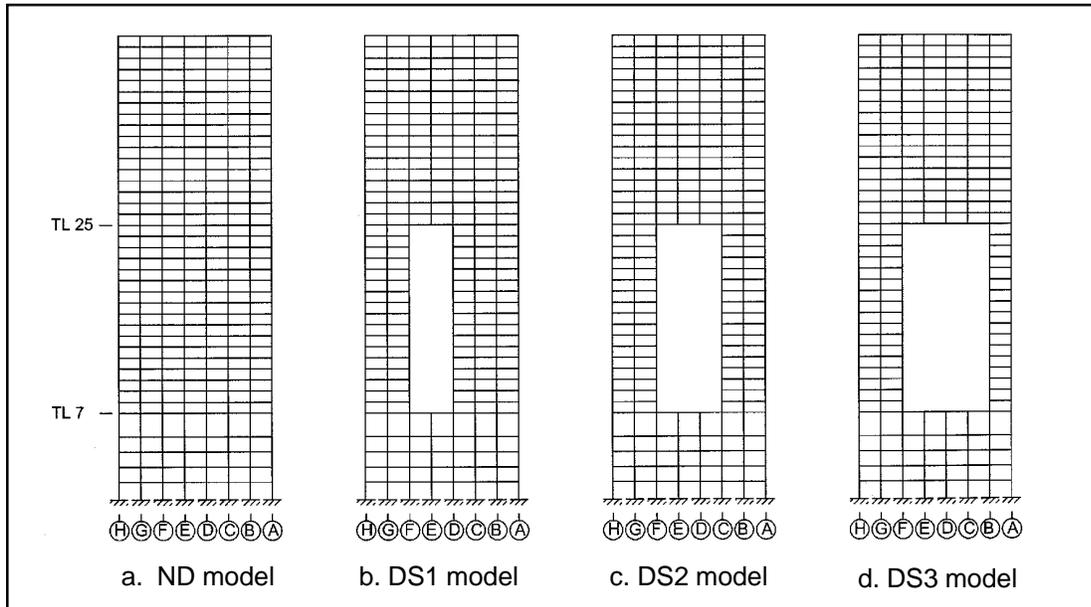
Figure 3.1. Two-dimensional mathematical models of framing on Line 8

Two- and three-dimensional finite element models were constructed using SAP2000 (CSI, 2000). First, a two-dimensional model (Figure 3.1a) was prepared that considered structural framing over all 39 stories along Line 8 (Figure 1.2). This model was constructed to study the response of a single frame with varying degrees of damage (or damage states). Second, a three-dimensional model was prepared that considered structural framing over all 39 stories along Lines 6, 7, and 8, including intermediate perpendicular framing (Figure 3.2). This model was prepared to better understand the response of the building for the observed damage state and to compare the results of two- and three-dimensional analysis. The red dashed line in Figure 3.2 identifies the zone of observed damage per Figure 3.1b.

The analyses presented below considered only gravity loads with a dead load and reduced live load of 50 psf each. A uniform distributed load of 260 lb/ft per story was assumed to account for the curtain wall loading. Mathematical models were analyzed for the undamaged state, denoted ND, and three damage states, one of which corresponds to the existing damage shown in Figure 2.1a. Each damage state involved the removal of columns on Line 8 from TL 7 to TL 25. The three damage states involved the removal of (1) the column on Line D (the observed damage per Figure 3.1b); (2) the columns on Lines D and E; and (3) the columns in Lines C, D, and E, denoted DS1, DS2, and DS3 in Figure 3.1,

Damage state DS1 (the observed damage) and the two-dimensional analysis is considered first. All D/C ratios are substantially less than one. The three-dimensional analysis shows similar results. These results provide an explanation for the observed behavior of the framing along Line 8 following the impact of debris from WTC 2 and the loss of a column on Line D, namely, that the moment-resisting framing above TL 25 provided an alternate (redundant) path for gravity loads around Line D and to the foundation without distress to the structural framing. As observed from DS1, models with increasing levels of damage (i.e., DS2 and DS3) showed that the moment-resisting framing above the damage provided an alternate path for gravity loads. For DS2 and DS3, Vierendeel truss action becomes more apparent.

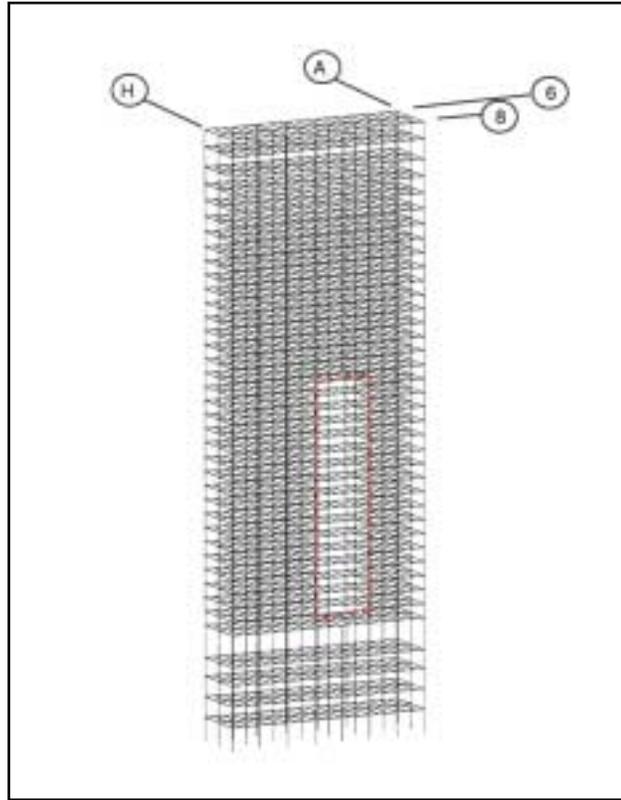
*Figure 3.2. Three-dimensional mathematical model of framing on Lines 6, 7 and 8 for DS1*

The mathematical models for damage states DS2 and DS3 were prepared to evaluate the robustness of a building frame with characteristics similar to those of 130 Liberty Plaza, where robustness herein is judged by the ability of the framing system to support gravity loads following the loss of multiple perimeter columns. The results of the two-dimensional analysis of the DS2 model (see Figure 3.3) show that the frame on Line 8 would have been compromised by the loss of columns on Lines D and E unless the moment-resisting connections were ductile (i.e., possessed some degree of inelastic rotation capacity). Review of the three-dimensional analysis results of Figure 3.4, however, shows that using the results of the two-dimensional analysis leads to conservative conclusions and that the moment-resisting framing perpendicular to Line 8 also participated in the redistribution of load around the lost columns on Lines D and E. Analyses for both the two- and three-dimensional models of DS3 (the loss of columns on Lines C, D, and E) show modest overloads in both instances. For the three-dimensional analysis, the D/C ratios are greatest in the framing perpendicular to Line 8, namely, Girders C87, D87, and E87.

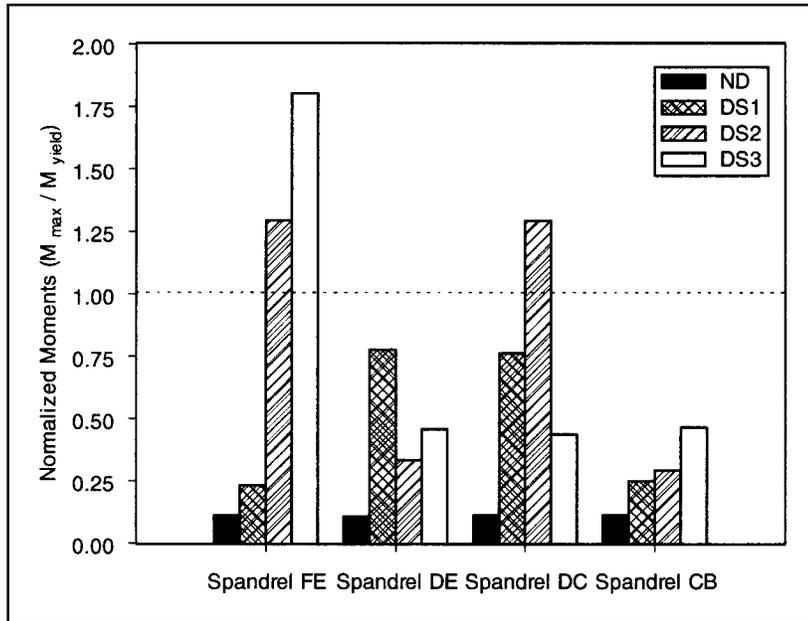
Figure 3.3. Demand-to-capacity ratios for two-dimensional linear elastic analysis

Figures 3.3 and 3.4 present some of the results of the two- and three-dimensional analyses, respectively. Shown in these figures are moments normalized by the yield moment for the assumed beam section sizes at TL 25; the floor level immediately above the observed damage. The spandrel beam designation (e.g., DE) refers to the grid lines between which the beam spans (e.g., Lines D and E). The girder designation (e.g., E87) refers to the grid line along which the girder is aligned (e.g., Line E) and the grid lines between which the girder spans (e.g., Lines 8 and 7). Such normalized moments represent demand-to-capacity (D/C) ratios for these elements, albeit not exactly, because  $M_{yield}$  is used in lieu of  $\phi \cdot M_{nx}$  and each beam is assumed to be fully braced.

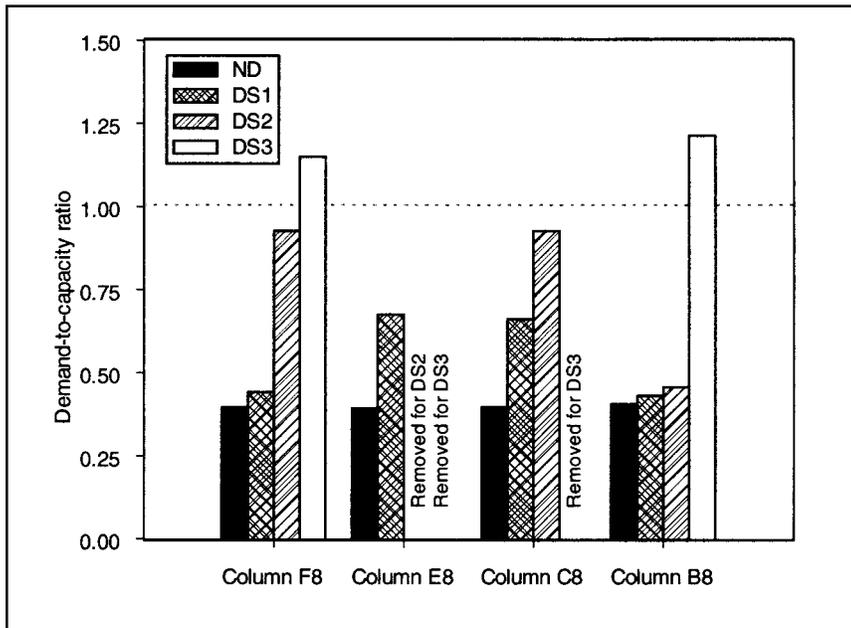
Figure 3.5. Demand-to-capacity ratios for two-dimensional linear elastic analysis

designation (e.g. F8) in Figures 3.5 and 3.6 refers to the column between TLs 24 and 25 at the intersection of Lines F and 8. Shown in Figures 3.5 and 3.6 are column D/C ratios. These ratios were calculated using the 1998 *Edition of the AISC Manual of Steel Construction, Load and Resistance Factor Design* (AISC 1998) nominal strength equation for members under combined forces (LRFD Eqn. H1-1a), namely,

The results of the two-dimensional analyses shown in Figure 3.5 indicate D/C ratios less than unity for the undamaged state, ND, and damage states, DS1 and DS2. For damage state DS3, the D/C ratios for columns F8 and B8 exceed unity. Ratios greater than unity can be attributed to an increase in both axial forces and moments due to the removal of columns C8, D8 and E8. This observed increase in bending moment for the two-dimensional analyses ranged from essentially zero for ND to approximately  $0.25 M_p$  (where  $M_p$  is the plastic moment of the section) for DS3. Noting that the span between adjacent columns for DS3 is four times the span in the undamaged state ND, an increase in moment demand is expected. The D/C ratios for the three-dimensional model (Figure 3.6) are less than unity for ND and DS1, DS2, and DS3. Again, the results of the three-dimensional analyses indicate that the use of two-dimensional analysis leads to conservative conclusions and that the presence of perpendicular framing provides additional redundancy and capability for gravity load redistribution to adjacent framing.

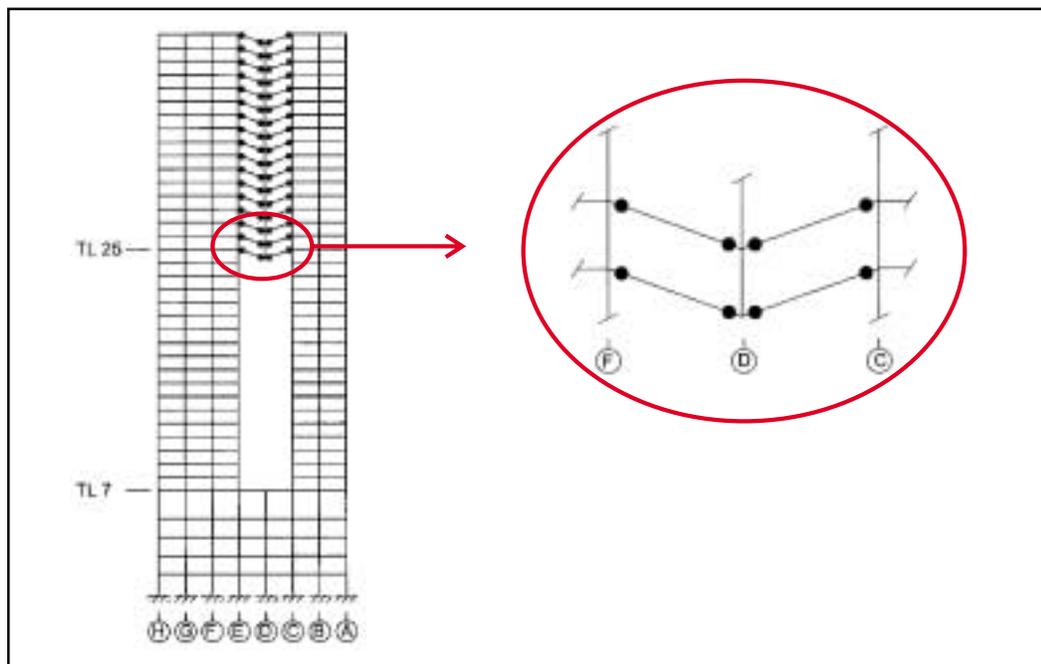
Figure 3.7. Two-dimensional collapse mechanism for DS1

Simple two- and three-dimensional plastic analyses were performed to determine an upper bound on the load carrying capacity of the framing system for each of the three damage states. In both the two and three-dimensional analyses, beam plastic moments were calculated assuming a yield stress of 36 ksi and the section sizes determined in the preliminary design (see Figure 1.2). All sections were assumed to be compact. Further, all beam-to-column connections were assumed to have unlimited rotation capacity. For the two-dimensional analyses, vertical "panel" mechanisms were assumed to form for each damage state. Figure 3.7

These analyses support the results of the elastic analysis, namely, that the framing system could have tolerated the loss of two columns without collapse. Note the additional load-carrying capacity that results from considering the framing perpendicular to Line 8.

However, it must be noted that the cover-plated moment-resisting connections employed in the construction of the building likely have limited plastic rotation capacity as demonstrated by a series of tests conducted following the 1995 Northridge earthquake (Kim et al., 2000). Therefore, the results of the simple plastic analyses must be interpreted with care.

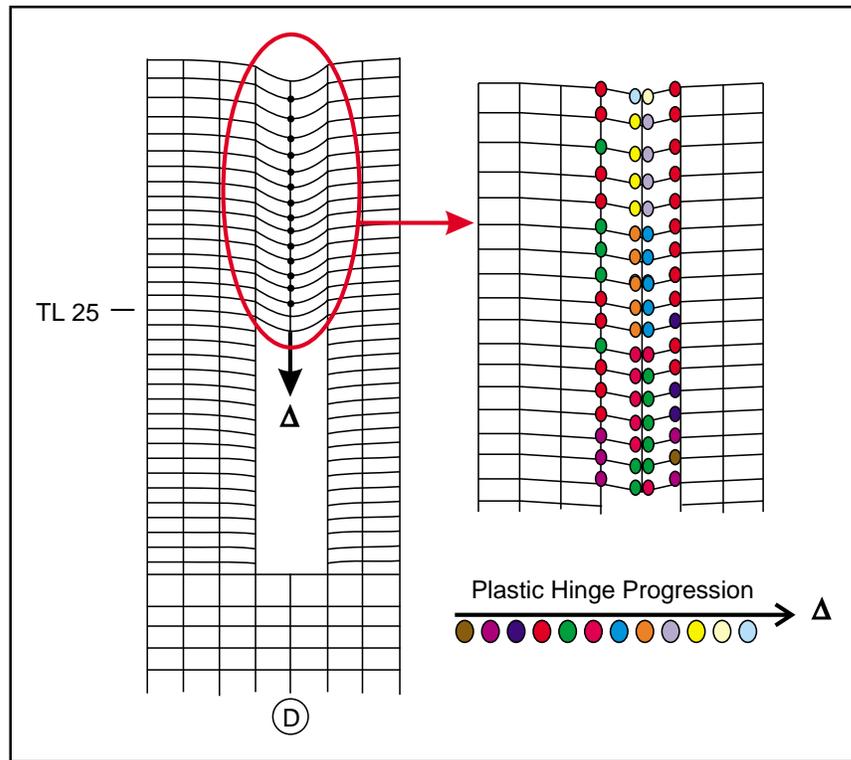
Figure 3.8. Progression of plastic hinge formation in DS1

Two-dimensional nonlinear static or "pushdown" analysis of the framing along Line 8 was performed for the three damage states to obtain insight as to the displacements that could be expected at the maximum floor loads predicted by simple plastic analysis. Elastic-perfectly plastic moment-rotation relationships were assumed for all beams. Connections were assumed to have infinite rotation capacity. The analyses were run using SAP2000 under displacement control and used the node at Frame Line D and TL 25 as the control node. The loading pattern was a series of equal valued point loads at the locations where the floor beams and perpendicular girders frame into the spandrel elements on Line 8. Prior to running the displacement controlled nonlinear static analysis, the curtain wall load was applied as a single force controlled step because it had been accounted for in the plastic analyses. Figure 3.8 shows the observed progression of plastic hinging for DS1. The hinging patterns for DS2 and DS3 were similar to DS1. Hinging started at the beam-to-column connections on Lines E and C near TL 25, progressed to the connections on Frame Line D, and then vertically up through the framing on Line 8.

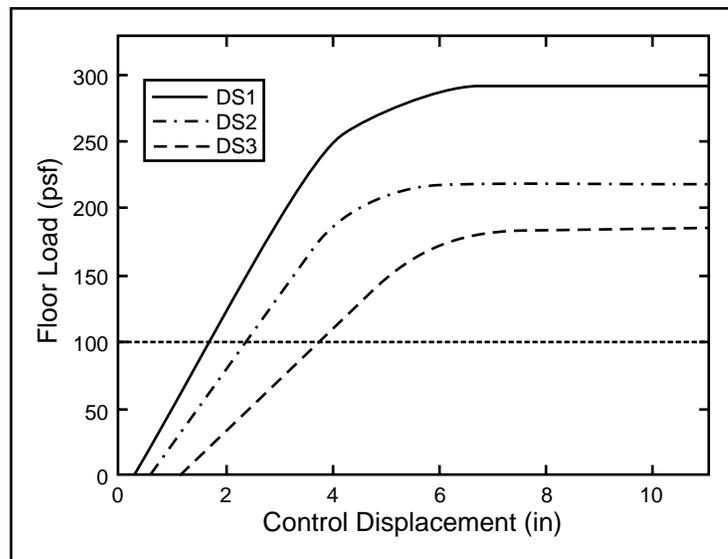
Figure 3.9. Two-dimensional pushdown curves for DS1, DS2, and DS3

Figure 3.9 shows the resulting relationships between floor load (psf) and the deflection of Line D at TL 25 for the three damage states, where the floor load is assumed to be present over the entire width of the damaged zone (i.e., between Lines C and E for DS1, Lines C and F for DS2, and Lines B and F for DS3). The initial displacements seen in the figure correspond to the deflection due to the prior application of the curtain wall load. Also shown in this figure is the research team's estimate of the likely maximum floor loading at the time of the attacks of September 11, 2001, of 100 psf. As expected, an increase in damage led to an increase in structural flexibility and reduced the maximum permissible floor load. The results of the nonlinear static analysis and those of the simple plastic analysis are in good agreement for all damage states.
