# Mechanical Texturing Of Three Bridge Decks

MECHANICAL TEXTURING OF THREE BRIDGE DECKS

Final Report on Research Project 12-6  
Conducted in Cooperation with  
The U.S. Department of Transportation  
Federal Highway Administration

Special Report 101  
December 1991

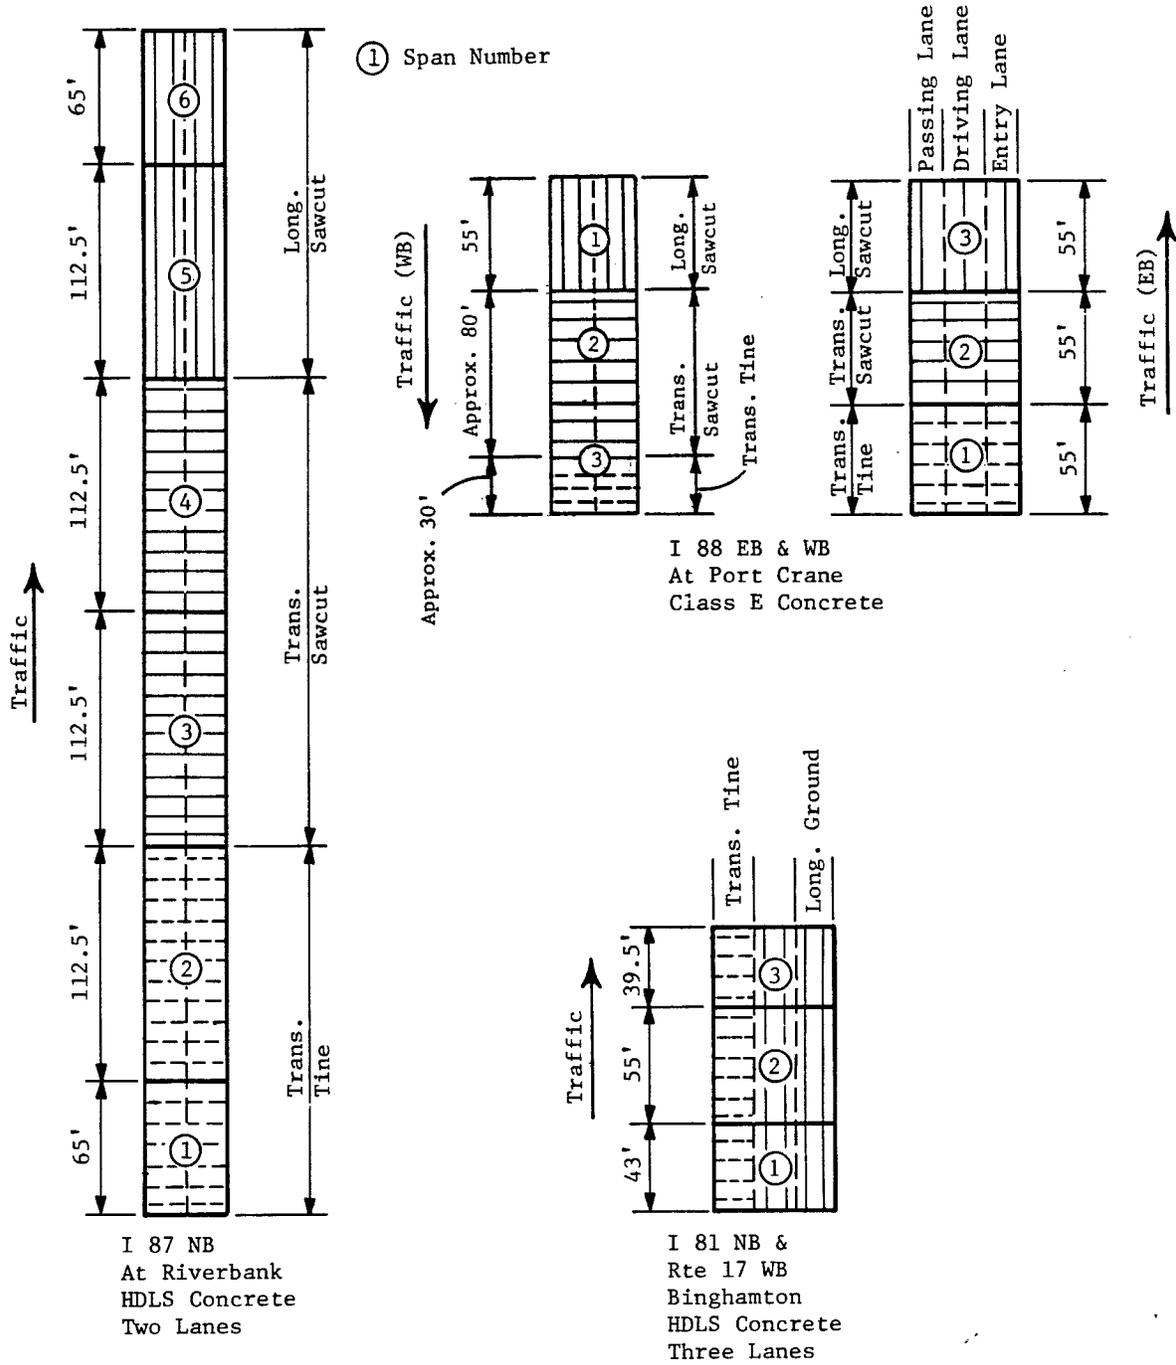
Figure 1. Texturing plans.

were textured transversely by tining, the third and fourth transversely by sawing, and the fifth and sixth longitudinally by sawing (Fig. 1).
