# **EVALUATION OF A MODIFIED STEEL POST W-BEAM GUARDRAIL SYSTEM**

Report 3963-S  
Research Study Number 7-3963  
Research Study Title: Guardrail Testing to NCHRP Report 350 Criteria

Sponsored by the  
Texas Department of Transportation

November 1997

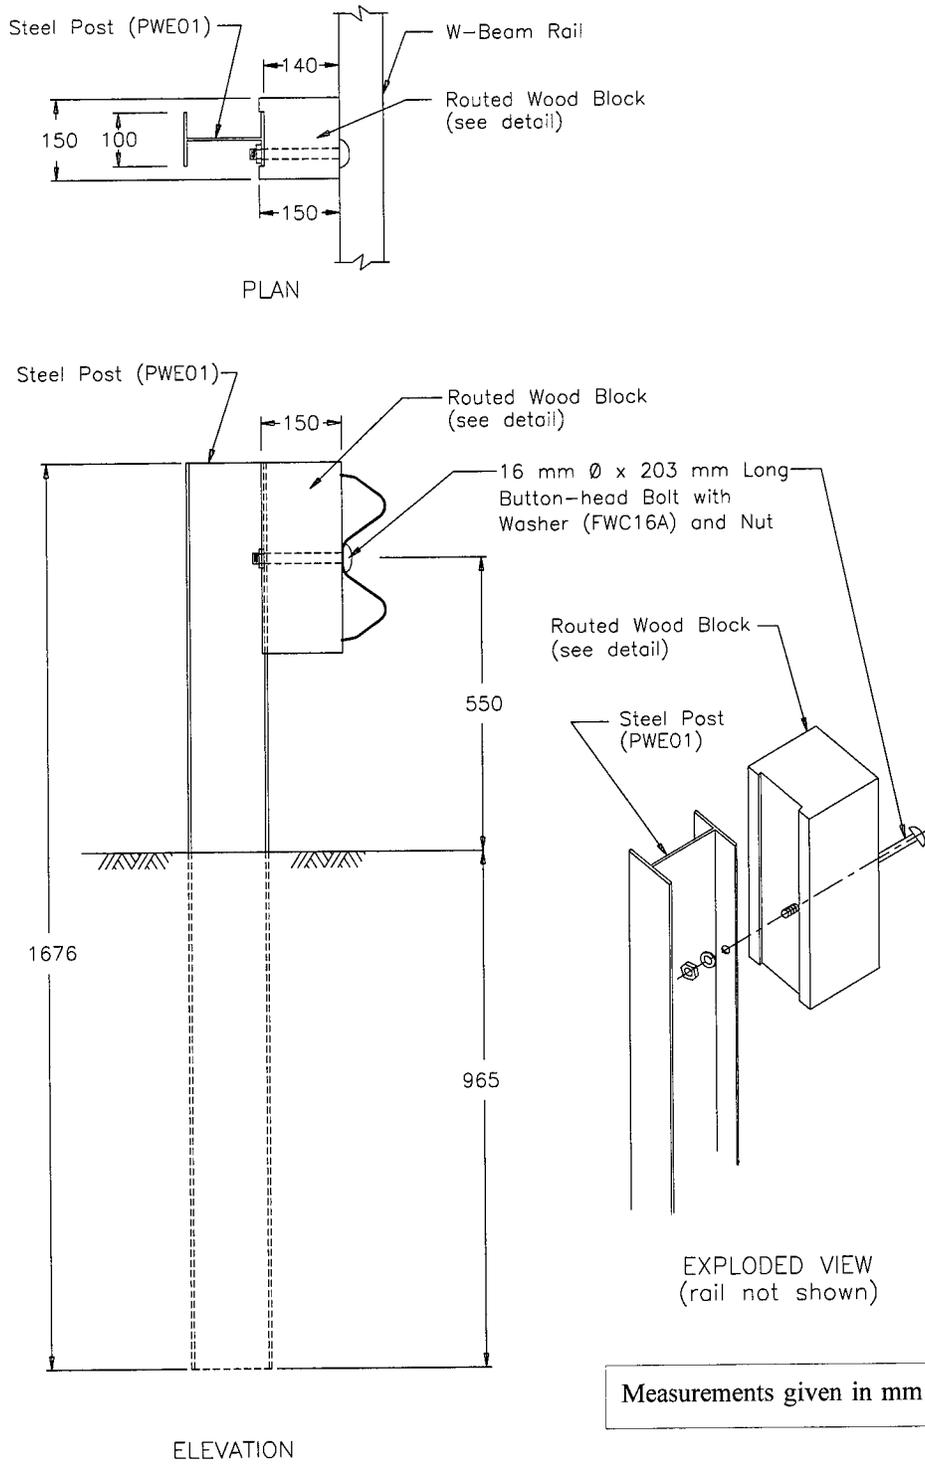
**Figure 1. Details of the TxDOT guardrail on steel posts installation.**

The W150×13.5 steel offset blocks used in the standard TxDOT steel post guardrail system (MBGF-95A(M)) were replaced with full 152 mm × 152 mm × 356 mm long solid wood blockouts. Details of the modified TxDOT steel post W-beam guardrail system are shown in Figure 1. A 108-mm wide by 10-mm deep channel is routed into the back side of the blockout to accept the flange of the W150×13.5 steel post and prevent rotation of the blockout in field applications. A 19-mm diameter hole is drilled through the blockout and offset 30 mm from the center of the blockout to avoid the web of the steel post and permit attachment through the flange. Details of the routed wood blockout are shown in Figure 2.

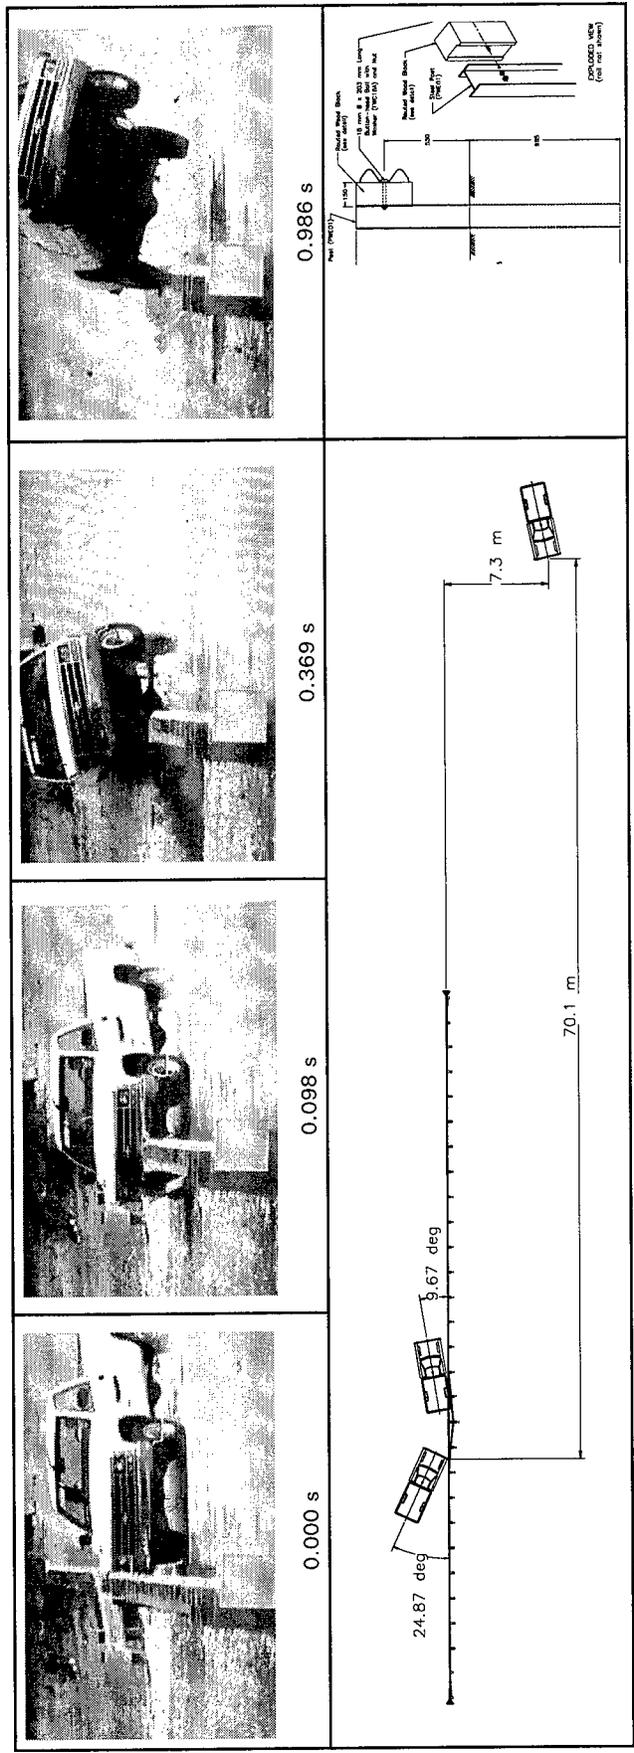
<b>General Information</b>		<b>Impact Conditions</b>		<b>Test Article Deflections (m)</b>	
Test Agency	Texas Transportation Institute	Speed (km/h)	101.84	Dynamic	0.75
Test No.	439637-1	Angle (deg)	24.87	Permanent	0.45
Date	08/05/97	<b>Exit Conditions</b>		<b>Vehicle Damage</b>	
Test Article	W-beam Guardrail	Speed (km/h)	62.35	Exterior	
Type	Mod. Steel Post W-beam Guardrail	Angle (deg)	9.67	VDS	01FR3
Name	53.3	<b>Occupant Risk Values</b>		CDC	01FREW3
Installation Length (m)	1676-mm long W150x13.5 steel posts and 152 mm x 152 mm routed elements	Impact Velocity (m/s)		Maximum Exterior	
Size and/or dimension	wood block	x-direction	7.38	Vehicle Crush (mm)	435
and material of key elements	Standard soil, dry	y-direction	5.21	Interior	
Soil Type and Condition		Ridedown Accelerations (g's)		OCDI	FS0020000
Test Vehicle		x-direction	-7.76	Max. Occ. Compart.	
Type	Production	y-direction	-6.54	Deformation (mm)	23

Designation	2000P	Max. 0.050-s Average (g's)		<b>Post-impact Behavior</b>	
Model	1992 Chevrolet 2500 pickup	x-direction	-7.01	(during 1.0 s after impact)	
Mass (kg)	2079	y-direction	-6.29	Max. Roll Angle (deg)	-15
Test Inertial	2000	z-direction	-4.15	Max. Pitch Angle (deg)	13
Dummy	No dummy			Max. Yaw Angle (deg)	-33
Gross Static	2000

The modified TxDOT steel post guardrail with routed wood blocks successfully contained and redirected the test vehicle through controlled lateral deflection. The vehicle did not penetrate, underride, or override the guardrail installation. Although the vehicle became completely airborne during the impact sequence, it remained upright and relatively stable both during and after the collision. The detached elements from the installation did not penetrate or show potential for penetrating the occupant compartment, nor did they present undue hazard to others in the area. The minimal deformation of the occupant compartment (23 mm) was not considered to have potential to cause injury. After exiting the installation, the vehicle steered back toward the guardrail and did not intrude into adjacent traffic lanes. Occupant risk factors were within the preferable limits specified in NCHRP Report 350. Additionally, the exit angle at loss of contact with the guardrail was only 9.67 degrees, which is less than 60 percent of the impact angle as recommended.

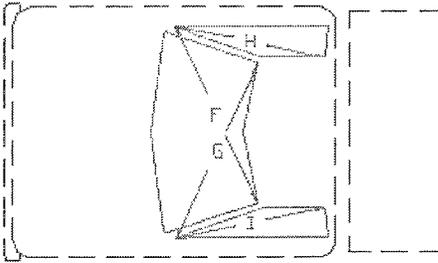
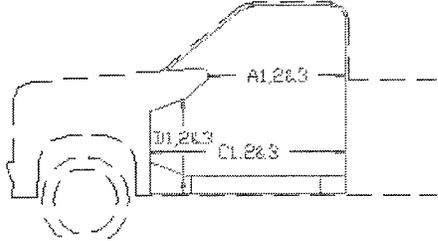
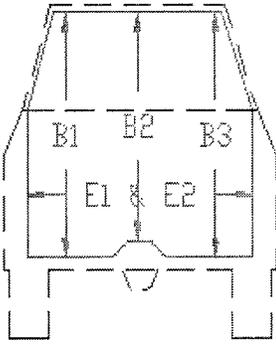
## Occupant Compartment Deformation

D.	Detached elements, fragments or other debris from the test article should not penetrate or show potential for penetrating the occupant compartment, or present an undue hazard to other traffic, pedestrians, or personnel in a work zone. Deformations of, or intrusions into, the occupant compartment that could cause serious injuries should not be permitted.	The detached elements and debris did not penetrate nor show potential for penetrating the occupant compartment, nor present undue hazard to others in the area. There was minimal deformation into the occupant compartment (23 mm) and was considered to not cause serious injury.	Pass

A1	1035	1035
	A2	1082	1082
	A3	1045	1045
	B1	1075	1075
	B2	1045	1030
	B3	1081	1070

C1	1368	1368
	C2	1264	1257
	C3	1371	1265
	D1	310	310
	D2	151	128
	D3	311	296

E1	1590	1590
	E2	1595	1595
	F	1460	1450
	G	1460	1460
	H	900	895
	I	900	900
