ARIZONA DEPARTMENT OF TRANSPORTATION

REPORT NUMBER: FHWA-AZ-8604

CRACK AND SEAT CONCRETE PAVEMENT

Construction Report

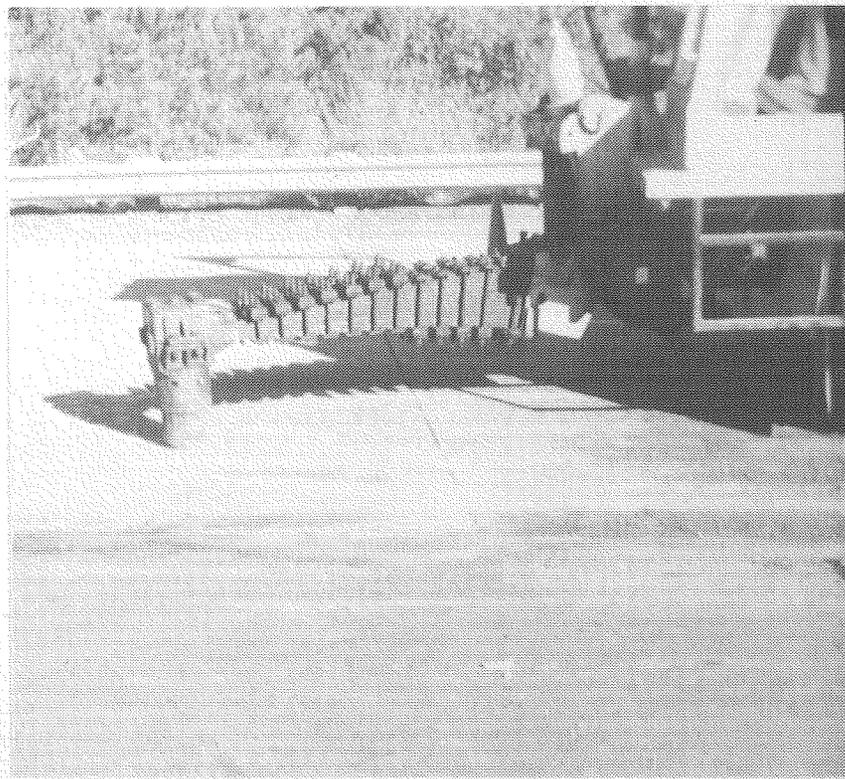
Figure 3 The Whiphammer Used for Cracking the PCCP

The cracking of the PCCP was accomplished using a whiphammer (Figure 3). The whiphammer utilized a centrally mounted impact device which was thrown against the pavement with a whip-like action impacting the pavement with a rectangular foot print (typical dimensions of approximately 4.5" x 7.0"). The special provisions specified cracking patterns of 3' x 3', 4' x 6' and 2' x 2' (See Appendix B for a copy of the special provisions).

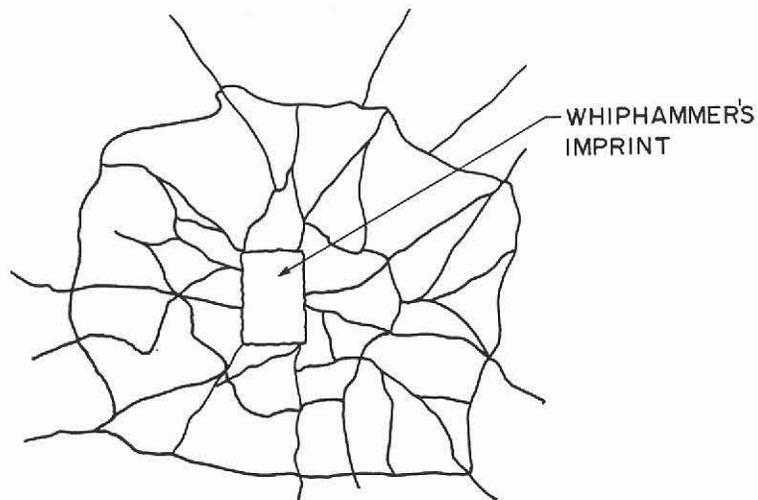
Figure 6 Rendering of the Expected and the Produced Cracking Pattern

TYPICAL "SPIDER WEB" CRACKING PATTERN
PRODUCED BY THE WHIPHAMMER

The size of the cracked pieces ranged between four and nine square feet. The cracked pieces were generally not square but were usually diamond or triangular in shape. A "Spider web" type of cracking pattern was produced by the Whiphammer. The cracks were not visually detectable on a dry pavement; therefore the pattern was checked periodically by applying water to the cracked surface so that the cracks could be more readily detected. Figures numbered 4 and 5 show a typical cracked PCCP. Figure 6 shows a rendering of the expected and the produced cracking pattern. Cores, randomly taken, verified that the hairline cracks penetrated the full depth of the slab (Figure 7).

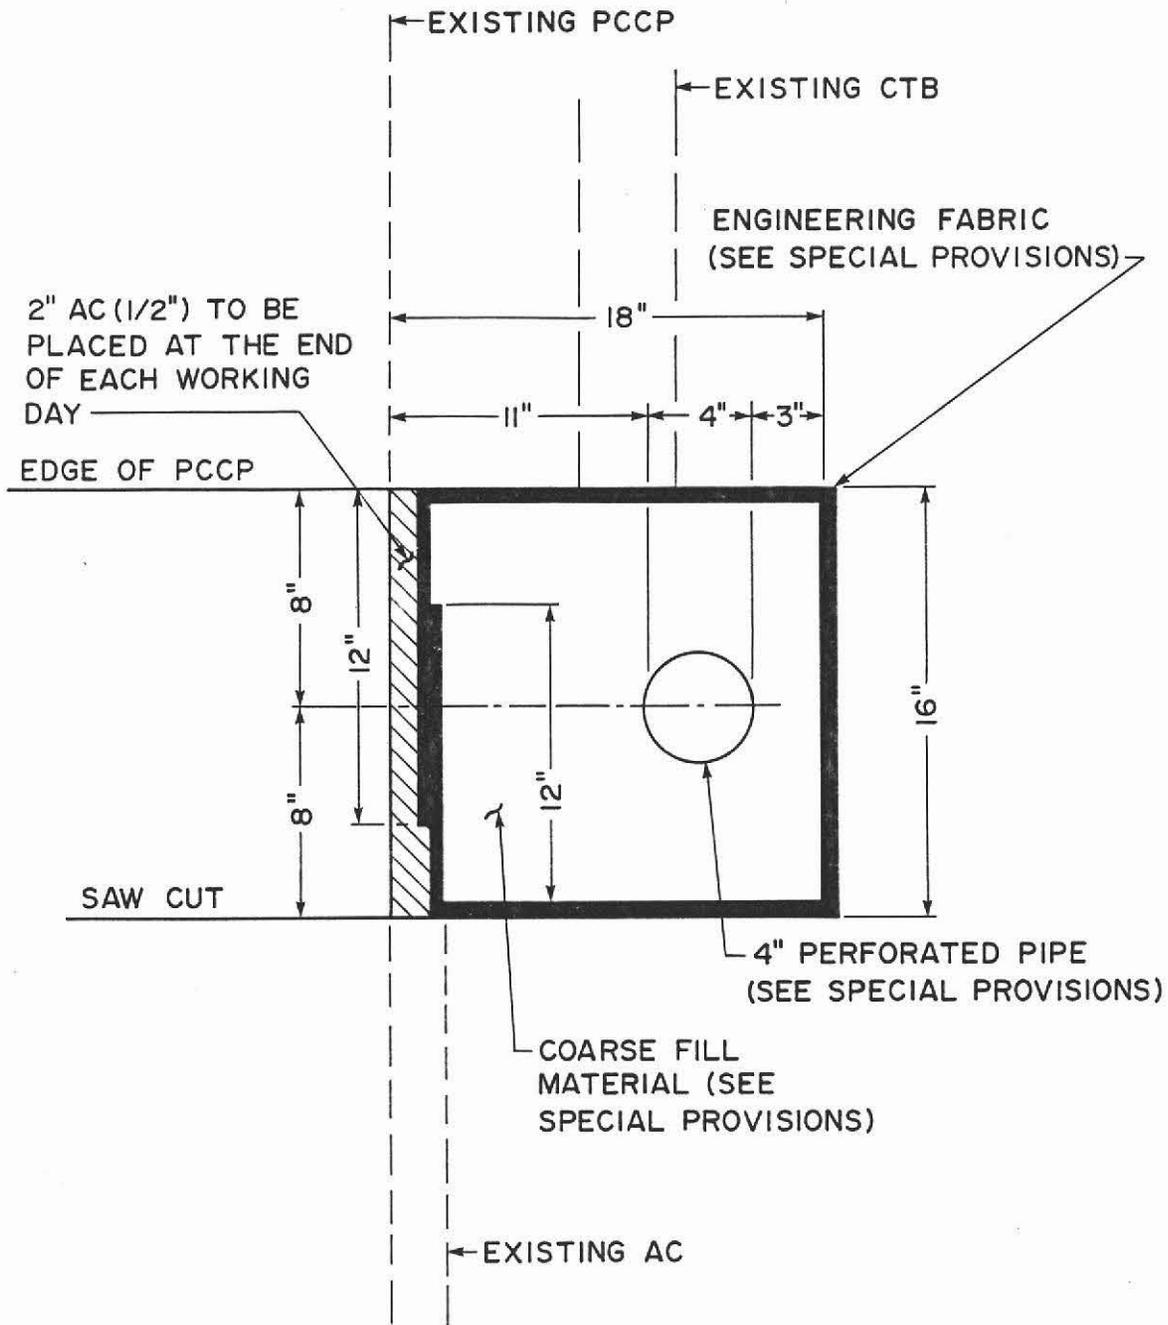
Figure 8 Collector Trench Drainage Design

The quality of the subsurface materials is highly suspect in the same areas that the slabs in the PCCP were in very poor condition. Since many of the broken slabs had not been sealed, water was allowed to intrude into the base materials. To ensure proper drainage, a collector trench was constructed on the edge of the PCCP (Figure 8 shows a typical section of the collector trench). The installation of the subsurface drainage collector system exposed approximately nine inches of the base material and it was observed that free water was frequently present at less than nine inches below the bottom of the slabs.

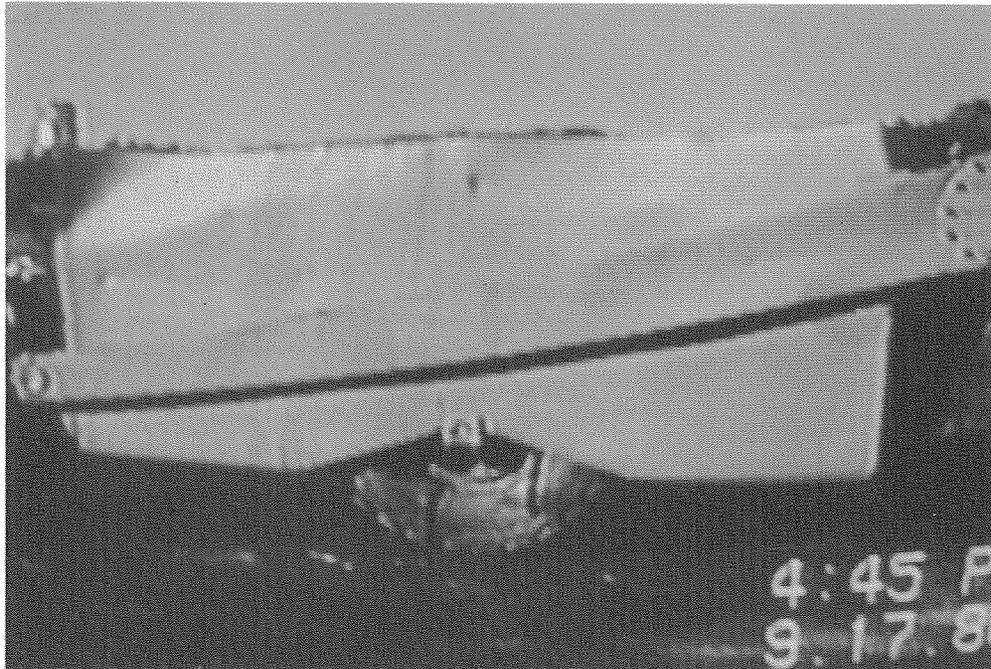
Figure 9 Tire-Roller Used for Seating the Cracked PCCP

The seating of the cracked PCCP slabs was conducted by rolling the slabs with at least 2 passes of a 50 ton "wagon-like" tire roller filled with sand ballast (Figure 9). Traffic was not allowed on the cracked and seated pavement for about 72 hours, and in general, the bottom 2 inch lift of the HMAC overlay was laid within 72 hours after the crack and seat operations, as per the special provisions.
