NCHRP Report 350 Crash Testing and Evaluation of the S-Square® Mailbox System

Research/Test Report 0-5210-7

1. Report No. FHWA/TX-10/0-5210-7	2. Government Accession No.	3. Recipient's Catalog No.	
4. Title and Subtitle NCHRP REPORT 350 CRASH TESTING AND EVALUATION OF THE S-SQUARE® MAILBOX SYSTEM		5. Report Date November 2009 Published: January 2010

Project Title: Roadside Crash Testing Program for Design Guidance
and Standard Detail Development

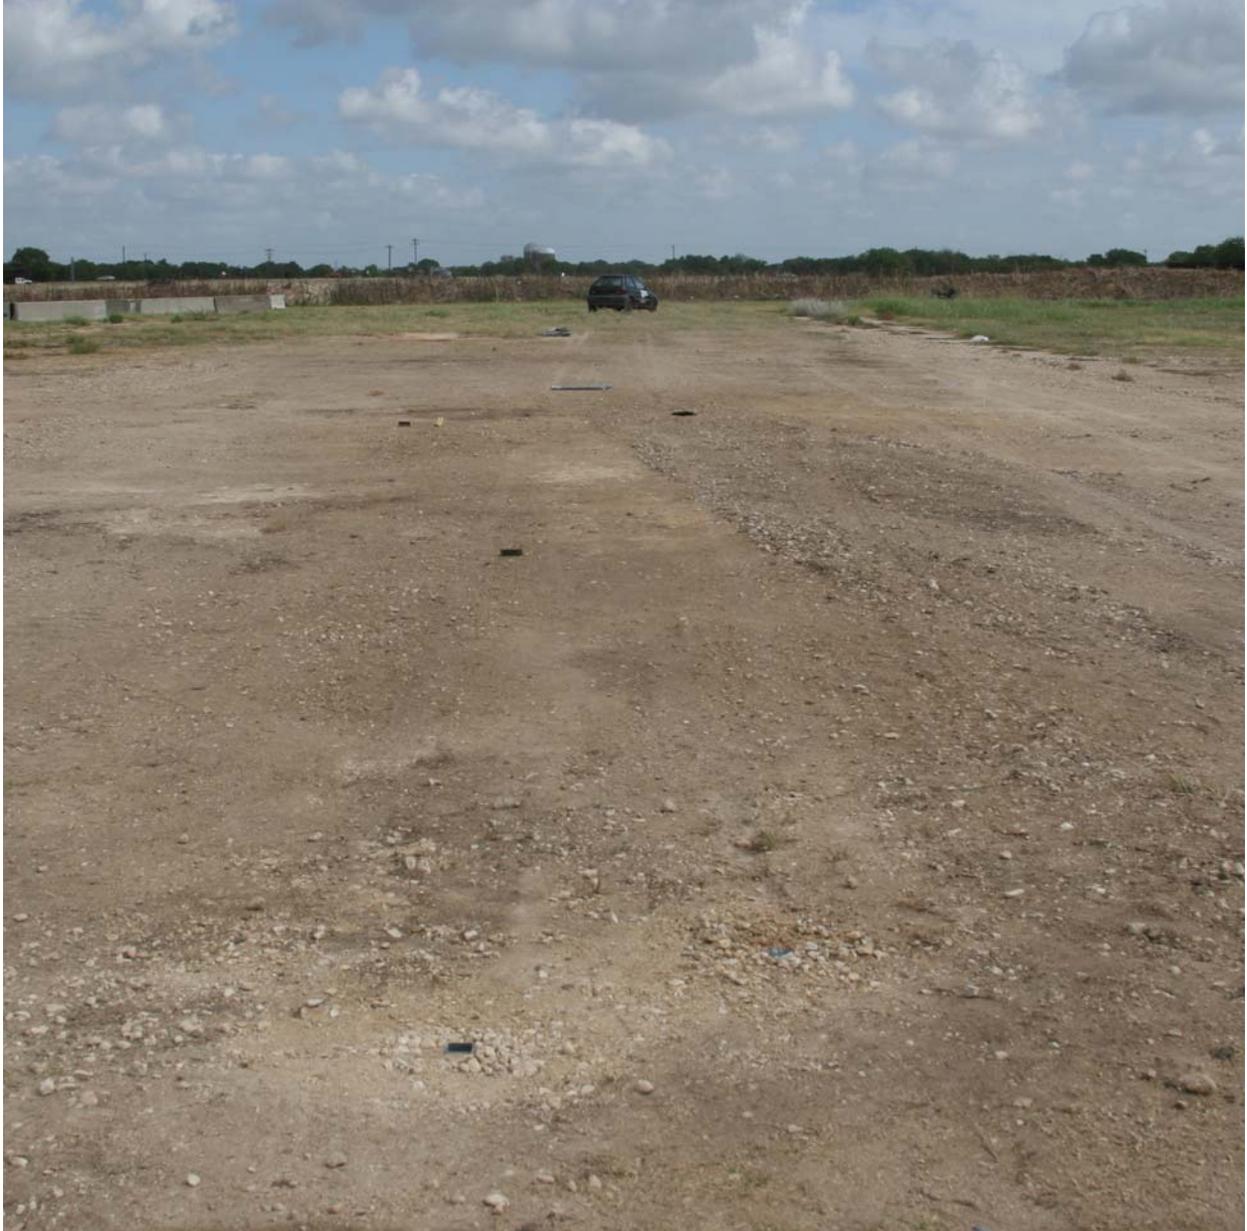
Figure 7. After Impact Trajectory Path for Test No. 452109-9.

The S-Square® dual mailbox support pulled out of the anchor sleeve, as shown in Figures 7 and 8. The ground socket moved 0.25 inch downstream through the soil, and the downstream edge of the sleeve was deformed. The support post was deformed at bumper height and at groundline, and came to rest 70 ft downstream of impact. The mailboxes separated from the support, were collapsed, and came to rest 131 ft downstream of impact.

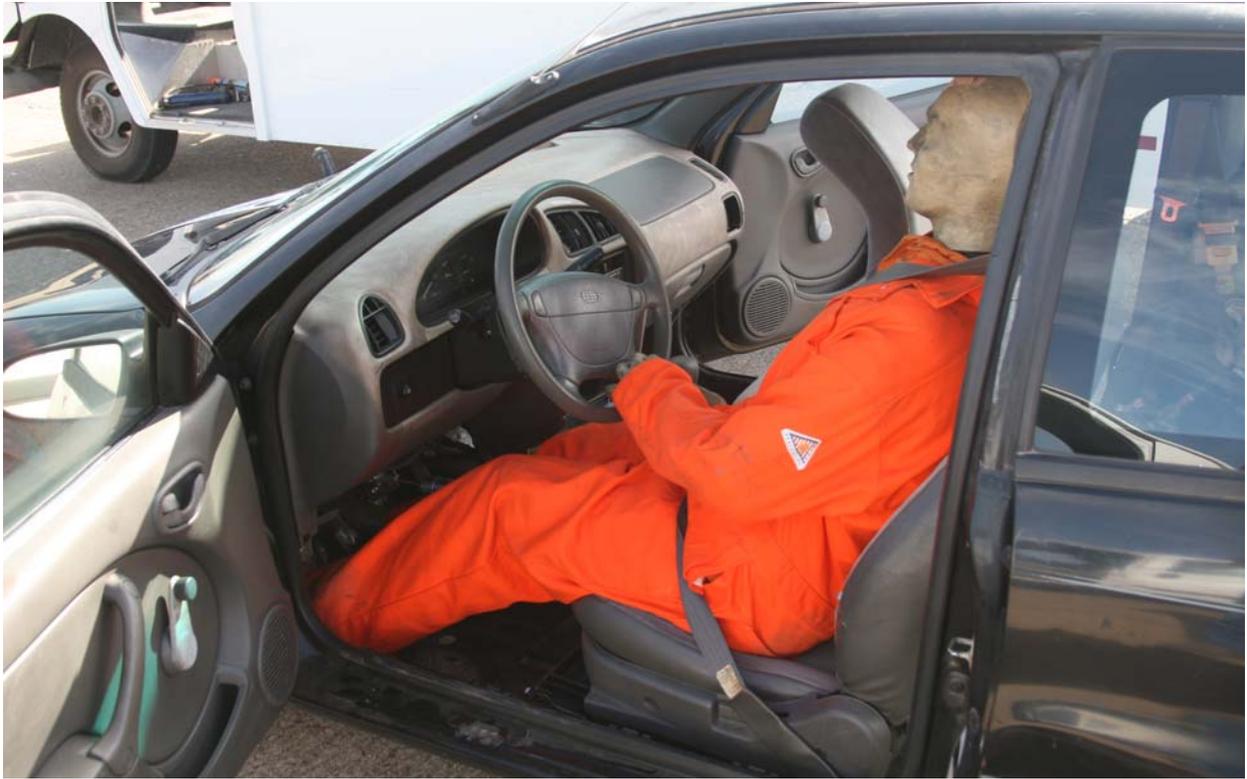
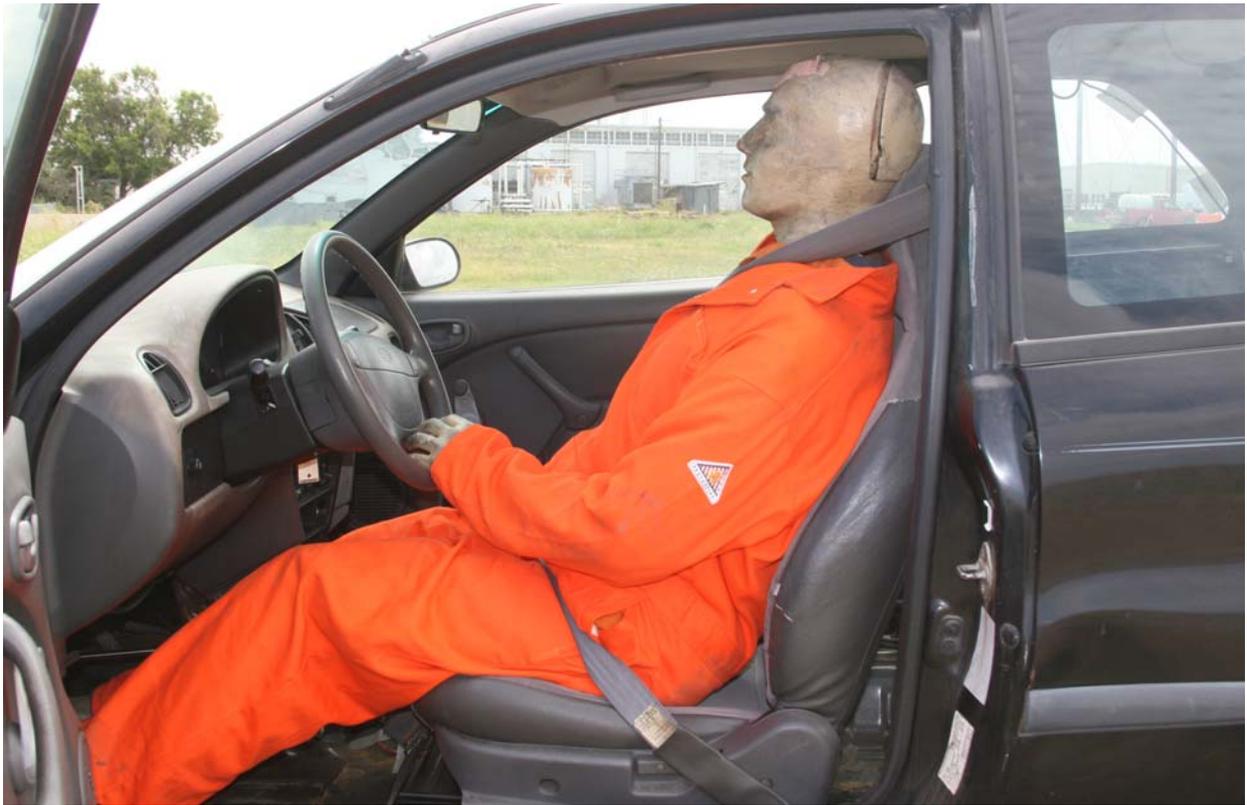
Figure 10. Interior of Vehicle for Test No. 452109-9.

Figure 9 shows the damage to the 820C vehicle. The front bumper, hood, and right front fender were slightly deformed. The hood sustained a dent just below the windshield on the passenger side measuring 10.25 inches × 20.86 inches × 0.16 inch deep. No occupant compartment deformation occurred. Photographs of the interior of the vehicle are shown in Figure 10. Exterior crush and occupant compartment measurements are presented in Appendix B, Tables 3 and 4.

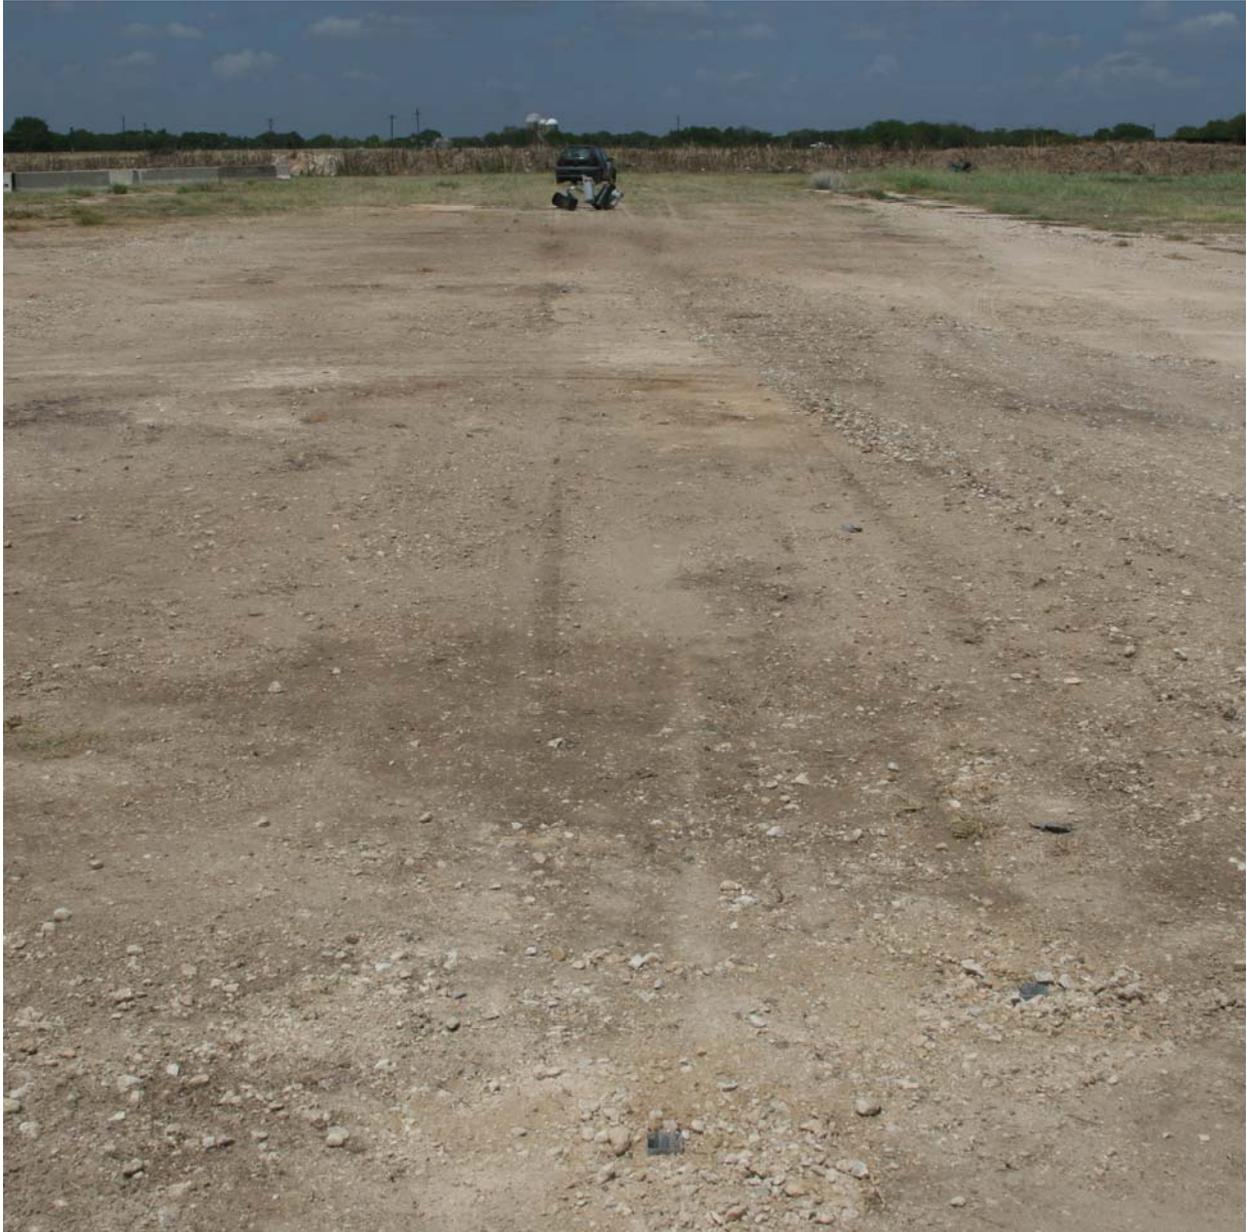
Figure 14. After Impact Trajectory Path for Test No. 452109-10.

The S-Square® multiple mailbox support pulled out of the anchor sleeve, as shown in Figures 14 and 15. The sleeve moved 0.5 inch downstream through the soil and was deformed on the downstream edge. The support was deformed at bumper height, and came to rest 131 ft downstream of impact and 3 ft to the left of centerline. The mailboxes remained attached to the support.

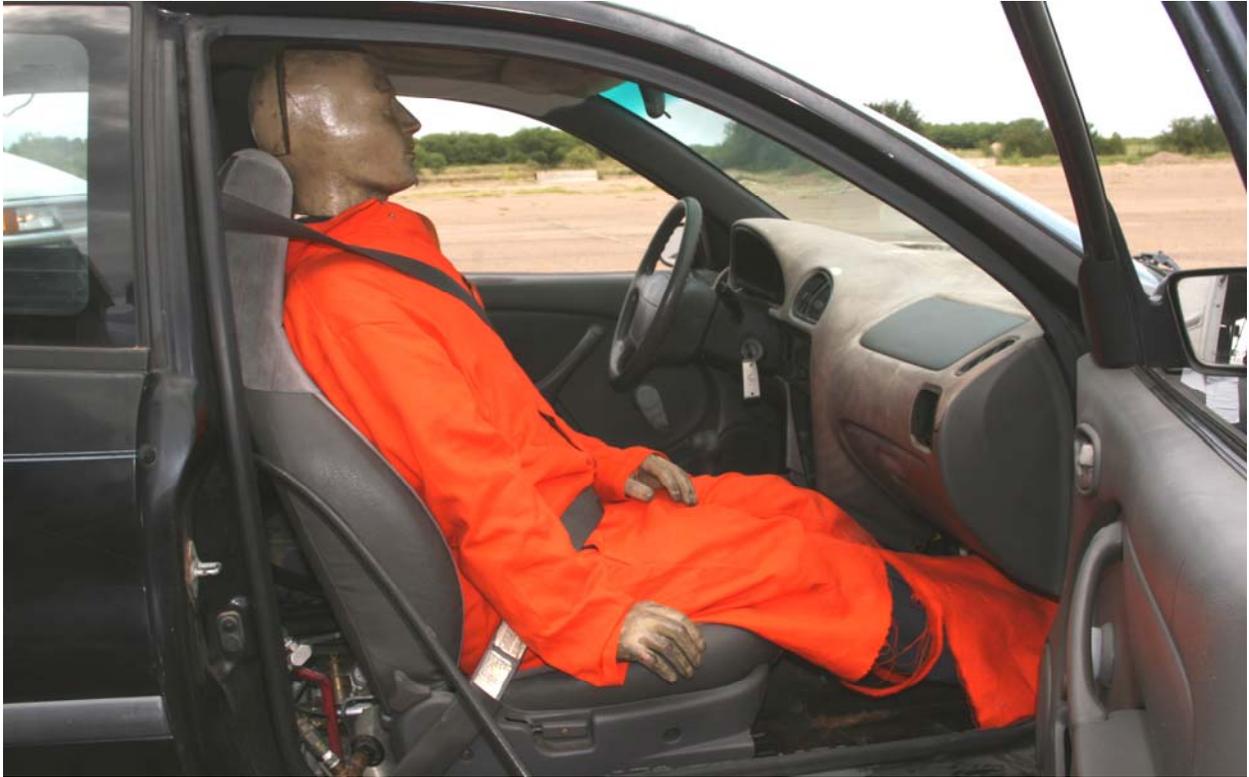
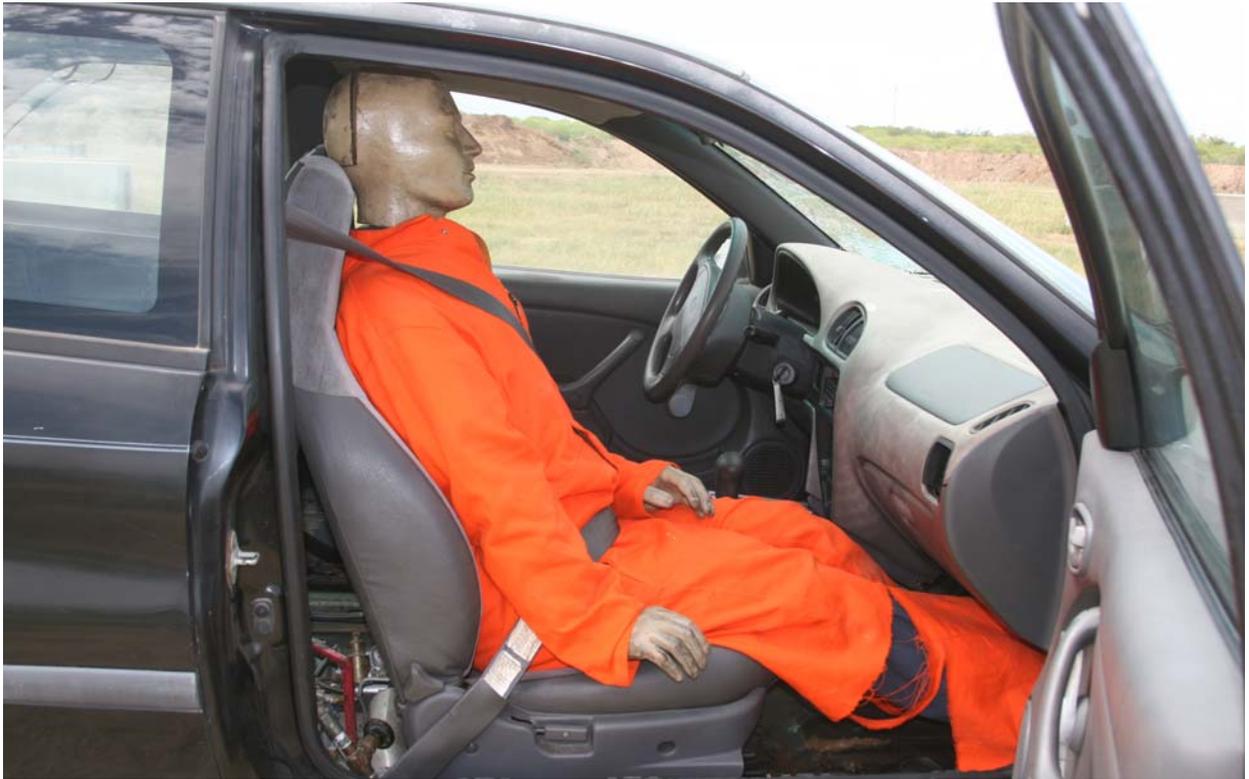
Figure 17. Interior of Vehicle for Test No. 452109-10.

Damage to the vehicle is shown in Figure 16. The front bumper was scuffed and the hood was deformed over an area measuring 23.6 inches × 1.2 inches and 0.6 inches deep. The windshield was shattered over an area measuring 26.8 inches × 9.8 inches with a maximum depth of 1.1 inches. Visibility was not obscured by the damage to the windshield. Maximum exterior crush to the vehicle was 1.1 inches in the lower left quarter of the windshield. Other than the windshield deformation, no other occupant compartment deformation occurred. Photographs of the interior of the vehicle are shown in Figure 17. Exterior crush and occupant compartment measurements are presented in Appendix B, Tables 5 and 6.

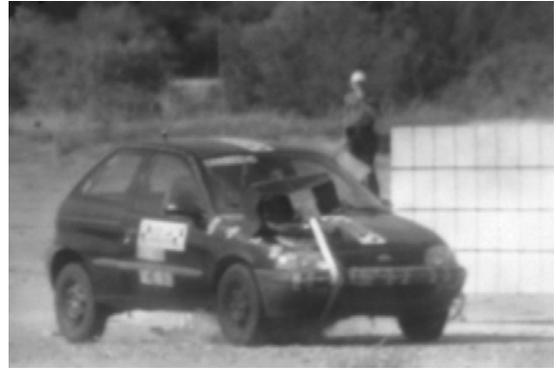
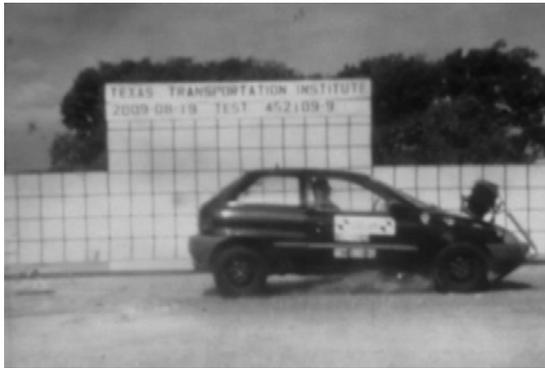
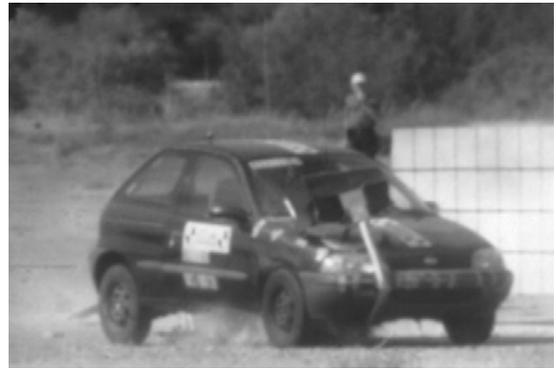
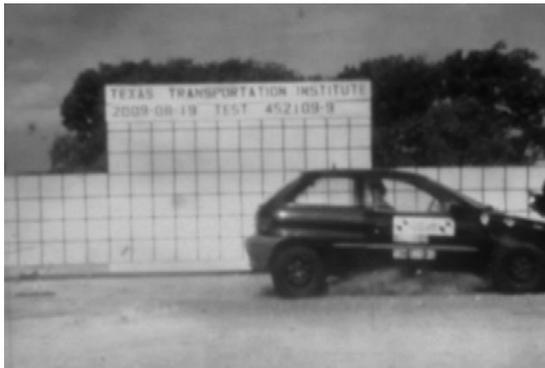
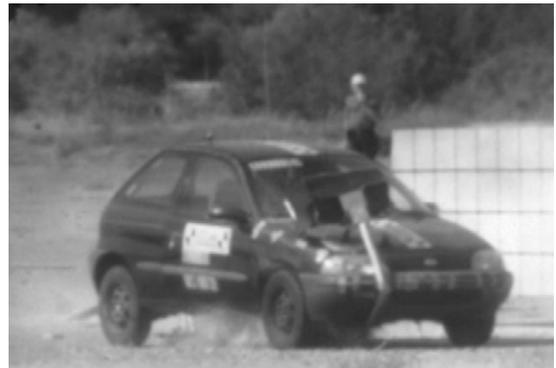
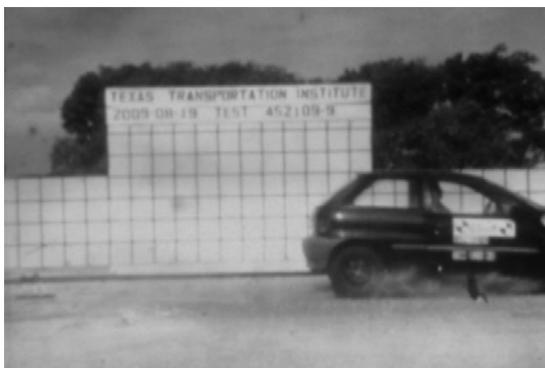
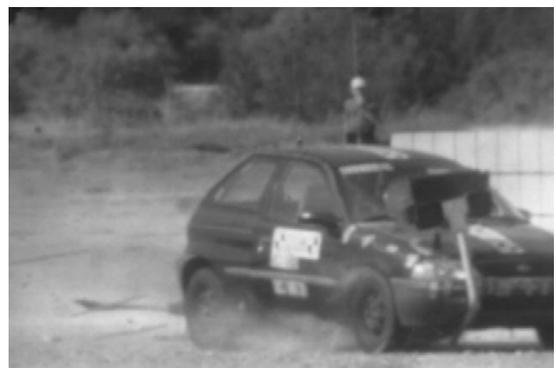
Figure 20. Sequential Photographs for Test No. 452109-9 (Perpendicular and Frontal Oblique) (Continued).

The 820C vehicle, traveling at an impact speed of 60.6 mi/h, impacted the S-Square® dual mailbox system end on (i.e., 0 degrees) with the centerline of the mailbox support aligned with the right quarter-point of the vehicle and at 0 degrees. Upon contact, the support began to deform around the bumper, and at 0.014 s, the support began to pull out of the anchor sleeve. The nearest mailbox contacted the hood of the vehicle at 0.031 s, and the support began to rise above the hood at 0.067 s. At 0.168 s, the vehicle lost contact with the mailbox and support at an exit speed of 59.6 mi/h. As the vehicle exited the test site, the mailboxes were carried along in front of the vehicle. Brakes on the vehicle were applied 0.8 s after impact, and the vehicle subsequently came to rest 236 ft downstream of impact. Figure 20 in Appendix C shows sequential photographs of the test period.

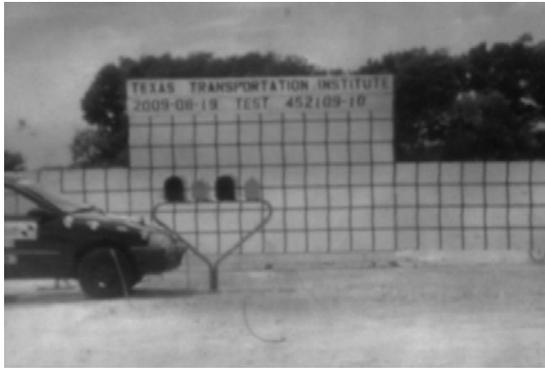
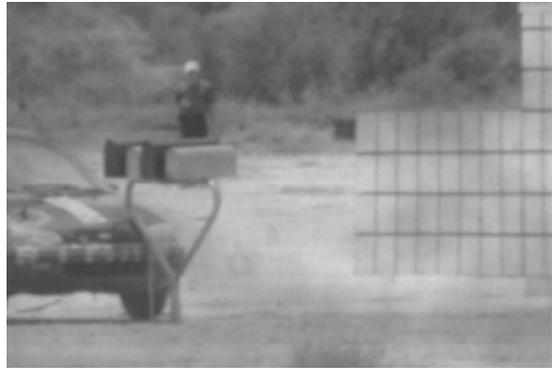
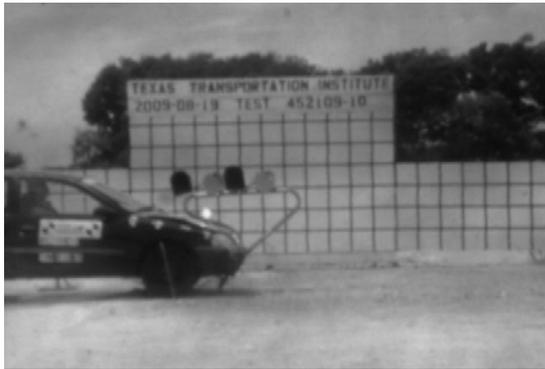
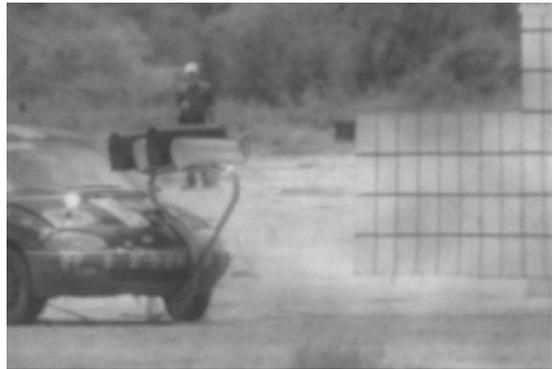
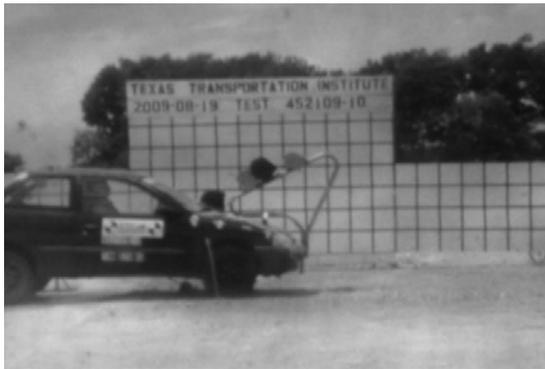
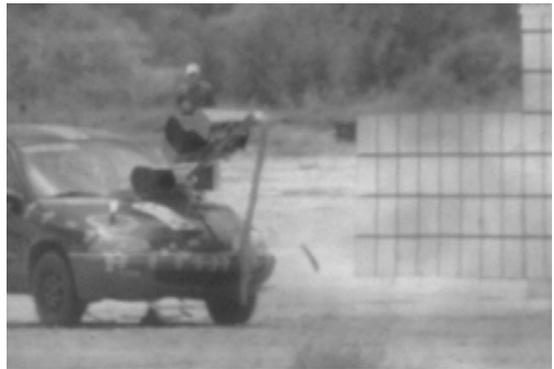
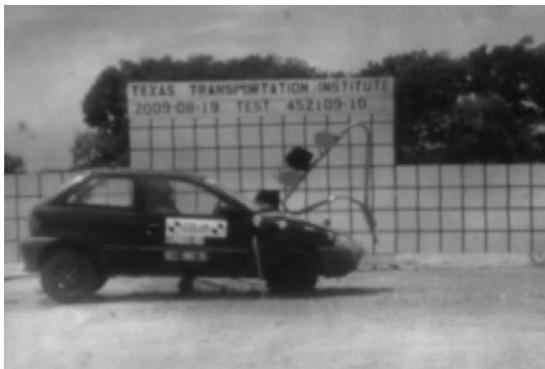
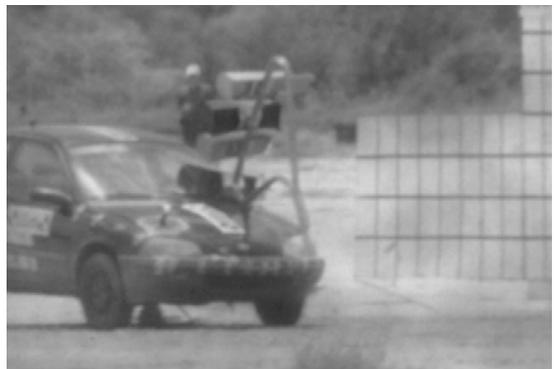
Figure 21. Sequential Photographs for Test No. 452109-10 (Perpendicular and Frontal Oblique Views).

The 820C vehicle, traveling at an impact speed of 61.9 mi/h, impacted the S-Square® multiple mailbox system end on (0 degrees) with the centerline of the mailbox support aligned with the right quarter-point of the vehicle. The vehicle contacted the support at 18.5 inches above the ground. Upon impact, the support began to deform around the bumper, and at 0.010 s, the support began to pull out of the anchor sleeve. The mailbox nearest the vehicle began to separate from the upper portion of the support at 0.017 s, but it did not become completely separated from the support. The support pulled completely out of the ground socket at 0.024 s and began rotating upward. The partially loose mailbox contacted the hood of the vehicle near the windshield at 0.046 s. At 0.138 s, the vehicle lost contact with the mailbox and had an exit speed of 61.5 mi/h. As the vehicle exited the test site, the mailboxes and support carried over the top of the vehicle. Brakes on the vehicle were applied at 0.062 s, and the vehicle came to rest 234 ft downstream of impact. Figure 21 in Appendix C shows sequential photographs of the test period.

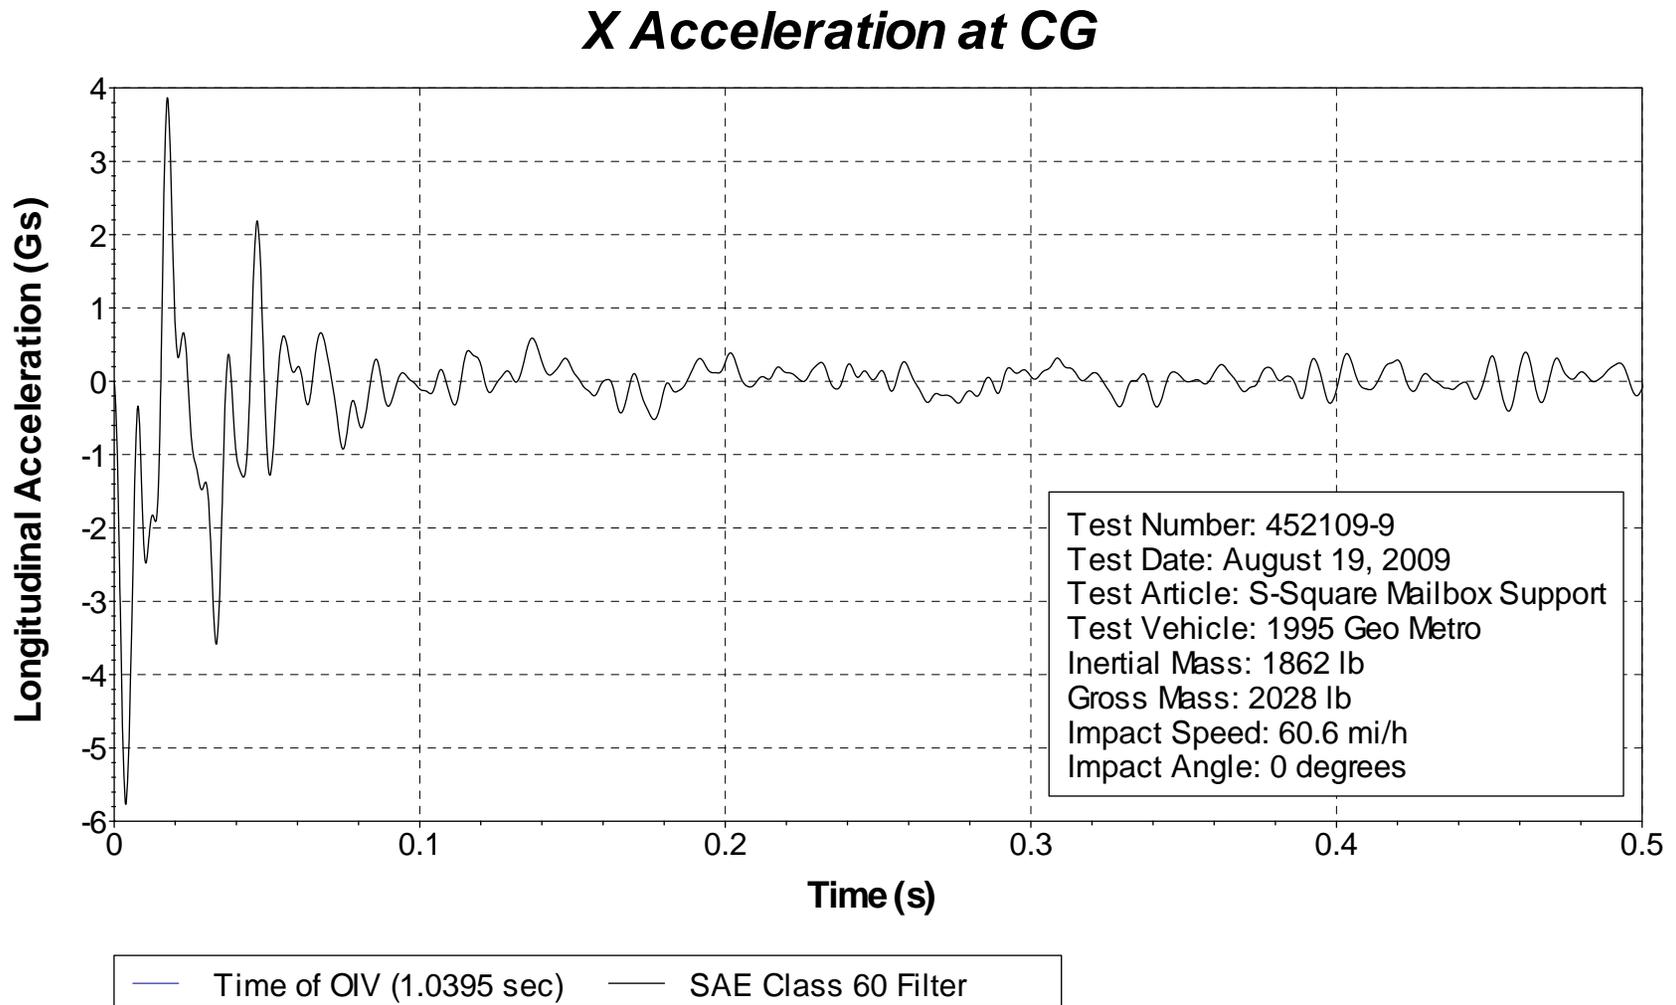
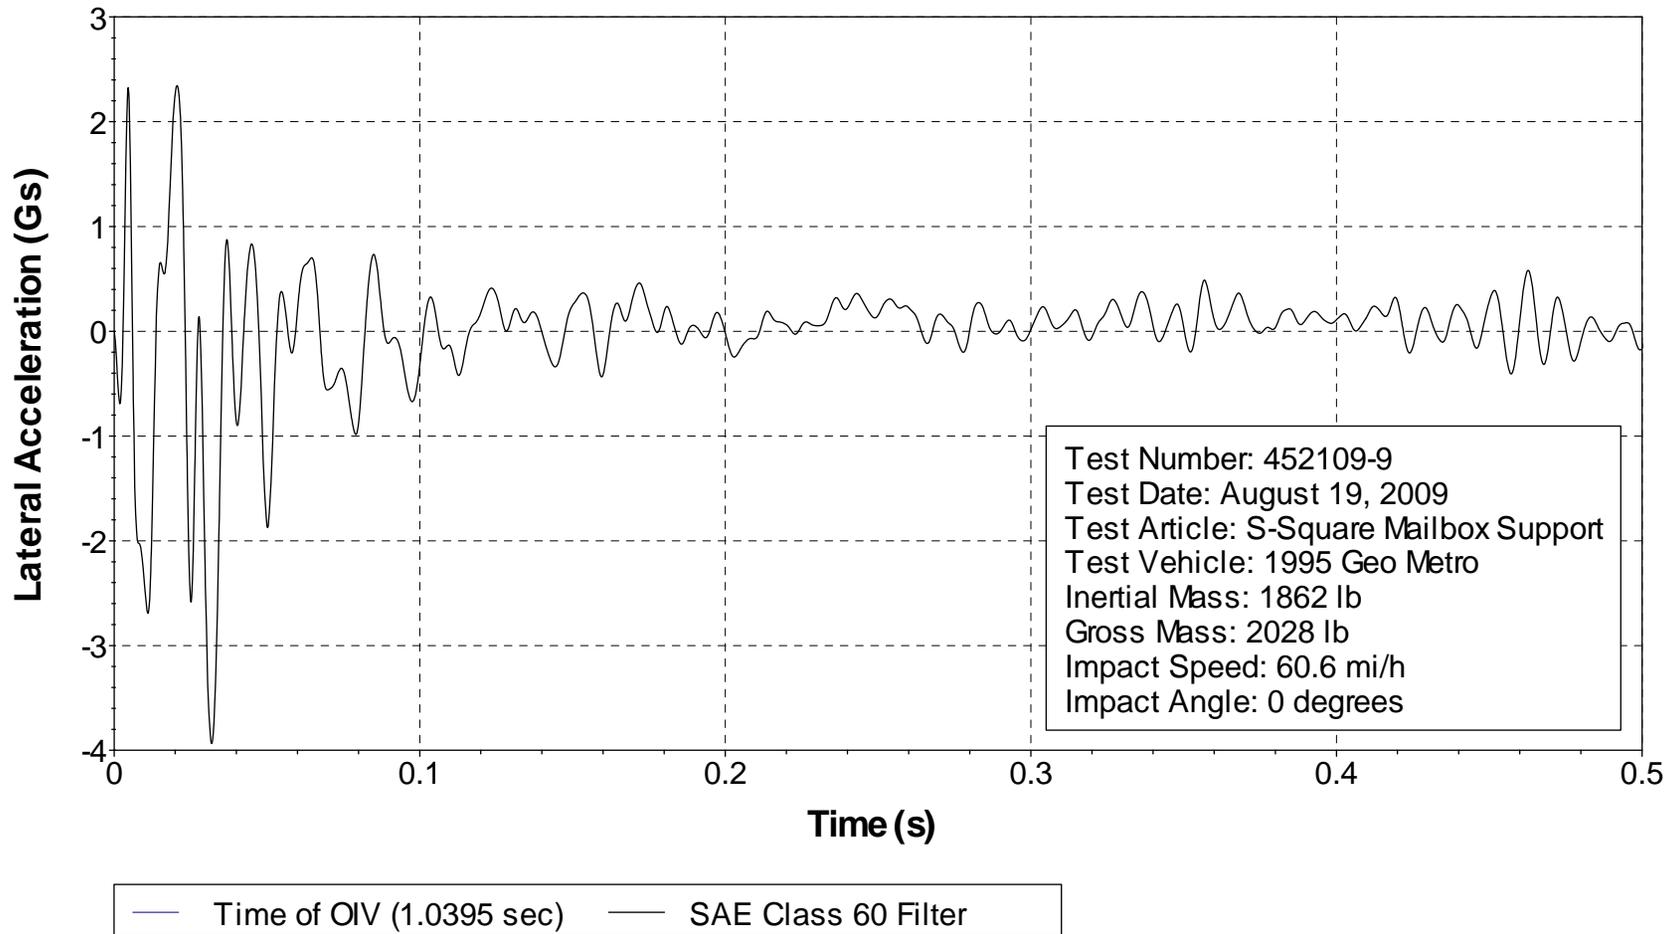
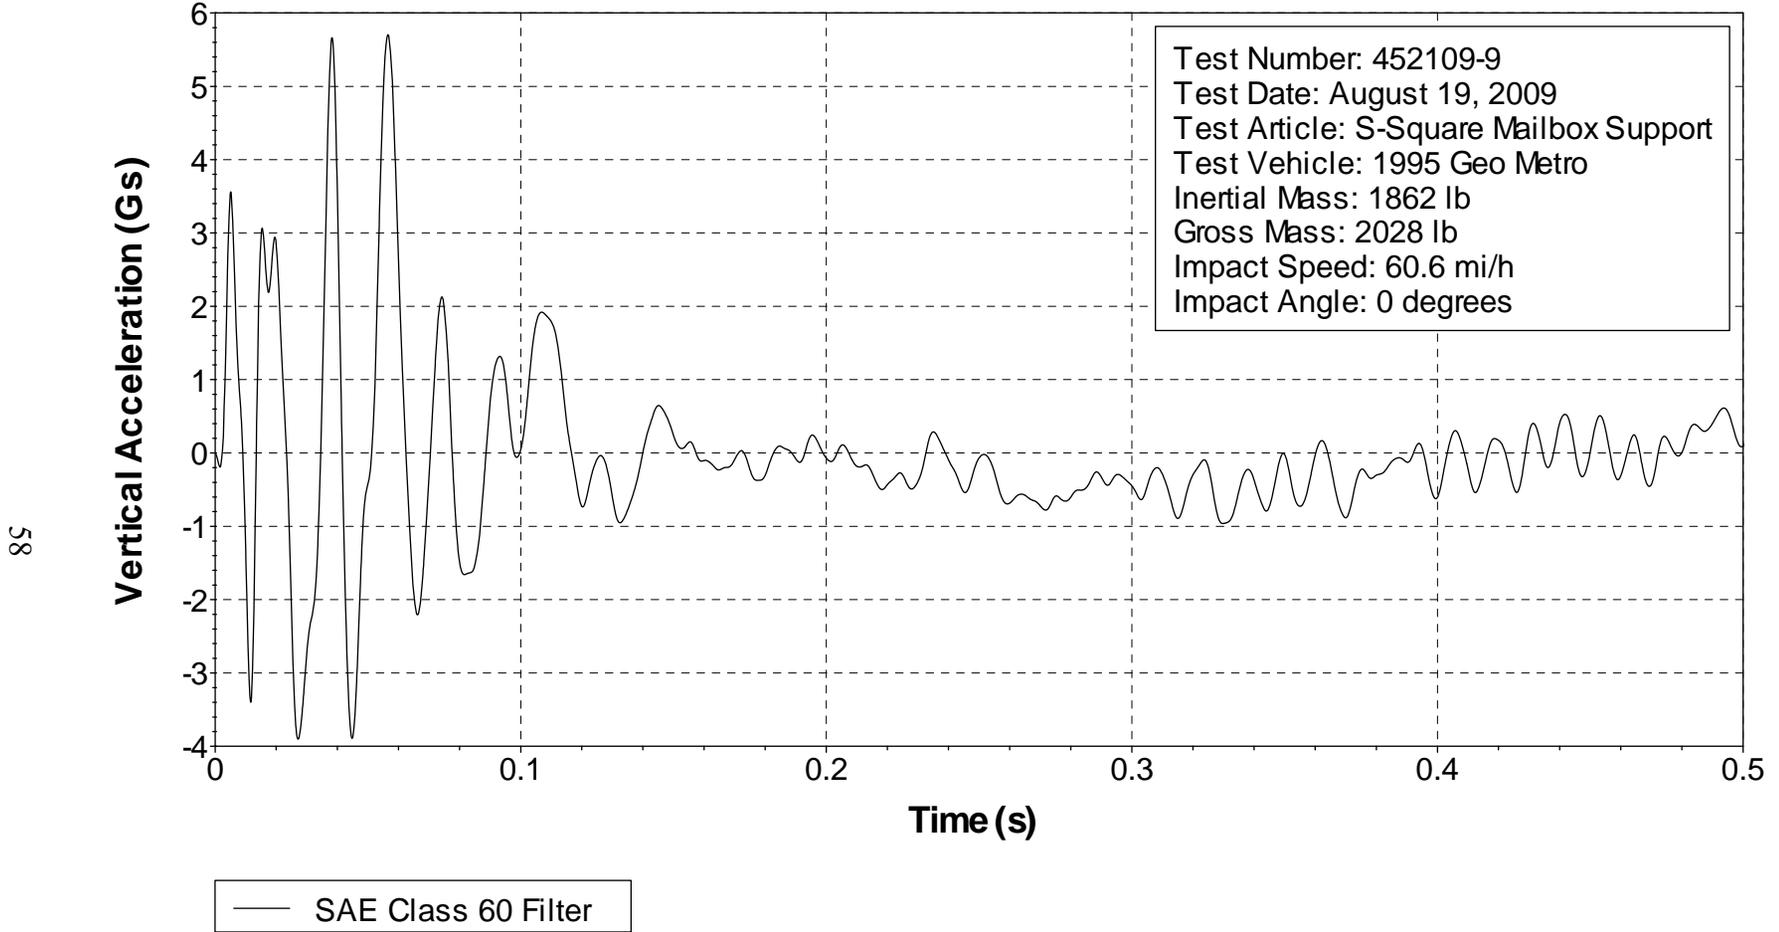
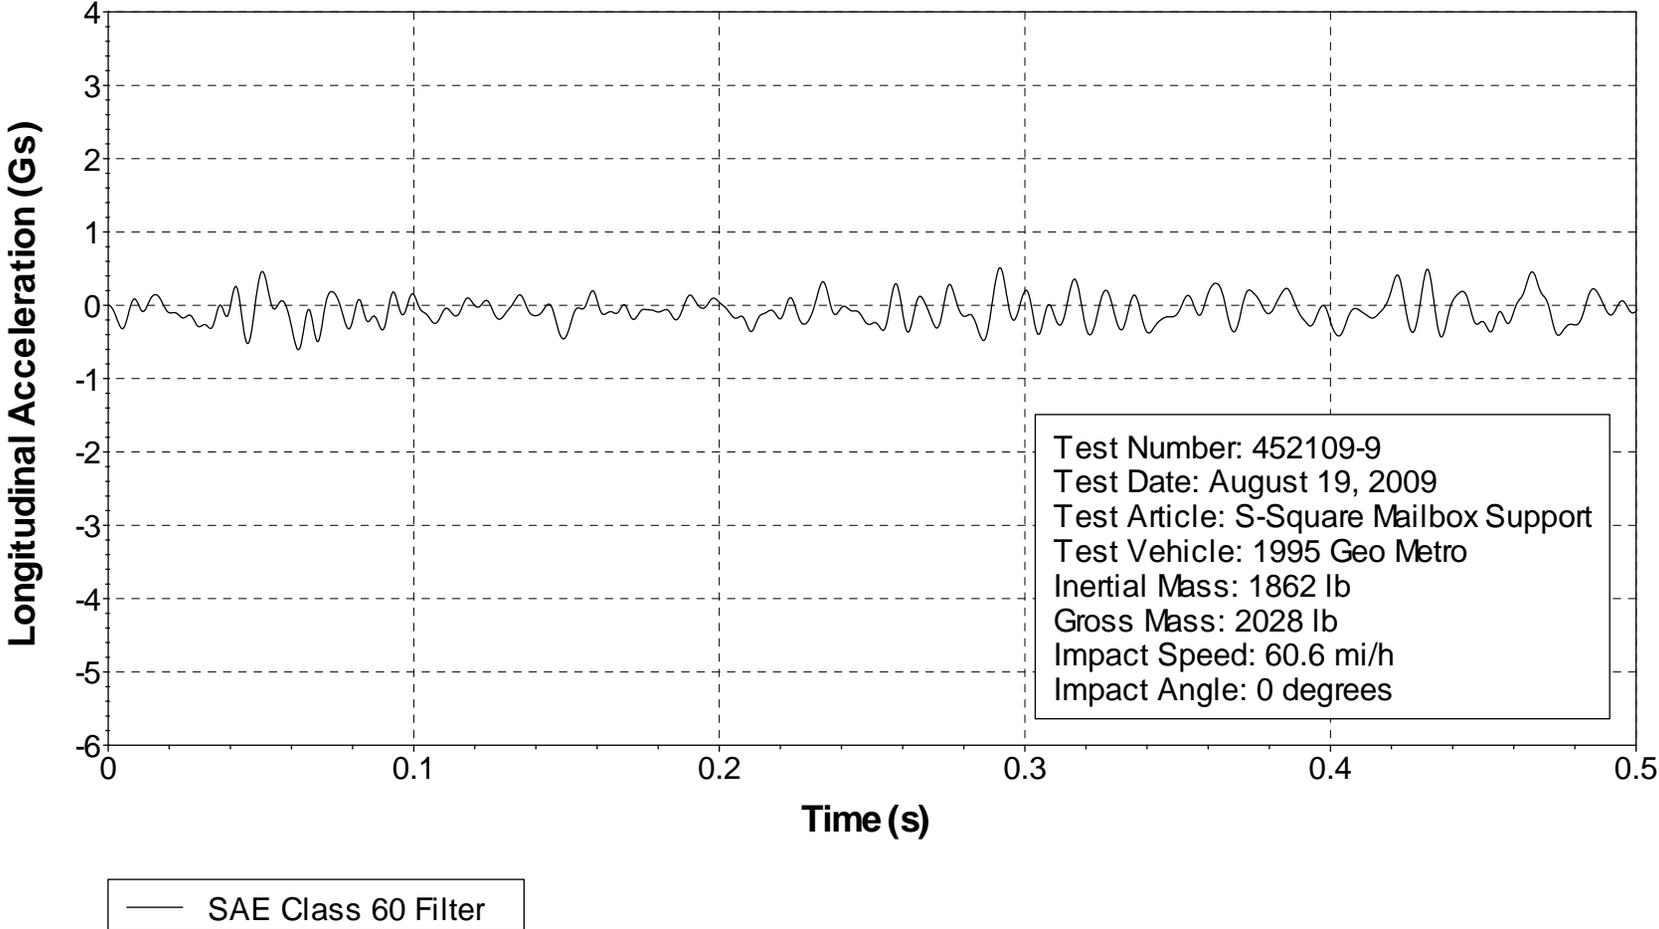
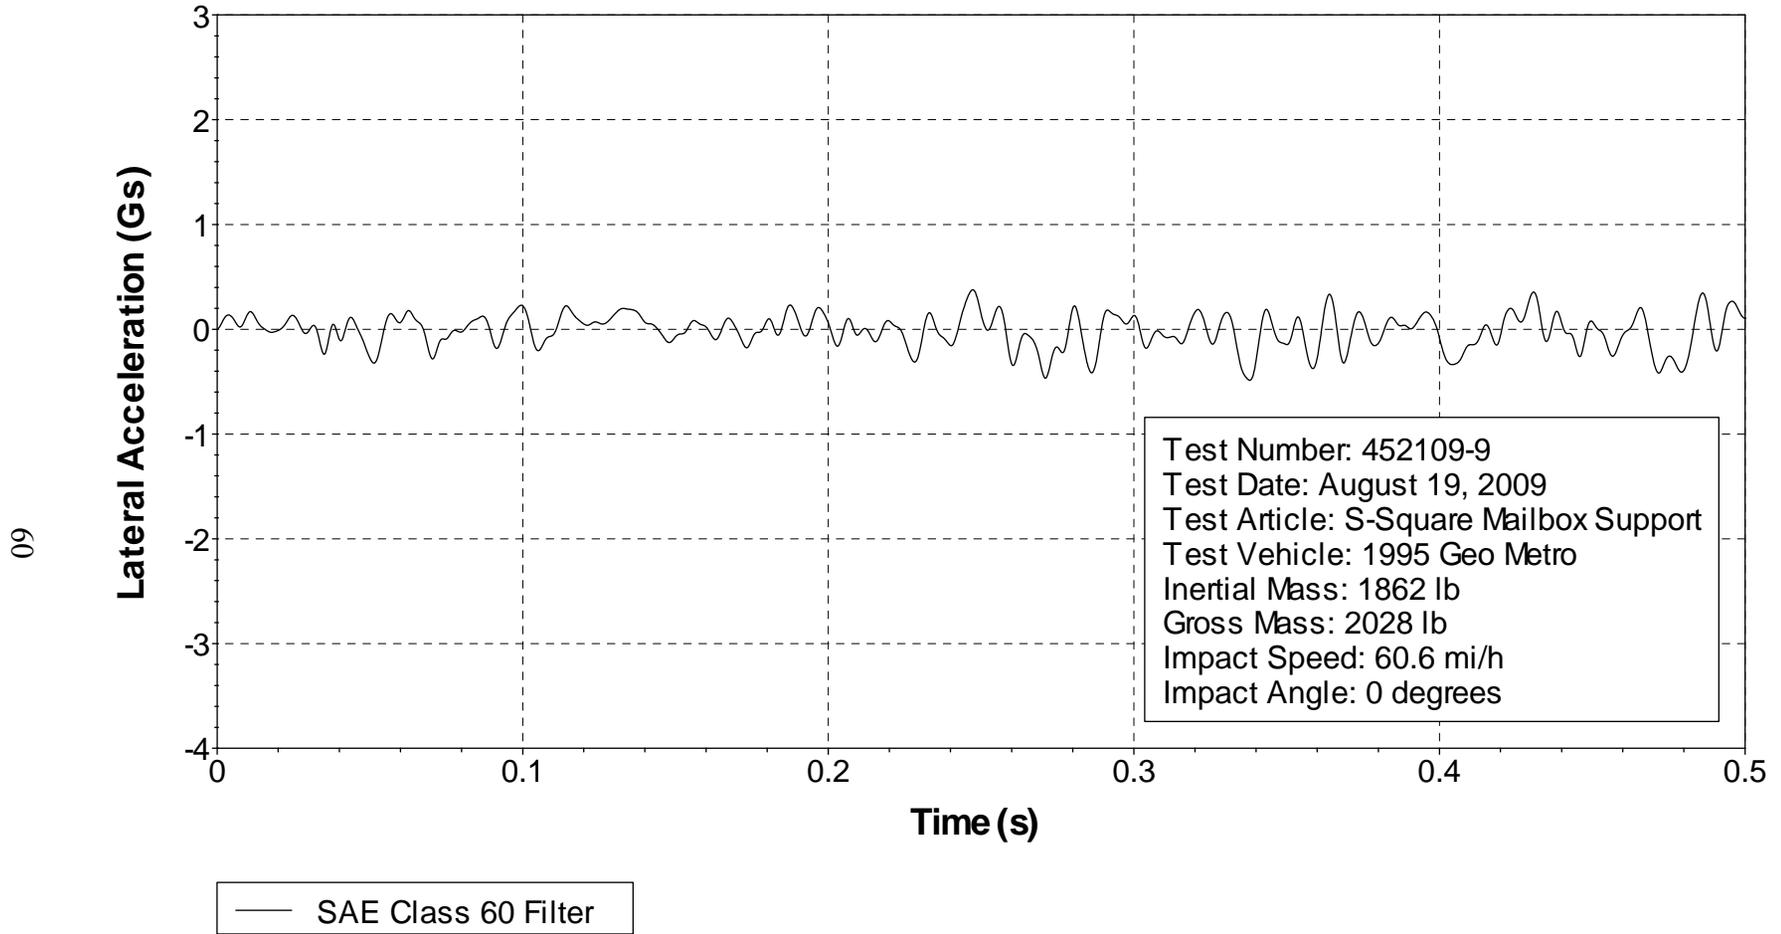
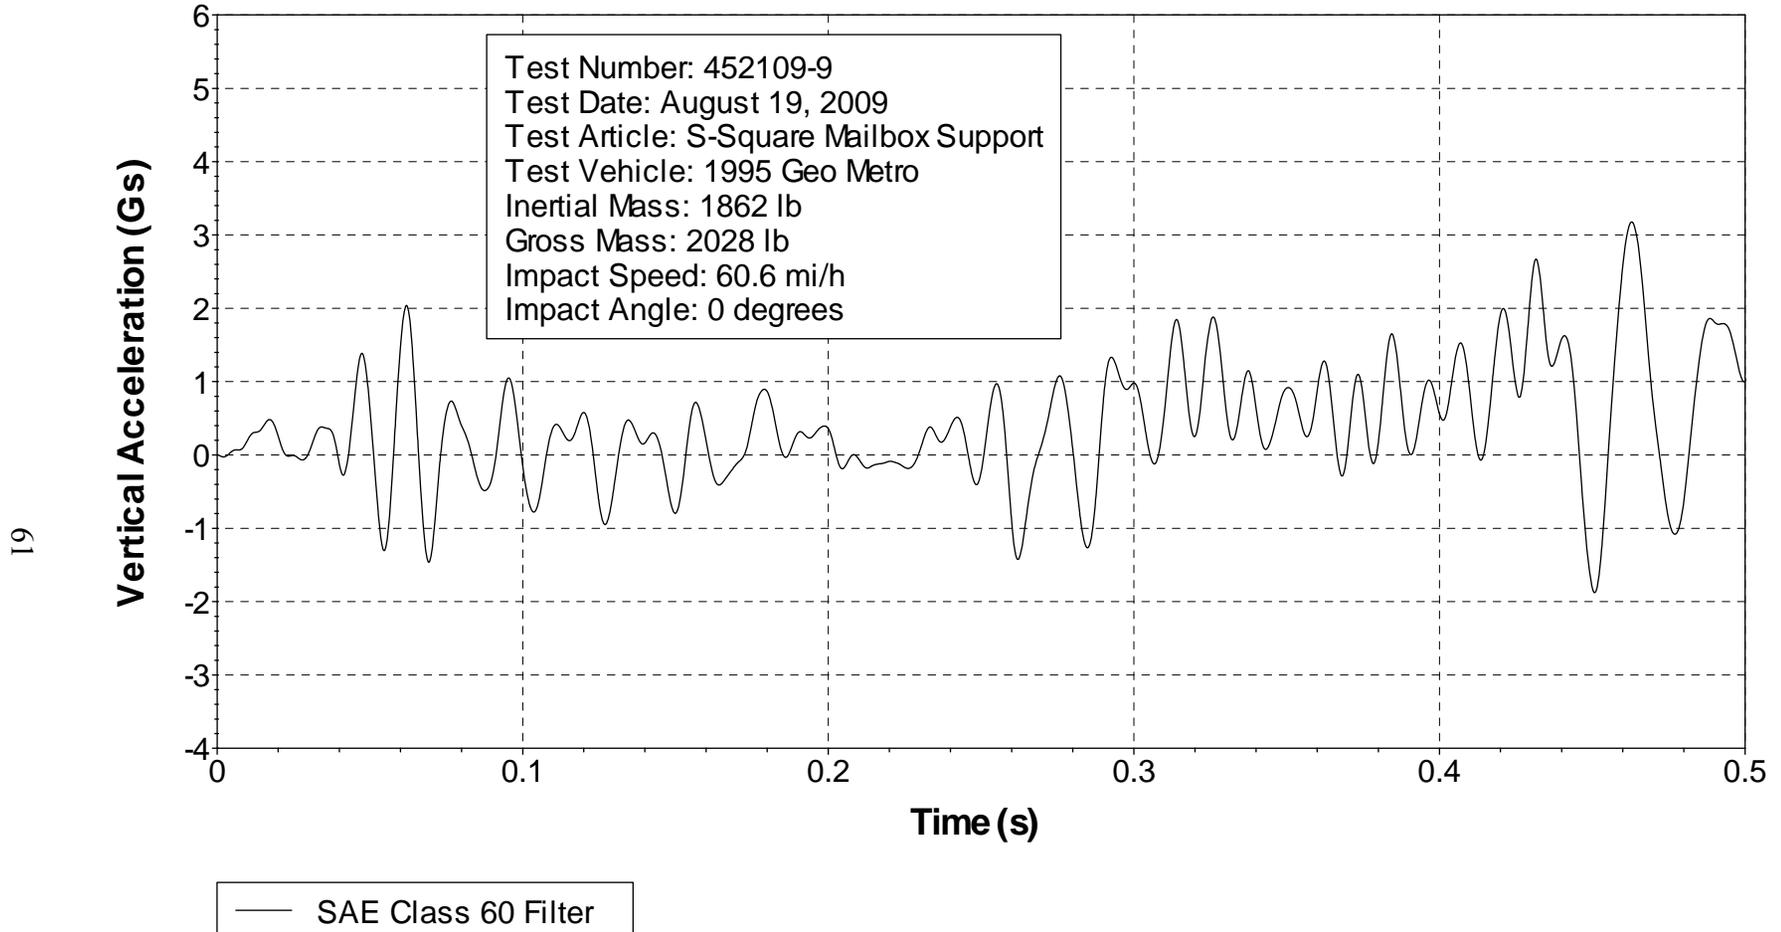
Data from the accelerometer, located at the vehicle center of gravity, were digitized for evaluation of occupant risk. In the longitudinal direction, no occupant contact occurred, and the maximum 0.050-s average acceleration was -1.0 G between 0.002 and 0.052 s. In the lateral direction, no occupant impact contact occurred, and the maximum 0.050-s average was -0.8 G between 0.006 and 0.056 s. Figure 11 presents these data and other pertinent information from the test. Figures 22 through 28 in Appendix D present the vehicle angular displacements and accelerations versus time traces.
