NCHRP Report 350 Crash Testing and Evaluation of the S-Square® Mailbox System

Research/Test Report 0-5210-7

1. Report No. FHWA/TX-10/0-5210-7	2. Government Accession No.	3. Recipient's Catalog No.	
4. Title and Subtitle NCHRP REPORT 350 CRASH TESTING AND EVALUATION OF THE S-SQUARE® MAILBOX SYSTEM		5. Report Date November 2009 Published: January 2010

Project Title: Roadside Crash Testing Program for Design Guidance
and Standard Detail Development

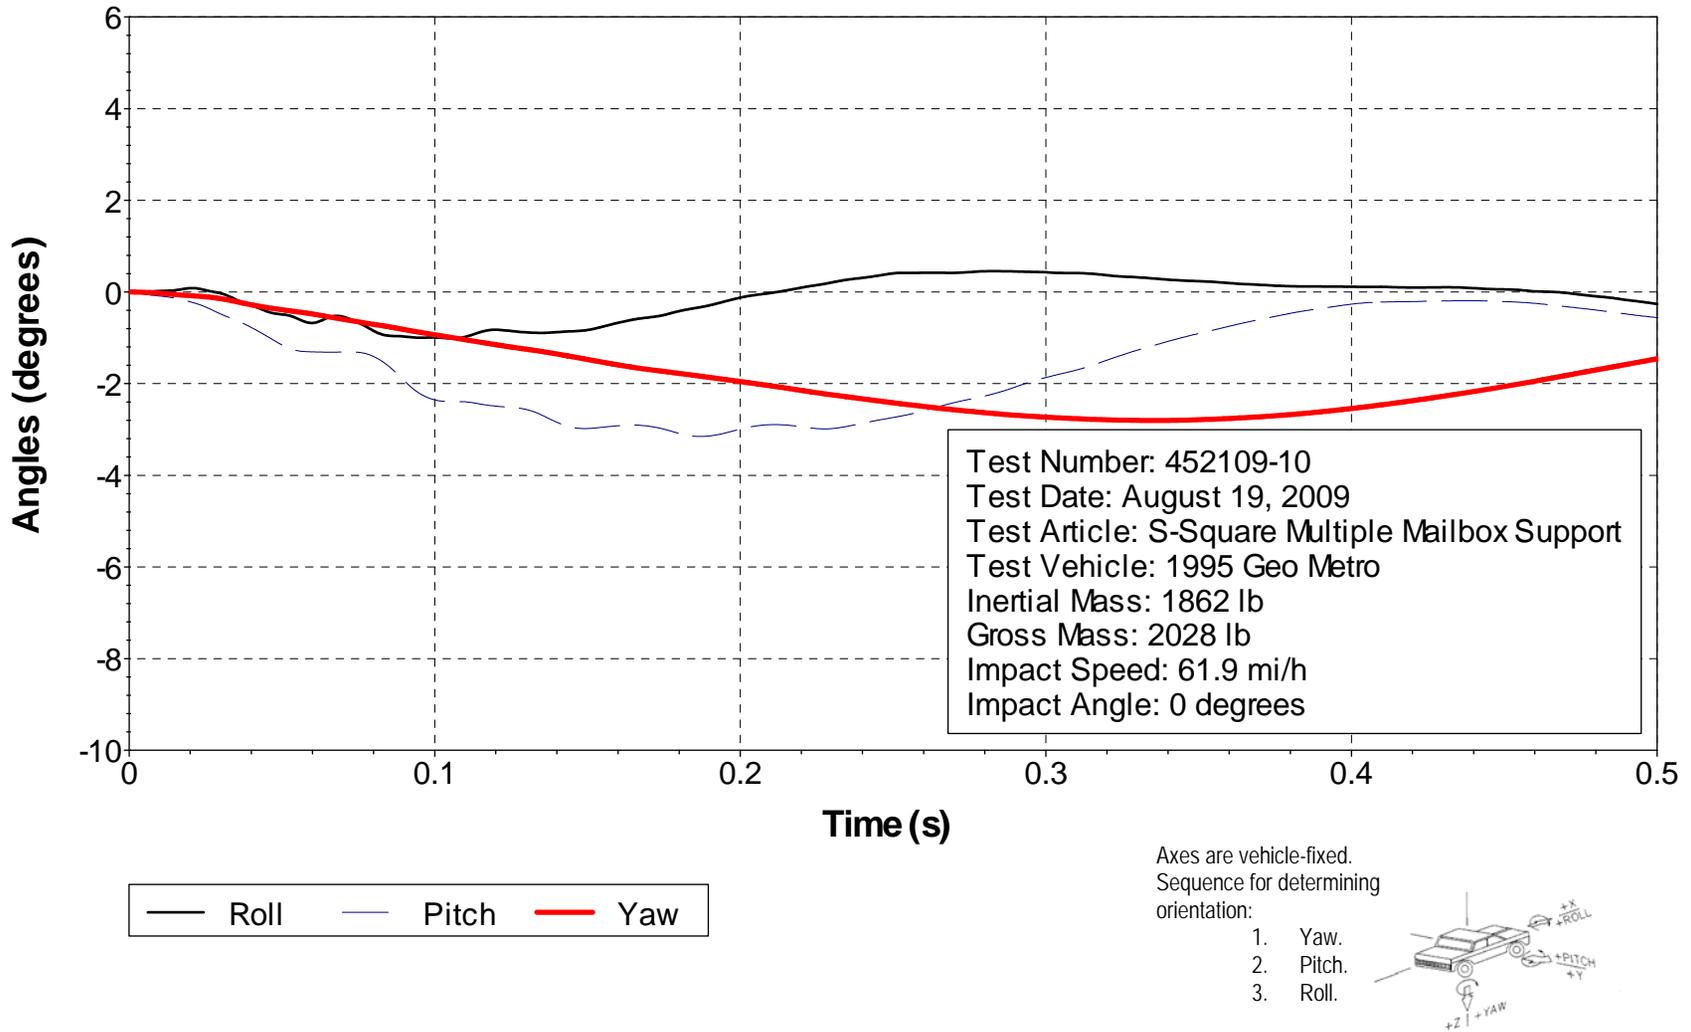
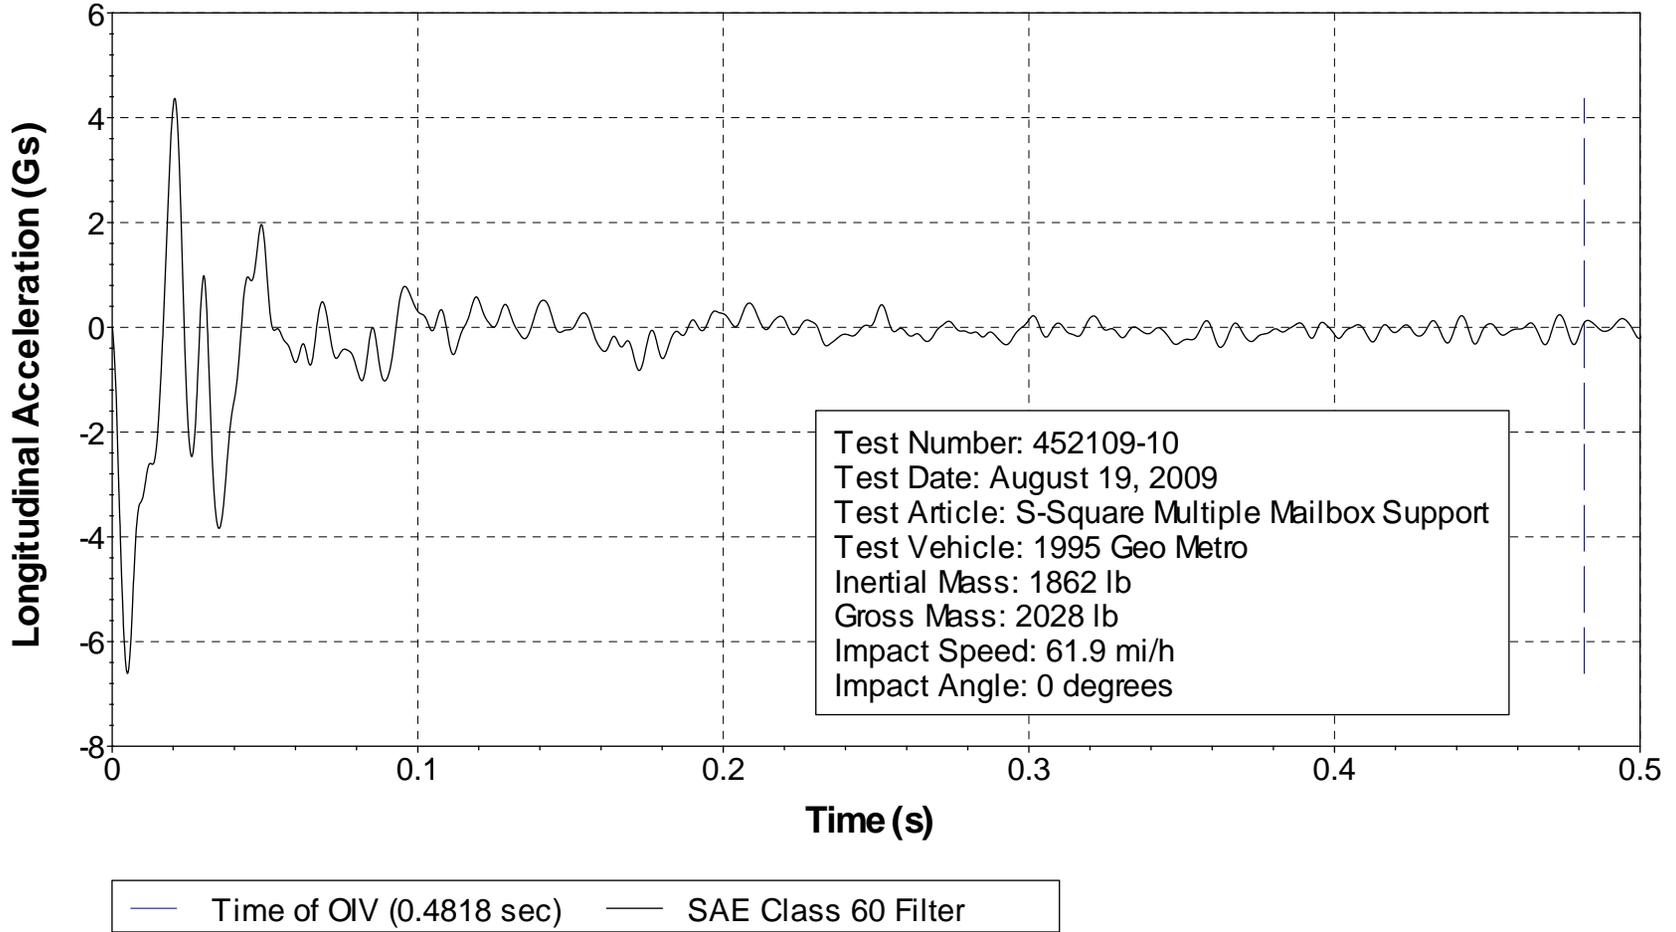
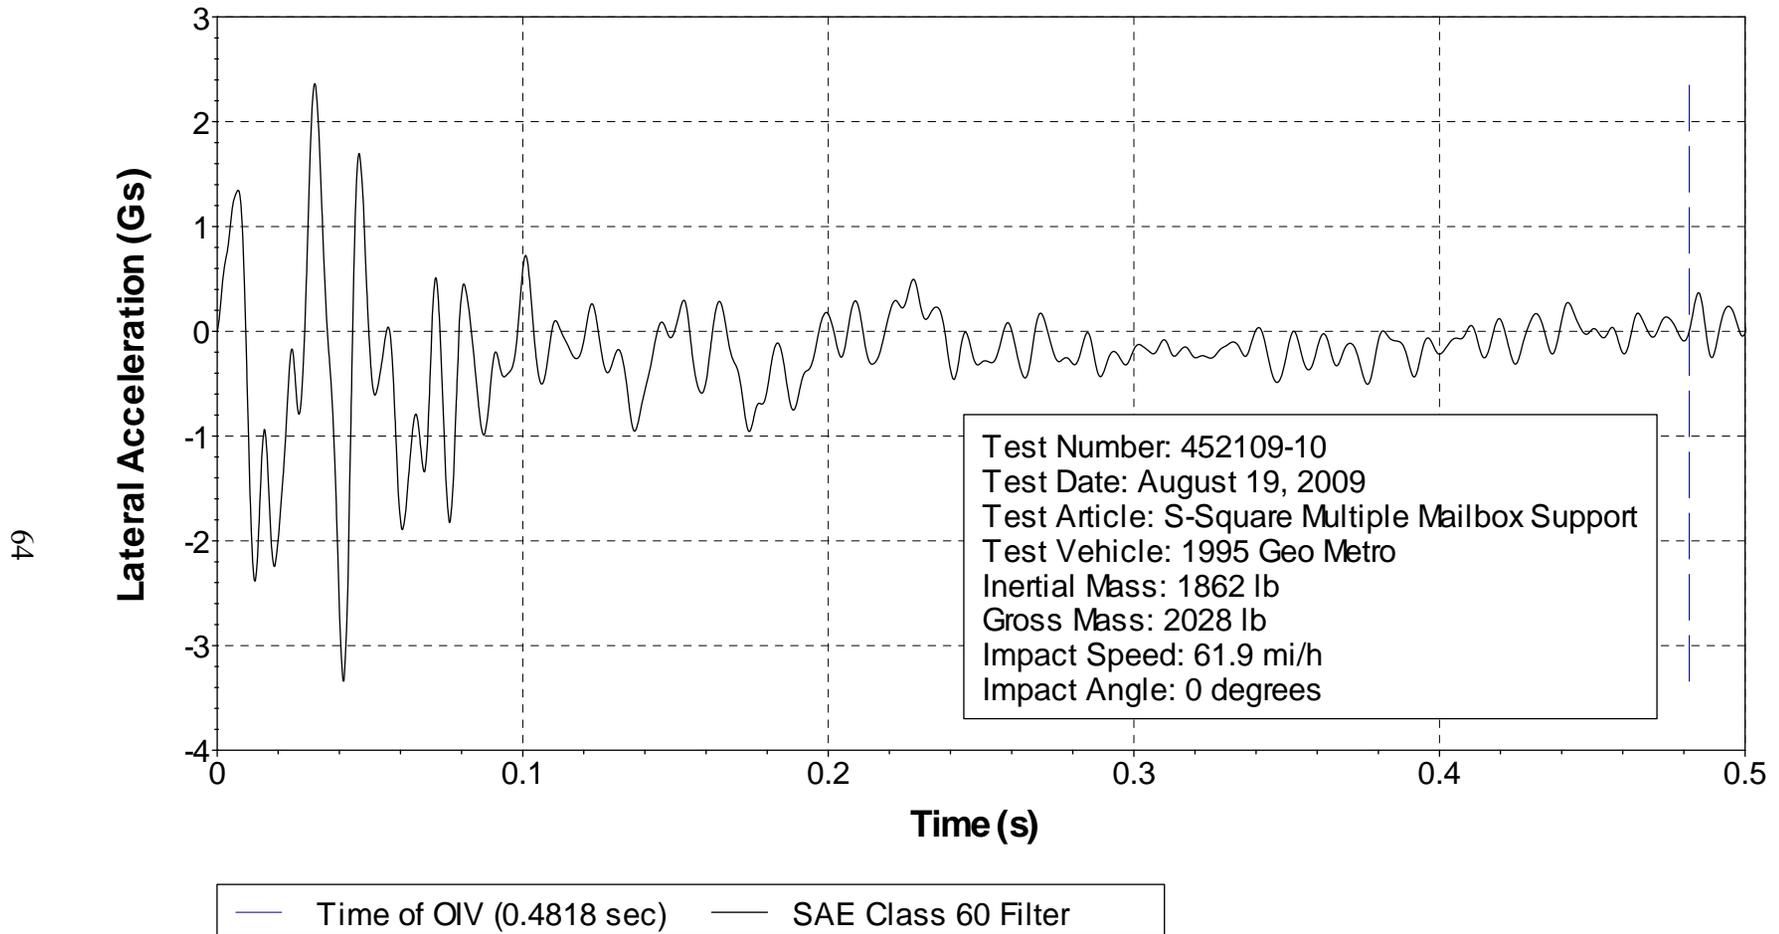
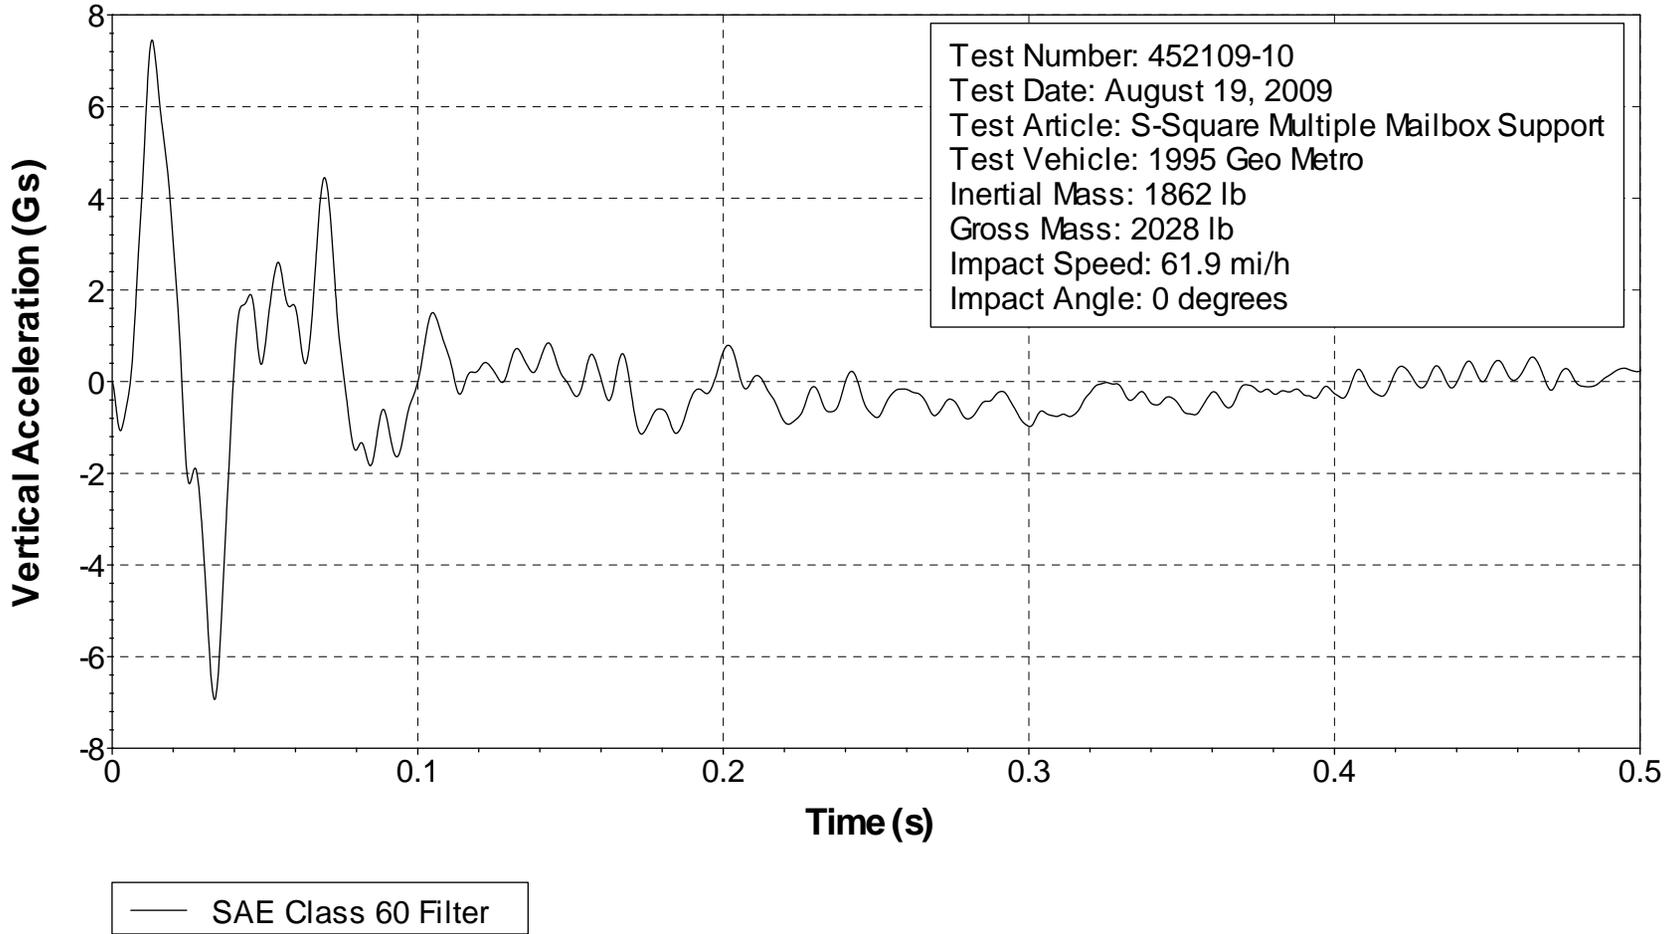
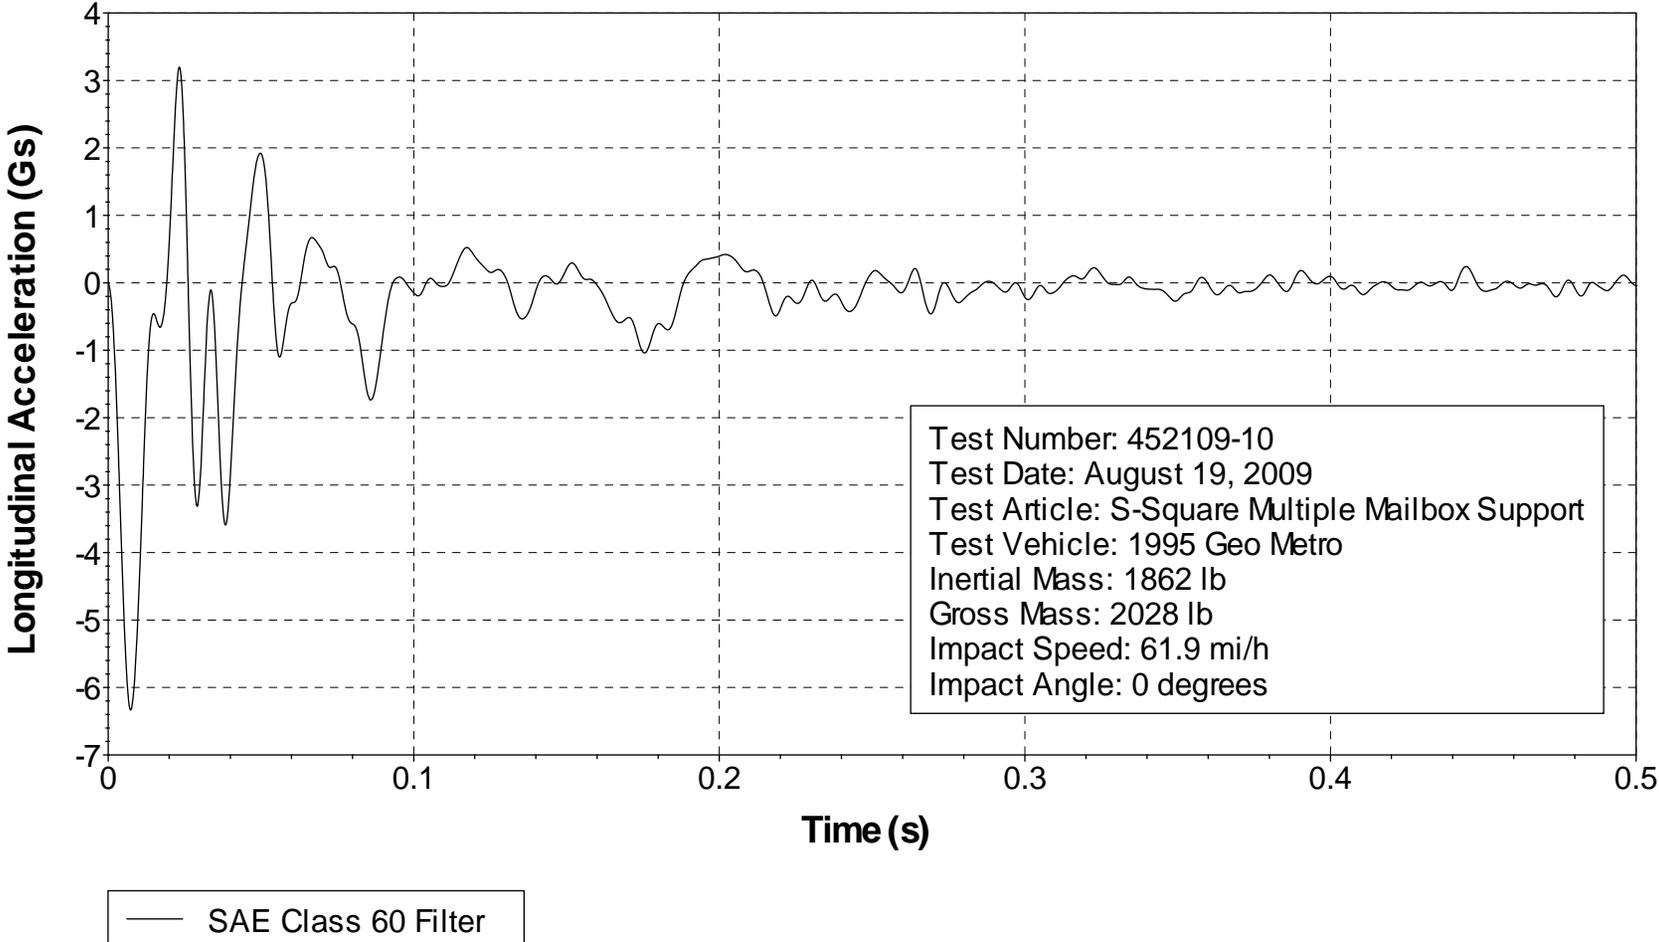
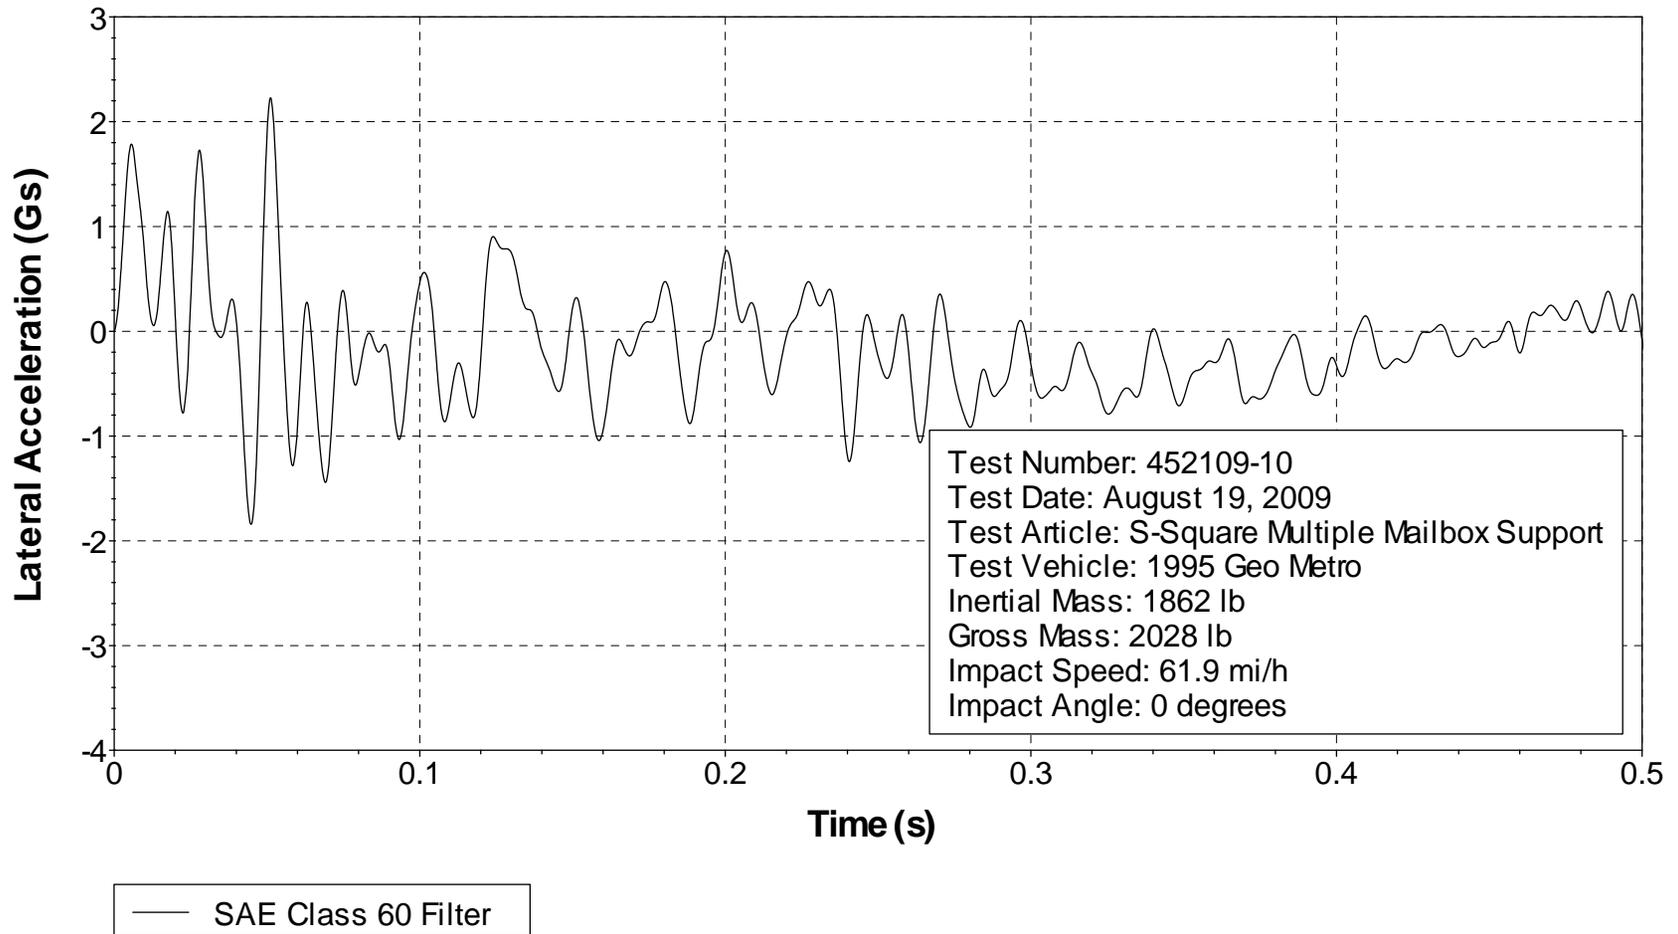
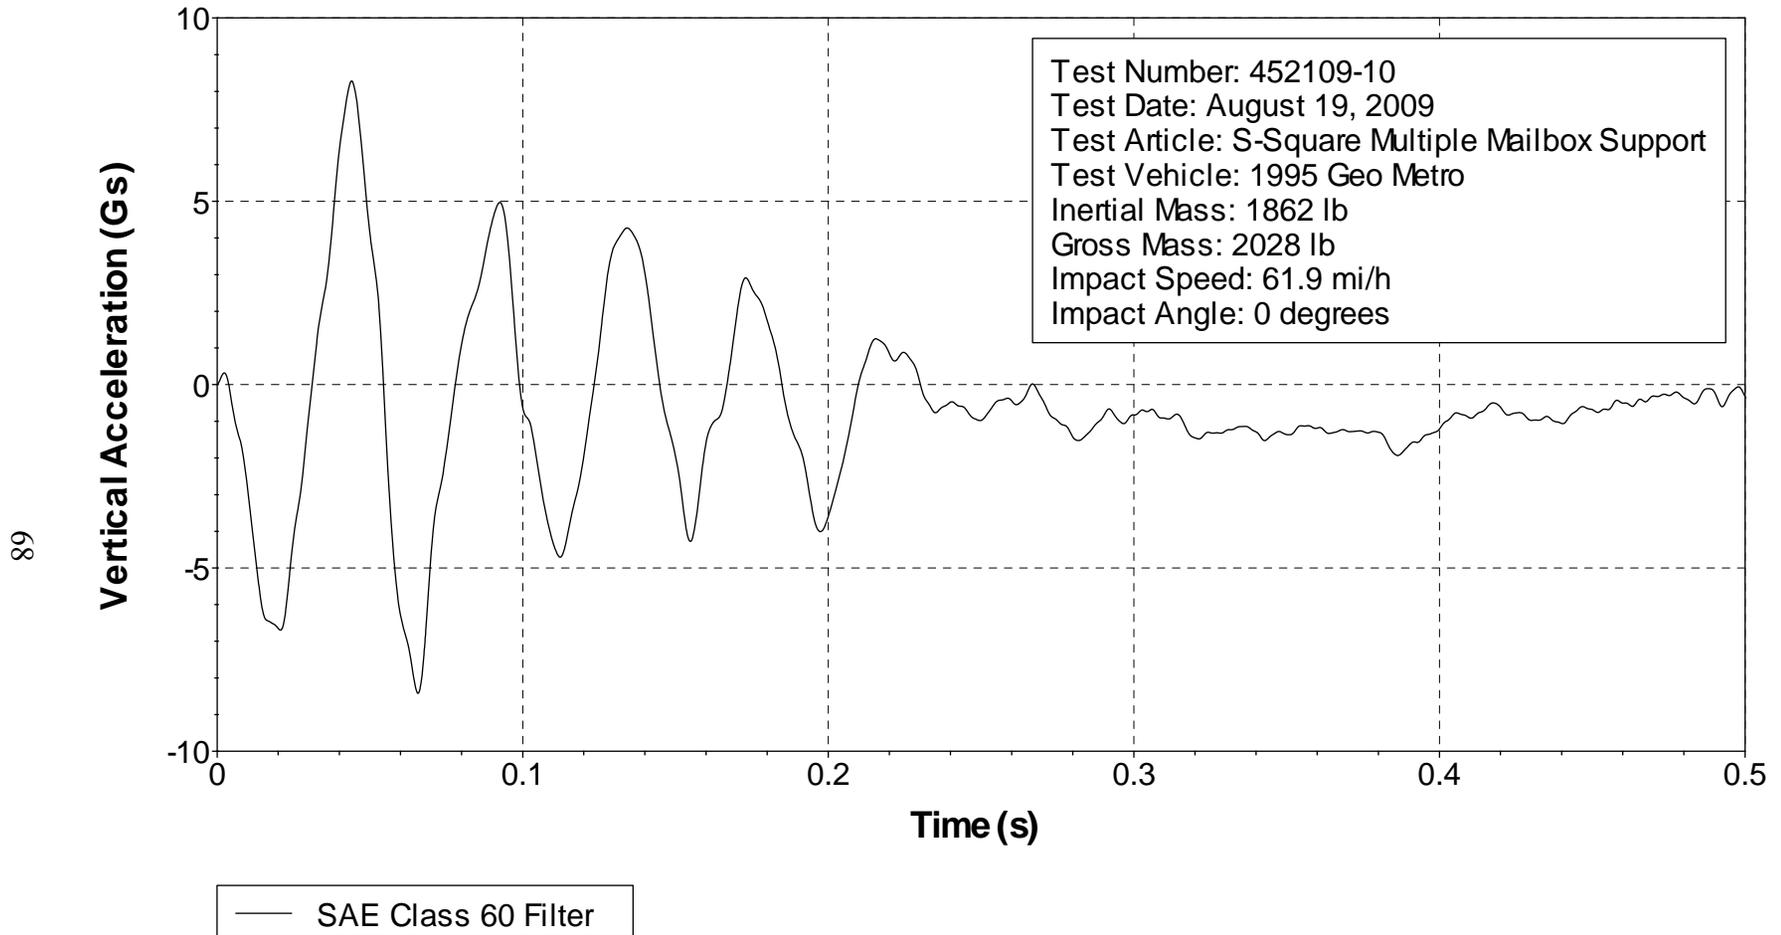
Data from the accelerometer, located at the vehicle center of gravity, were digitized for evaluation of occupant risk. In the longitudinal direction, the occupant impact velocity was 3.0 ft/s at 0.482 s; the highest 0.010-s occupant ridedown acceleration was -1.4 G from 0.869 to 0.879 s, and the maximum 0.050-s average acceleration was -1.2 G between 0.000 and 0.050 s. In the lateral direction, the occupant impact velocity was 3.3 ft/s at 0.482 s; the highest 0.010-s occupant ridedown acceleration was 0.4 G from 1.654 to 1.664 s, and the maximum 0.050-s average was -0.7 G between 0.039 and 0.089 s. Figure 18 presents these data and other pertinent information from the test. Figures 29 through 35 in Appendix D present the vehicle angular displacements and accelerations versus time traces.
