FINAL REPORT  
FATIGUE STUDY OF A GRP PEDESTRIAN BRIDGE

Fred C. McCormick  
Faculty Research Scientist

December 1986  
VHTRC 87-R7

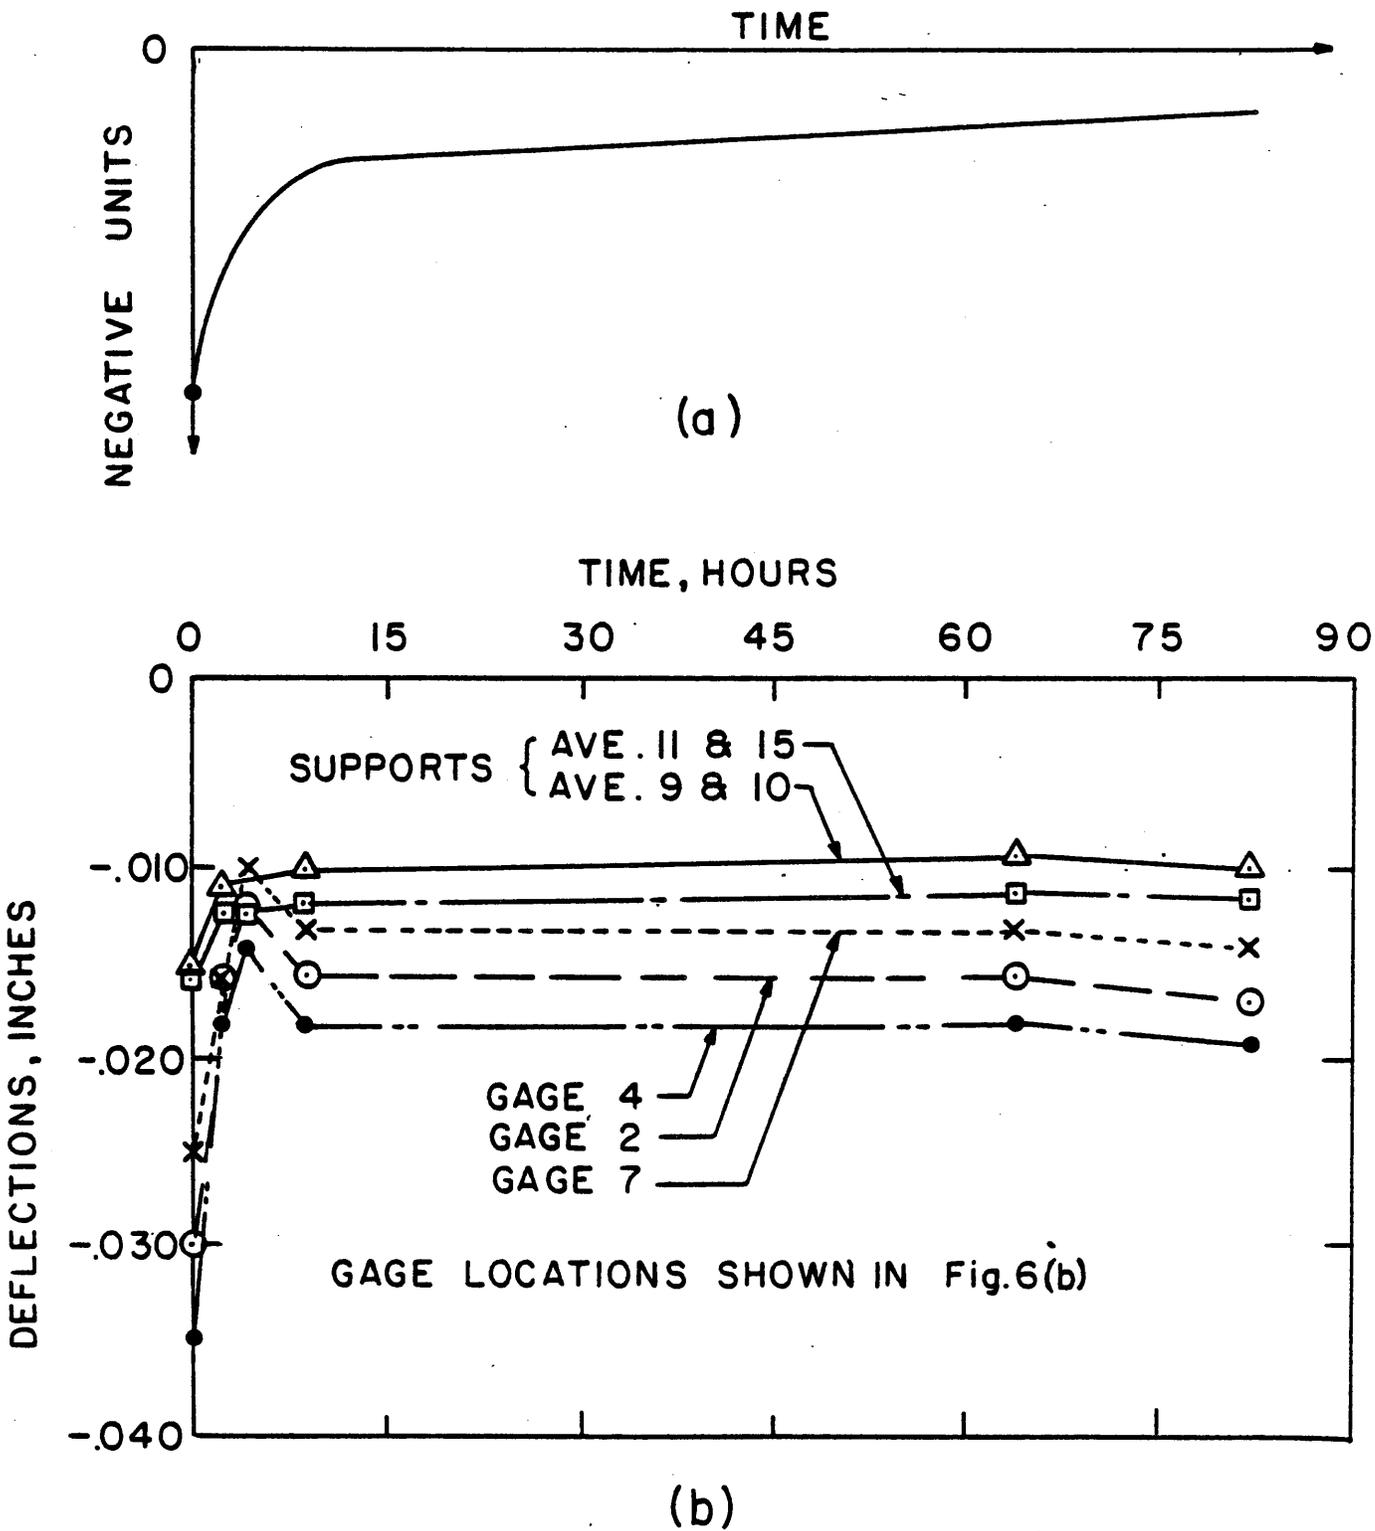
Figure 10. Deflection relaxation curves for (a) typical polymeric composite and (b) supports and interior panels of the middle girder of the bridge.

Ordinarily, one would expect a relaxation curve for a glass-reinforced polymeric composite to follow a form similar to the one shown in Figure 10(a). Following the 150,000 cyclic static load test of series 1, relaxation deflections and strains were recorded for a period of 81 hours. The deflection data from this investigation are shown in Figure 10(b) for the middle girder. Data from the two outside girders were quite similar. It is observed that the general shape of the relaxation curves for the supports (indicated by gages 9-10 and 11-15) corresponds to that of the typical polymeric composite. It is believed that the shape of the support curves was generated principally by the action of the elastomeric bearing pads and overall recovery of the bridge. However, the shapes of the curves defined by gages 2, 4 and 7 contain an irregular "hump" which may be attributed to viscoelastic buckling of the deck assembly during the period of sustained load. When loaded, the buckled shape of the deck (upward displacements between the load points) was so minor that it was undetectable by eye or by the instruments when compared with the relatively large downward displacements of the deck. With the removal of the live load, the elastic upward rebound of the bridge resulted in a residual deflection (0.35 in at gage 4) which diminished further with time. Simultaneous with the continuing viscoelastic recovery of the bridge as a whole, the deck began to recover viscoelastically from its upward buckled shape to its normally straight shape, which produced a net downward movement of the

center portion of the structure. After approximately 4 hours, the rate of the downward movement of the deck exceeded the rate of the upward movement of the overall bridge and formed the "hump" in the deflection curves shown. Several bonded strain gages monitored with a continuously plotted record over the relaxation period disclosed similar "humps" in the recovery data.

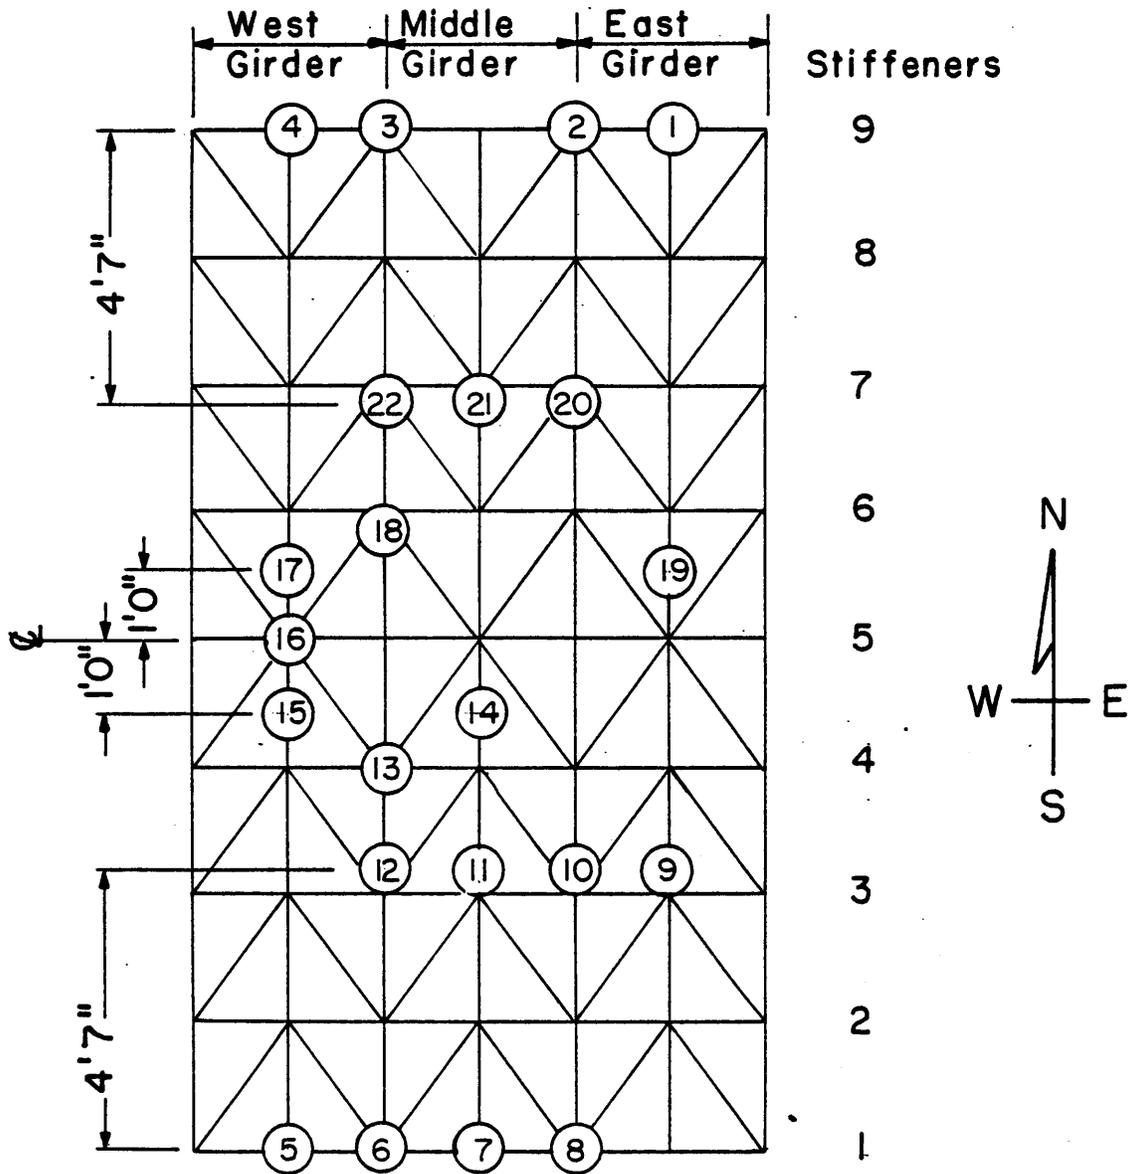
Figure 14. Location of cores drilled through the polymer concrete wearing course for tensile bond test.

Several times during the fatigue test program wearing course was inspected visually for surface cracks, but none were found. An effort was made to determine the integrity of the bond at the interface by tapping the surface with a light hammer and listening for a difference in sound from point to point. Again, no evidence of delamination was apparent. A third determination of the interfacial bond was made by means of ACI test procedure 503R, wherein 2 in diameter cores were drilled through the wearing course and subjected to an ultimate tensile test. Figure 14 shows the location of the cores on a plan view of the

While the strength of the material over the joints apparently was lower than that of the other material, the modes of failures of the various cores do not provide conclusive evidence of preferential degradation of strength at the joint locations. For example, both cores 5 and 8 experienced failure predominantly at the interface and core 3 had a smaller interfacial failure area than core 1. While most of the failures at the interface of the polymer concrete and the GRP cover plate revealed few air voids, the surface at core 6 had a large area over which no resin was applied. Several of the fracture surfaces also included small patches of the GRP plate which had failed just beneath the fill coat of the composite. Thus, it is not known whether the variation in the core strength was due to prior damage to the structure or represents a normal distribution of strengths in the materials for this type of installation.

The locations of cores 9 through 22 were distributed over the loaded area of the deck to determine if the action of the repeated loads had degraded the bond of the polymer concrete to the GRP cover plate. As in the data from cores 1 through 8, there was considerable variation in the tensile strengths of the cores. Several failures occurred between the epoxy adhesive and the surface of the steel cap. In addition, the strength of two cores exceeded the capacity of the test fixture. From an analysis of the test data, the average bond strength of the wearing course over the joints between girders was greater than 475 psi and the average strength in the material away from the joints was greater than 467 psi. From these values, it does not appear that the strength of the polymer concrete wearing course was adversely affected by the presence of joints between the girders, and that the 1/4 in thick cover plate was adequate to successfully transmit the shear and flexural stresses generated throughout the bridge deck.

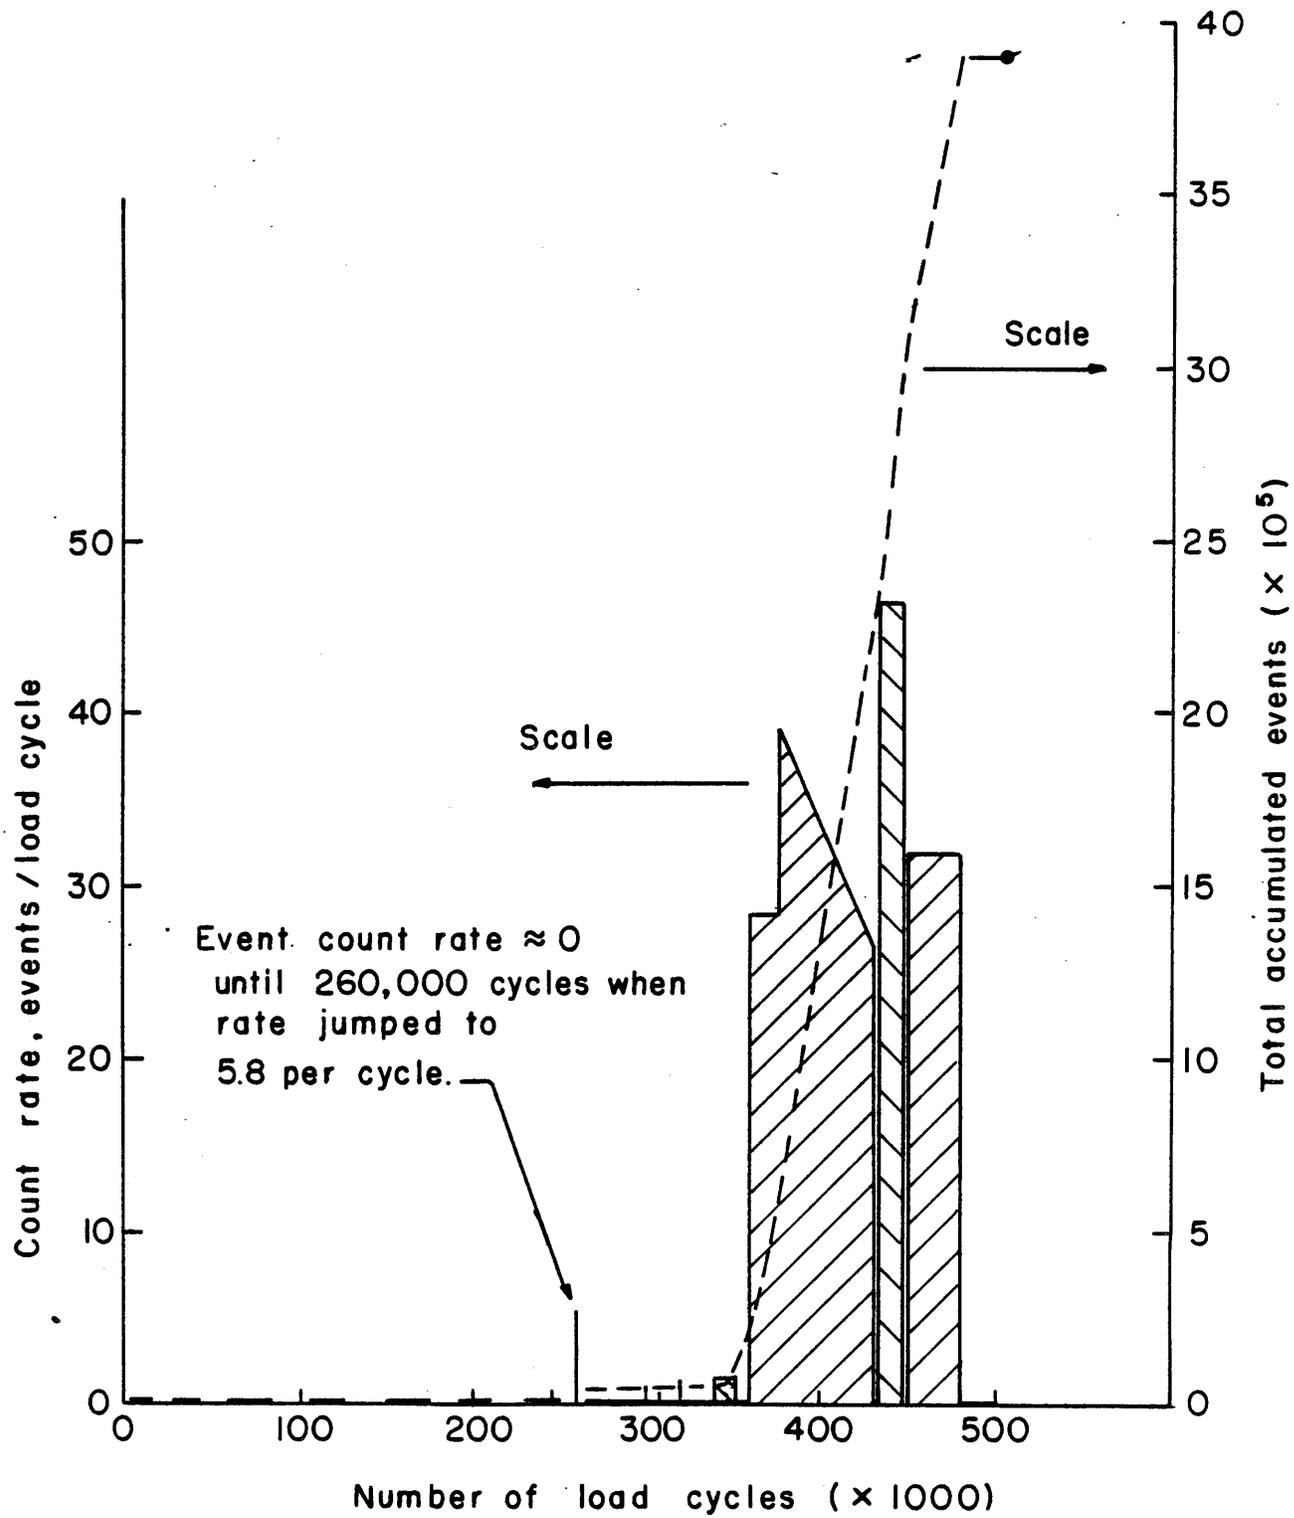
Figure 17. Acoustic emission data for load series 1.

Earlier discussion of the failure of the vertical web stiffener (page 27) alluded to some of the AE data obtained during load series 1. A summary of the complete record of the data is presented in Figure 17. An analysis of the AE data based on the extensive crack pattern in the stiffener provided some understanding of the erratic output of the AE processors. As seen in Figure 17, both the counts and count rate were practically nonexistent until the first observed spike in the count rate at 144,000 cycles (still too small to plot at the scale of Figure 17). At this point, the first crack presumably formed in the stiffener. The AE record shows another spike of 0.40 per load cycle at 246,000 cycles of load which is indicative of a significant growth in the initial crack or the formation of another crack in the stiffener. This spike is just perceptible in Figure 17. The next AE count rate spike of 5.8 per load cycle appeared at 260,000 cycles of load. Thereafter, the AE counts remained relatively quiet, with five additional count rate spikes appearing at 305, 311, 320, 338 and 352 x 10<sup>3</sup> load cycles. At 360,000 cycles, very high count rates continued, as shown plotted in Figure 17. These AE outputs indicate ongoing and irregular crack growth or rubbing between the surfaces of the newly formed cracks in the stiffener. The clicking heard prior to and for a time following the discovery of the

damaged stiffener may have been attributable to the rubbing action of the crack surfaces. The sound would increase and decrease in intensity for no particular reason nor at any particular time. The variations correlated, to an extent, with the observed AE count rate. While undocumented, it is now believed that the rough surfaces of new cracks produced clicks until the surfaces were polished by the cyclic motion of the loads, at which time the audible clicks and the AE counts ceased. Figure 17 also shows the accumulated number of events counted during load series 1. Note that no counts were recorded for the last 20,000 load cycles and that the total number of counts was approximately  $39 \times 10^5$ , most of which occurred after 360,000 cycles of load. Undoubtedly, the initial cracks which formed and propagated in the stiffener were so small that they escaped detection prior to the damage which occurred at 360,000 cycles and beyond.

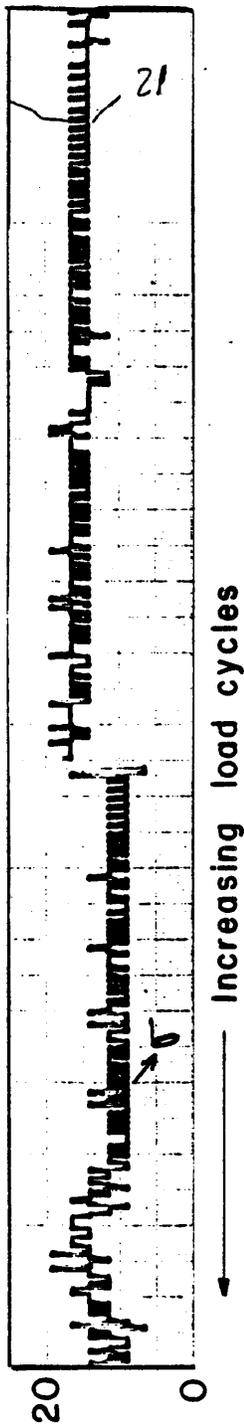
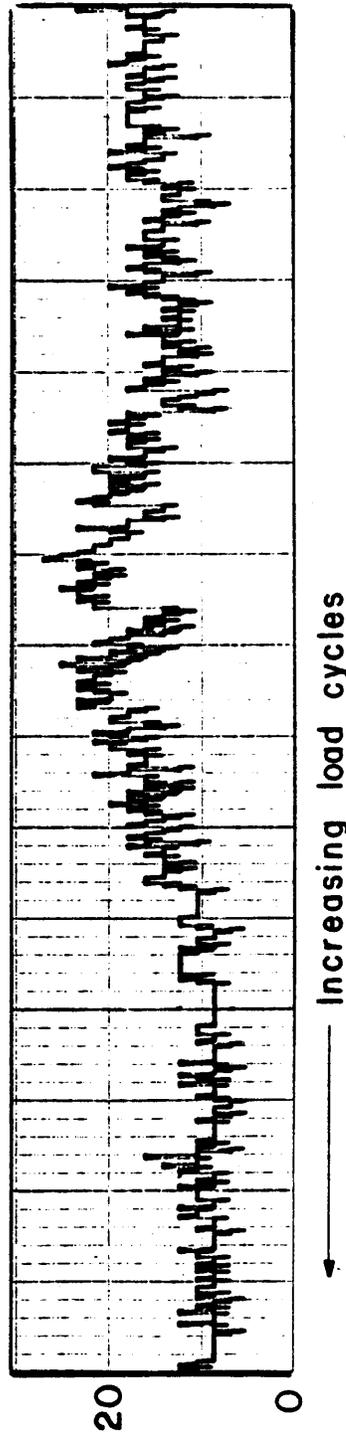
Figure 18. Representative acoustic emission rates for load series at a load rate of 5 cpm.

Figure 18 presents representative copies of strip chart plots of the AE counts vs time for load series 5 and 6. Figure 18(a) depicts a relatively quiet period of emissions recorded during series 5 when the count rate was quite regular over a considerable length of time. The data shown in Figure 18(a) are typical of those expected from emissions originating from machine noise or surfaces rubbing together at a relatively constant energy level. Figure 18(b) was taken from the record of load series 6 after 15,200 cycles. These data are typical of a periodically fluctuating rate of emissions which characterized much of the recordings made during load series 6 and 7. Figures 18(a) and 18(b) are directly comparable since the cyclic load rates were 5 per minute in both cases. Note that the spread of the count rate band increased somewhat from load series 5 (3 counts/min) to load series 6 (6 counts/min) in addition to the fluctuating oscillation of the band. Figures 19(a) and 19(b) were taken from emission count rate data for load series 7 and represent the extremes in "quiet" and "noisy" periods of emissions observed throughout the period of cyclic loading. Figure 19(a) depicts a narrow count rate band with a nearly constant emission rate of 2.8 counts per cycle (computed from 28 counts/min at a load rate of 10 cycles/minute) which extended over a period of 15 hours. Figure 19(b) depicts widely fluctuating count rates over relatively short periods of time and large changes in the count rate magnitudes. Count rates varied from a low of 1 to a high of 7 per load cycle within a period of 10 hours. It is significant that the chart record of Figure 19(b) occurred near the beginning (13,000 cycles) of load series 7, whereas the record of Figure 19(a) was taken after 175,000 cycles of load. An inspection

of AE data from both load series 5 and 6 revealed the same information; the count rate at the start-up period of the load series was significantly higher and more variable than the rates which occurred as the load test progressed. These observations support the deflection data discussed previously and support the contention that the bridge underwent a shakedown each time a load magnitude or distribution was changed. During this time new cracks would be formed or old ones would be extended as the structure shifted loads from one element to another and attempted to adjust to a different stress and displacement environment. After the period of adjustment, the structure would respond to the cyclic loads with a diminished rate of crack formation and extension and with fewer emissions.

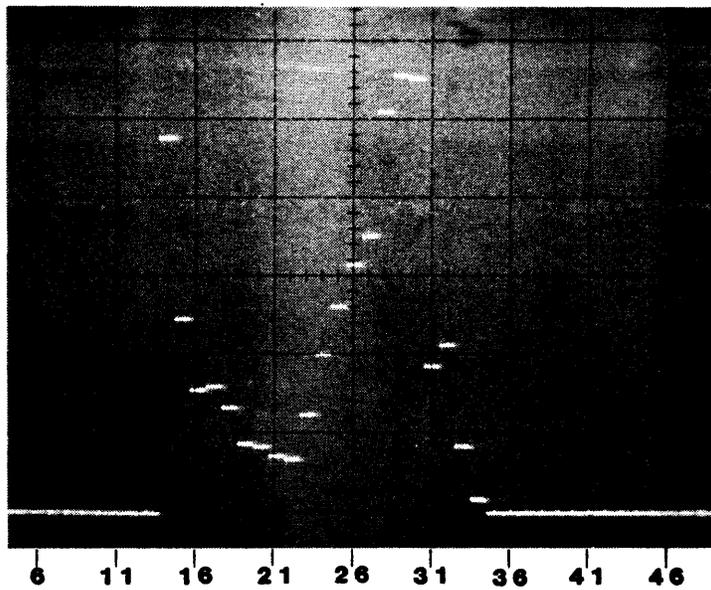
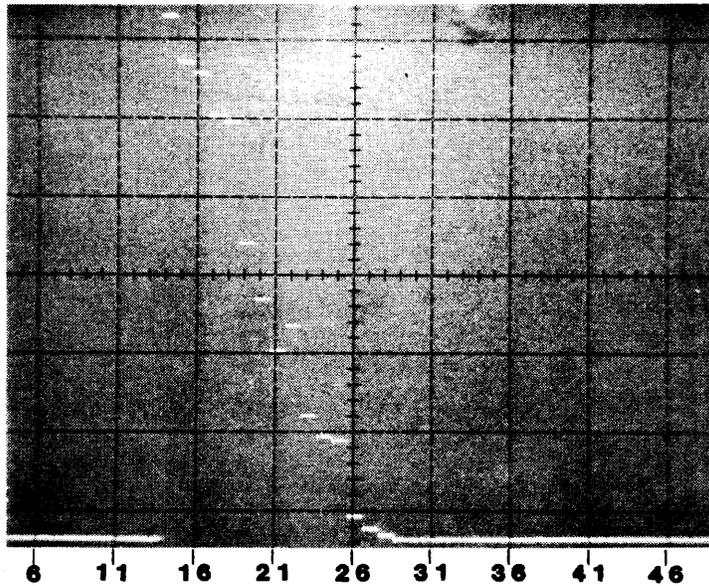
Figure 21. Amplitude distribution of acoustic emissions from load series 7.

Figure 21(a) is a record of the amplitude distribution of counts during load series 7 after 380,200 cycles of load ranging from 6,400 to 9,040 lb. Figure 21(b) is a view of the emissions recorded approximately two hours earlier when the load range was 6,320 to 8,400 lb. Other test conditions were essentially the same for the emission displays recorded. The change in the character of the emissions from Figure 21(a) to 21(b) is a demonstration of the phenomenon known as the Felicity effect in AE technology. In this particular case, the pattern of emissions indicate that a reduction in the mean load magnitude on the bridge

(a) Bimodal trace of events with amplitudes to 34 db cyclic load range from 6,400 to 9,040 lb.

(b) Emission at cyclic load range of 6,320 to 8,400 lb showing psuedo Kaiser effect of high db values produced in (a).

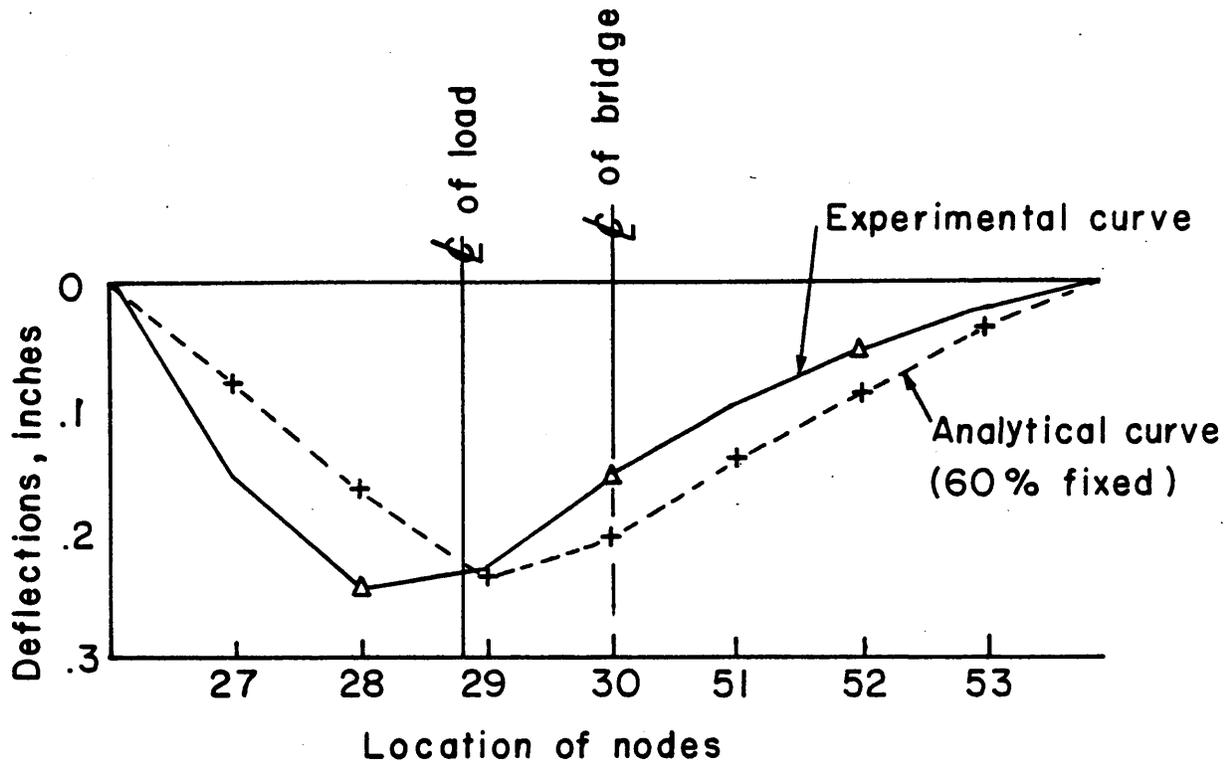
Figure 25. Comparison of experimental and analytical deflections for load series 2.

The results of the computations for load series 2 also are shown in Table 7. The difference between the experimental and analytical results are much larger for load series 2 than for load series 1. The larger differences are attributed to the upward buckling of the deck over the northern half of the bridge. The elastic buckling of the deck was not considered in the analytical model, so differences in the numerical values were expected; particularly for gages 4, 5, 6, 7, and 8, which were located in the buckled region of the bridge. A graphical comparison of the experimental and analytical data is shown in Figure 25 for the deflections of the lower chord along the centerline of the middle girder for the assumed 60% fixed rotational constraint of the horizontal stiffeners. The deflection profile deduced from the several known experimental data points clearly shows the effect of the buckled deck when compared with the deflection profile from the analytical solution.
