**INVESTIGATION
OF PAVEMENT PERMEABILITY:
OLD BRIDGE ROAD**

**Virginia Transportation Research Council
(A Cooperative Organization Sponsored Jointly by the
Virginia Department of Transportation and
the University of Virginia)**

**October 2001
VTRC 02-TAR5**

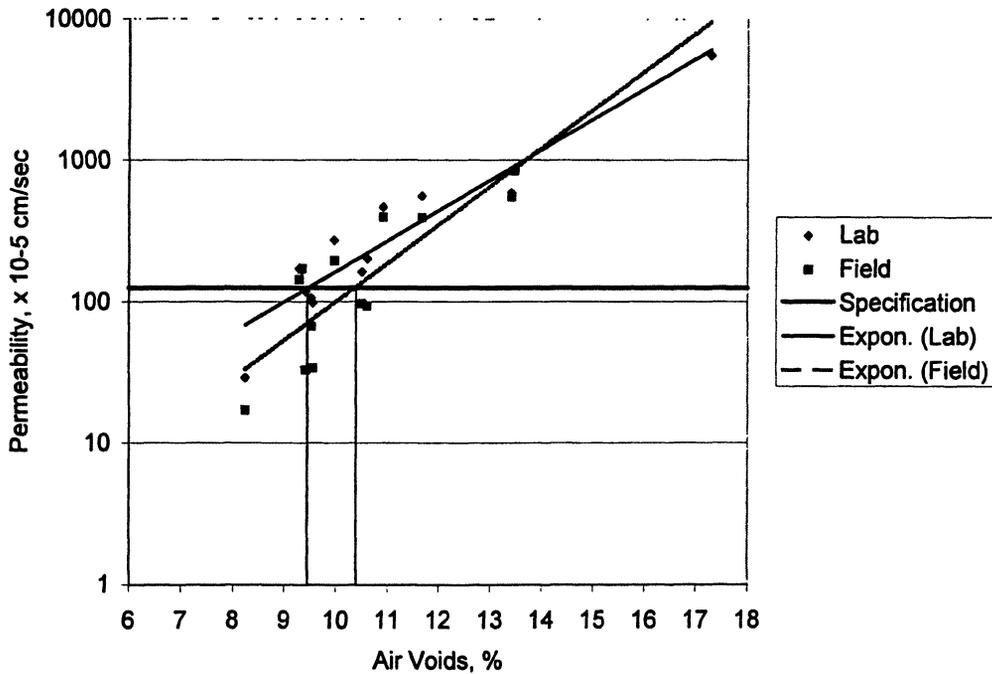
Figure 6. Permeability Versus Air Voids. Note: 1 cm/s = 2835 ft/day.

An allowable specification for field permeability has not been established. However, data indicate that it produces results similar to those for the lab permeability test. The field permeability test is probably more indicative of water movement through a pavement since it allows lateral flow. Based on the Florida DOT's specification for the laboratory permeability test of a maximum permeability of 125×10^{-5} cm/sec (3.54 ft/day), four of five center lane cores and one of four left lane cores did not comply with the field permeability specification. All center lane cores and two of four left lane cores did not comply with the Florida DOT's criterion for laboratory permeability. Based on a comparison of the observed segregation for the extra cores, segregation of the mix corresponds with an increase in air voids and failing permeability. Figure 6 shows the relationship between air voids and both field and laboratory permeability. Based on the figure, the mix would need to be compacted below 9.5% air voids to meet Florida's specification. Based on the field permeability results, air voids levels less than 10.5% may be acceptable. Three additional field permeability readings, E1-A, E1-B, and E1-C, were taken from a segregated area slightly uphill from Wood Hollow Drive in the center lane. E1-A, E1-B, and E1-C had field permeability readings of 805 , 1576 , and 475×10^{-5} cm/s (22.8, 44.7 and 13.5 ft/day), respectively. All three of these areas would fail Florida DOT's specification of 125×10^{-5} cm/s (3.54 ft/day).

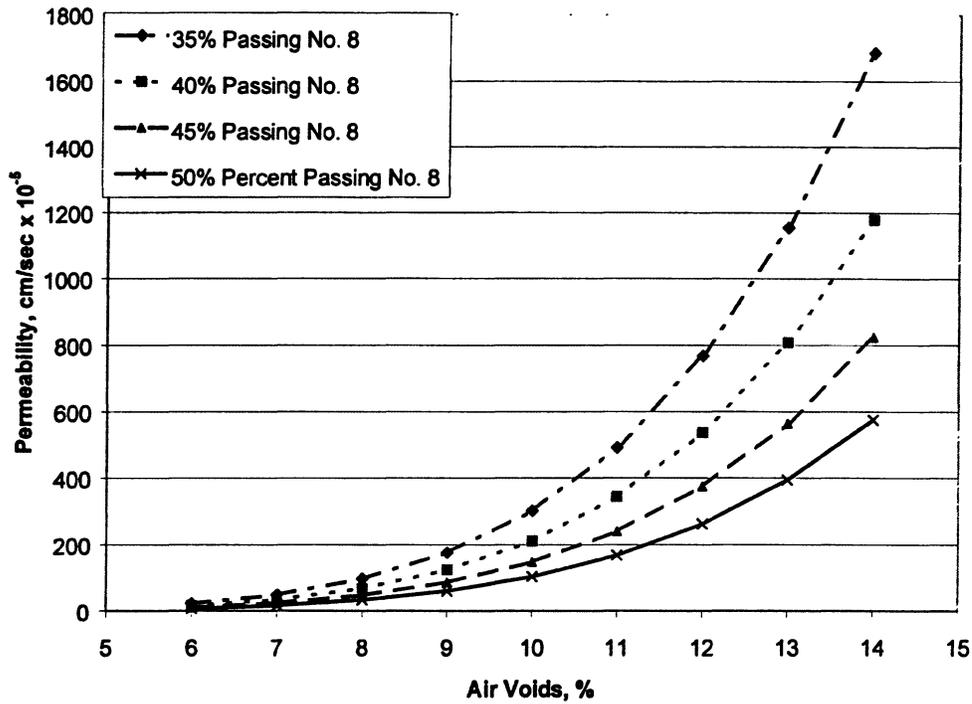
Figure 7. Laboratory Permeability as Function of Air Voids and Percent Passing No. 8 Sieve. Note: 1 cm/s = 3.54 ft/day.

A multiple regression was performed using the natural log of air voids and the percent passing the No. 8 sieve (2.36 mm) as predictor variables for both the natural log of laboratory and field permeability. An R^2 of 0.97 with a standard error of 0.164 was determined for the laboratory permeability measurements. An R^2 of 0.94 with a standard error of 0.321 was determined for the field permeability measurements. Figure 7 shows the relationship between air voids and laboratory permeability for various percentages of material passing the No. 8 (2.36 mm) sieve. Figure 8 shows the relationship between air voids and field permeability for various percentages of material passing the No. 8 (2.36 mm) sieve. Both figures indicate how segregation can dramatically increase the permeability of a pavement at a given void level. In

this case, the job-mix formula was set at 36% passing the No. 8 sieve (2.36 mm). If the contractor had not generally produced a finer mix, the permeability of the pavement would have been much worse. The areas with percents passing the No. 8 (2.36 mm) sieve close to those of the job-mix formula are actually considered segregated compared to the average production gradations. The figures also confirm previous research that indicates coarser mixes are more permeable at the same void level. It should be noted that the effect of the No. 8 (2.36 mm) sieve is minimal in the range of passing densities (less than 8% air voids).
