Assessment of Tri-Dyne Precast Concrete Panels

LTRC Project Number 08-2TA

Louisiana Department of Transportation and Development
Louisiana Transportation Research Center
4101 Gourrier Ave
Baton Rouge, LA 70808
www.ltrc.lsu.edu

January 2008

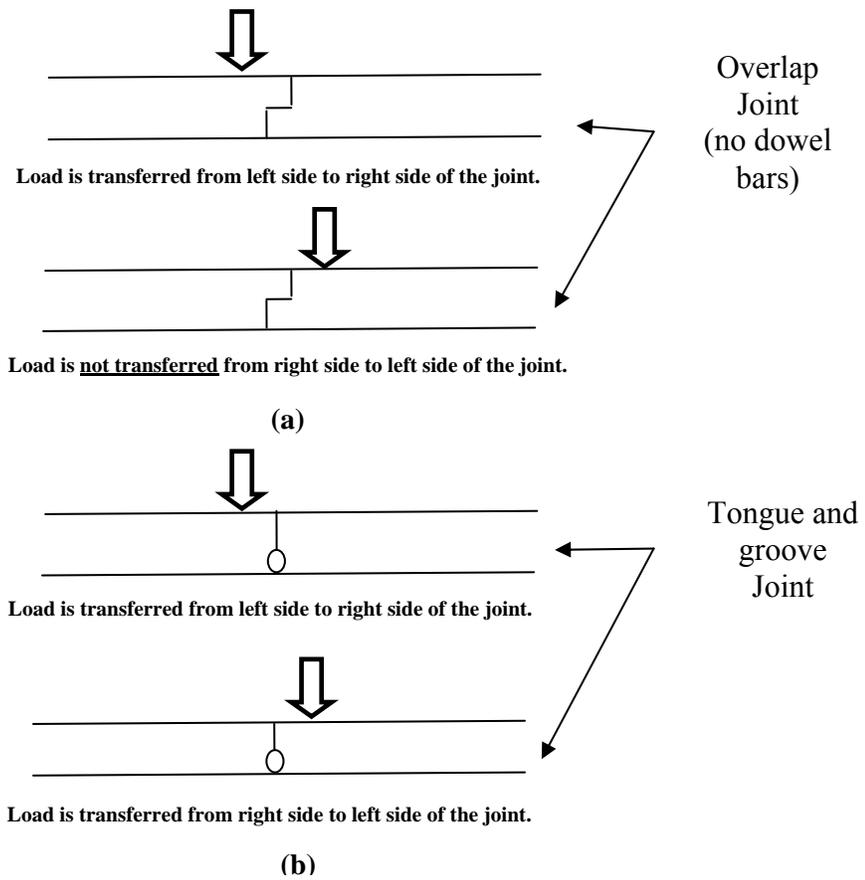
Figure 7: Load transfer detail for joints

Two joint mechanisms were used. In the transverse direction, non doveled overlap joints, as shown in Figure 3, were used. According to Tri-Dyne, these joints were used in an attempt to allow quick placement of the slabs and do not employ dowel bars as load transfer mechanisms, as with typical cast in place pavements used in highway construction. Because of this, load

transfer between slabs is possible from only one direction, as shown in Figure 7a. In the longitudinal direction, finger type tongue and groove joints were used, as shown in Figures 4 and 5. These joints connect through overlapping composite-steel-concrete elements and do not employ dowel bar load transfer mechanisms or tie bars to hold the slabs together. Unlike the overlap joint, this joint mechanism allows load transfer across the joint from both directions, as shown in Figure 7b. Further details are presented in the discussion of results section of this report.

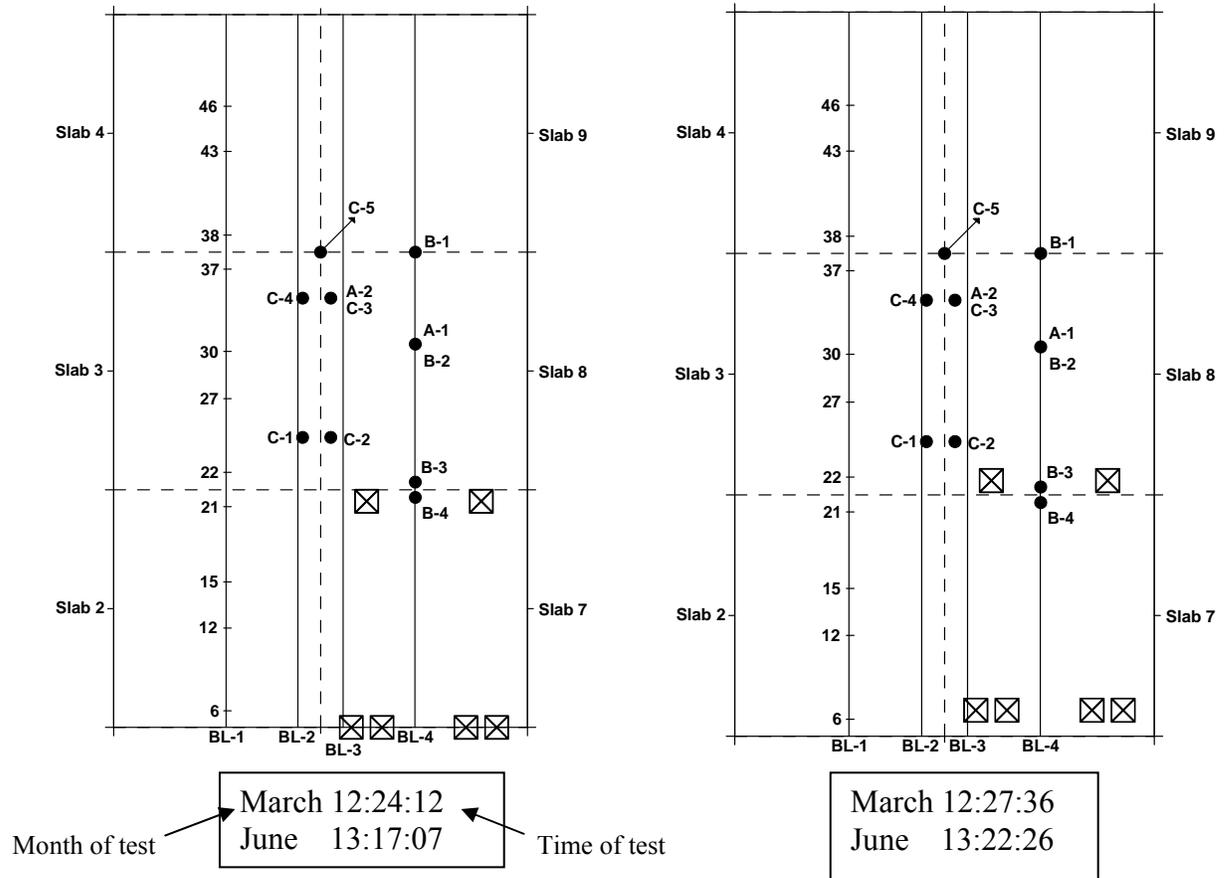
Figure 26: Wheel loading for approach side (21) and leave side (22) of the joint

Loading at locations 21 and 22: Figure 25 presents the pressure cell readings (B-4 and B-3), measured when dead loading from the front wheels of the large cone truck was applied at the approach side (21) and leave side (22) for the March and June evaluations, as shown in Figure 26.

When the load was applied to location 21 (March 12:24:21), the pressure cell readings for B-4 and B-3 were 0.8 psi and 10.1 psi, respectively. If the slabs were equally and fully supported by the base course and properly aligned vertically and horizontally, the pressure readings from pressure cells B-3 and B-4 should be similar when loaded at location 21 and different when loaded at location 22 due to the load transfer mechanism, as shown in Figure 25. However, there was a pressure differential of 9.3 psi across the joint when loaded at location 21. Due to the void

at location 21; profile differential between slabs 7 and 8, as shown in Figure 19; and the mechanism of load transfer, as shown in Figure 25; the load applied at location 21 was carried predominately by the base at location 22 (slab 8).

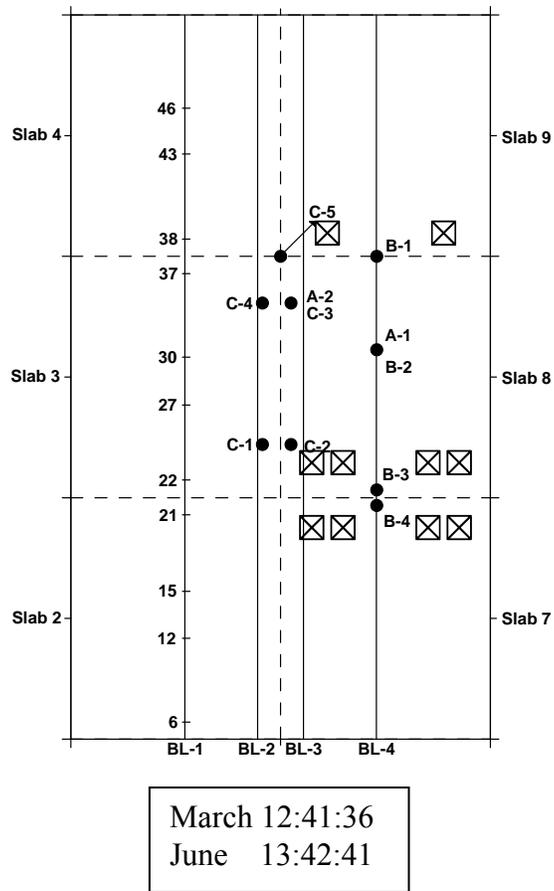
Figure 28: Loading location

Simultaneous loading at locations 19.5 and 23.5: The pressures for B-4 and B-3 were 2.5 psi and 30 psi, respectively, for the March 12:41:36 data set when the rear wheels of the large cone truck were located equidistant (24 in.) from the joint at slabs 7 and 8, as shown in Figures 27 and 28. Because the lap joint system was a poor load transfer mechanism, slab 8 bears the full load of the tires (location 23.5) over it and the majority of the load applied (location 19.5) to slab 7. This trend was also evident in the June 13:42:21 data, as the pressures for B-4 and B-3 were 12.2 psi and 40 psi, respectively.

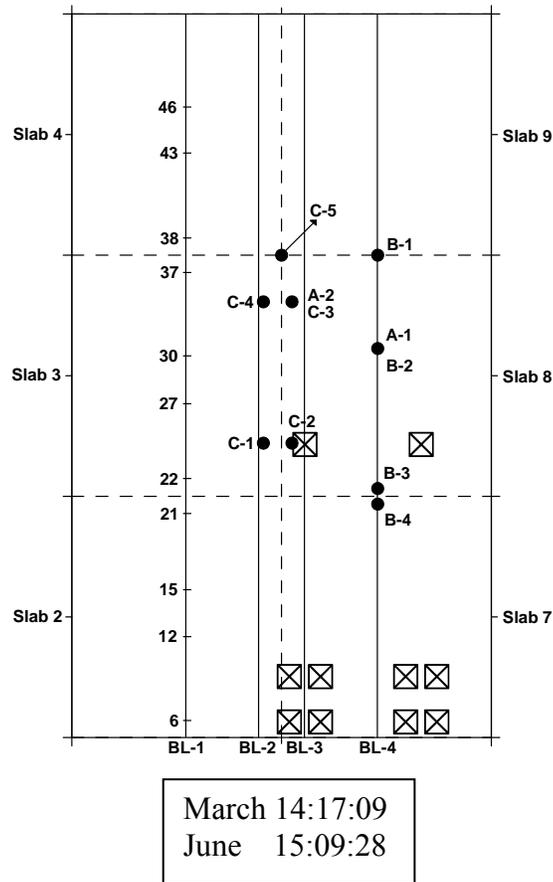
Figure 29: Front wheel load near sensor C-2

As shown in Figure 30, the pressures for C-1 and C-2 were 4.1psi and 6.4 psi, respectively, for the March 14:17:09 data set and 6.9 psi and 4.6 psi, respectively, for the June 15:09:28 data set. Similar pressures across the longitudinal joint at slabs 3 and 8 were observed for both the March and June data sets.

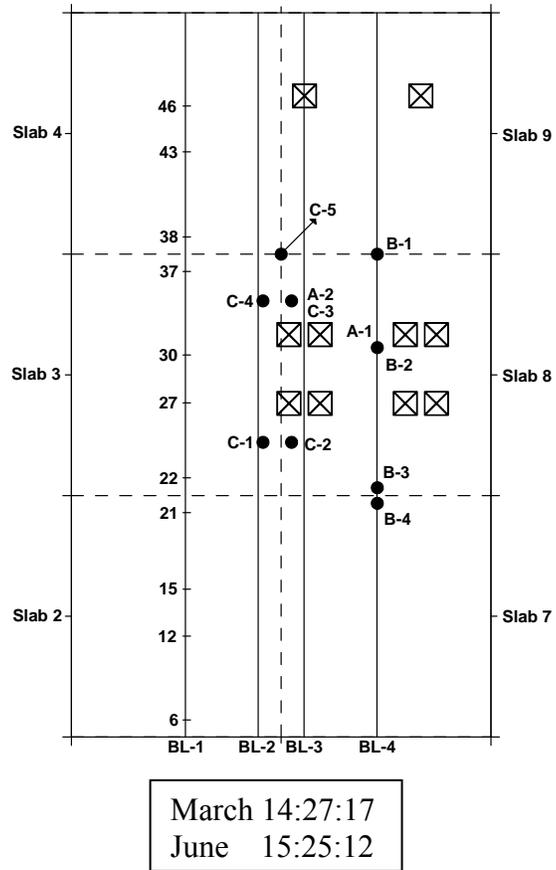
Figure 31: Front wheel load near sensor C-2

As shown in Figure 32, the pressures for C-1 and C-2 were 2.8 psi and 8.2 psi, respectively, for the March 14:27:17 data set and 4.3 psi and 4.4 psi, respectively, for the June 15:25:12 data set. The reason for the differing pressures between the March and June data set could be that the better contact between the slab and base course was created by the injection of leveling material in June.
