# Evaluation of Salvage and Replanted Native Plants on ADOT Projects

Final Report 587  
June 2012

Arizona Department of Transportation  
Research Center

Logan Simpson Design, Inc.  
51 West Third Street, Suite 450  
Tempe, AZ 85281

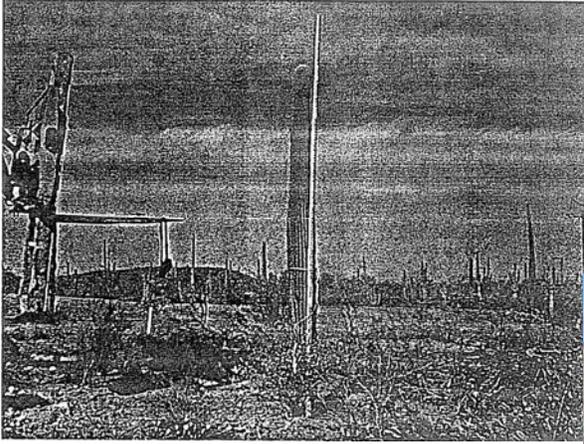
Above: Contractor's presalvage photo of saguaro tag #82.

Right: Saguaro dead at time of inventory, January 28, 2008. Original tag #82, LSD #101.

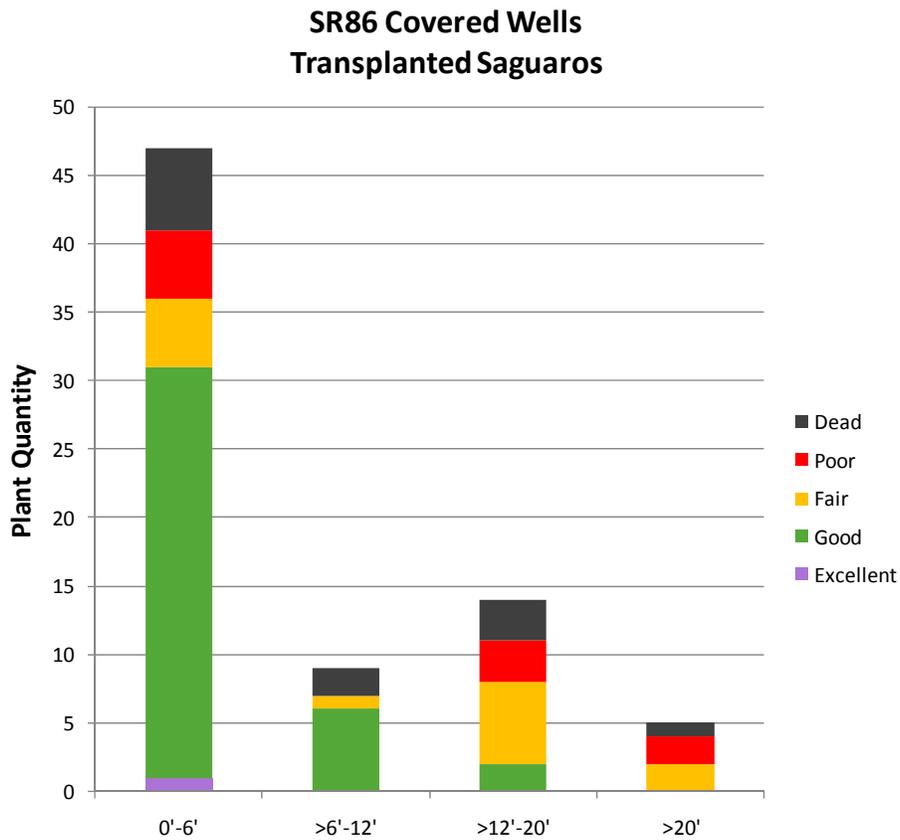
**Figure 1. Plant Height.**

Table 3 and Figure 1 show plant health rating by height classifications. The majority of the 0- to 6-foot saguaros (64%) were in good health, but health decreased as the height of saguaros increased.

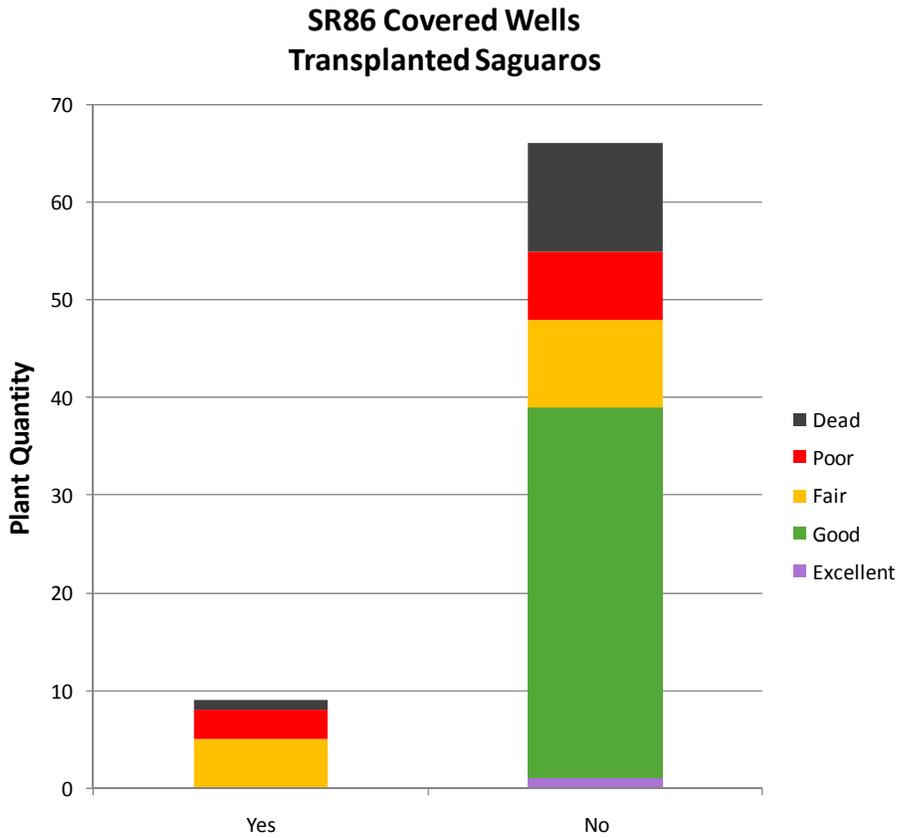
**Figure 2. Presence of Arms.**

There were significantly more saguaros (66 plants, 88%) without arms than with arms (9 plants, 12%), making a direct comparison more difficult; nonetheless, the plants without arms were noticeably healthier. The majority of plants without arms were in good health (58%), while one plant (2%) was found to be in excellent health; 14% were in fair health; 11% were in poor health; and 17% were dead. Of those plants with arms, none were found to be in excellent or good health; 55% were in fair health; 33% were in poor health; and one plant (11%) was dead (Figure 2).

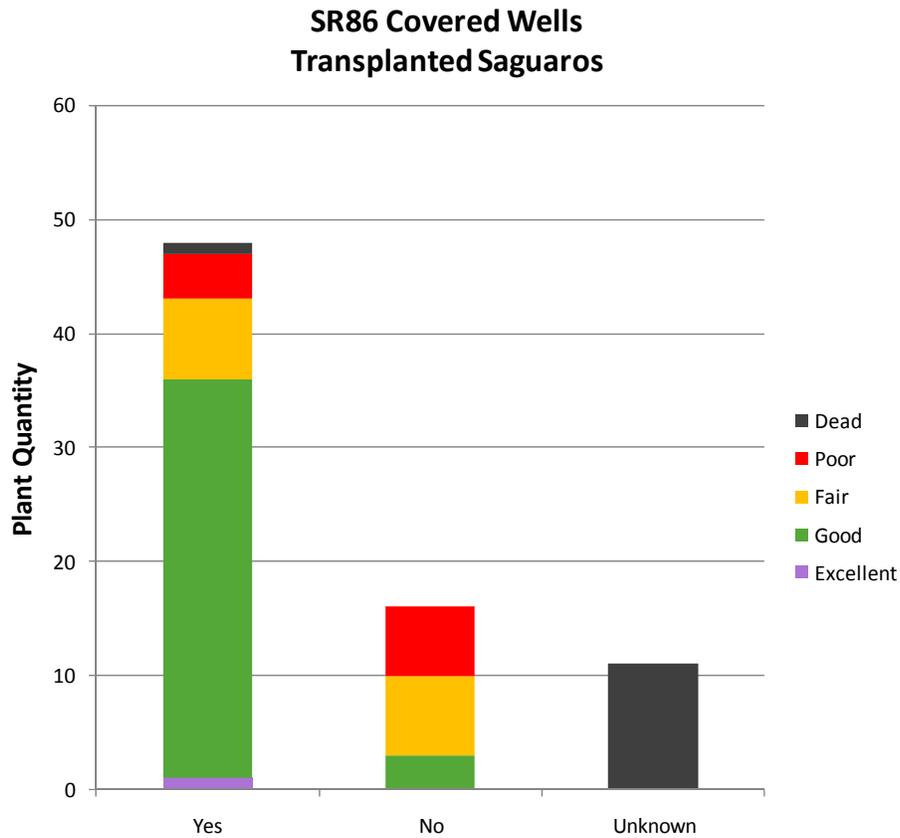
**Figure 8. Taper at Base.**

The presence of a tapering stem at the base of the saguaro, an indication that the saguaro was not planted too deeply, was correlated with good plant health (Figure 8). Saguaros exhibiting taper were mostly in good health (73%), with 2% in excellent health, 15% in fair health, 8% in poor health, and 2% (one plant) were dead. In contrast, only 19% of the plants with no taper were in good health, 44% were in fair health, and 38% were in poor health. Whether there was taper could not be determined for another 11 plants, all of which were dead.

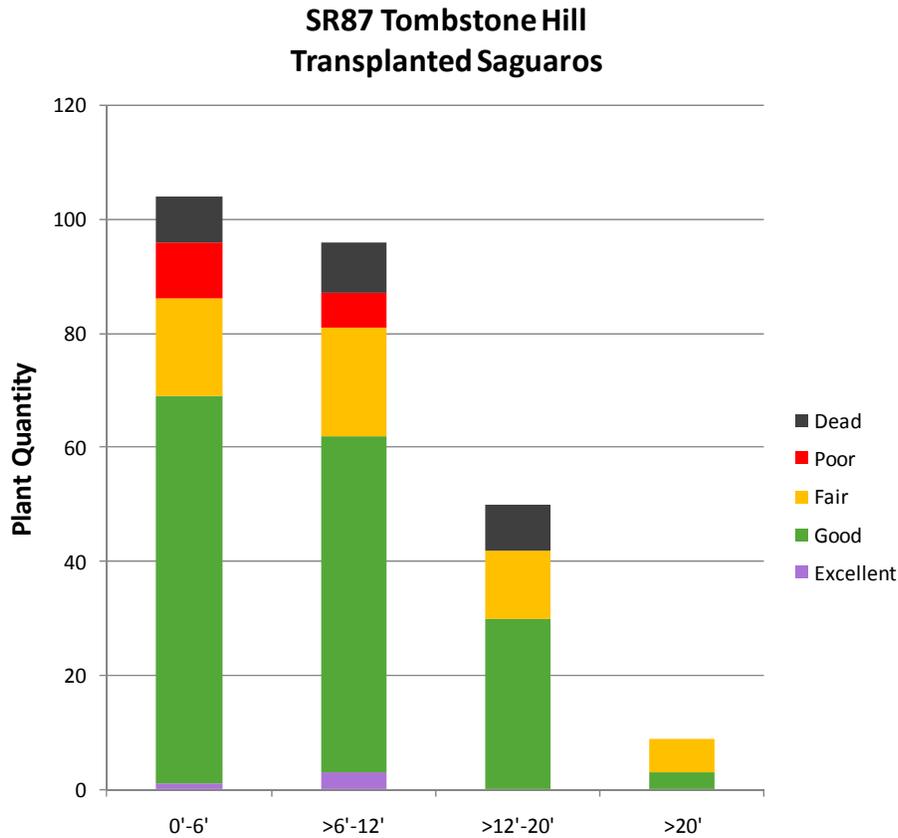
**Figure 9. Plant Height.**

Figure 9 shows plant health rating by height classifications. The majority of the 0- to 6-foot-high saguaros (65%) were in good health; one plant (1%) was in excellent health; 16% were in fair health; 10% were in poor health; and 8% were dead. The majority of the >6- to 12-foot-high saguaros (62%) were in good health; 3% were in excellent health; 20% were in fair health; 6% were in poor health; and 9% were dead. As the height of saguaros increased, health decreased: 60% of the >12- to 20-foot saguaros were classified as good, 24% as fair, and 16% as dead.

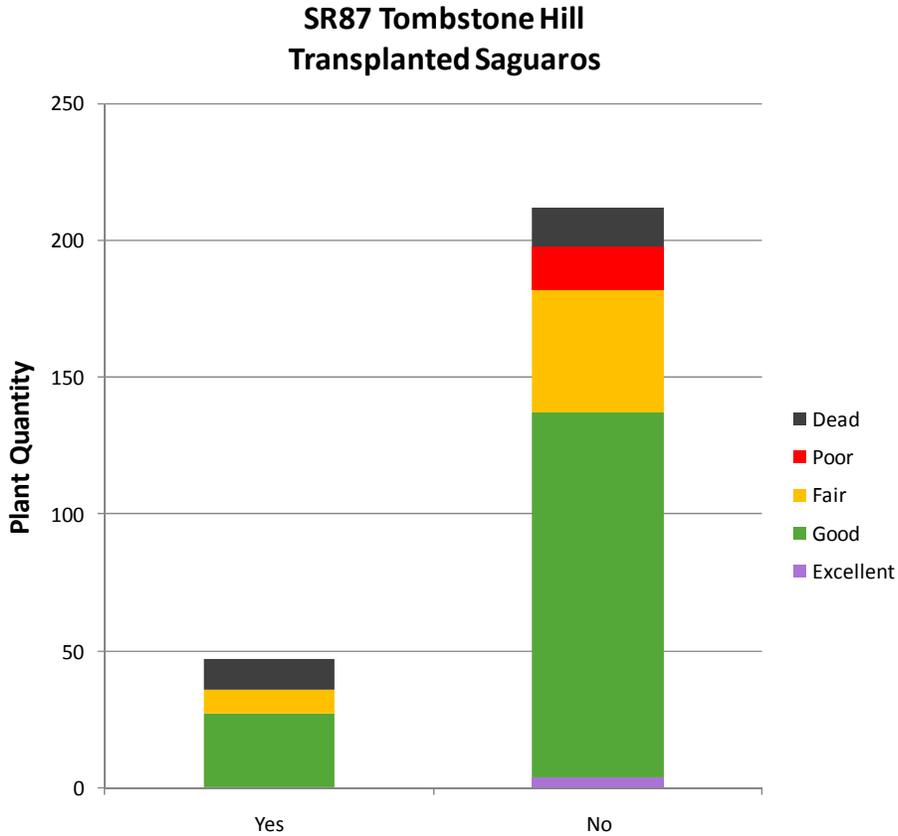
**Figure 10. Presence of Arms.**

The presence of arms appeared to have a negative effect on the health of the plants. The most noticeable difference between the plants with arms and plants without arms was in the percentage of dead plants (23% versus 7%, respectively). Of the plants without arms, the majority were in good health (63%); 2% were in excellent health; 21% were in fair health; and 8% were in poor health. Of the plants with arms, 57% were in good health and 19% were in fair health (Figure 10).

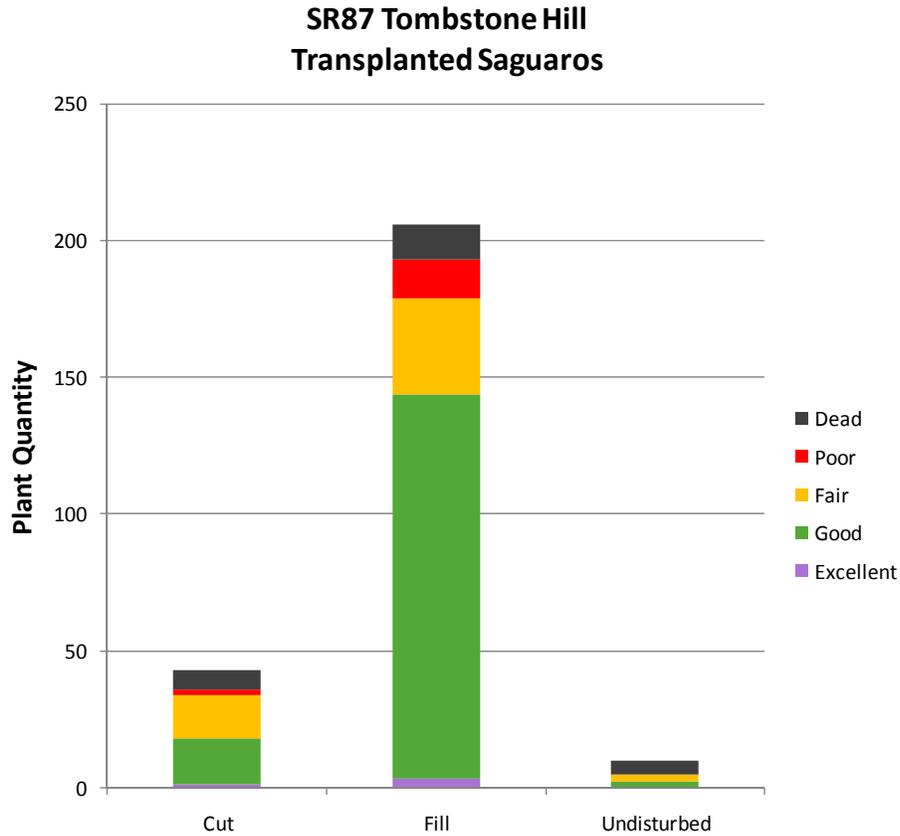
**Figure 14. Cut/Fill.**

A significant increase in the health of the plants was noted when the planting area was composed of fill material rather than being cut material or undisturbed. Of the plants in the fill material, 68% were in good health; by comparison, only 40% of the plants in cut material were in good health, and only 20% in undisturbed soil were in good health. Table 10 and Figure 14 show the relationship of the soil material to plant health.

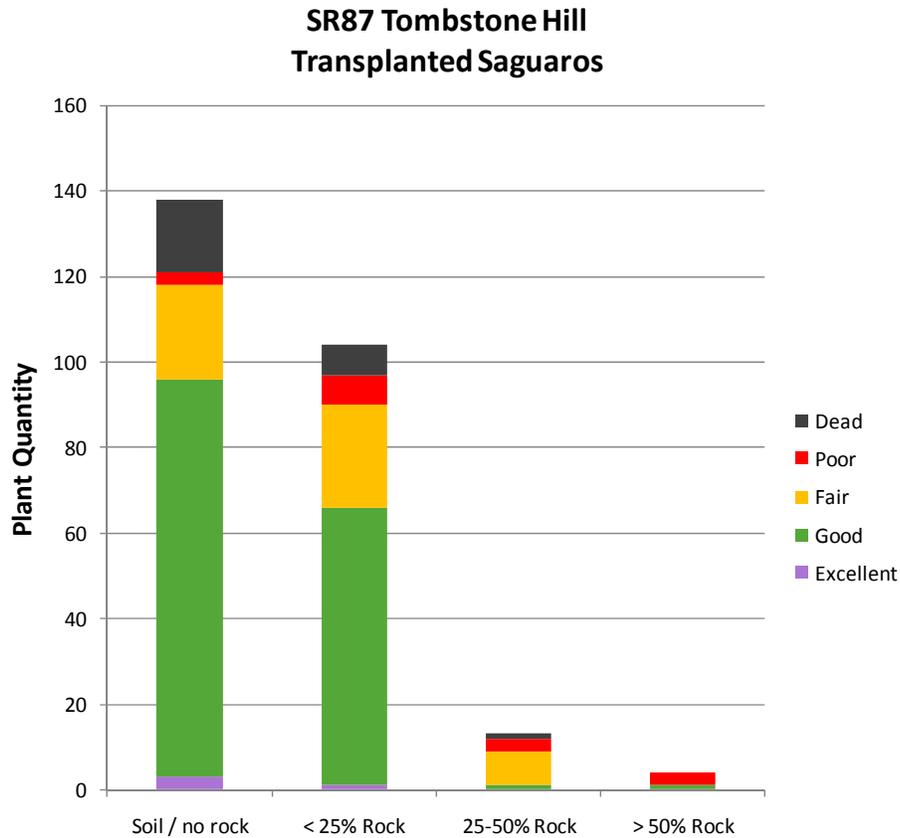
**Figure 15. Amount of Rock in Soil.**

As shown in Table 11 and Figure 15, a smaller amount of rock in the soil corresponds to better health of the plants. Of saguaros planted in soil with no rock, 67% were in good health, 2% in excellent health, 16% in fair health, 2% in poor health, and 12% dead. When the amount of rock was <25%, 63% of the plants were in good health, 1% (one plant) in excellent health, 23% in fair health, 7% in poor health, and 7% dead. For soil composed of 25% to 50% rock, 8% of the plants were in good health, 62% in fair health, 23% in poor health, and 8% dead. The health of plants in soils containing >50% rock was mostly poor (75%), with 25% (one plant) in good health.

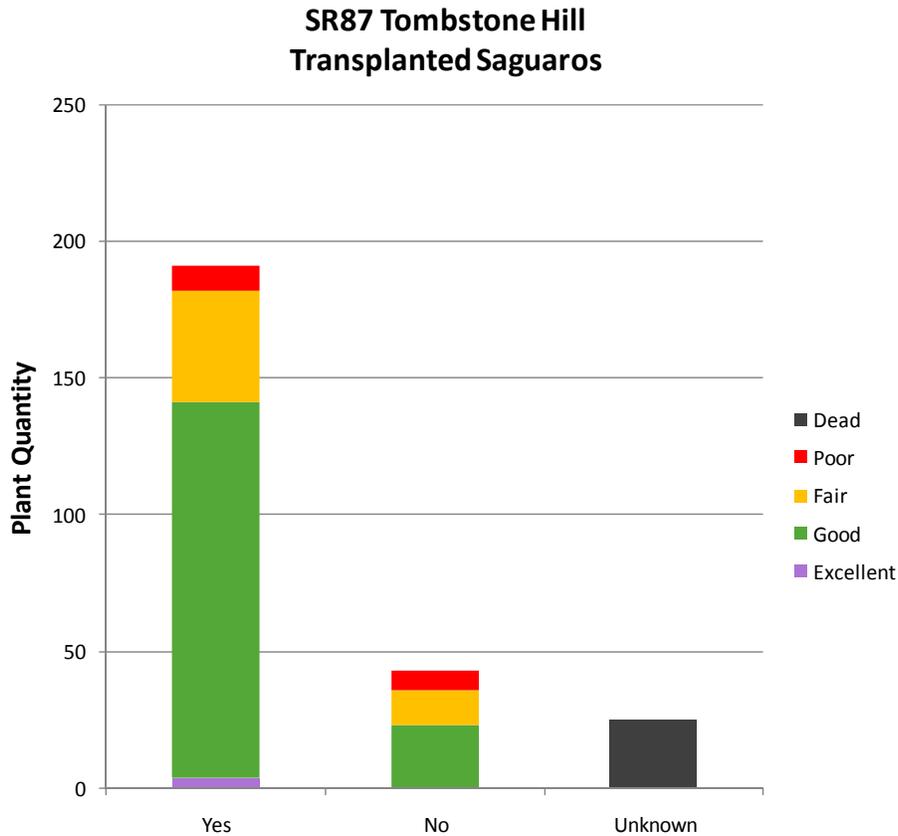
**Figure 17. Taper at Base.**

The presence of a tapering stem at the base of the saguaro, an indication that the saguaro was not planted too deeply, was correlated with good plant health (Figure 17). Saguaros exhibiting taper were mostly in good health (72%), with 2% in excellent health, 21% in fair health, and 5% in poor health. Of the saguaros with no visible taper, the overall percentage of plants in good health (53%) is smaller than those with a taper, with 30% in fair health and 16% in poor health. The presence or absence of a tapering stem could not be determined for the 25 dead plants.

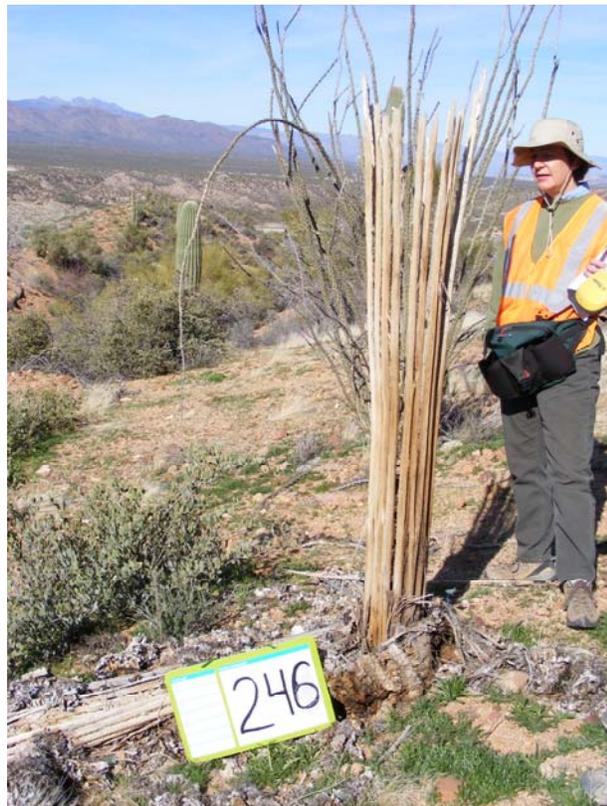
Above: Contractor's presalvage photo of saguaro tag #530.  
Right: Saguaro dead at time of inventory, February 13, 2008. Original tag #530, LSD #246.

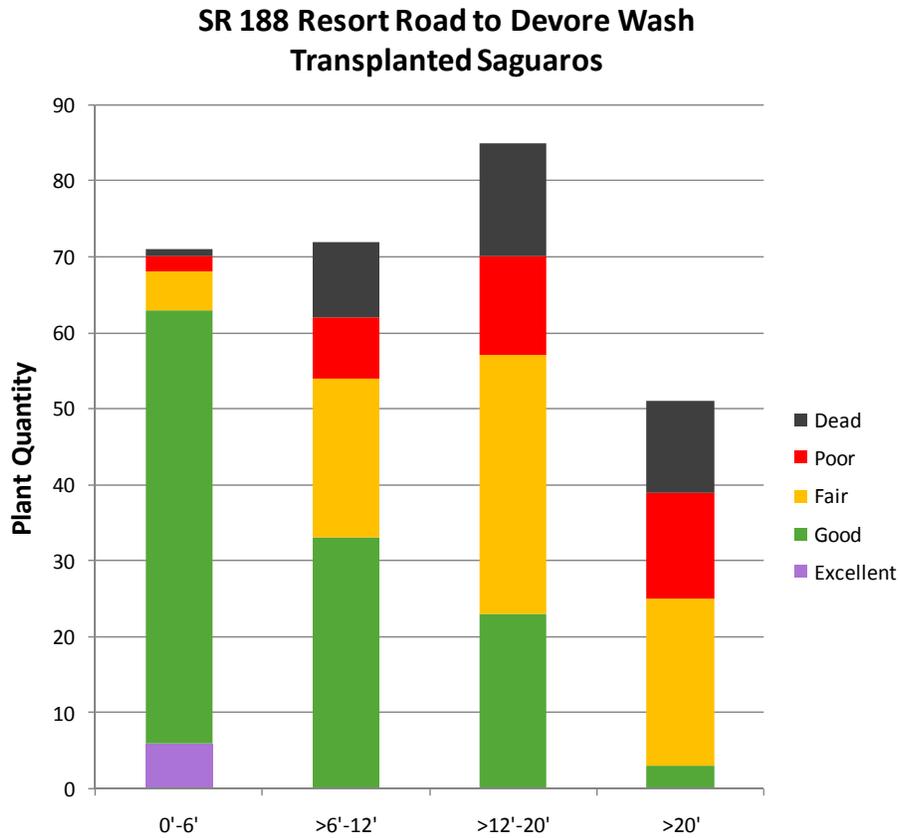
**Figure 18. Plant Height.**

Table 14 and Figure 18 show plant health rating by height classifications.

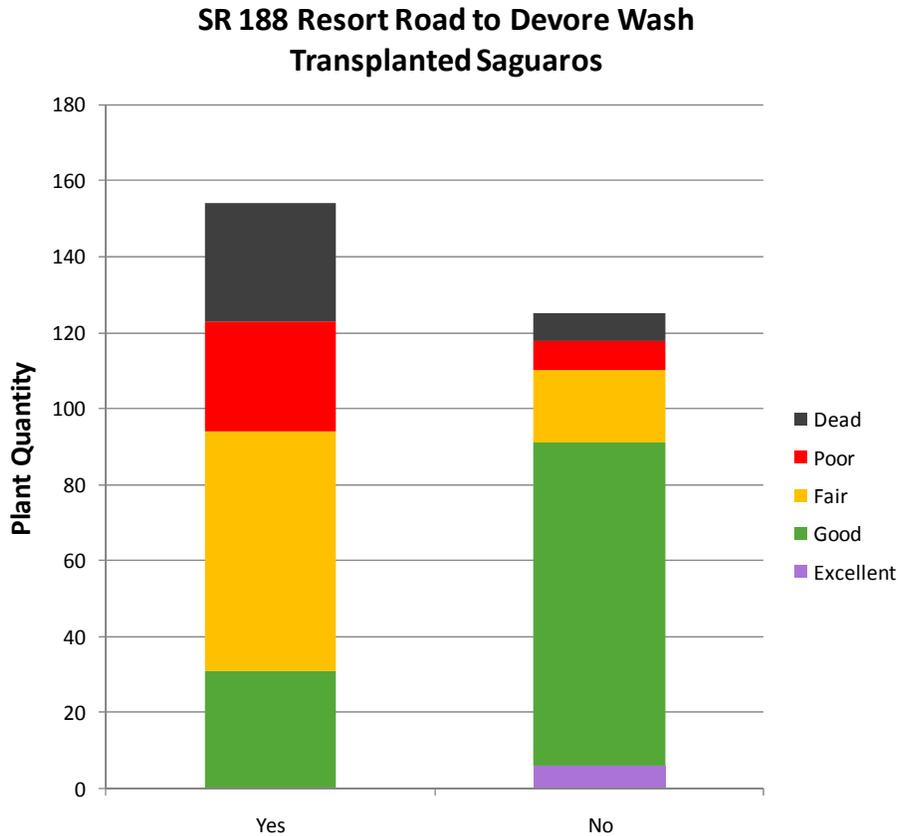
**Figure 19. Presence of Arms.**

The presence of arms appeared to have a negative effect on the health of the plants (Figure 19). Of the plants with arms, 20% were in good condition; 41% were in fair condition; 19% were in poor condition; and 20% were dead. Of the plants without arms, the majority were in good health (68%), while 5% were in excellent health; 15% in fair health; 6% in poor health; and 6% were dead.

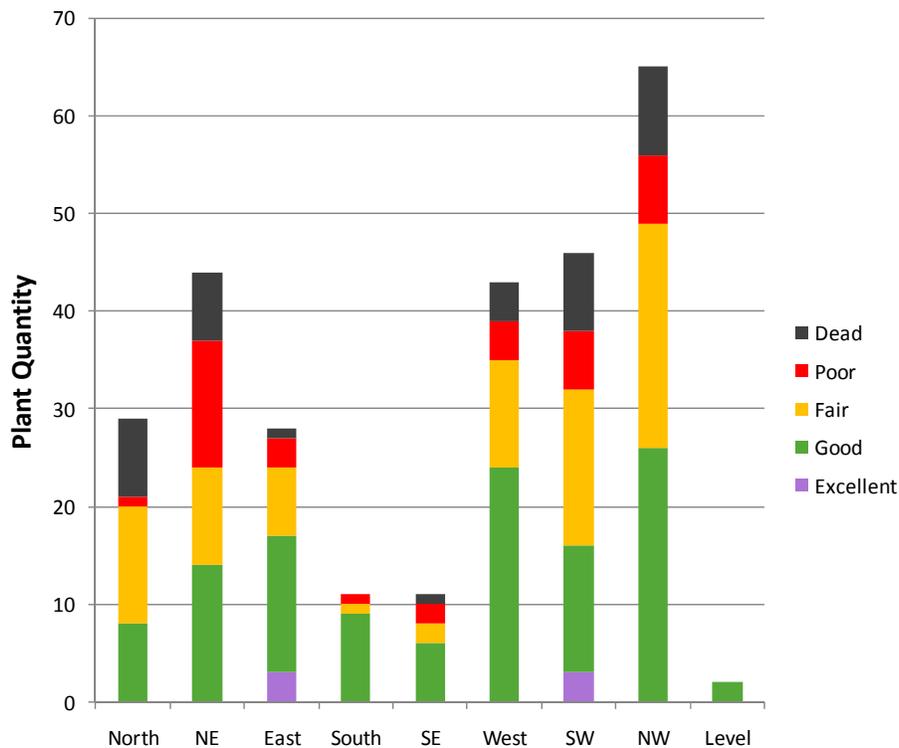
**Figure 20. Aspect.**

Aspect (the directional orientation of slope) appeared to have an effect on plant health (Table 15 and Figure 20), with the southern exposure containing the highest percentage of plants in good health (82%), aside from the two plants (100%) with no aspect (level ground) that were in good condition. Conversely, the northern exposure contained the highest percentage of dead plants (28%).

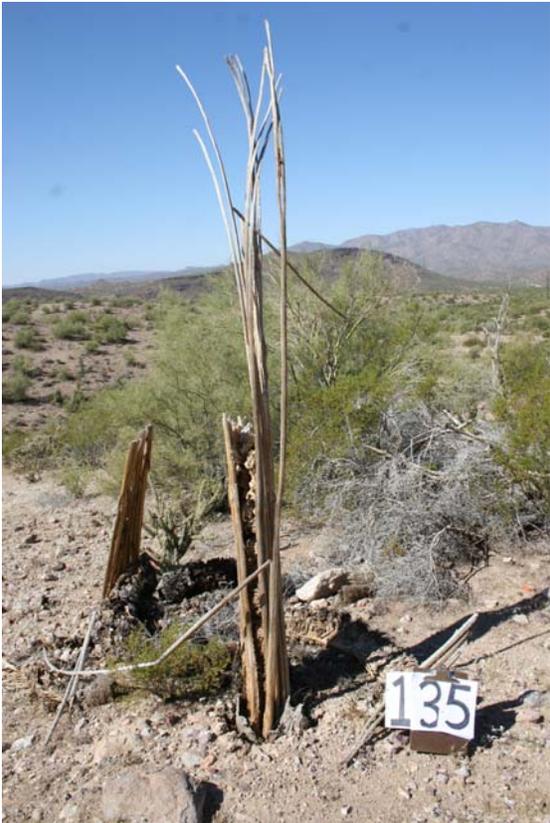
Left: Contractor's presalvage photo of saguaro tag #8372.  
Below: Saguaro dead at time of inventory, October 9, 2008. Original tag #8372, LSD #135.
