Testing and Recommended Practices to Improve Nurse Tank Safety, Phase I

U.S. Department of Transportation
Federal Motor Carrier Safety Administration

October 2013

1. Report No. FMCSA-RRR-13-032	2. Government Accession No.	3. Recipient's Catalog No.	
4. Title and Subtitle Testing and Recommended Practices to Improve Nurse Tank Safety, Phase I		5. Report Date October 2013

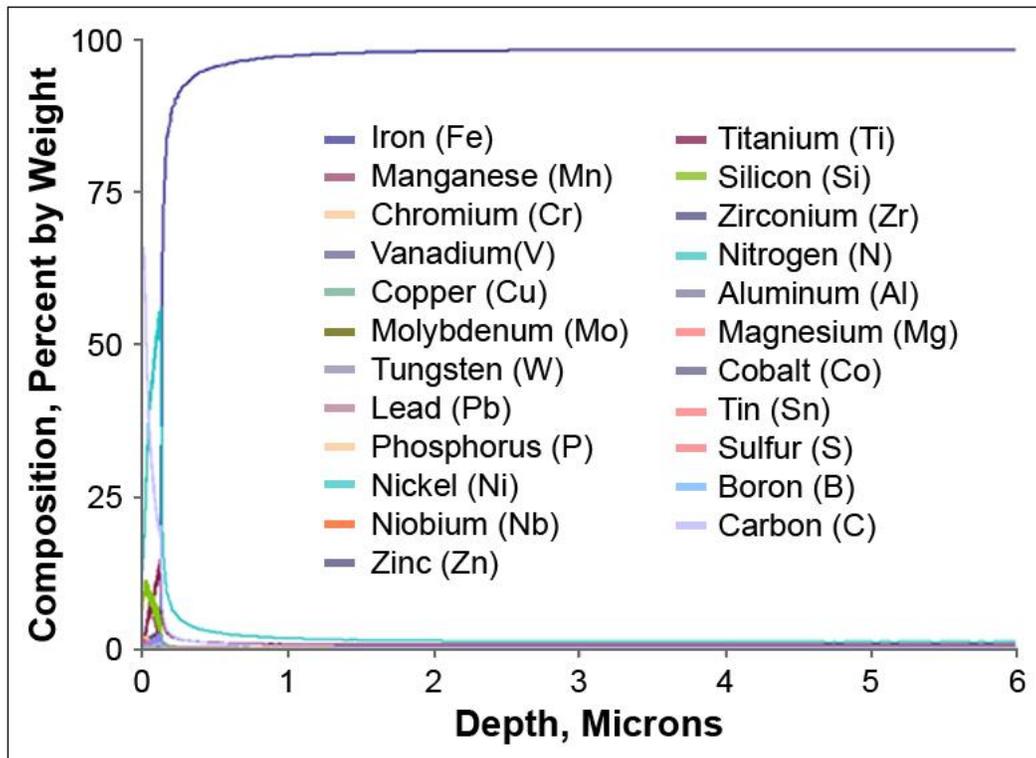
This technique is a particularly sensitive method for determining carbon content in shallow depths below the metal’s surface, and it was thought that any decarburized regions could be analyzed accurately with this method. The glow discharge results were consistently similar to the example seen in Figure 2. Aside from a very thin (less than 1 micron thick) oxidized layer near the inner tank surface, there were no significant deviations from the expected carbon content of the metal. This oxidized layer is the sort that forms on nearly all free metal surfaces exposed to the atmosphere and is not the same as the adsorbed oxygen discussed earlier in this document. The content of other elements was also consistent with what one would expect for steels of these nominal compositions.

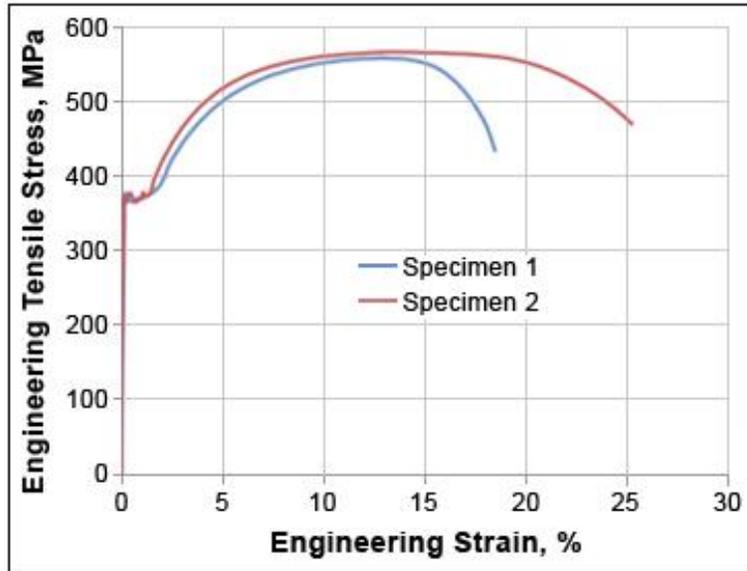
Figure 3. Graph. Tensile test results from a 1,000-gallon nurse tank manufactured in 1966.

ultimate strength, and tensile ductility by elongation. (Ductility is the degree to which a material can be deformed, dented, twisted, or stretched without breaking. A high-ductility material is a copper wire; a low-ductility material is a glass pane.) The data acquired by tensile testing (see Appendix B) were almost entirely within the expected performance range for these steels. The few specimens that fell below the minimum expected strength values were within 1 to 2 percent of the minimum strength value.

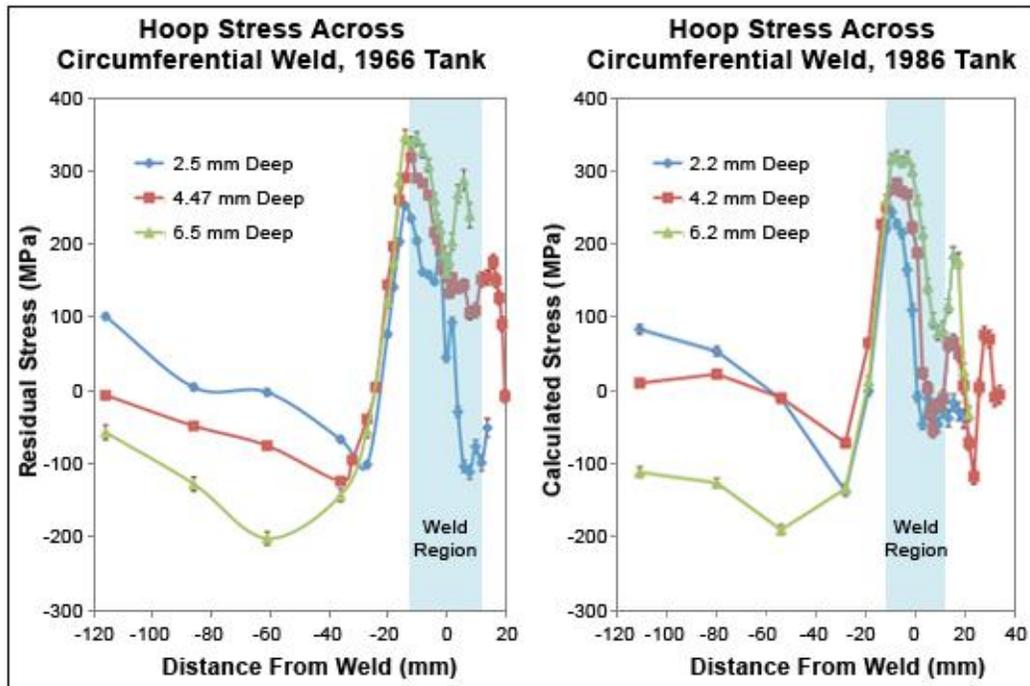
Figure 8. Graph. Residual hoop stress distributions measured by neutron diffraction at LANSCE.

The stress distributions shown in Figure 8 are quite similar for the two different tanks studied using diffraction. In each case the residual tensile stresses (denoted by the positive stress values on the plots) are nearly as large as the tensile yield strength of the steel. (Tensile yield strength is the stress value at which the steel begins to permanently deform under load. If that deforming load is then removed, the steel will not elastically recover its original dimensions.)

When tanks are pressurized with anhydrous ammonia (NH_3), additional stresses are imposed on the metal such that the yield strength of the metal is exceeded, and the ultimate strength that the metal can hold is approached (Figure 9 and Table 1). Thus, the combination of the very high residual stress near the weld and the pressure of the NH_3 , places the metal adjacent to the weld at nearly the highest possible tensile stress state, making it especially susceptible to the initiation of stress corrosion cracking in these regions.

It is significant that the highest tensile stresses are found at the boundary of the HAZ, not in the weld's fusion zone. This information can guide future inspection methods, indicating that the most productive search for cracks would be performed along the unannealed HAZ.

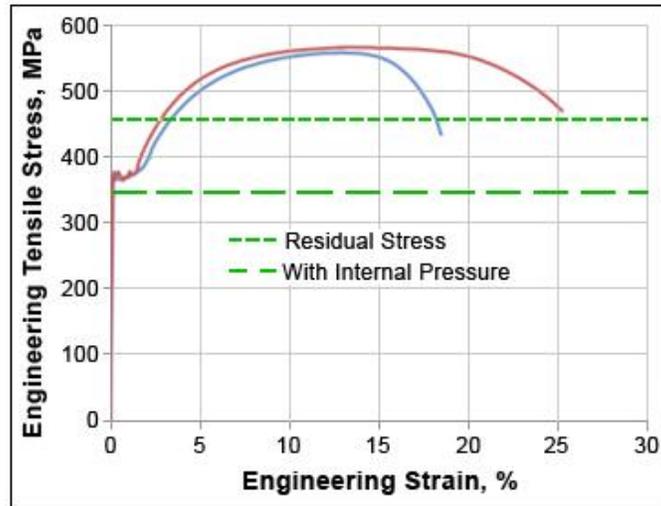
Figure 9. Graph. Superimposition of the maximum residual tensile stress measured at LANSCE (lower horizontal line) with the stress-strain plot for the steel coupons measured from that tank in tensile testing.

In Figure 9, the upper horizontal line shows the sum of the residual tensile stress in the weld heat-affected zones, plus the stress imposed by pressurizing the tank with NH₃; this is the net stress on the steel in a nurse tank in service, neglecting transient stresses on these parts associated with towing the tank over rough ground in farm fields. As noted above the stresses on the feet are not addressed.

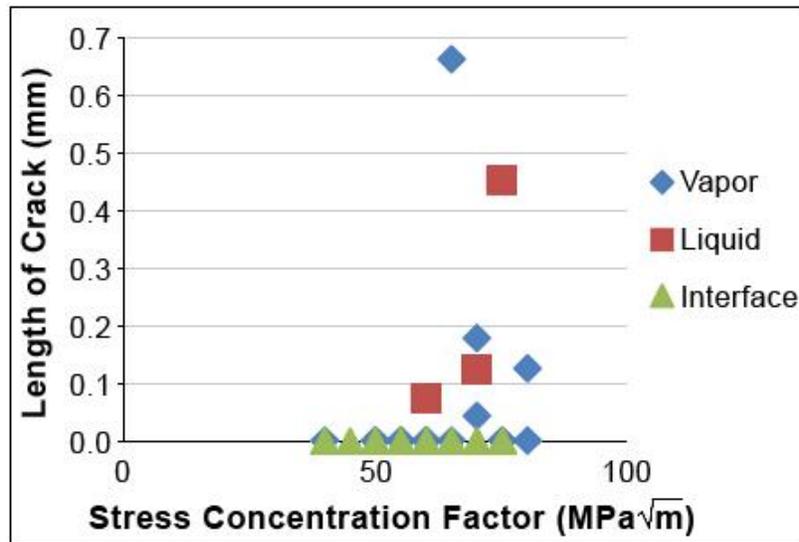
Figure 10. Graph. Crack size as a function of stress intensity factor after 4 months of exposure to NH_3 .

The crack sizes measured in this experiment are displayed in Figure 10 as a function of the stress intensity factor imposed on the specimen (a higher stress intensity factor correlates to a higher stress on the specimen). This figure also indicates the location of the cracked specimen in the tank (i.e., whether it was above, at, or below the tank's vapor-liquid level).

The symbols in Figure 10 indicate whether the cracked specimen was tested in NH_3 vapor only, in ammonia liquid solution only, or partially in vapor and partially in liquid (interface).

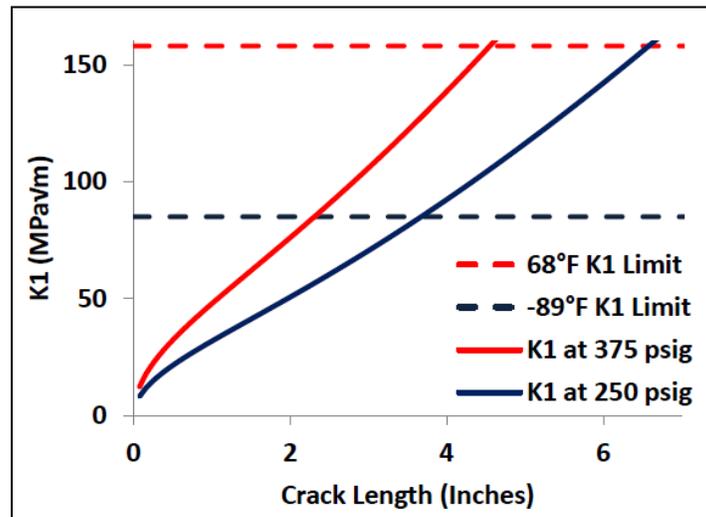
Figure 18. Graph. K1 versus crack length in a 1,000-gallon nurse tank.

Hydrostatic pressure tests will reveal the existence of some subcritical size flaws. By testing at pressures 50 percent higher than working pressures, some subcritical cracks may be revealed. For the 1,000 gallon tank described in Figure 18, at room temperature and 250 psig, the critical crack length is 6.25 inches long. However at the higher pressure when a tank is hydrostatically tested at 375 psig, then the critical crack length is 4.25 inches long. Thus, we would expect that all subcritical cracks between 4.25 inches and 6.25 inches long should be revealed. Note that for this tank, if localized cooling occurs because of a leak allowing anhydrous ammonia to evaporate and chill the steel, then the critical crack length at 250 psig is reduced to 3.7 inches.

In Figure 18, a less than 4.25-inch-long crack is not critical at 20° C (68° F) and 375 psig, but cracks 3.7 to 4.25 inches long *are* critical at -70° C (-94° F) at 250 psig. If this crack develops a through-the-wall leak, localized cooling can cause the temperature at the crack tip to drop to -70° C (-94° F) and the fracture toughness to drop from 185 to 85 MPa $m^{1/2}$ resulting in a catastrophic failure.

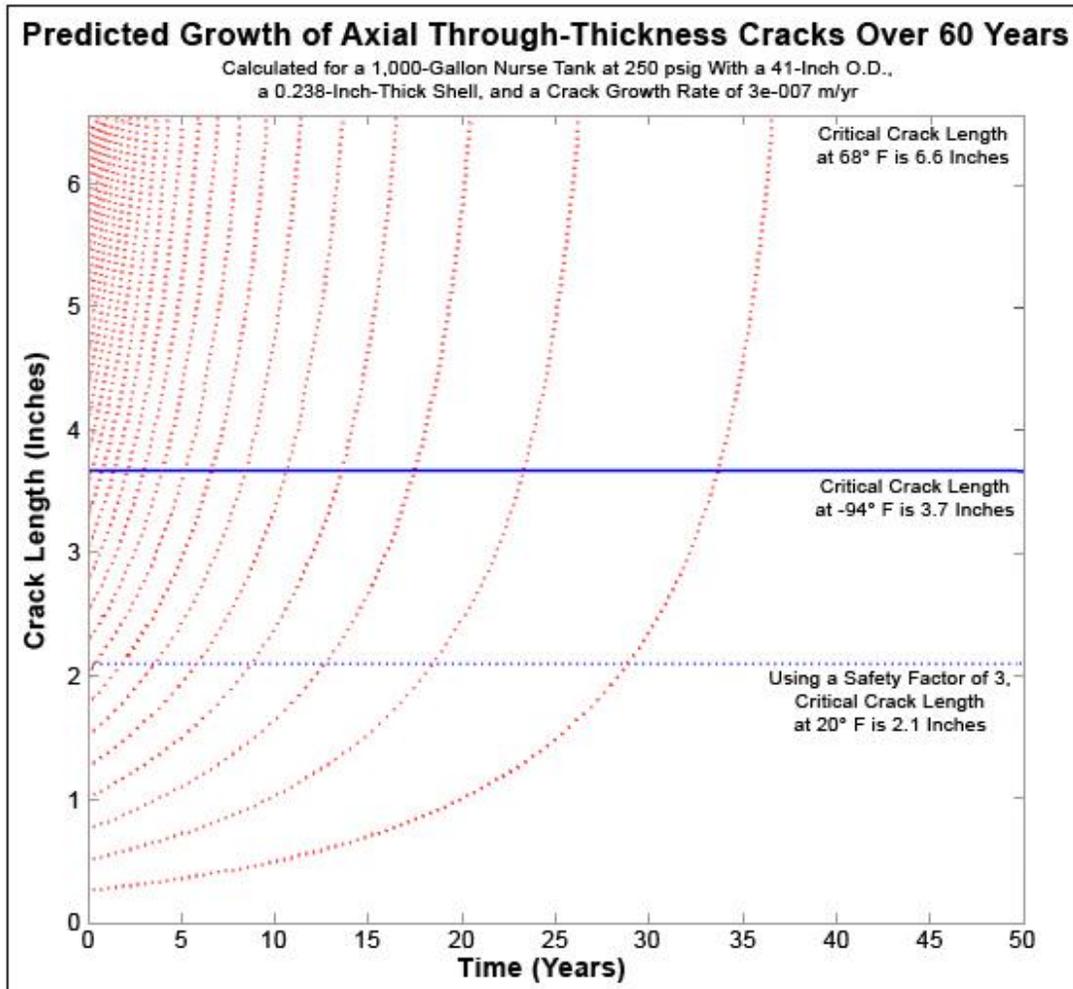
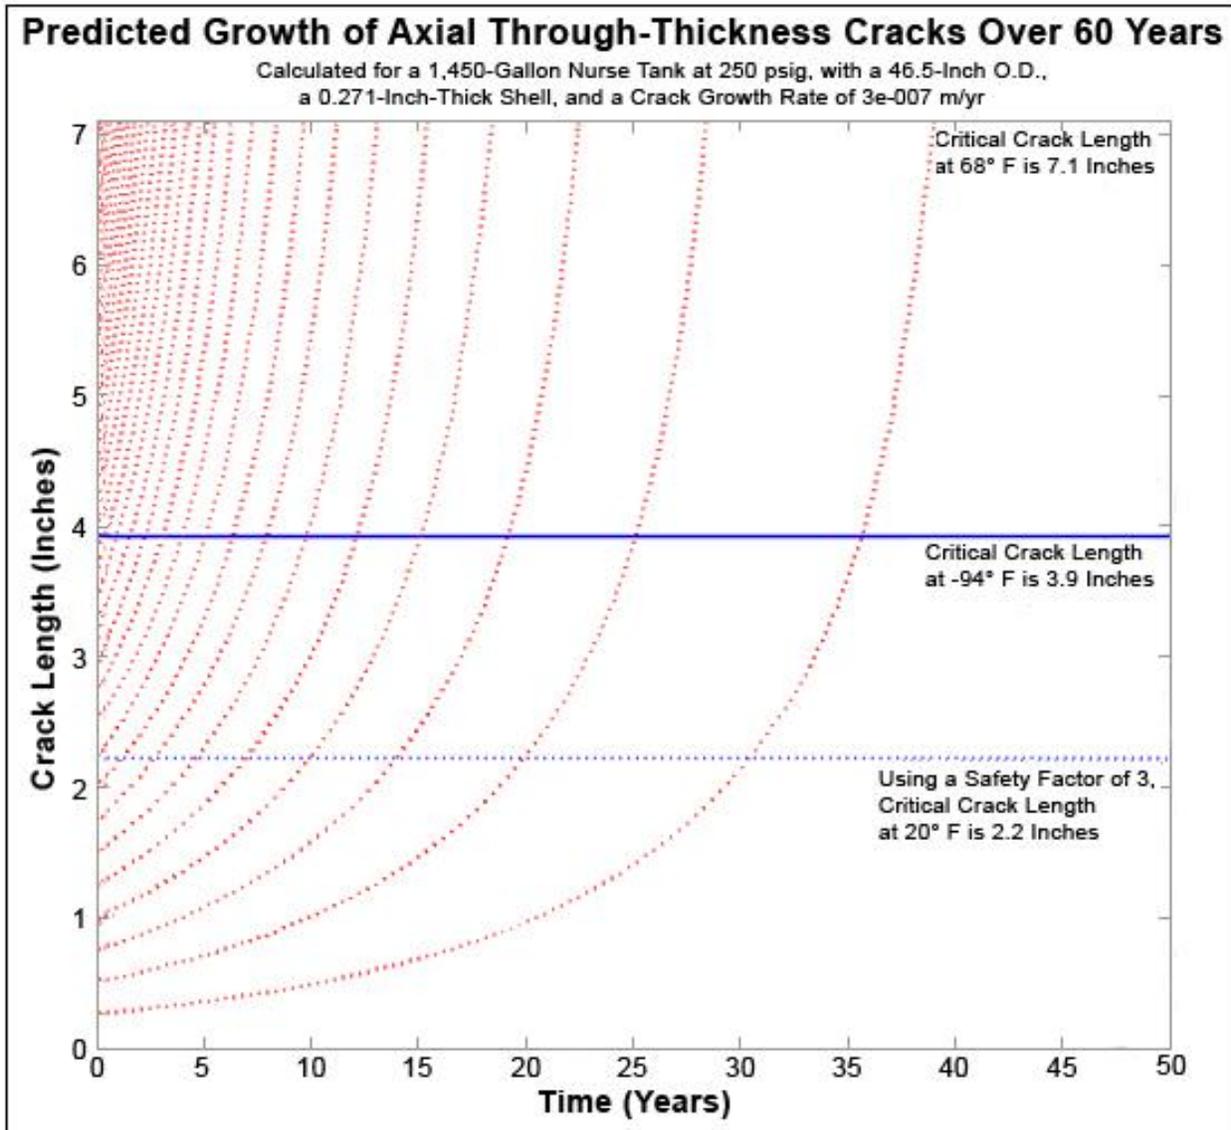
Figure 30. Graph. In this representative 1,000-gallon nurse tank with crack growth based on the highest measured crack growth rate, cracks less than 1.25 inches long will not reach critical length at -94° F for at least 10 years.

Figure 31. Graph. In this representative 1,450-gallon nurse tank with crack growth based on the highest measured crack growth rate, cracks less than 1.25 inches long will not reach critical length at -94° F for at least 10 years.

Figure 30 and Figure 31 represent calculations for 1,000- and 1,500-gallon tanks respectively. For 1,500-gallon tanks, cracks longer than 1.25 inches will not reach critical length at -70° C (-94° F) for at least 10 years, and 2.25-inch cracks will not reach critical length at -70° C (-94° F) for 5 years. For these two examples, the smaller 1,000-gallon tank fails slightly sooner than the 1,500-gallon tank. These calculations allow safe inspection intervals to be calculated.

In the angle-beam inspections performed on the tanks purchased by this project, cracks less than 0.25 inch long were detected. Even the extreme predictions (Figure 30 and Figure 31) show that cracks of less than an inch will not become critical within 10 years. Thus, if the focus of the angle beam inspections were on determining tanks with cracks of around 1 inch or greater, then a

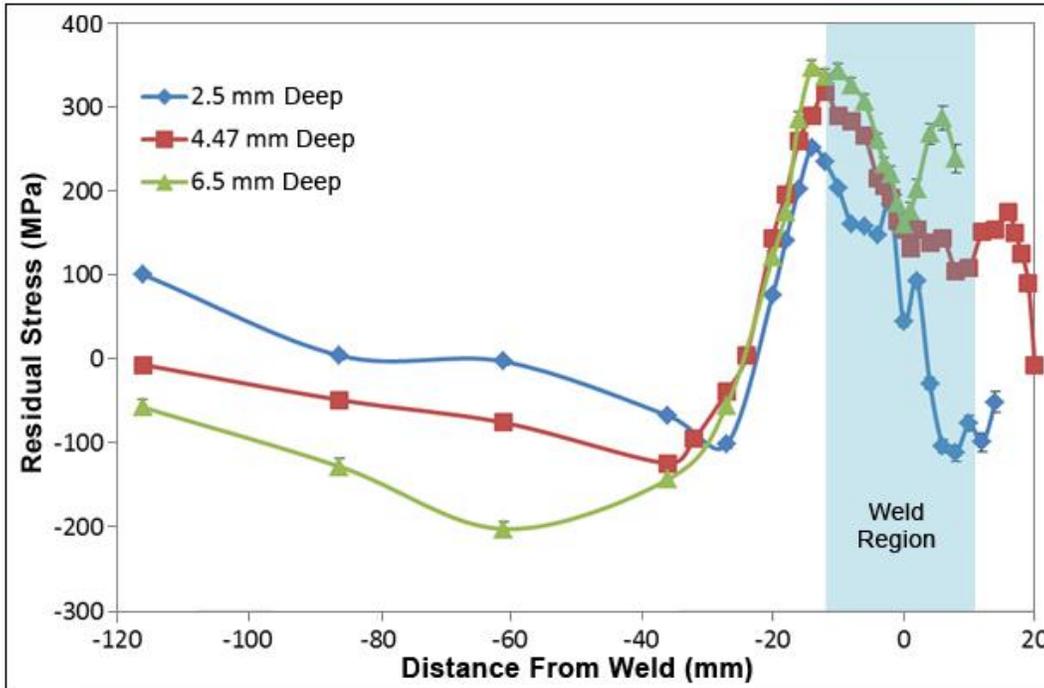
Figure 32. Graph. Hoop stress across the circumferential weld in a 1,000-gallon nurse tank manufactured in 1966. The region of high residual stress extends only 1 inch from the weld.

- These calculations do not incorporate the residual stress due to welding. This is because the region of high residual stress in the heat-affected zones does not extend more than 1 inch (25.4 mm) from the weld as shown in Figure 32. The residual stress in the heat-affected zones is a significant danger for the *initiation* but not for the continued growth of axial cracks.

It should be noted that the vertical band labeled “weld region” on Figure 32 (and on similar residual stress plots that follow) marks the greatest width of the fusion zone of the weld at the surface of the tank (the region where the metal actually melted during welding). However, the fusion zone is tapered (V-shaped). It is widest at the exterior surface of the tank and narrows substantially at greater depths below the exterior surface. All of the neutron diffraction measurement regions were at increasing depths below surface of the tank steel. Thus, although the maximum stress values appear to lie right at the HAZ-weld region boundary, these maximum stress positions actually lie entirely within the HAZ. Although not measured directly by neutron diffraction, the stress right at the interior surface of the nurse tank is probably slightly higher than the highest value shown here. This is because at the surface, residual tensile stress probably equals the steel’s yield strength, meaning that it exceeded the yield strength and caused the metal to plastically deform until the residual stress dropped to the yield strength value. Residual stress equal to the yield strength is often observed in welded structures that have not been given a stress-relief annealing treatment after welding.

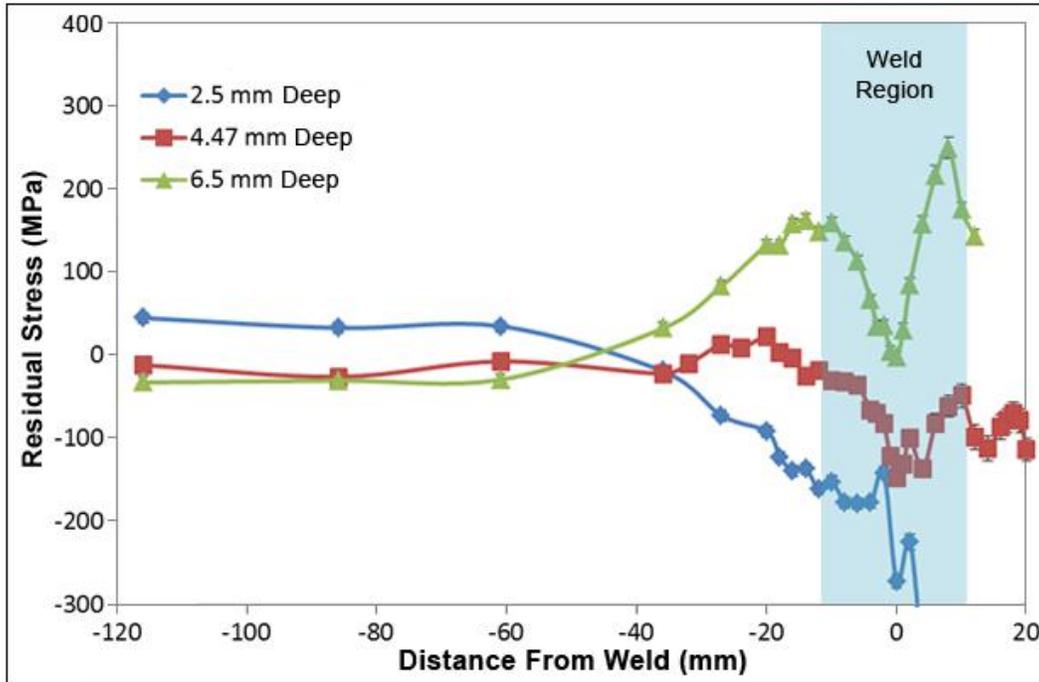
Figure 33. Graph. Axial stress across a circumferential weld in a 1,000-gallon nurse tank manufactured in 1996.

The axial residual stress is more dangerous in its effect on cracks that grow in the hoop direction. Axial stress acts directly on these cracks and the cracks continuously grow within the HAZ stress field, i.e., they do not grow out of this stress field. Additionally, circumferential cracks can grow in both directions along the region where stress is the highest. However, as pointed out early in this appendix, the reason for this report’s focus on axial cracks is because the axial stresses that cause perpendicular hoop cracks to initiate were calculated to be half those of the circumferential or hoop stresses that cause axial cracks to initiate. Thus cracks in the hoop direction are much less likely to initiate, but presumably would grow faster if they initiate. This can be easily seen by comparing Figure 32 with Figure 33.

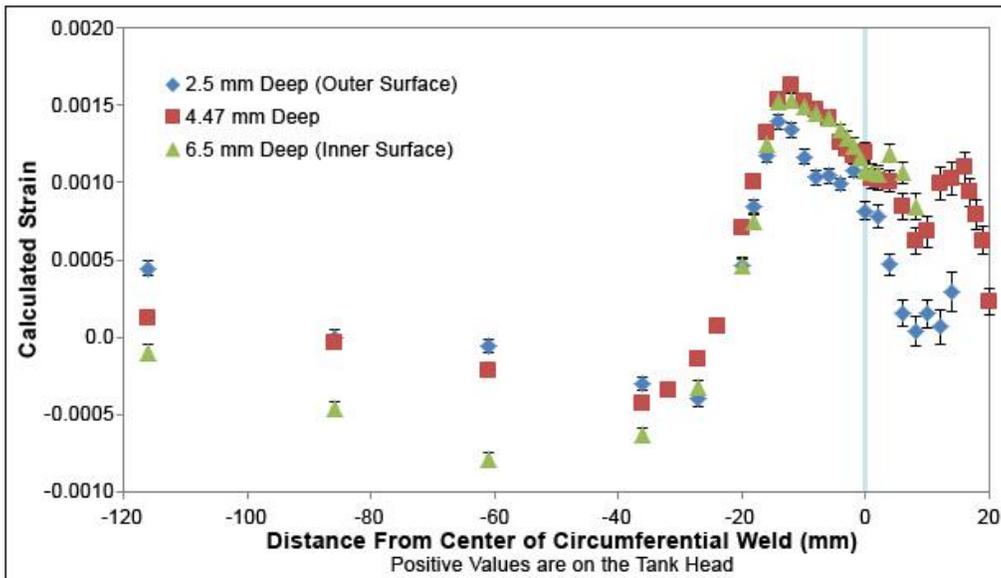
Figure 56. Graph. Hoop strain across the circumferential weld in a 1,000-gallon nurse tank manufactured in 1966.

The hoop strain has higher error bars than the radial or axial strain because the beam had to pass through a greater thickness of steel to get these patterns, and there was more attenuation. The highest tensile strain and therefore strongest contributor to SCC is found within 20 mm of each side of the weld (as seen in Figure 57).

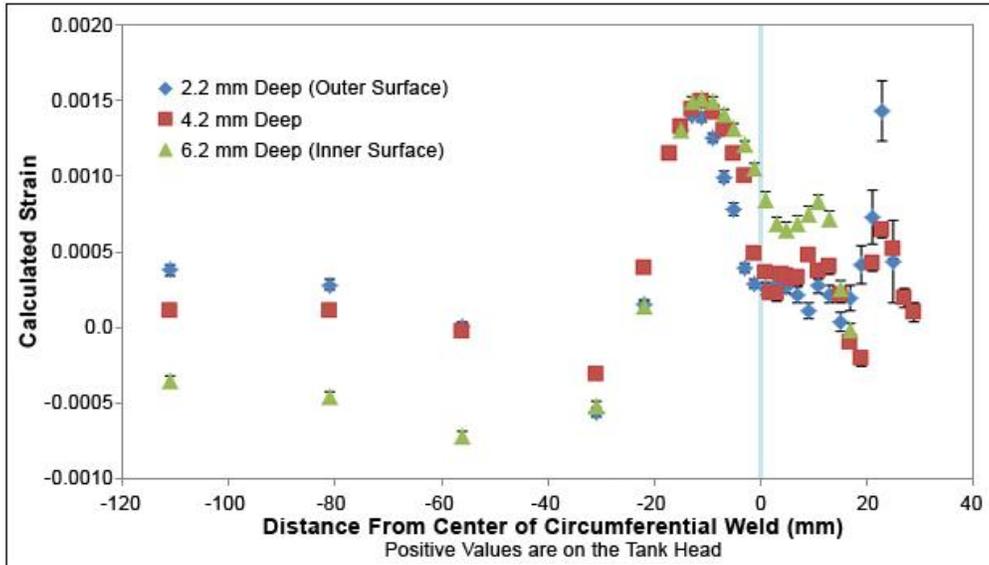
Figure 59. Graph. Hoop strain across the circumferential weld in a 1986 nurse tank.

The error bars grow much larger at 20–30 mm from the weld due to signal attenuation as the beam passed through double thicknesses of steel.

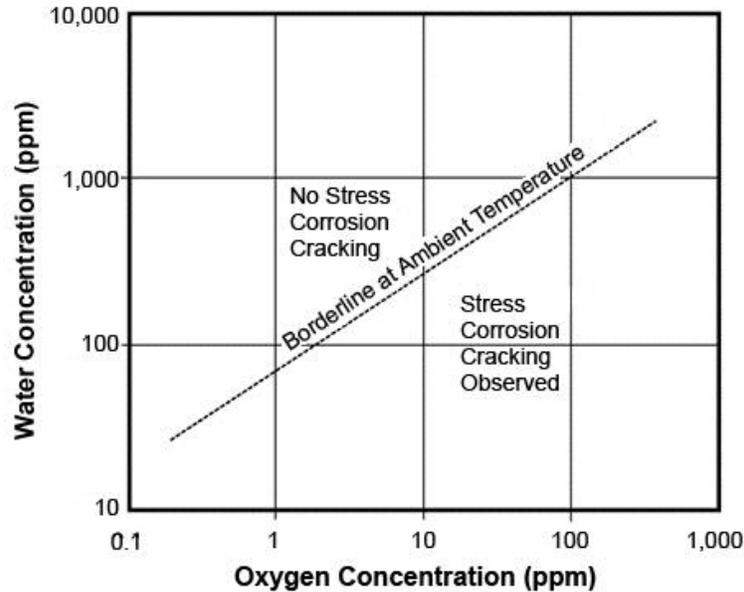
Figure 78. Graph. SSC susceptibility as a function of water and oxygen concentrations in anhydrous ammonia at 18° C (64.4° F). No liquid SCC has been observed above and to the left of the line drawn on the graph.

SCC susceptibility increases as dissolved oxygen content in NH_3 increases and water content decreases. With one exception, no SCC has been observed in environments above and to the left of the dashed borderline in Figure 78 at ambient temperatures (18°C). However, the exception is that SCC has been shown to occur when NH_3 vapor is allowed to condense on steel, even with high concentrations of water present in the liquid solution of NH_3 , as seen in Figure 78.⁽¹⁹⁾

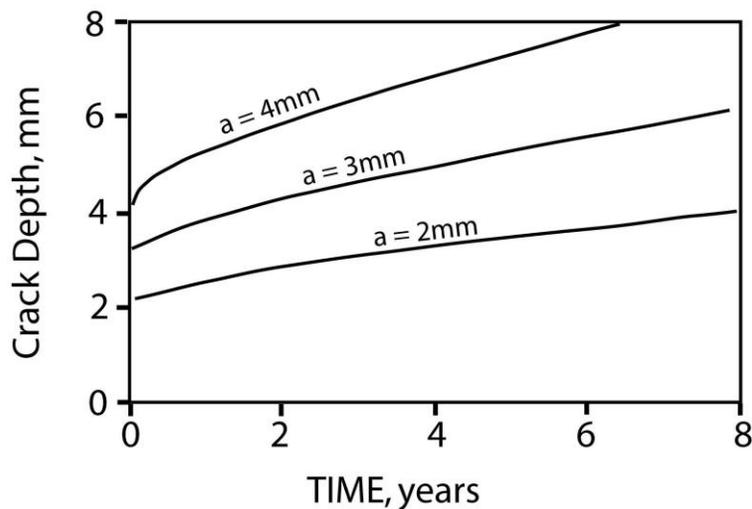
Figure 80. Growth rates predicted by the model above for three possible situations:

reported to be around $50 \text{ MPa m}^{1/2}$. Thus for a 3-mm crack in an 11-mm wall, the crack will grow 5 mm in 4 years and 6 mm in 8 years according to the model (as shown in Figure 80). The Lunde and Nyborg model above was developed by machining notches into compact tension specimens (as shown in Figure 81) to develop samples with known K_I values. The compact tension specimens were then subjected to different stresses while in an NH_3 -oxygen environment over periods of 200 to 900 hours. The extent of cracking was studied, and crack lengths were compared as a function of stress intensity factor and time (as shown in Figure 82). The maximum observed crack growth rate for 380 MPa yield strength C-Mn steel, an alloy quite similar to the A455 and A516 steels often used in nurse tanks, was 2mm per year for a K_I of $40 \text{ MPa m}^{1/2}$ and 6mm/year for a K_I of $60 \text{ MPa m}^{1/2}$.⁽²²⁾ It was noted that strain rate and amplitude are important factors in determining crack growth rates, and higher values for either led to faster flaw propagation.⁽²³⁾
