Uncontrolled Concrete Bridge Parapet Cracking

State Job Number *134602*

June 2013

FINAL REPORT

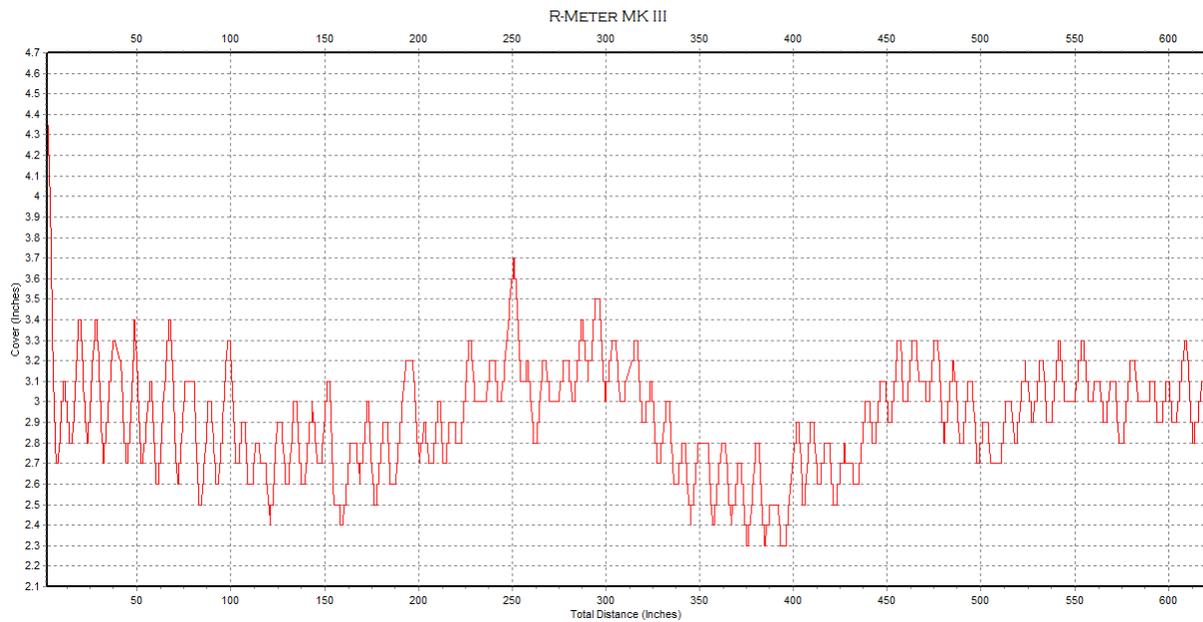
Figure 23: Scan map of Sheldon Road, north parapet, 0-48 feet

The cover meter's "scan map" function was used to determine the spacing between the vertical bars for the entire length of each parapet. This function works by taking continuous cover readings along a specified length, from which the locations of the bars can be determined by identifying the low values points in the graph generated from this data. The device was set to record data in intervals of 48 feet (14.6 m), however this process was repeated for every 40 foot (12.2 m) section of the parapet in order to make it easier to identify the location where each scan map begins. Hence, each parapet required six separate scan maps of 48 feet (14.6 m) – where the final eight feet of each map is repeated in the first eight feet (2.4 m) of the next map – to cover the full distance of 226 feet (68.9 m) between the construction joints on either end of the bridge. These maps show a typical spacing of approximately 12 inches (305 mm). This again indicates that, in general, the parapet reinforcement was constructed properly. An example of one of the scan map graphs can be seen in Figure 23 below. All scan maps for the north parapet can be found in Appendix C. All scan maps for the south parapet can be found in Appendix D.
