Testing and Recommended Practices to Improve Nurse Tank Safety: Phase II

U.S. Department of Transportation
Federal Motor Carrier Safety Administration

December 2013

1. Report No. FMCSA-RRR-13-055	2. Government Accession No.	3. Recipient's Catalog No.	
4. Title and Subtitle Testing and Recommended Practices to Improve Nurse Tank Safety: Phase II		5. Report Date December 2013

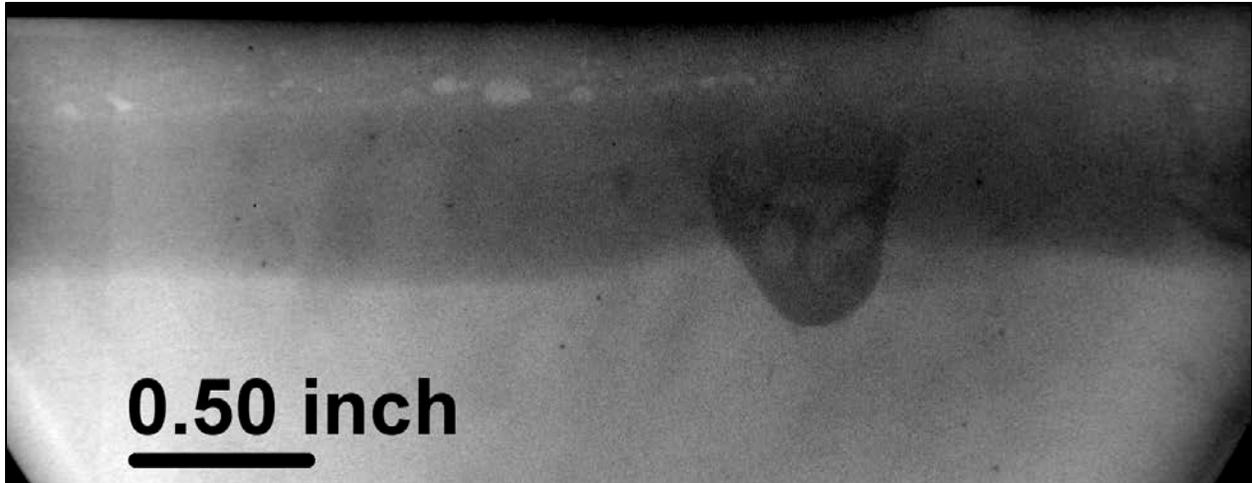
Figure 12. Photograph. Close-up of the weld shown in Figure 11.

Figure 11. Photograph. Radiographic image of section of center girth weld showing radio-opaque markers (1 and 2) placed at the locations of the pinholes.

Note: A line of porosity (ellipses) can be seen in the center of the weld.

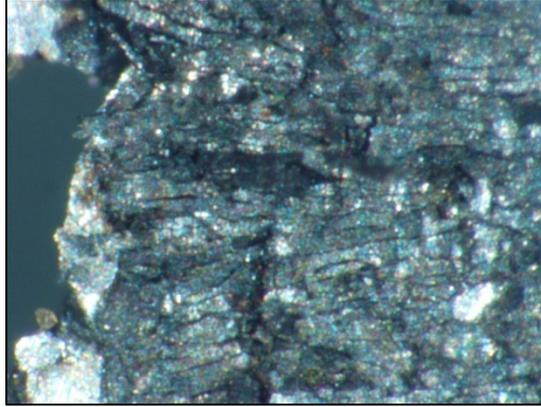
Figure 19. Photograph. Sample #055 before the sample was inserted into the tank.

Figure 21 shows a close-up of one specimen before, during, and after 15 months of exposure. The crack lengthened during the first 3 months of exposure. No further growth was seen after that.

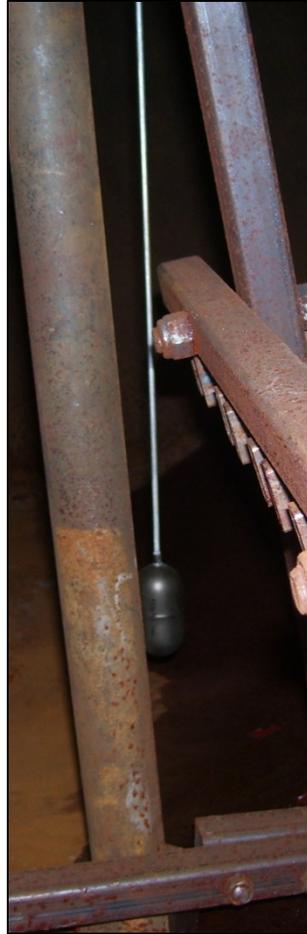
The interior surface of the tank containing N-Serve had more corrosion product than the other two tanks. Another example of adverse corrosion effects of N-Serve was that the float gage in the N-Serve tank had corroded and broken off, while the other two float gages were still whole (see Figure 24 and Figure 25). Analysis of nurse tanks during Phase I of this project showed that there was little wall thinning due to corrosion from NH₃ containing 0.2 percent water. However, Phase II observations of the test tank containing N-Serve indicate that tanks containing N-Serve should be monitored to ensure that the walls have not become dangerously thin.

Figure 25. Photograph. The float gauges from the other tanks (not containing N-Serve) were still whole.

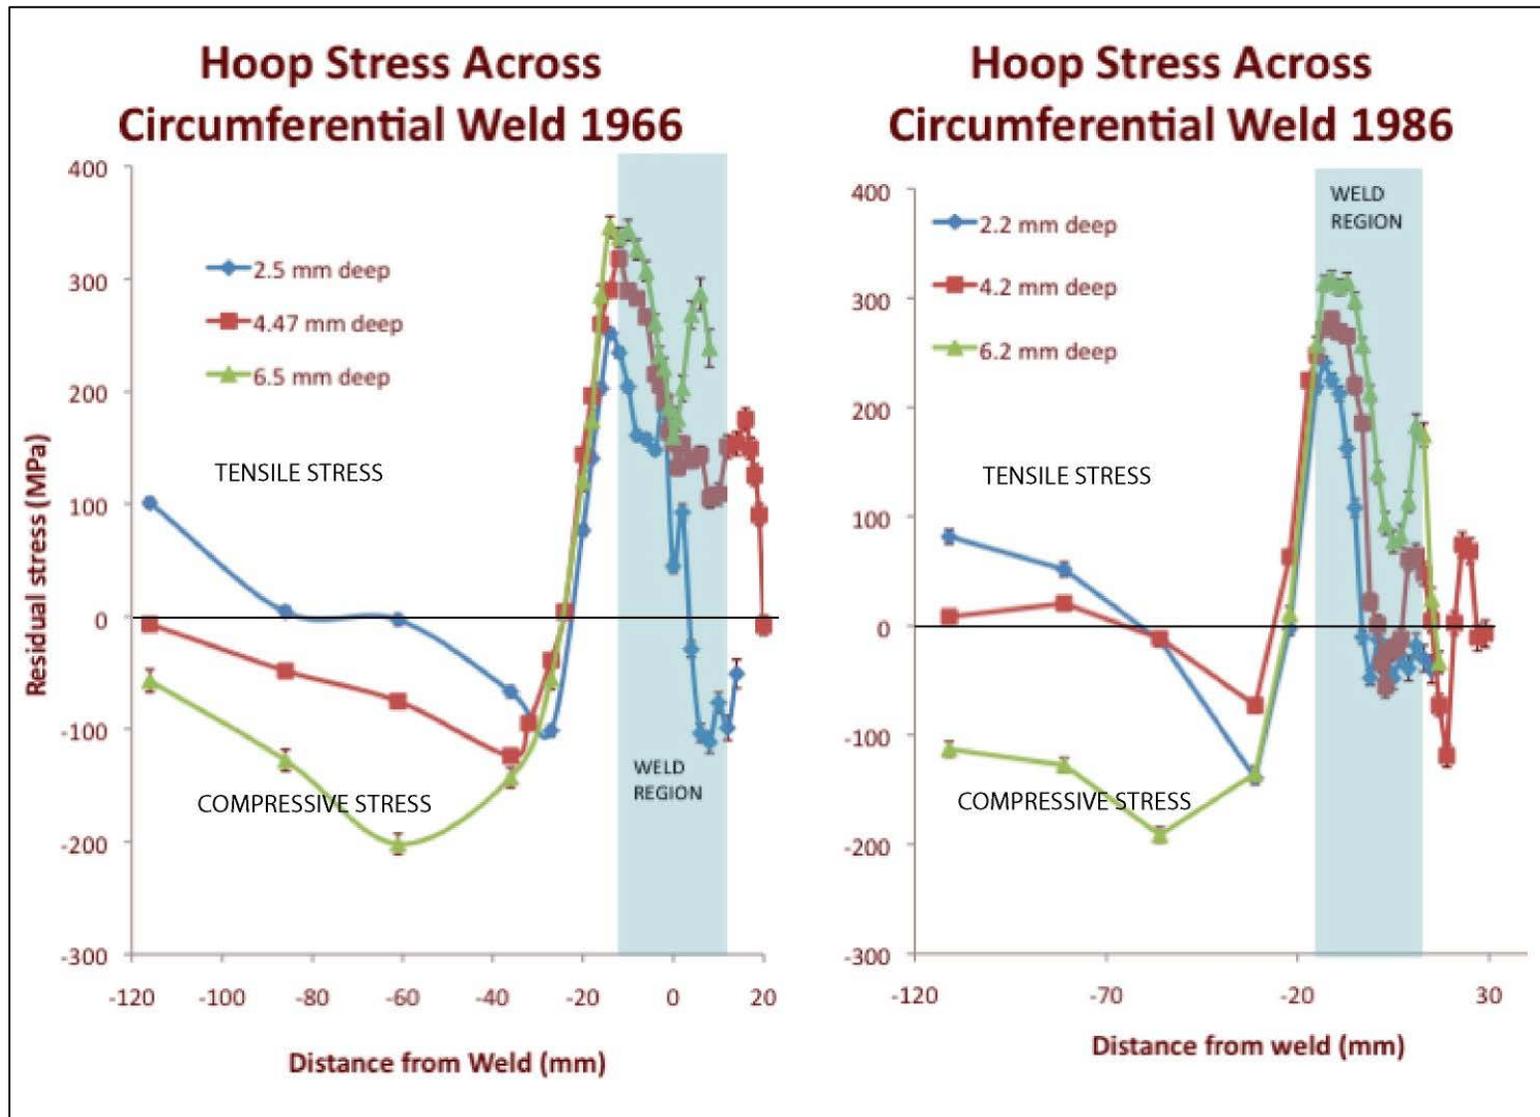
The stress distributions shown in Figure 31 are quite similar for the two different unannealed tanks studied using diffraction in Phase I. In each case, the residual tensile stresses (denoted by the positive stress values on the plots) are nearly as large as the tensile yield strength of the steel. Tensile yield strength is the stress value at which the steel begins to permanently deform under

It is significant that the highest tensile stresses are found at the boundary of the weld and the HAZ, not in the weld's fusion zone. This information can guide future inspection methods, indicating that the most productive search for cracks would be performed along the edge of the weld bead looking at both the HAZ and the weld.

Figure 31. Scatterplot. Residual hoop stress distributions measured by neutron diffraction at LANSCE; tensile stresses are positive, while compressive stresses are negative.

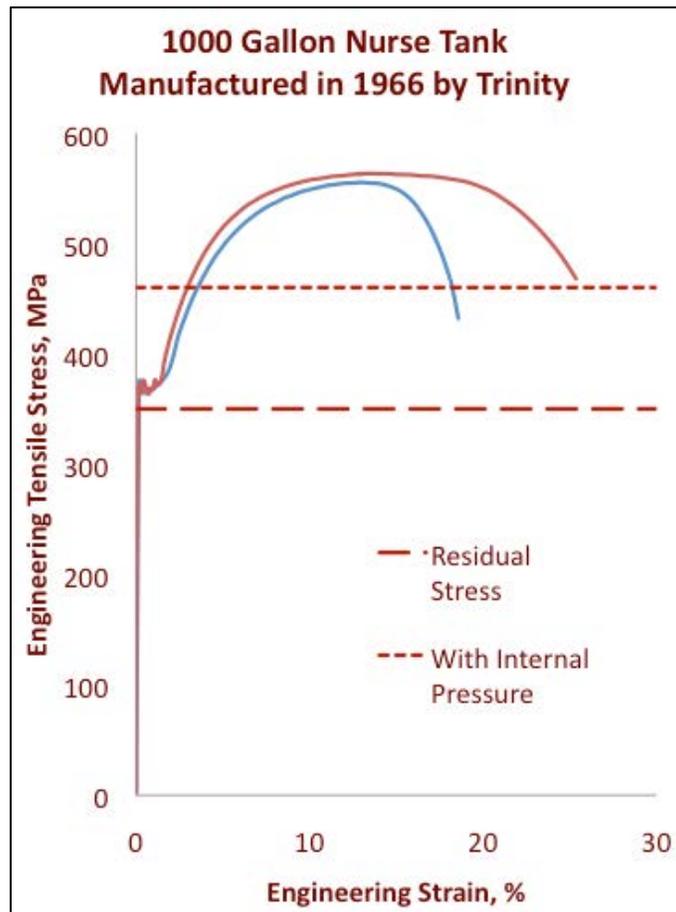
When tanks are pressurized with ammonia, additional stresses are imposed on the metal such that the yield strength of the metal is exceeded, and the ultimate strength that the metal can hold is approached (Table 5 and Figure 32). Thus, the combination of the high residual stress near the weld and the pressure of the ammonia places that metal at nearly the highest possible tensile stress state, making it especially susceptible to SCC initiation in these regions.

Figure 32. Line graph. Superimposition of the maximum residual tensile stress measured at LANSCE (lower horizontal line) with the stress-strain plot for the steel coupons measured from that tank in tensile testing.

Figure 32 above displays several things. First, the top two curves show the stress-strain behavior of steel specimens from a nurse tank wall as the samples were pulled in tensile stress (y-axis) to ever increasing strain deformation lengths (x-axis). Notice that lines for both samples rise to about 375 MegaPascals (MPa) without showing any strain deformation. This is the elastic range where the steel will return to its original shape with removal of the stress. As shown in Figure 32, when stress greater than 375 MPa was placed on the steel, the stress began to cause plastic deformation along the x-axis, and the stress rose to a maximum value near 14 percent on the strain axis. Then the stress value actually began to decrease at higher strain deformations until the specimen broke at the right end of the curve.

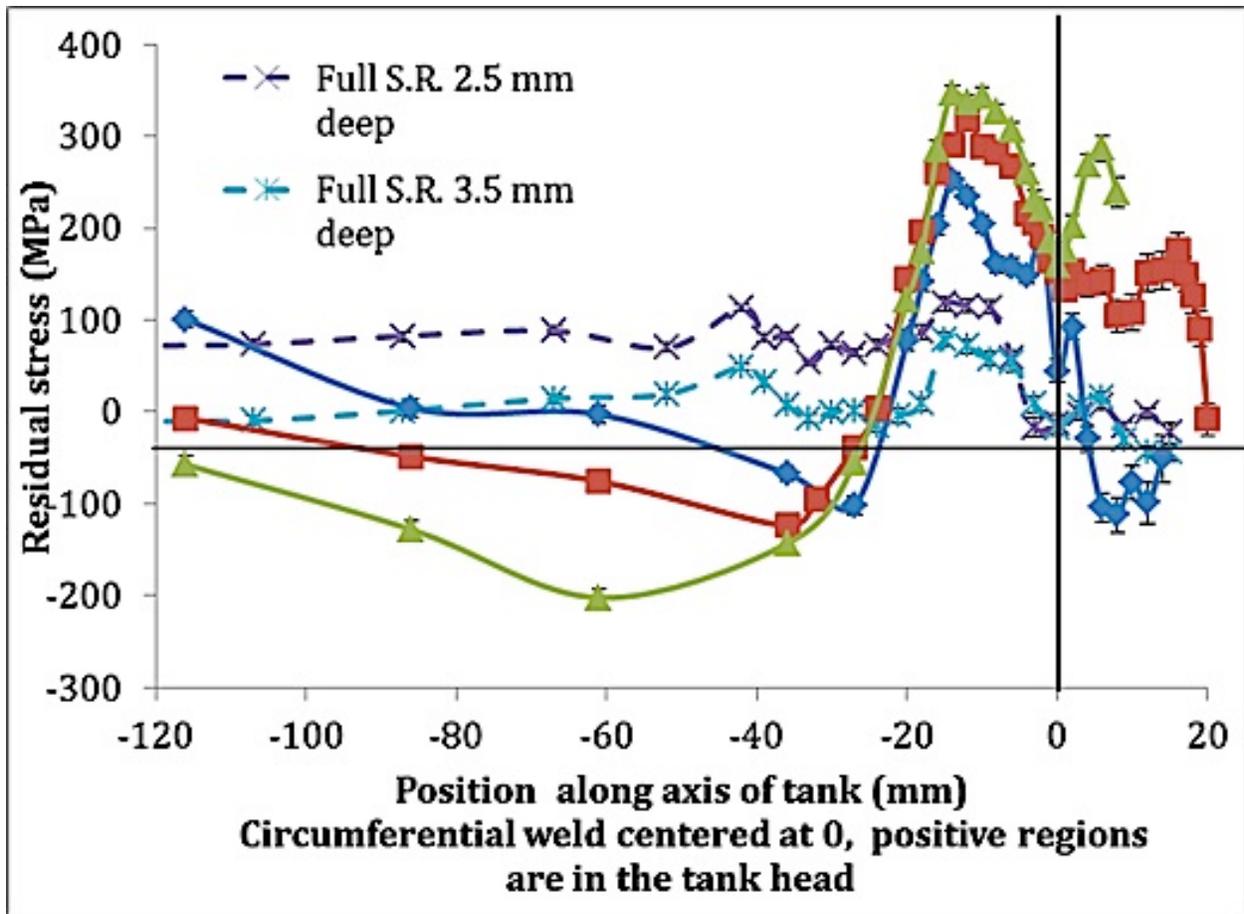
The results of these diffusion measurements and calculations of stress are shown below in Figure 34, Figure 35, and Figure 36. Figure 34 shows the effectiveness of the annealing (or PWHT) process. The hoop stress has been reduced from a maximum value of 346 MPa (50 kilopounds per square inch [ksi]) to a maximum value of 118 MPa (17 ksi). This is a 66-percent reduction in residual stress. The axial stress remains the highest stress in the annealed tank, with a high of 166 MPa (24 ksi), but this has been reduced from a high of 251 MPa (36 ksi) in the unannealed tank. These results demonstrate the effectiveness of the ASME-recommended PWHT in relieving the residual stress in a nurse tank.

Figure 34. Graph. Hoop stress across circumferential weld in a fully strain-relieved (S.R.) nurse tank manufactured in 2011 (solid lines) overlaid with an unannealed tank manufactured in 1966 (dashed lines).

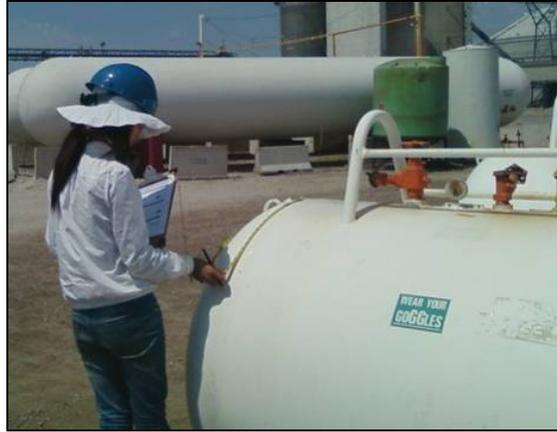
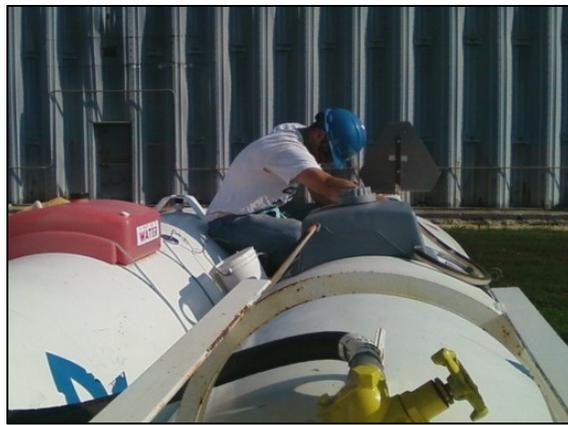
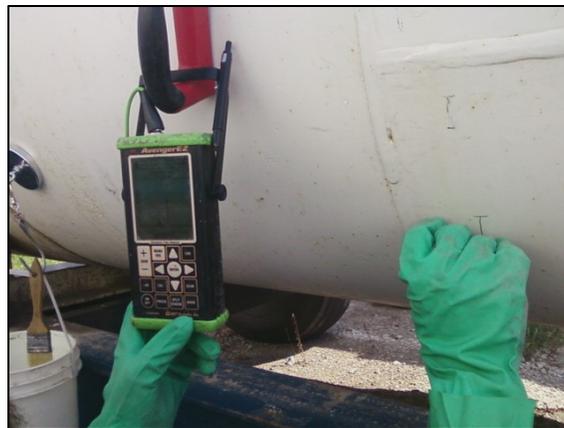
Figure 38, Figure 39, and Figure 40 show students performing ultrasonic inspections of typical tanks. One inspector could typically examine one tank in 2-4 hours. One thousand gallon tanks had 50 ft of welds and had to be inspected in two orientations on both sides of the weld for a total of 200 ft of inspection. One thousand four hundred fifty-gallon tanks had up to 66 ft of welds for a total of 264 ft of inspection. Tanks with more flaws took more time to inspect because the length of each flaw had to be determined, and the length and location had to be recorded. Figure 41, Figure 42, Figure 43, Figure 44, and Figure 45 show the form that was used by the students when recording the indications for each tank.

Figure 38. Photograph. Student conducting an examination of a nurse tank.

Figure 39. Photograph. Close-up of inspection of a nurse tank.

Figure 40. Photograph. Close-up of the unit used to conduct nurse tank inspections.

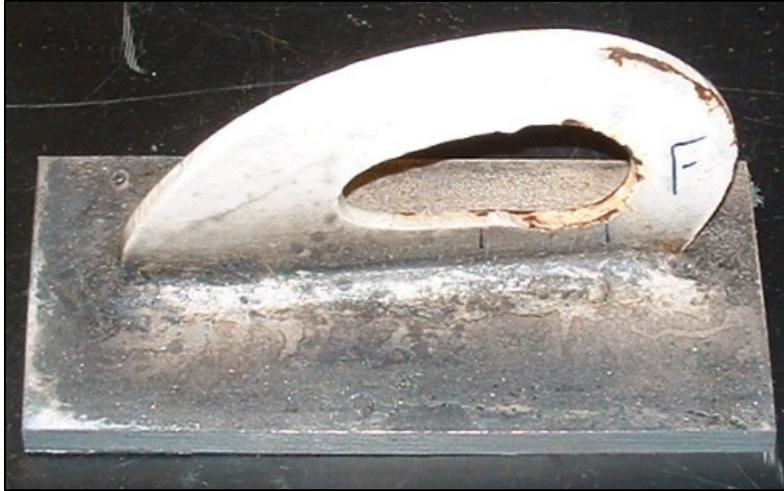
Cutting apart lifting lugs has shown that these regions often have voids between the handle steel and the shell. These voids occur because the tank handles are T-welds that are fillet-welded on each side. Figure 59 shows one of these tank handles. If complete penetration is achieved, the welds on either side of the handle meet and no void results. However, as shown in Figure 60, if penetration is incomplete, a crack can exist between the T of the handle and the base metal of the tank.

Figure 59. Photograph. Example of one type of tank handle.

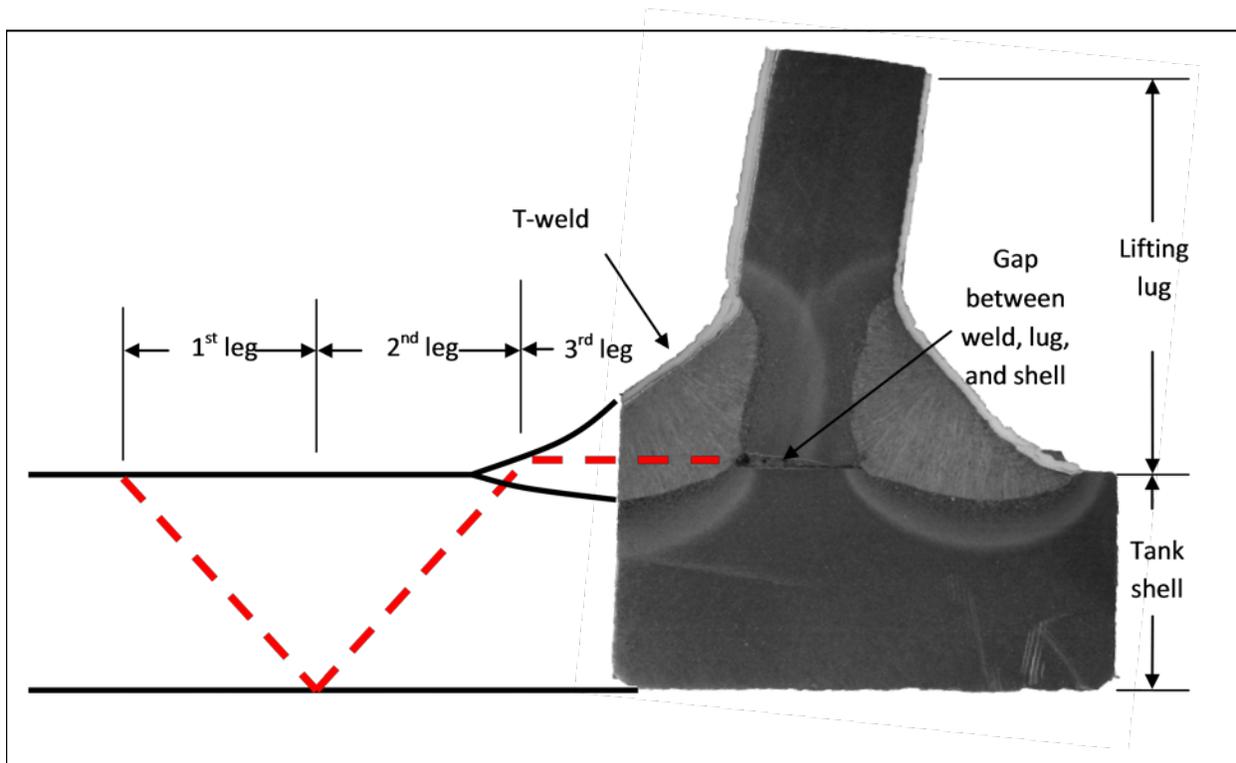
Figure 60. Diagram. Schematic showing how a third 'leg' response in the acoustic signal can be caused by a gap between the lug and the base metal.

Although this might be considered a flaw since complete penetration has not been achieved, this type of weld does meet ASME Boiler and Pressure Vessel Code because the welds are at least 1/4-inch thick. The relevant diagram detailing how measurements are taken is shown in Figure 61.

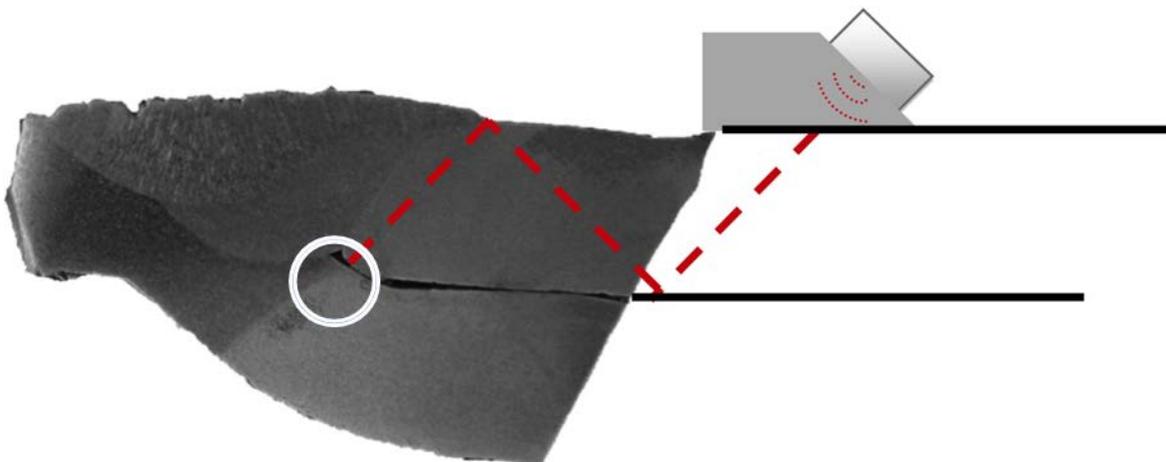
Many indications found at lap welds, such as the head-to-shell, were recorded separately as indications “in the weld” and were classified differently than those from the HAZ. Micrographs taken from regions with these in-the-weld indications show that these readings can occur because of the nature of the joint between the two welded sections (see Figure 62). In these regions, the weld bead does not penetrate to the bottom edge of the overlapping plate. This produces a “corner trap” (circled in Figure 62) where the acoustic signal can be reflected, producing an indication from the unwelded corner and not from a crack. For comparison, Figure 63 shows an example of a weld where complete penetration has been achieved.

Figure 62. Diagram. Schematic with a cross-section of a lap joint showing why a signal is generated at a weld containing a blind corner.

These in-the-weld indications were seen in the majority of tanks. Figure 62 illustrates why (in tanks where in-the-weld indications were found) they would be detectable from only one side of a girth weld. It was suspected that over 50 percent of the length of the circumferential welds contained “blind corner” regions.

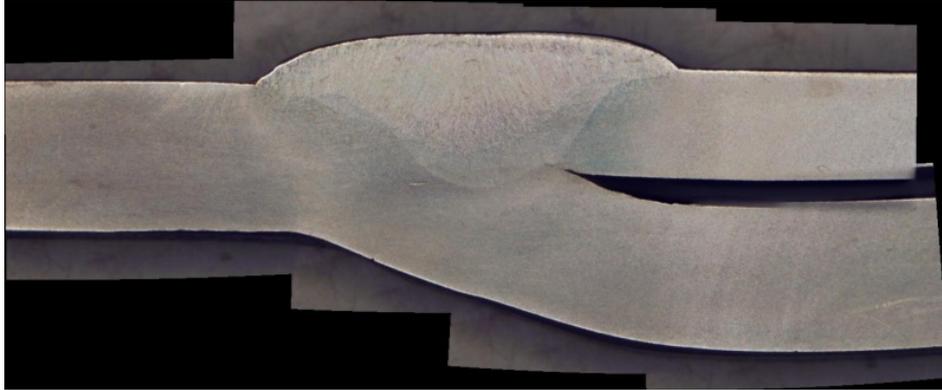
Figure 63. Diagram. A cross-section of a lap joint showing full penetration of the weld bead.

Note: This section of weld did not have indications “in the weld.”

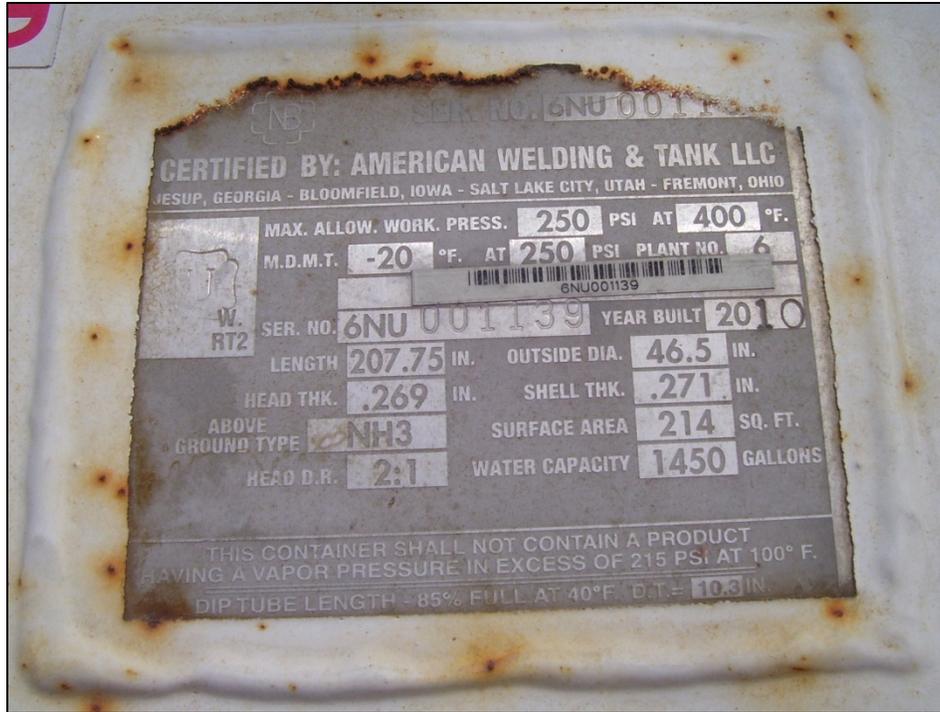
The 1,450-gallon tank with serial number 6NU001139 was donated to ISU by AWT. The data plate is shown in Figure 74. Manufactured in 2010, this tank quickly developed a pinhole leak (also on vapor valve), as shown in Figure 75.

Figure 74. Photograph. Data plate for nurse tank 6NU001139, which was certified in 2010 by AWT.

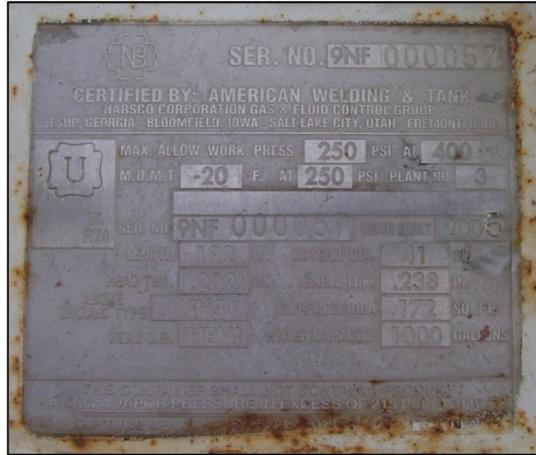
Figure 78. Photograph. The data plate for nurse tank 9NF000057, which was certified by AWT in 2005.

A nurse tank with the serial number 9NF000057 was donated to ISU by AWT. This tank developed a leak at one of the welds connecting a leg to the tank. The data plate for this tank is shown in Figure 78. This is more likely to be a fatigue failure than a welding problem since the leg weld does not penetrate the shell.

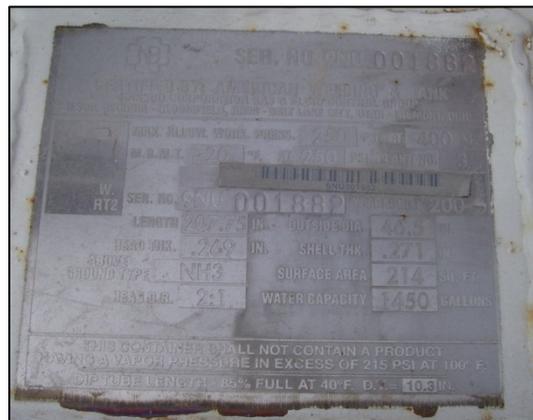
Figure 85. Photograph. Data plate for nurse tank 9NU001882, which was certified by AWT in 2007.

A nurse tank with serial number 9NU001882 (Figure 85) was also certified by ATW and donated to ISU. This tank had two leaks on the center circumferential weld (Figure 86).
