**DEVELOPING GUIDELINES FOR REPAIRING SEVERE EDGE
FAILURES: TECHNICAL REPORT**

Report 0-6271-2-1

Project 0-6271

Published: April 2014

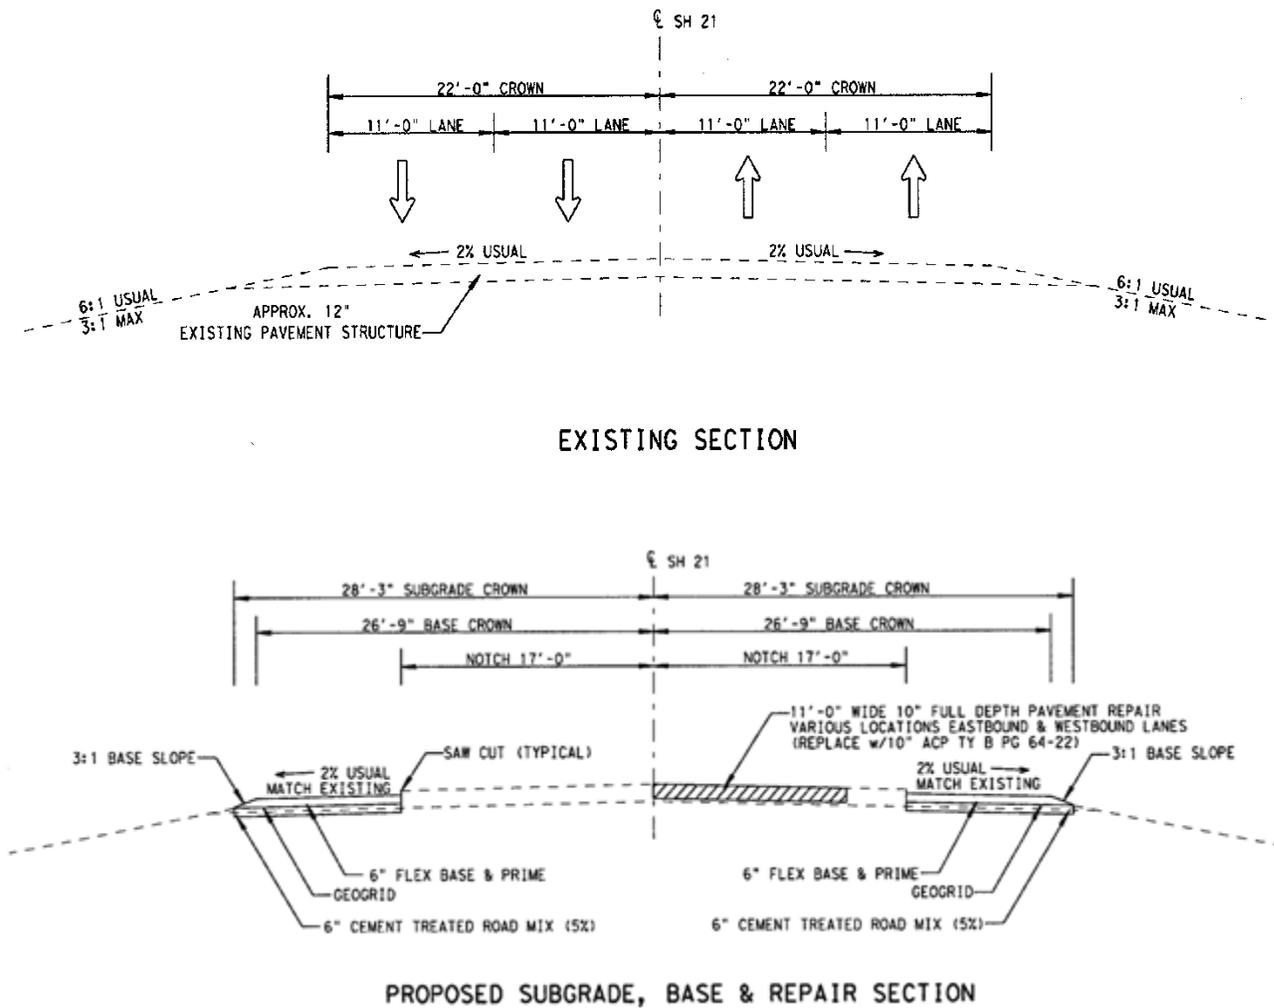
Figure 3. Existing and Proposed Sections on SH 21 from US 290 to FM 2440.

Figure 3 presents the existing and proposed typical sections from the Austin District project on SH 21 from US 290 to FM 2440. Key elements from the plans included:

- Use of road-mixed cement treatment with a geogrid on top of the cement-treated layer.
- Placement of a flexible base course over the geogrid to provide additional protection from reflection cracks.
- Treatment of distress in the inside lines with full-depth pavement repair replacing with Type B mix.

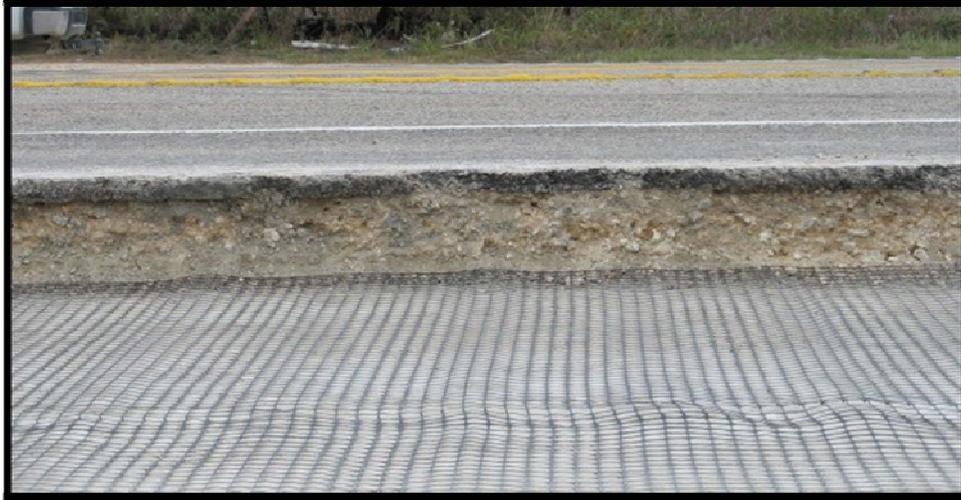
Figure 4. Geogrid Placement on SH 21.
Image Courtesy of Mike Arellano.

These sections have been constructed. Figure 4 shows the geogrid placement on SH 21.

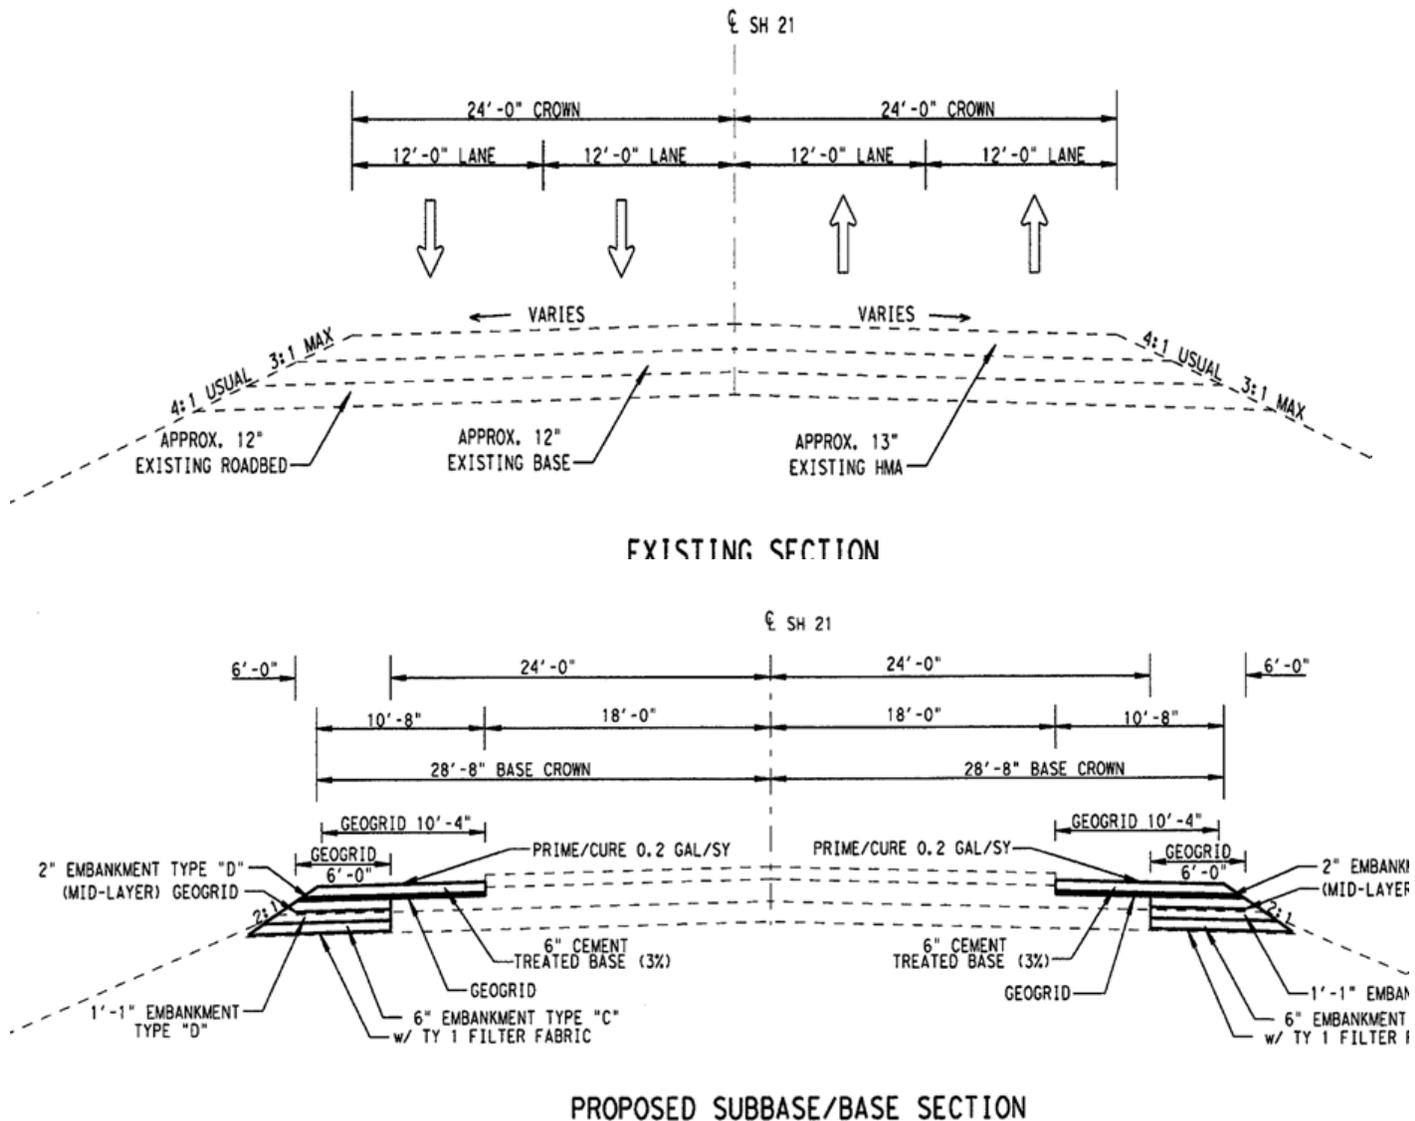
Figure 6. Existing and Proposed Double Geogrid Sections on SH 21.

Figure 6 presents the typical existing section and the proposed double-geogrid section. Key elements from the plans included:

- The pavement would gain a 4 ft shoulder and the subgrade would be cut to a depth exceeding the depth of the weak zone observed in the DCP profiles.
- The widened pavement embankment included a mid-level geogrid.
- The cement treated base would be over a second geogrid; the plans also called for microcracking the cement treated base.
- The final surfacing would be a thin overlay mix designed using both the Hamburg and Overlay Test.

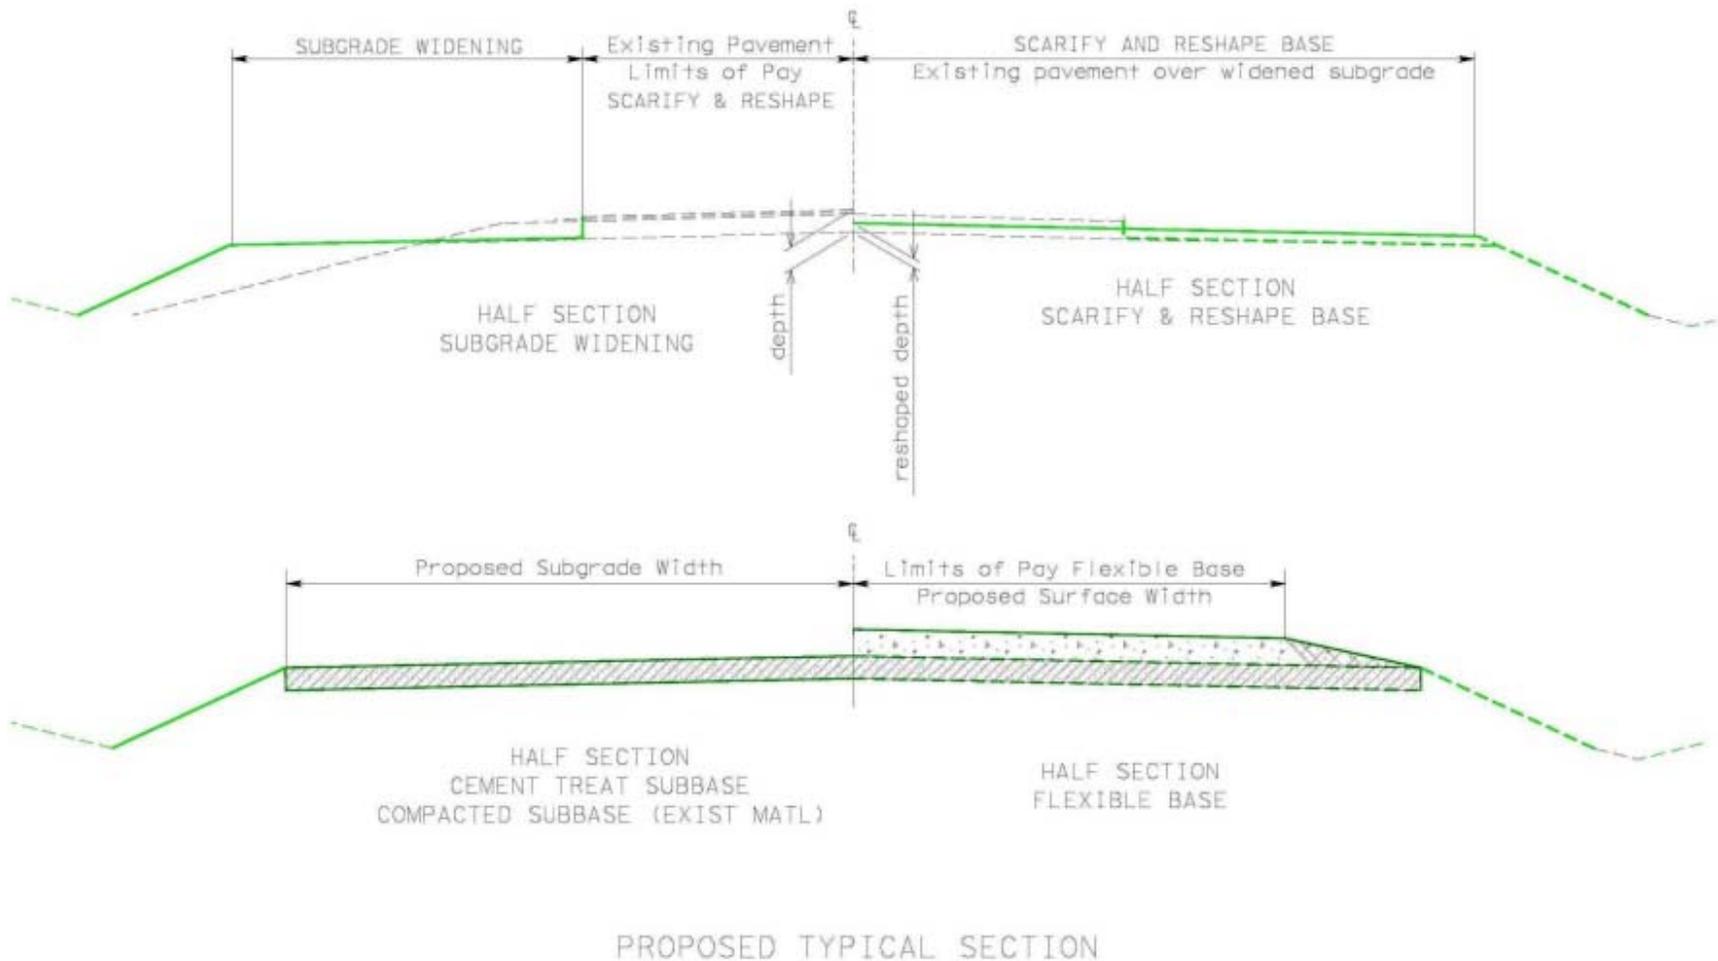
Figure 7. Typical Section for Low-Volume Roadway Repair in the Bryan District.

Figure 7 illustrates a typical cross section for low volume roadway repair in the Bryan District. Based upon the soils tests, historical problem areas, and zones of weak subgrade detected in the FWD, the district will select limits of where to use geogrid reinforcement. The purpose of the geogrid is to minimize reflective cracking from the subgrade up through the pavement structure.

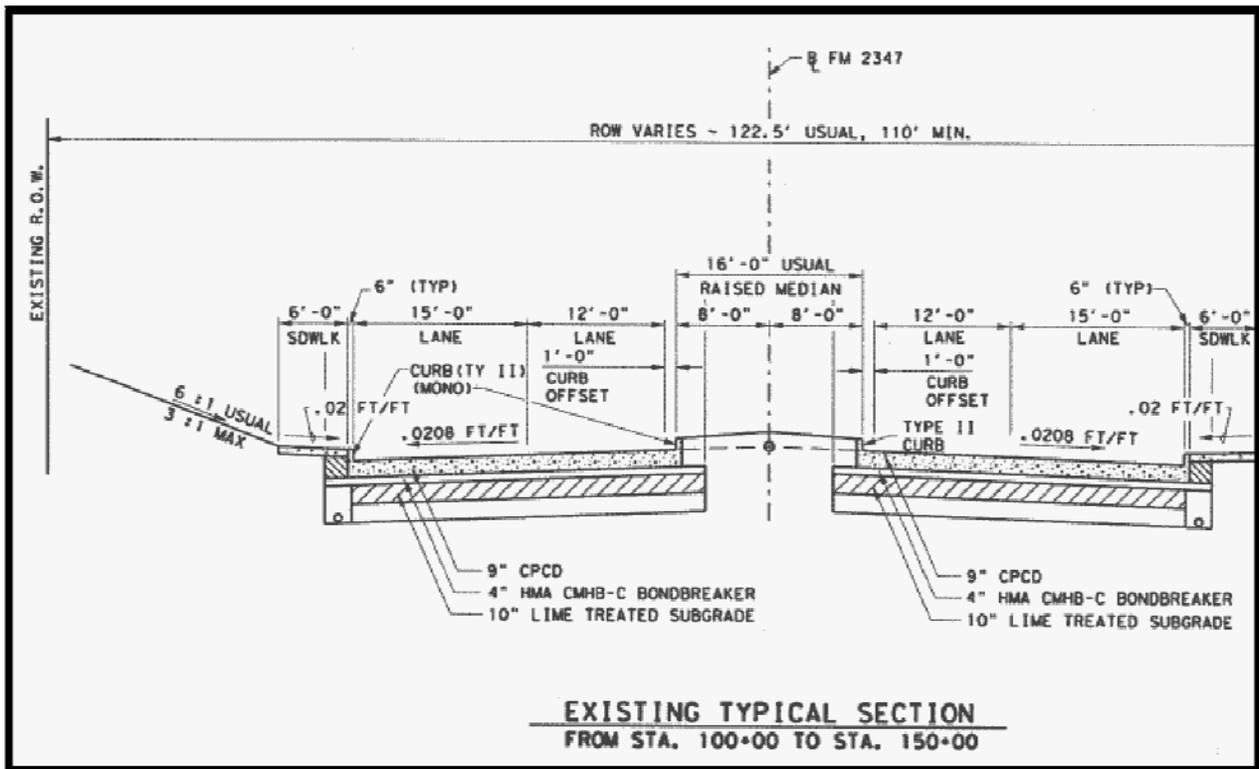
Figure 10. Typical Existing CPCD Section.

The Bryan District also has one of the few well documented cases of edge repair of concrete pavement. The distress shown in Figure 9 occurred shortly after construction. The subgrade plasticity index ranged from 14 to 49. Figure 10 presents the typical existing section. Figure 11 presents the repair details, which used a continuously reinforced concrete pavement (CRCP) repair tied to the existing concrete pavement contraction design (CPCD). As Figure 12 illustrates, although the crack did recur, the crack severity is much less than before.

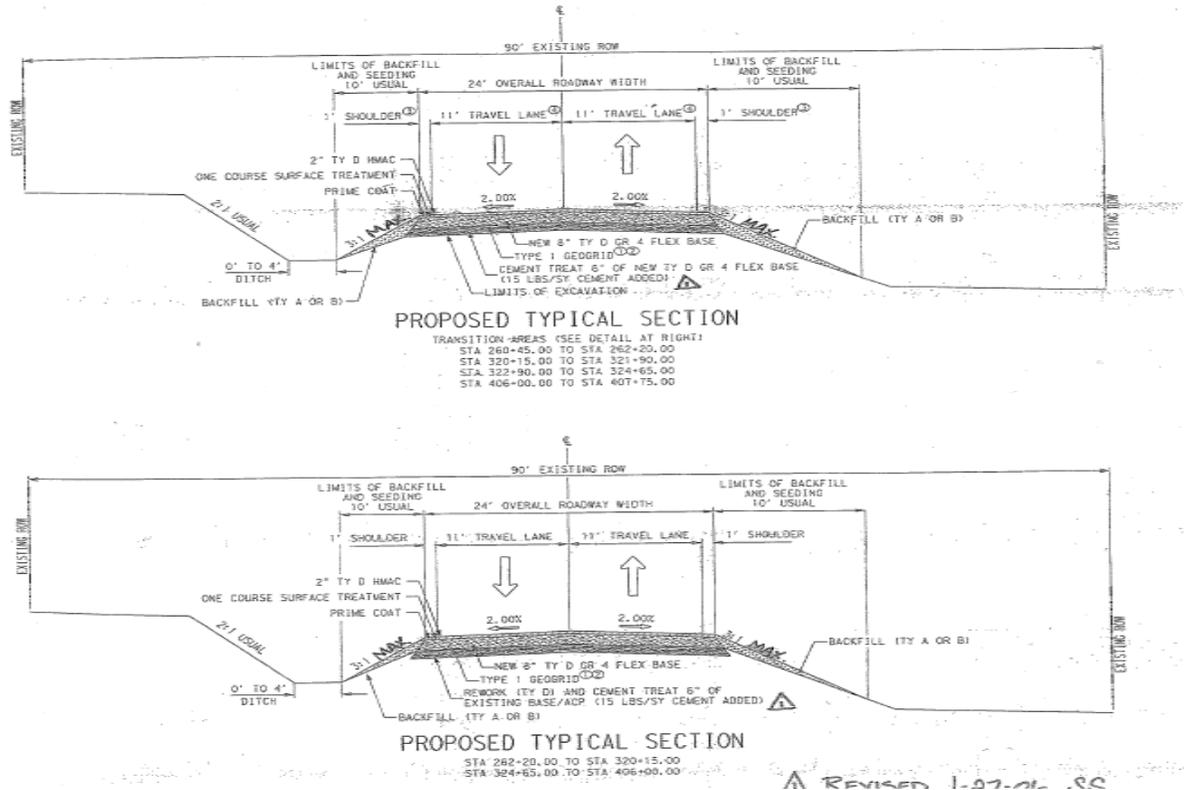
Figure 13. Typical Sections from Dallas District.

Figure 13 presents a typical cross section for projects in the Dallas District. Over the past years, the district has performed repairs on the following pavements:

- FM 549, FM 1827, FM 550, FM 148: FDR with geogrid and flex base overlay.
- FM 548, FM 740, FM 429: FDR with cement/emulsion and geogrid reinforcement.

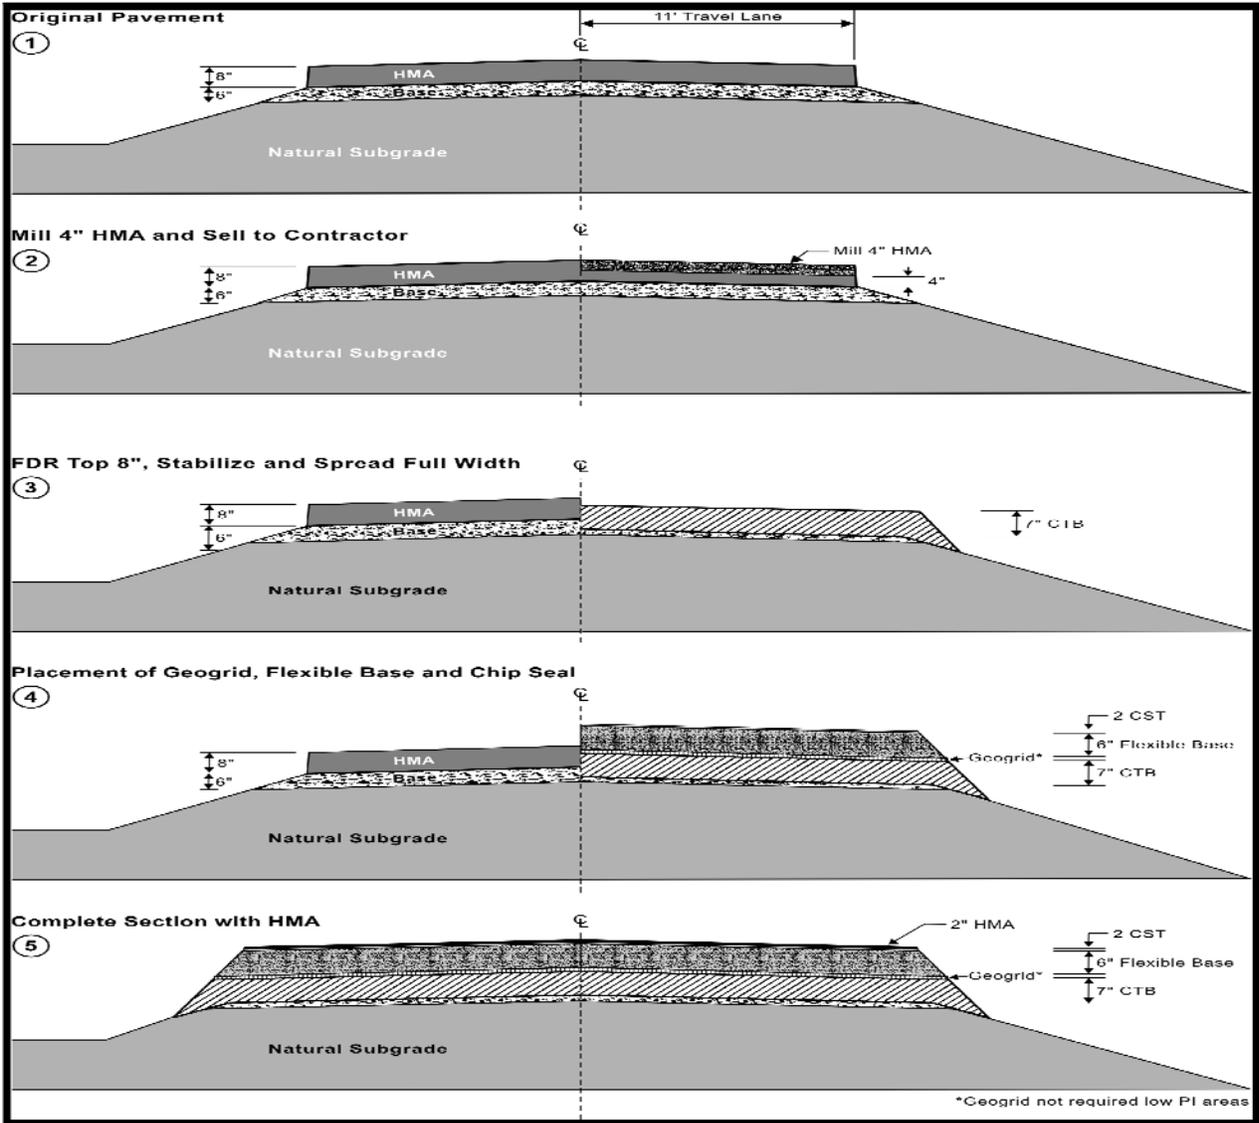
Figure 15. Repair Sequence for FM 148.

FM 550 and FM 148 both employed similar repair strategies. Figure 15 presents the repair sequence proposed for FM 148. Constructed in 2010, Figure 16 illustrates the constructed section tested met the structural design expectations.

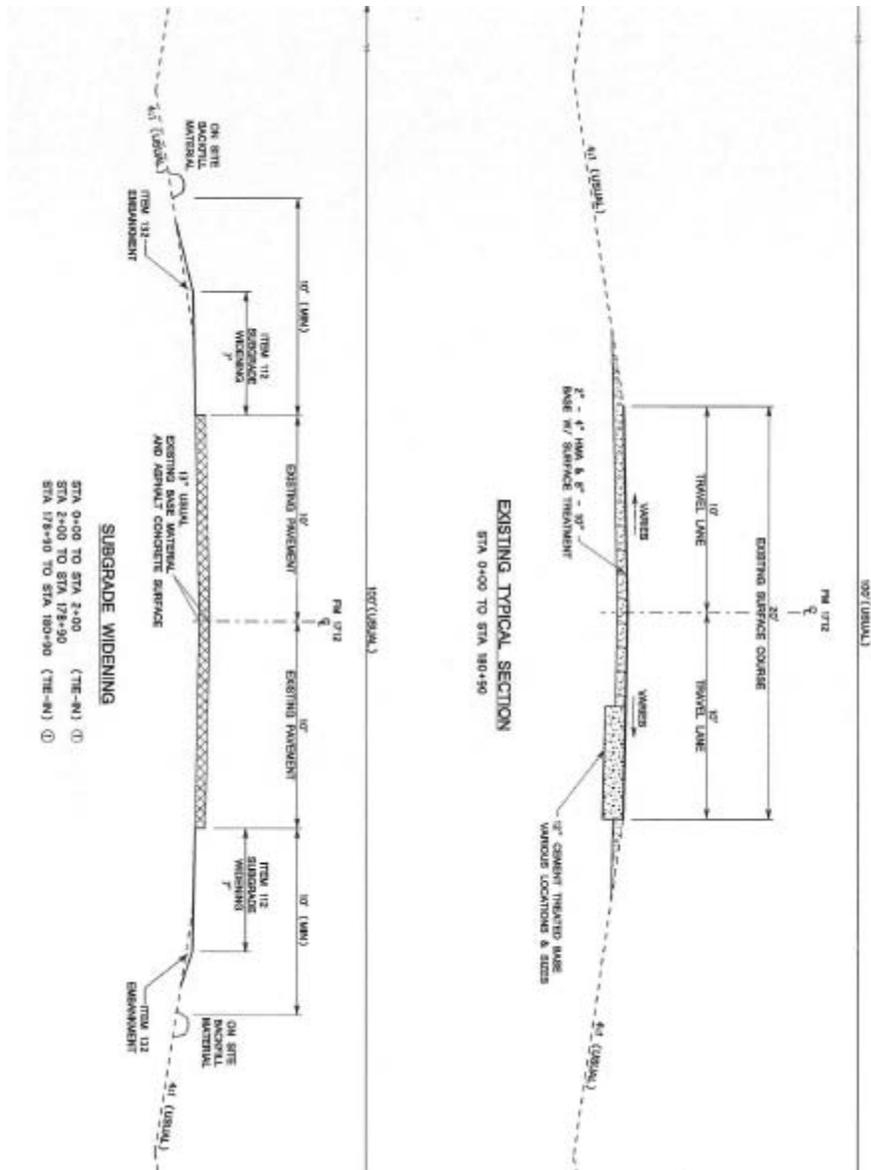
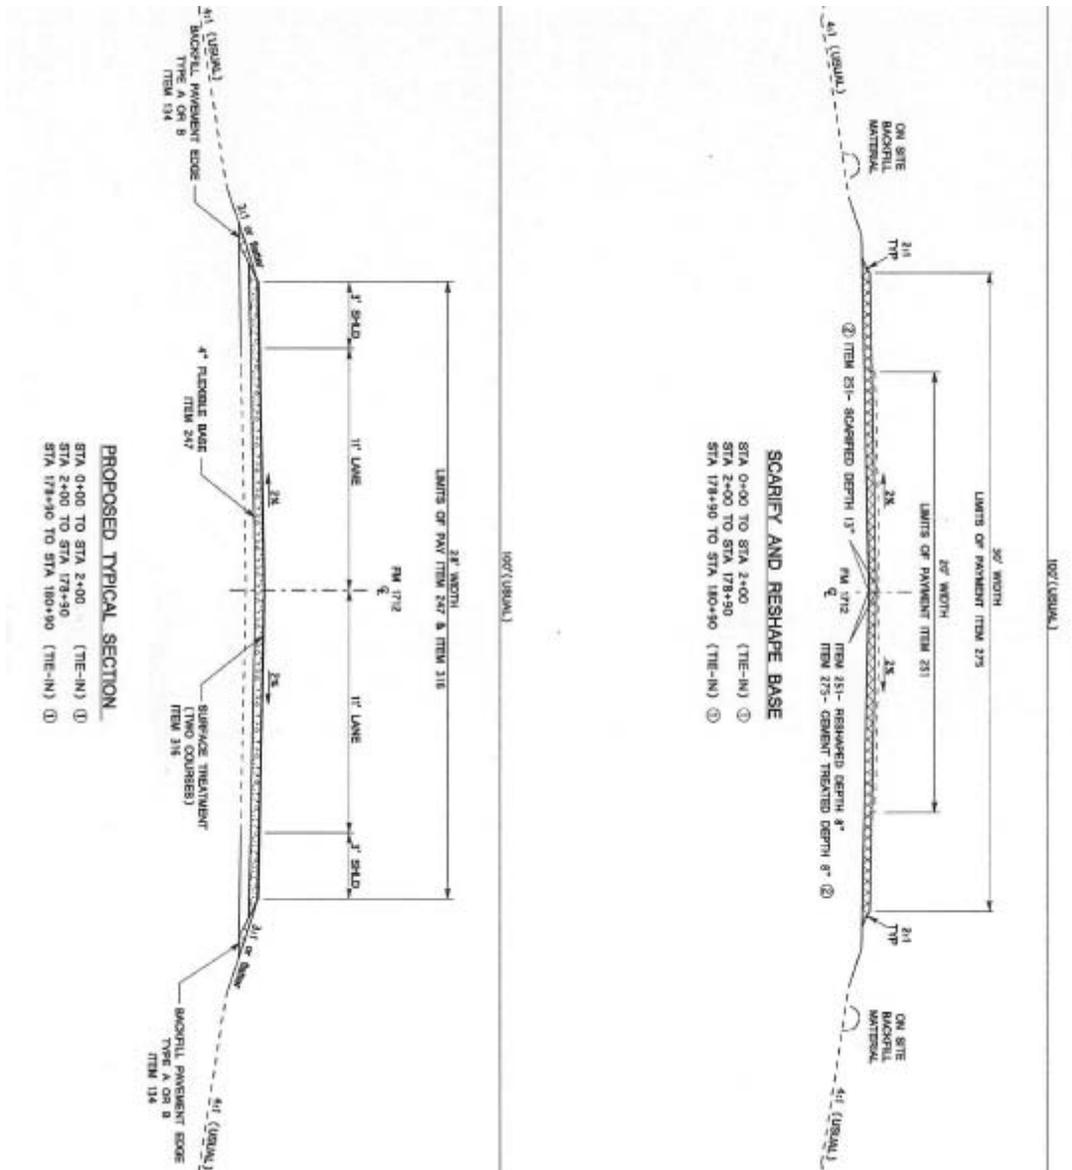
Figure 18. Existing and Proposed Sections for FM 1712.

Figure 18 presents the existing and proposed typical sections for FM 1712 from reference marker 406+1.604 to FM 487. The edge problems on this pavement were addressed by subgrade widening, scarifying, and reshaping the existing material followed by cement treatment to a depth of 8 inches, and then a 4 inch flexible base layer surfaced with a two course surface treatment. The Bryan District used Type D, Grade 2 flexible base for the new flexible base layer. Figure 19 shows representative images of the pavement's present condition. No distresses were observed.

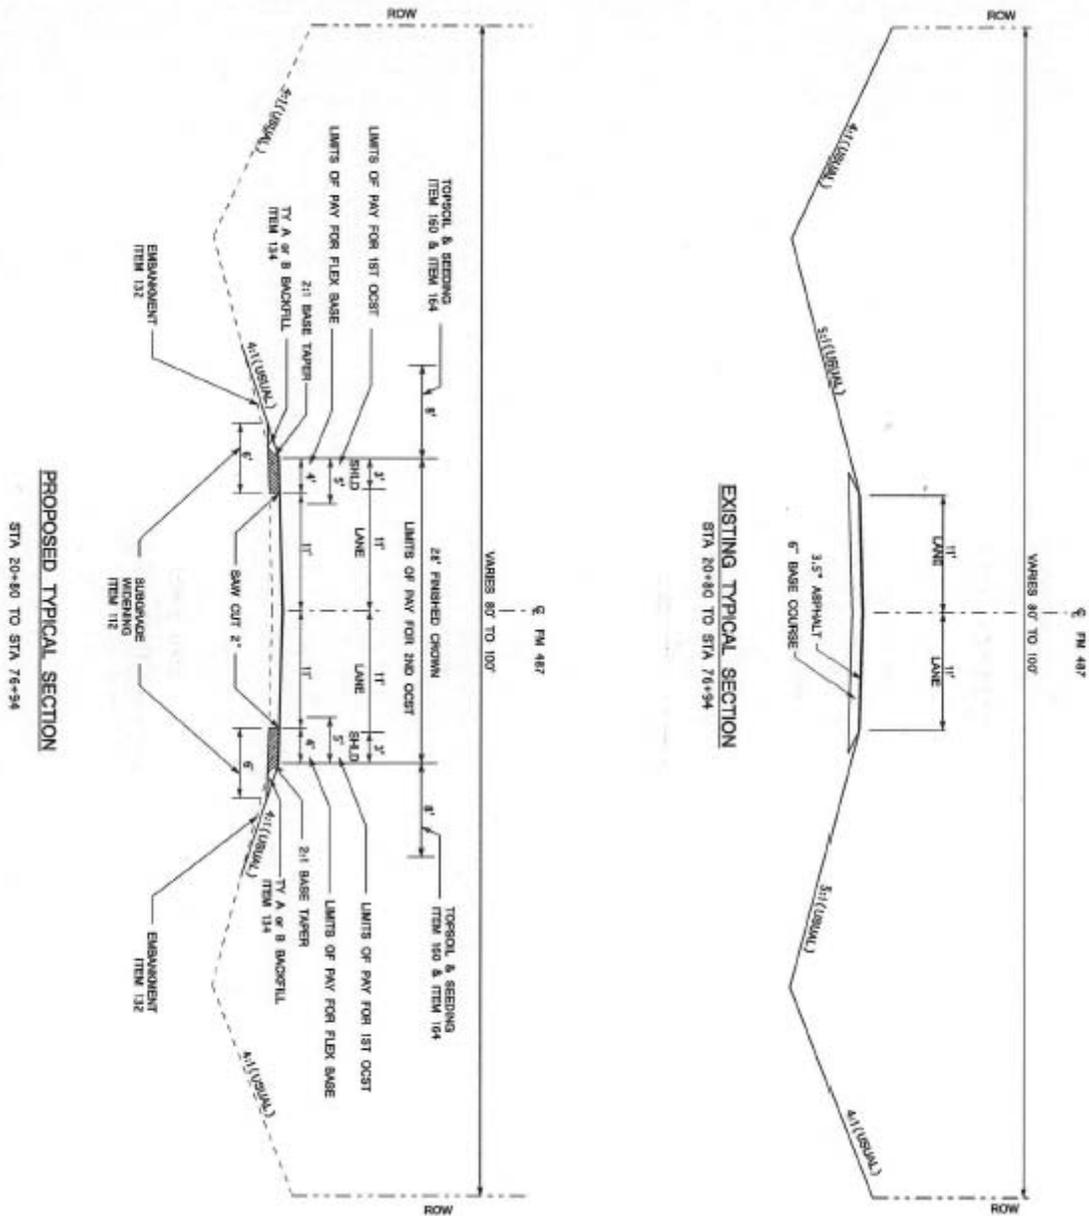
Figure 20. Existing and Proposed Sections for FM 487.

Figure 20 presents the existing and proposed typical sections for FM 487 from FM 1712 to reference marker 590+0.016. FM 487 was widened by adding shoulders alongside the existing pavement. The shoulders were constructed with Type D Grade 2 flexible base.

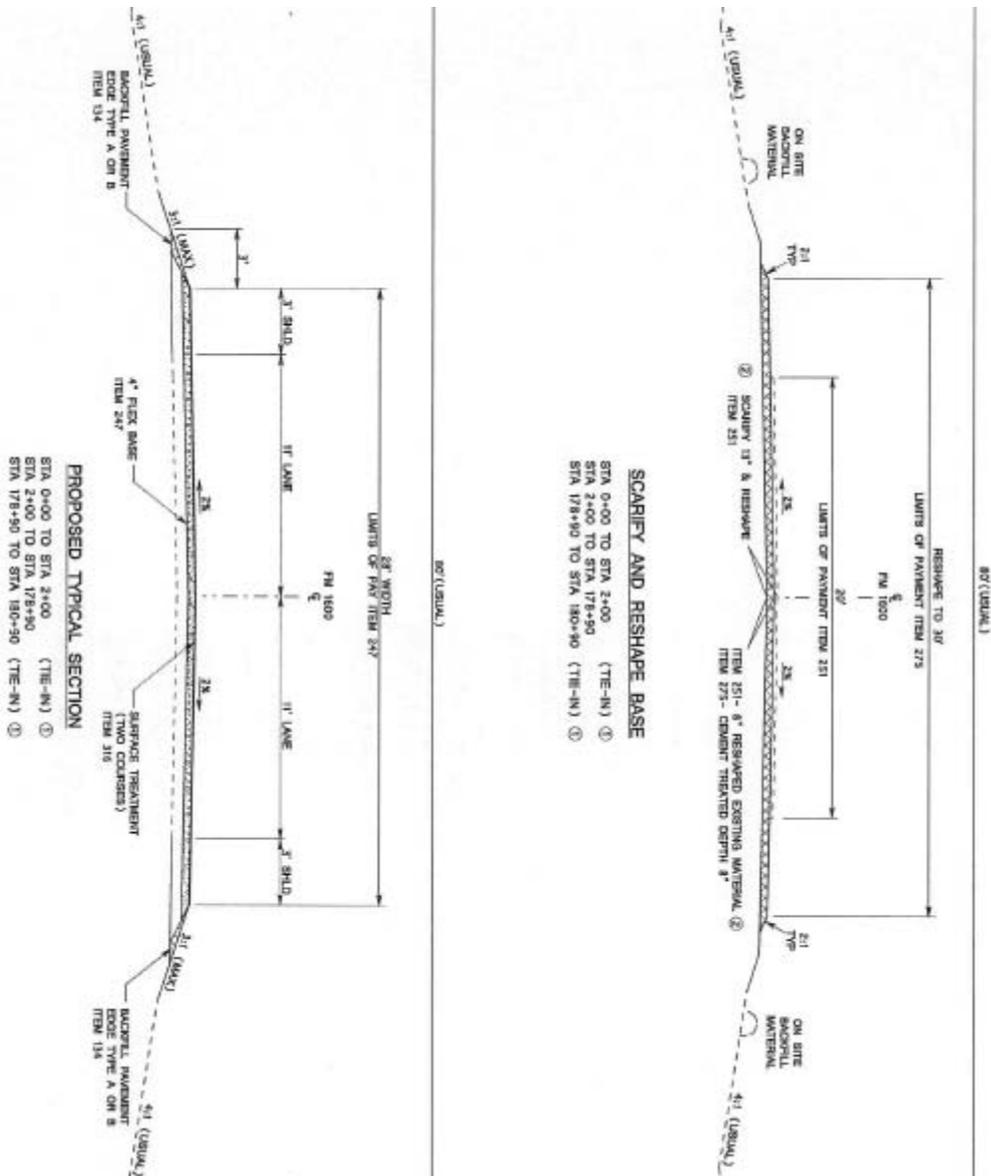
Figure 22. Existing and Proposed Sections for FM 1600 (Cont.).

Figure 22 presents the existing and proposed typical sections for FM 1600 from reference marker 400+1.700 to reference marker 404+1.205. This section was widened by full depth recycling of the existing pavement and placement of new flexible base. Type D Grade 2 flexible base was used for the new 4 inch flexible base layer. Cement stabilization of the existing roadbed was performed to an 8 inch depth.

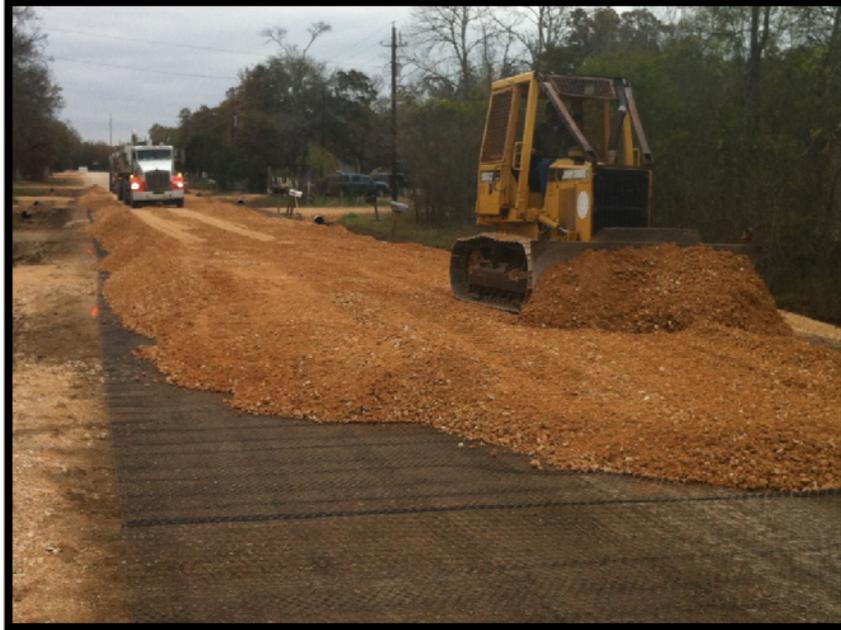
Figure 27. Construction of Geogrid Section on Benchley Dr.

Brazos County officials recently embarked on trying geogrid reinforcement on problem county roads near Benchley, TX. Figure 27 shows construction of the geogrid section on Benchley Dr. in 2013. Figure 28 shows extensive cracking currently exists in the section without geogrid, while Figure 29 and Figure 30 show that the section with grid reinforcement has improved performance but is not totally crack free. The geogrid sections were constructed with a lime treated subgrade, geogrid, 6 inches of Grade 1 flex base, and then a two course surface treatment.
