# Risk Assessment and Update of Inspection Procedures for Culverts

**Final Report**  
**February 2005**

**RISK ASSESSMENT AND UPDATE OF INSPECTION  
PROCEDURES FOR CULVERTS**

**Leading Research Agency:** Ohio Research Institute for Transportation and the  
Environment (ORITE), Russ College of Engineering and Technology,  
Ohio University:

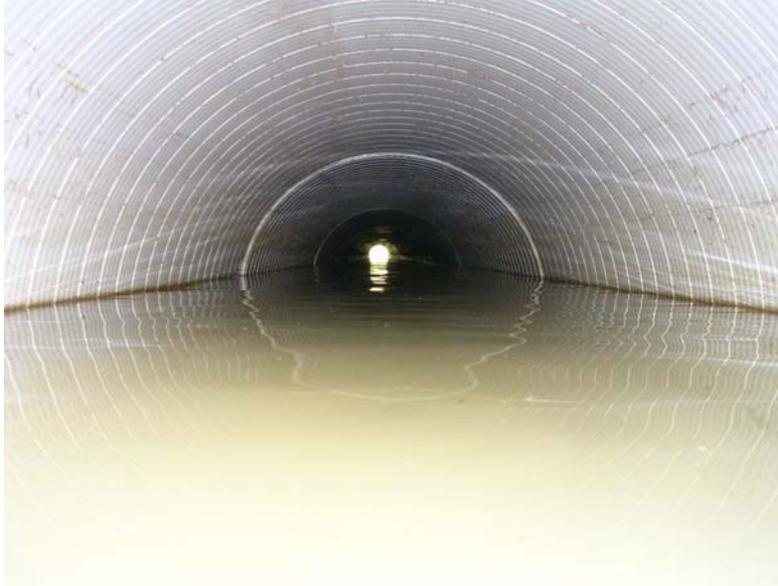
The 48-inch (1.22-m) diameter PVC pipe (FAI-33b-Sta. 587+96) had a smooth wall. It consisted of thirteen standard length sections and a short section added next to a manhole (total pipeline length 173.8 ft or 53.0 m). The height of cover was 14 ft (4.3 m) on the day the culvert was inspected. The final construction plan calls for 17 ft (5.2 m) cover. The headwalls, as well as the bottom half of the pipe, were submerged in drainage water. According to the inside diameter measurements, the pipe was experiencing less than 5% deflections. The pipe material visible above the water surface looked new and free from any defects. Figure 6.21 shows a general interior view of this pipe.

**Figure 6.21: General View Inside PVC Pipe (FAI-33b-Sta. 587+96)**

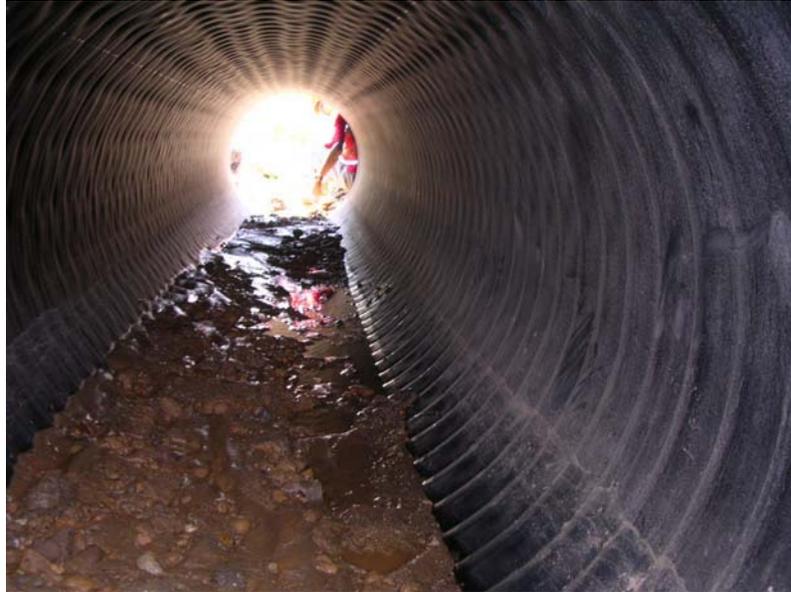
At the 36-inch (0.91-m) diameter corrugated HDPE pipe (FAI-33b-SR18-Sta. 86+00) site, it was possible to inspect only the first three sections of the pipeline structure. The culvert did not have a standard straight-out inlet end. The inlet end was tied to a catch basin, and the culvert had more than 12 inches (0.31 m) of sediment accumulated inside. This pipe was backfilled with ODOT Item 304 Type 2 (crushed limestone). At the second joint (from the outlet end), shallow dimples covered the pipe wall surface

around the circumference, shown in Figure 6.22. No tearing of the inside hydraulic liner or liner seams was detected.

**Figure 6.22: General View Inside HDPE Pipe (FAI-33b-SR18-Sta. 86+00)**

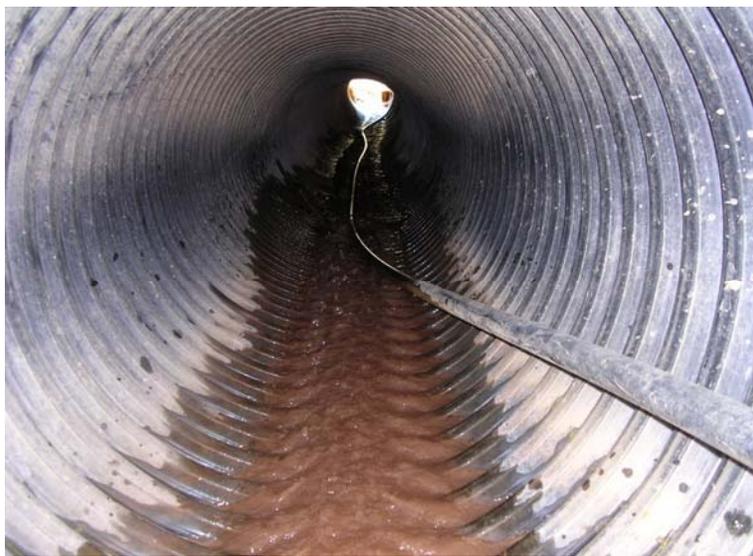
The conditions of the 24-inch (0.61-m) diameter HDPE pipe (NOB-145-3.59) were especially worth noting. This plastic pipe was installed 23 years ago and has been serving under low-pH and abrasive drainage flow, with only 12 inches (0.31 m) of cover. The pipe's cross-sectional shape at the mid-length was like a horizontal ellipse, with vertical deflection at 8.3%. However, no signs of localized wall buckling were detected inside the pipe. The pipe wall surface inside had many shallow scratch marks. However, no puncture holes or tearing were detected anywhere inside the pipe. Figure 6.23 shows a general interior view of this pipe.

**Figure 6.23: General View Inside HDPE Pipe (NOB-145-3.59)**

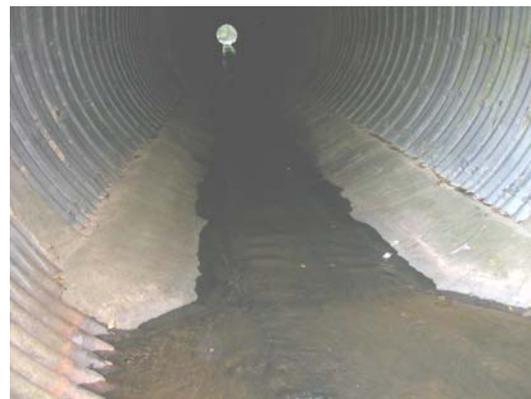
**Figure 8.4: Example of Good Invert Paving**

Utilizing skilled and conscientious installers yielded a much better product. If abrasion is a concern, then the aggregate source for the concrete mix design should be harder than the streambed load. Extremely abrasive conditions, such as steep and rocky conditions, may require that the invert be steel plated. This is only necessary in areas that have shown resistance to concrete paving the invert.

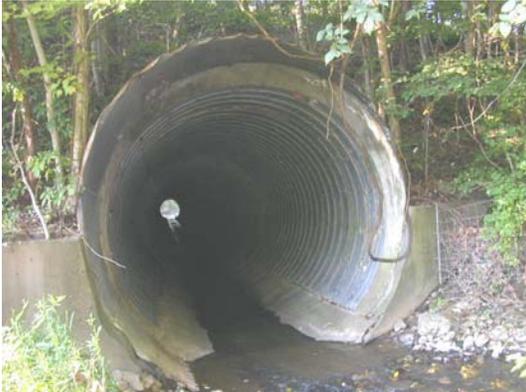
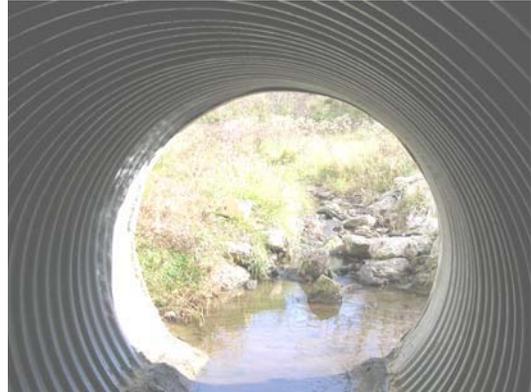
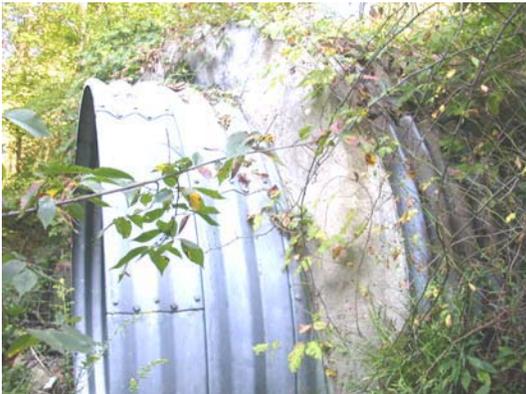
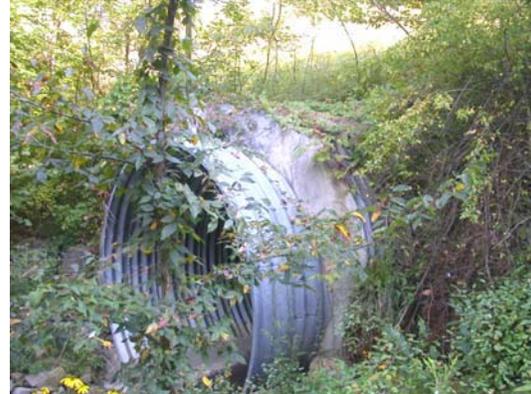
**Figure 8.10: Views of 15-Year-Old Sliplined Pipe (Licking County, Ohio)**

Within Ohio many culverts have been sliplined. One interesting location is under the ramp for State Route 668 on Interstate 70. This location was installed in the late 1980’s and includes some interesting design features. Two different size liners were installed. A larger pipe was used at the inlet end to provide for better hydraulics that was necessary because of the overall reduction in pipe size. Inside the pipe, the size of the liner pipe was reduced because of shape distortions in the host pipe. After the liner was

inserted and grouted into place the bottom was paved with concrete to increase the flow capacity and to combat corrosive factors against the steel liner. Today, this pipe is in very good condition as shown below.

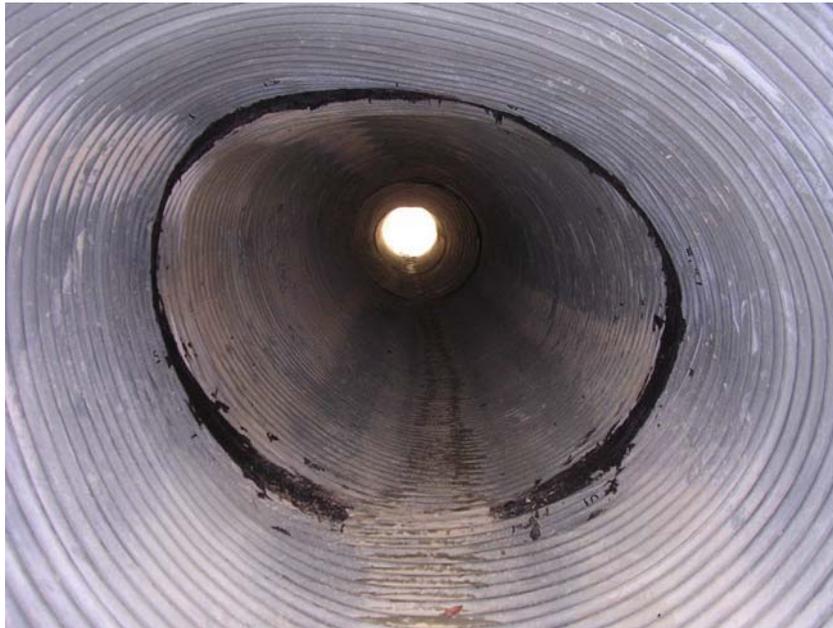
Distance from Outlet End	Vertical:		Horizontal:	
	Diameter (in.)	Deflection (%)	Diameter (in.)	Deflection (%)
0 (Outlet End)	56.00	+ 3.7	53.00	- 1.9
5 ft	55.25	+ 2.3	52.75	- 2.3
13 ft	53.00	- 1.9	52.375	- 3.0
24 ft (Near Joint 1)	48.50	- 10.2	56.00	+ 3.7
50 ft (Near Joint 2)	53.25	- 1.4	54.50	+ 0.9
75 ft (Near Joint 3)	52.25	- 3.2	54.25	+ 0.5
85 ft	54.75	+ 1.4	55.00	+ 1.9
100 ft	54.125	+ 0.2	54.00	0.0
102 ft (Inlet End)	54.25	+ 0.5	55.00	+ 1.9

**Figure H.2: Cross-sectional Shape of Culvert at Joint 1 (Near Outlet)**

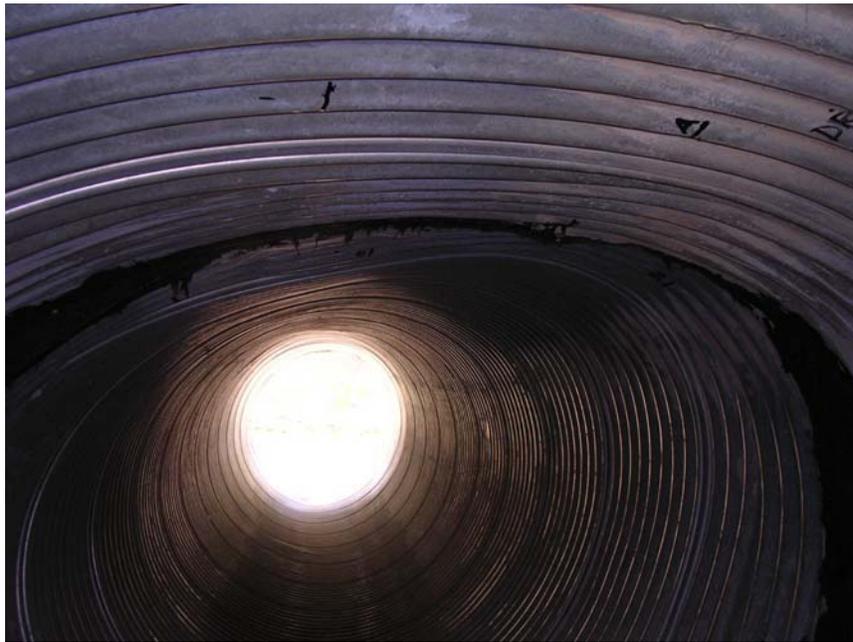
**Figure H.4: Another View of Culvert Shape Taken Near Joint 1**

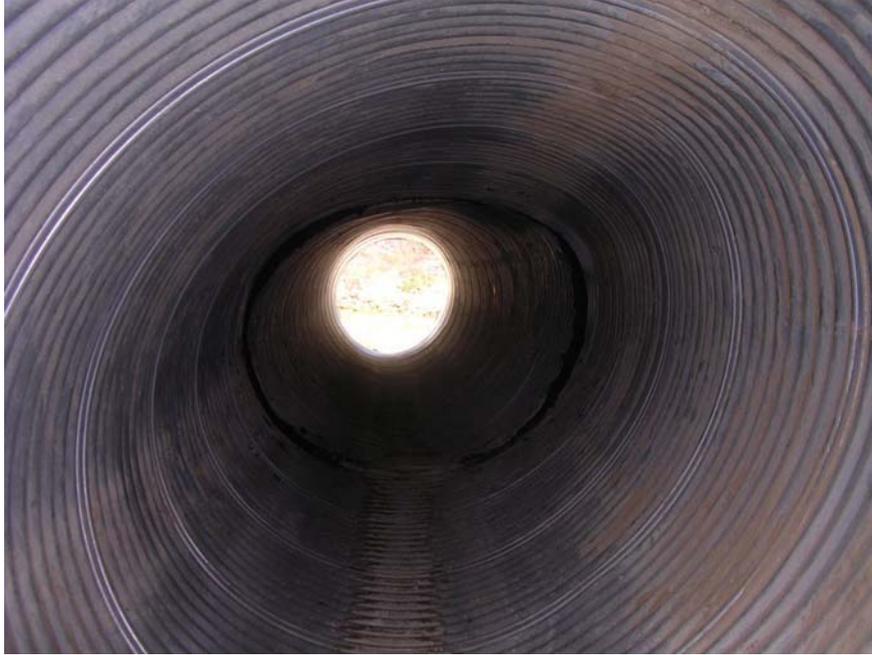
**Figure H.5: General View of Culvert Shape Taken at Mid-Length (Looking Toward Outlet End)**

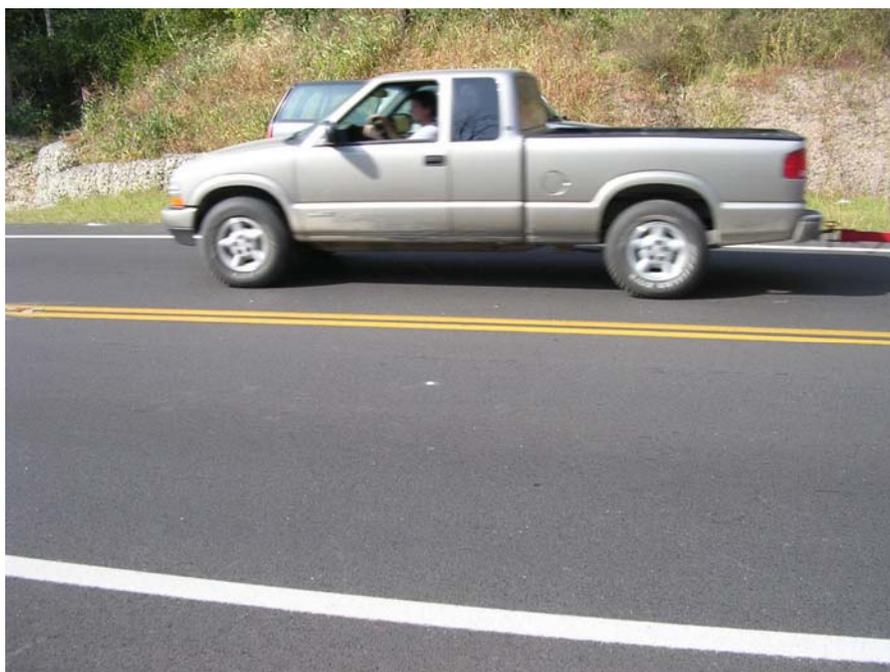
**Figure H.10: Close-Up View of Pavement Surface Over Culvert**

(Note: The white dot on the asphalt surface corresponds to the culvert crown at Joint 1)

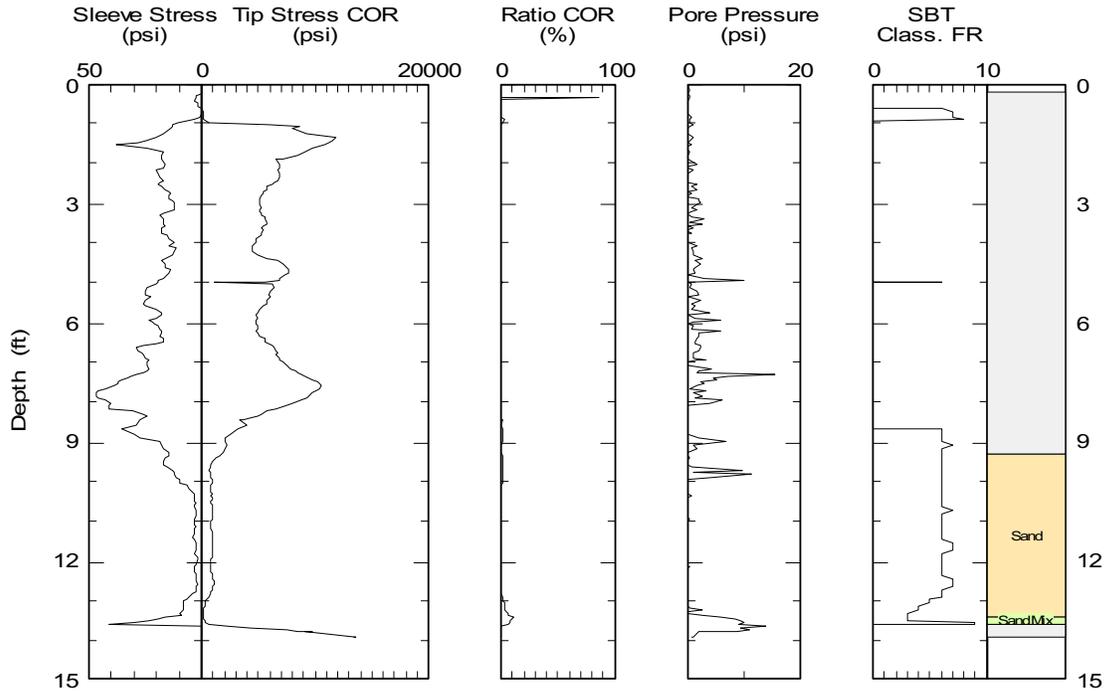
**Figure H.14: CPT Log for Hole #1 at WAR-48-20.95**

The CPT sounding began at Hole #1 at 12:00 p.m. The goal was to reach a minimum depth of 20 ft (6.10 m) or the top of bedrock, whichever was shallower. One of the team members stayed inside the culvert again as a precautionary measure. The dummy cone was pushed 12 inches (0.30 m) into the soil. Figure H.14 presents a CPT log that resulted from the sounding in Hole #1. The culvert was believed to be located from 10 ft (3.1 m) to 15 ft (4.6 m) below the ground surface. The backfill soil type was recognized again correctly in the log. According to the log, both tip resistance ( $q_c$ ) and sleeve friction ( $f_s$ ) readings decreased significantly from the depth of 12 ft (3.66 m). The probe encountered a very stiff layer at 14.7 ft (4.48 m). The truck started lifting off the roadway surface. The sounding of Hole #1 was completed at 12:30 a.m.

The team felt that the CPT sounding work conducted at this site was successful. The fact that the CPT readings decreased significantly while penetrating the backfill soil below the crown elevation indicated the presence of loose backfill zone next to the culvert. According to the way the culvert had deformed, it was leaning toward south. This leaning might have compacted the backfill on the south (Hole #2) side somewhat more and loosened the backfill on the north (Hole #1) side. Figure H.15 plots the tip resistance stress measurements recorded in both holes. Figure H.16 plots the tip resistance stress ratio (Hole #1)/(Hole #2) over the depth range. When these plots are examined closely, it

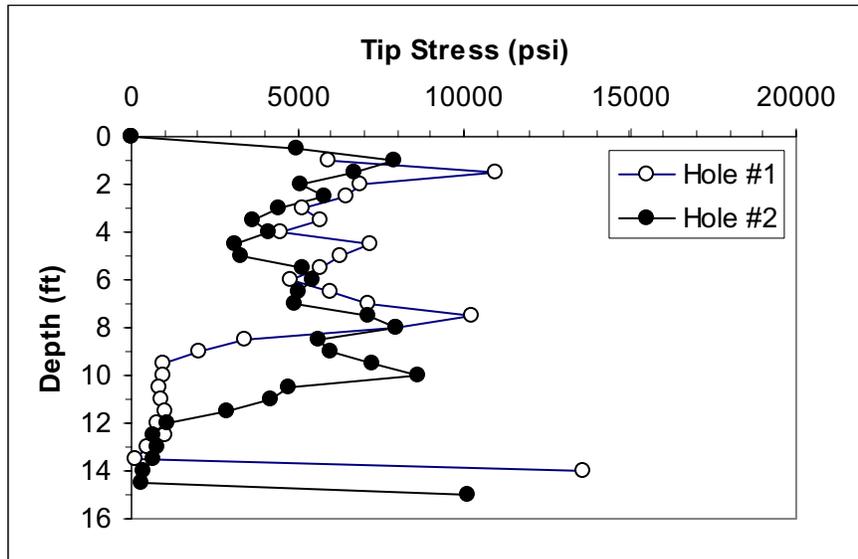
Figure H.15: Tip Resistance Stress Measurements at WAR-48-20.95

is realized that the tip resistance readings were indeed higher on the south (Hole #2) side at the depth range corresponding to the culvert depth and rise.

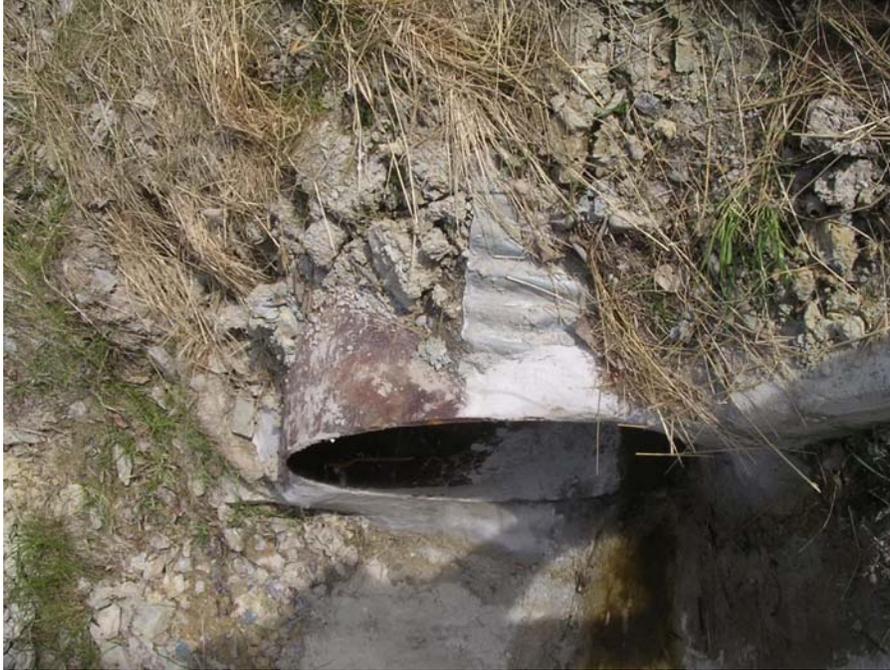
**Figure H.17: Inlet End of Rehabilitated Culvert**

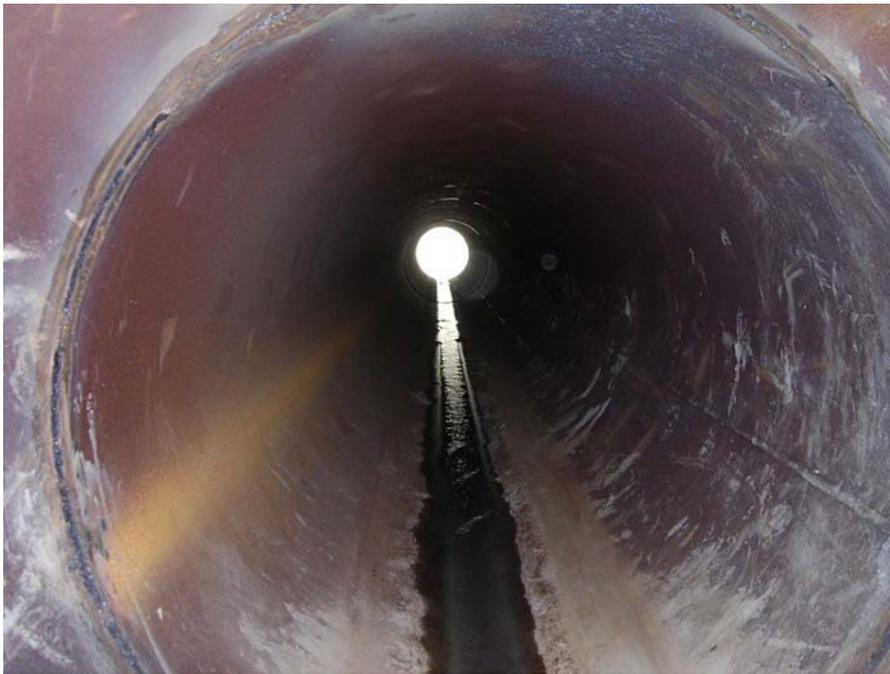
**Figure H.18: Interior View of Rehabilitated Culvert**

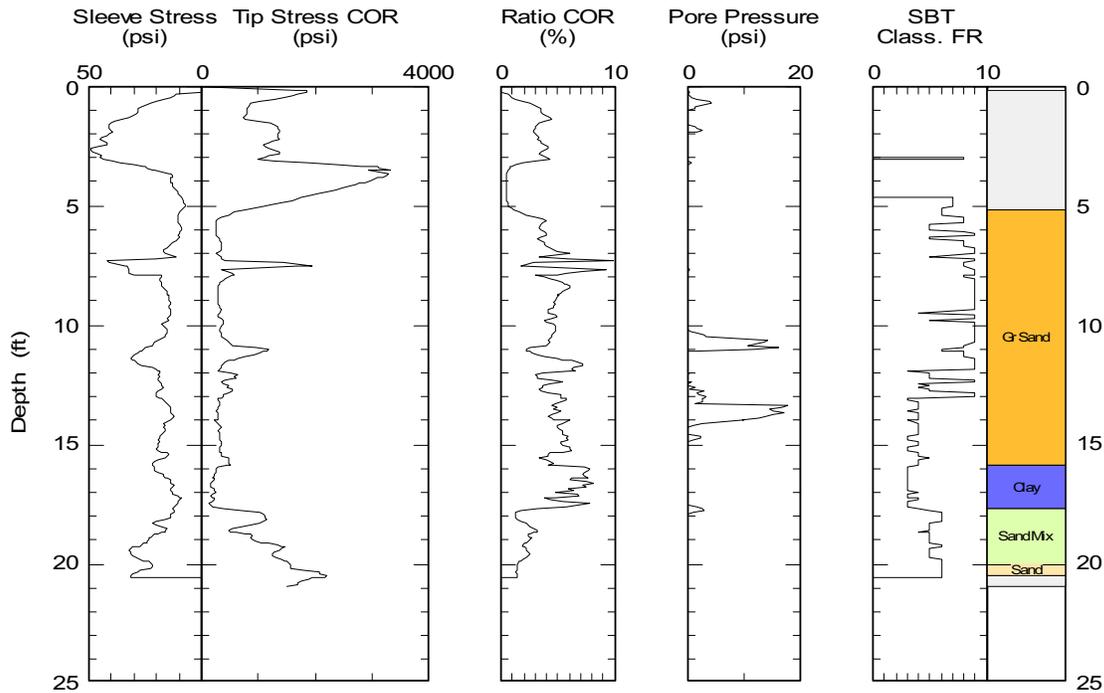
**Figure H.28: CPT Log for Culvert FAI-33b-Sta. 446+92**

A reconnaissance trip to the site of this 60-inch (1.52-m) diameter HDPE pipe was made on February 16, 2005. The CPT work was performed at this culvert location on March 4, 2005. As it was reported earlier in Chapter 6, the inspection team found this culvert to be in poor conditions, experiencing up to 8% deflections and exhibiting localized buckling of liner at the springline positions. Prior to conducting CPT, the asphalt concrete layer was cored with a portable coring device. Figures H.23 through H.27 are the photographs taken during the field work. The CPT log obtained at this site is shown in Figure H.28. The culvert was believed to be located from 8 ft (2.44 m) to 14 ft (4.27 m) below the ground surface. According to the log, the backfill material was categorized as a sandy soil based on the CPT soil behavioral classification method. Tip resistance stress recorded in the depth range corresponding to the culvert location and size was mostly less than 400 psi (2.76 MPa).

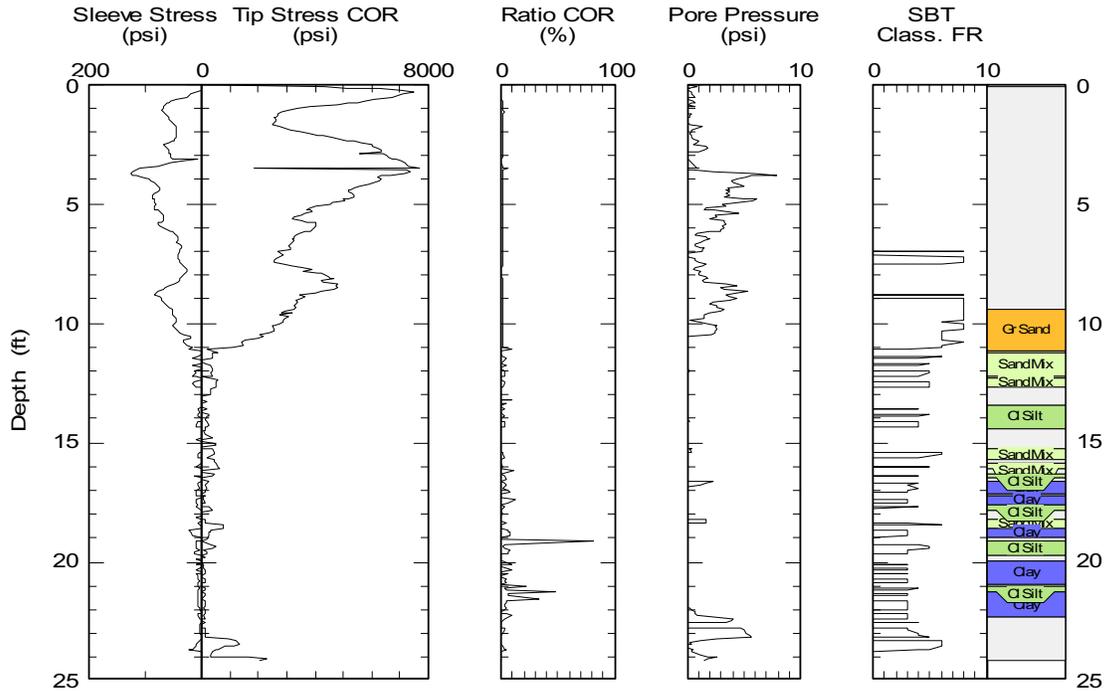
**Figure H.30: CPT Log for FAI-33b-Sta. 587+96**

A reconnaissance trip to the site of this 48-inch (1.22-m) diameter PVC pipe was made on February 16, 2005. The CPT work was performed at this culvert location on March 4, 2005. As it was reported earlier in Chapter 6, the inspection team found this culvert to be in good conditions, exhibiting no cracks anywhere and deflections of less than 5%. Prior to conducting CPT, the asphalt concrete layer was cored with a portable coring device. Figure H.29 is a photograph taken during the field work. The CPT log obtained at this site is shown in Figure H.30. The culvert was believed to be located from 17 ft (5.2 m) to 22 ft (6.7 m) below the ground surface. According to the log, the tip resistance remained

less than 500 psi (3.45 MPa) from the depth of 11 ft to 23 ft (3.35 m to 7.01 m). The crushed limestone material was identified as either sand mix or clayey silt by the CPT soil behavioral classification method.
