Paper presented at the 1991 Meeting of the Transportation  
Research Board

# EVALUATION OF PAVEMENT BLEEDING PROBLEM ON I-55 IN ILLINOIS

E. R. Brown  
Stephen A. Cross  
J. G. Gehler

NCAT Report No. **91-7**

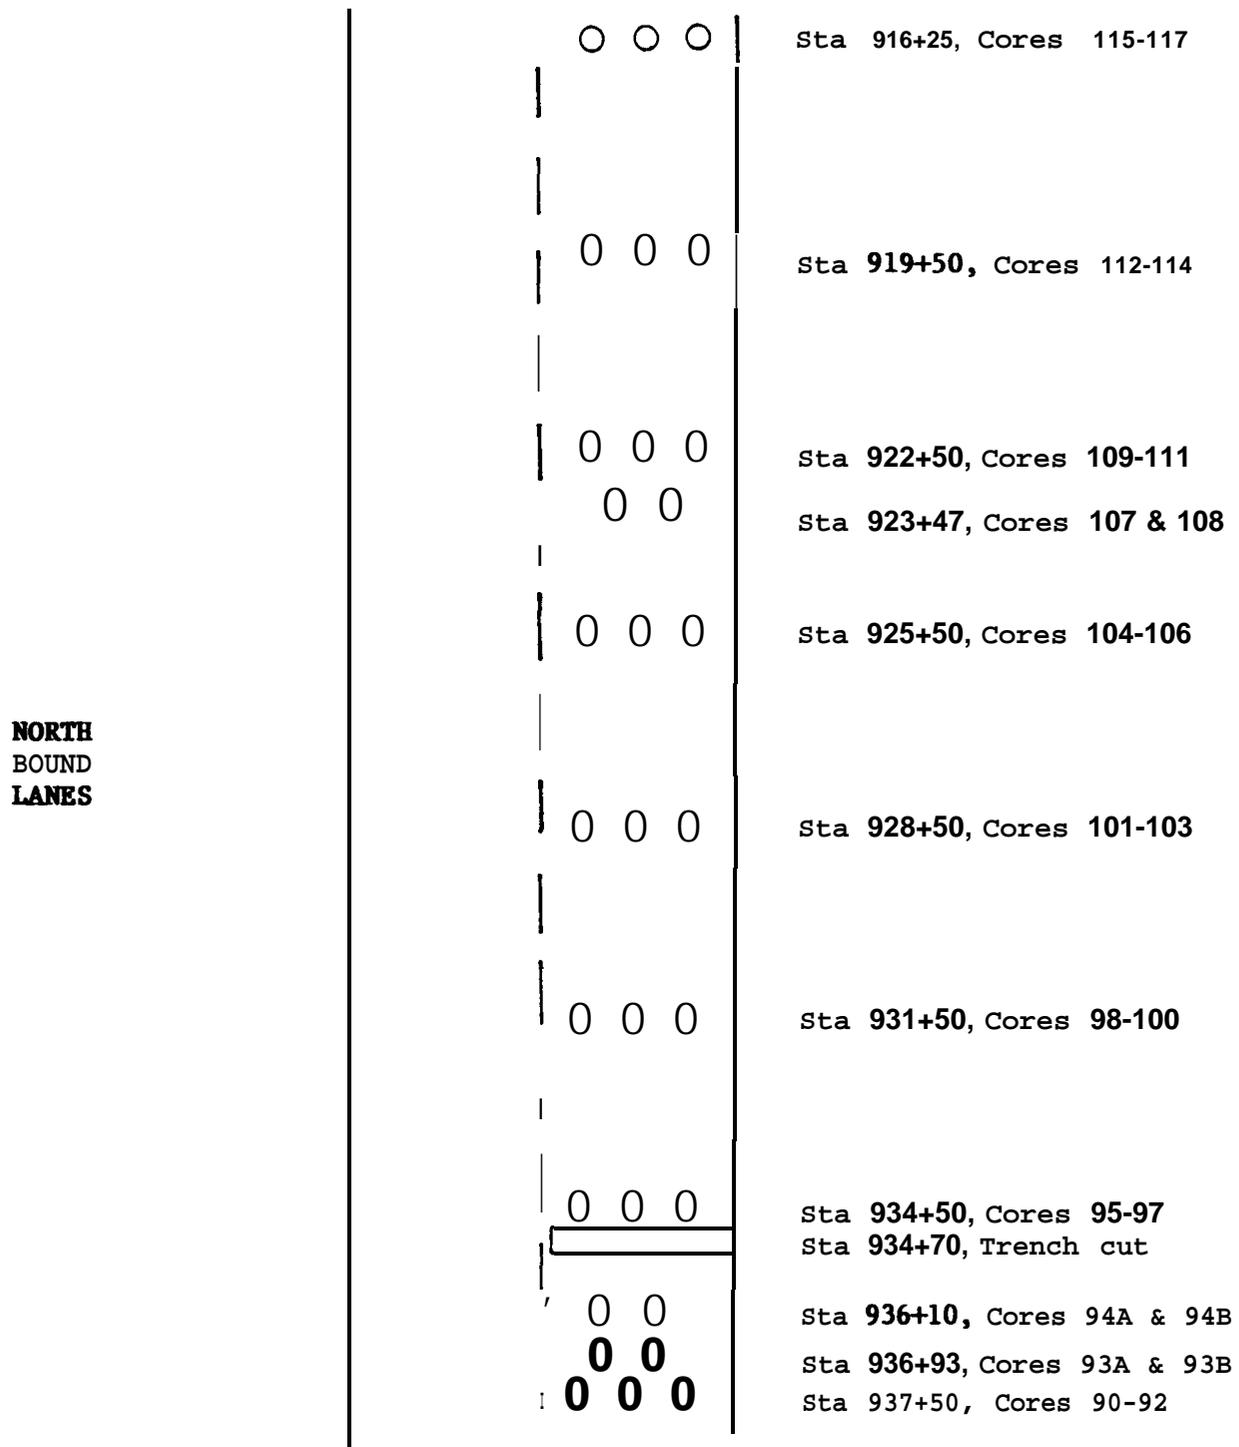
Figure 1. Layout of Test Section North Bound Lanes, 1-55, Near Collinsville, IL.

A test plan was developed for 1-55 to determine the cause of localized bleeding. Samples of asphalt mix were taken in the fat spots, adjacent to the fat spots, and at random from station 916+25 to station 937+50 (Figure 1). A total of 30-4 inch cores were taken for testing. A trench approximately 2 ft. wide and approximately full width was excavated at station 934+70. The trench was selected at a location that had bleeding spots to determine if the problem could be identified by viewing the side of the trench.
