PREMATURE FAILURE OF ASPHALT OVERLAYS FROM STRIPPING: CASE HISTORIES

**Prithvi S. Kandhal
Ian J. Rickards**

NCAT Report 01-01

April 2001

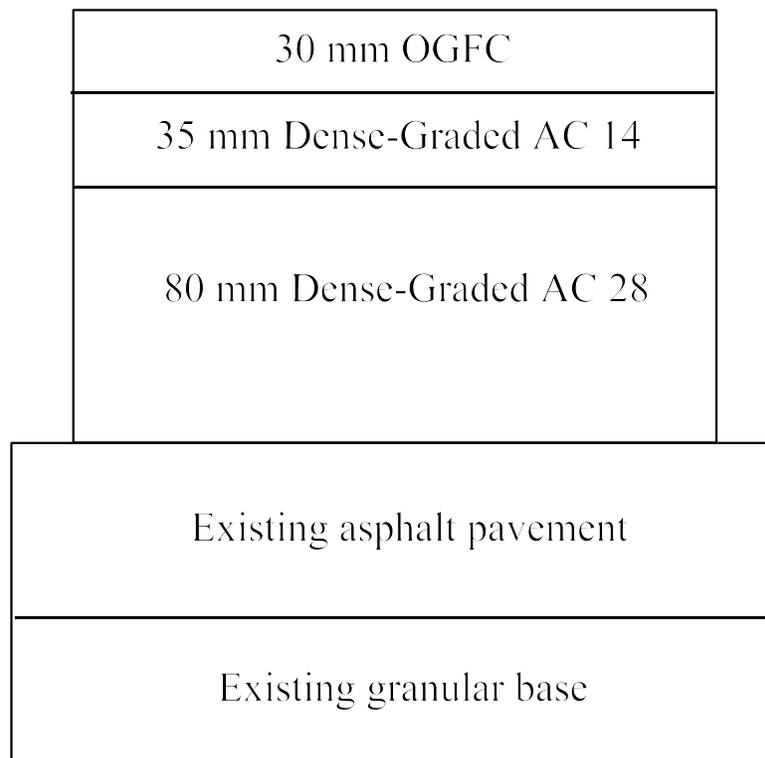
Figure 23. Courses used in new asphalt overlay on Hume Highway.

An existing asphalt section of the 4-lane Hume Highway south of Sydney in New South Wales was overlaid in May/June (winter in Australia) 1993. As shown in Figure 23, the asphalt overlay consisted of the following:

The southbound lanes of the Hume Highway started to develop potholes in February 1995 (during the second summer some 20 months after construction). The potholes were occurring in the wheel tracks of the slow lane. Both the southbound and northbound highways comprise a 3-m emergency shoulder, two 3.5-m lanes, and a 1-m shoulder. The pattern of potholes (which

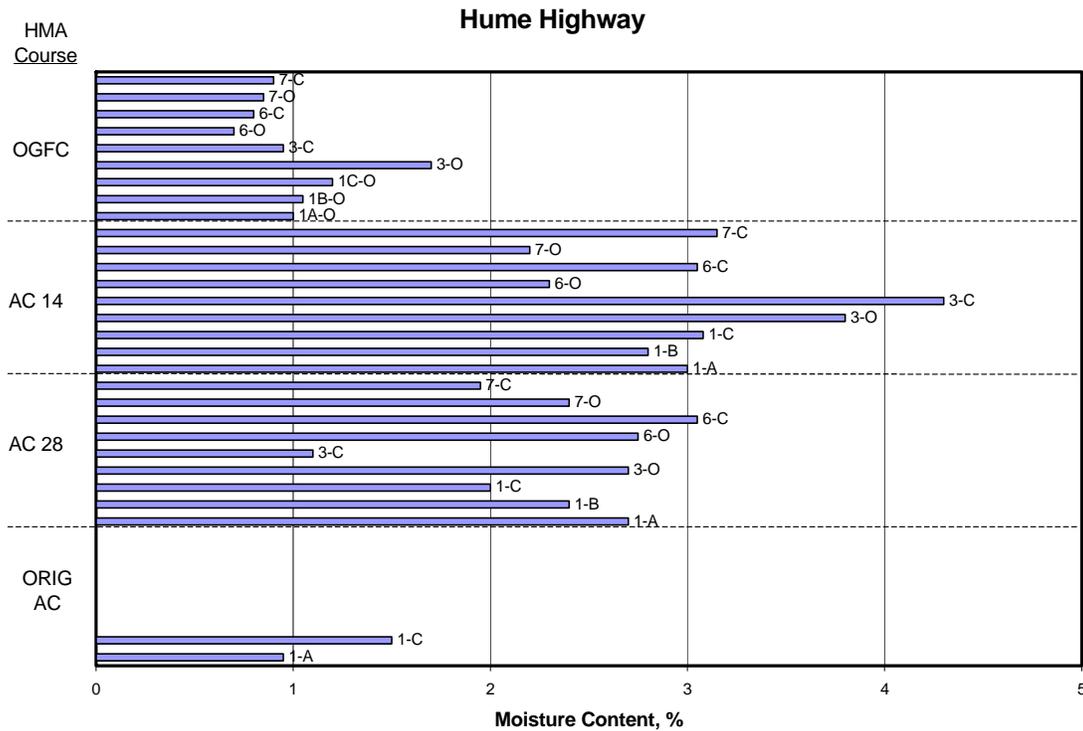
Figure 28. Moisture content profile at Site 1, 3, 6, and 7.

Figure 28 shows typical moisture contents in OGFC, AC 14, AC 28, and existing asphalt course at four locations. Designation C such as Site 7-C stands for test hole in the center of the lane (between the wheel paths). Designation O such as Site 7-O stands for test hole on the wheel path. There was no significant difference in moisture content of the materials extracted from test holes at the failed and adjoining non-failed sites, indicating the water ingress preceded, and was not as a consequence of, the failure.

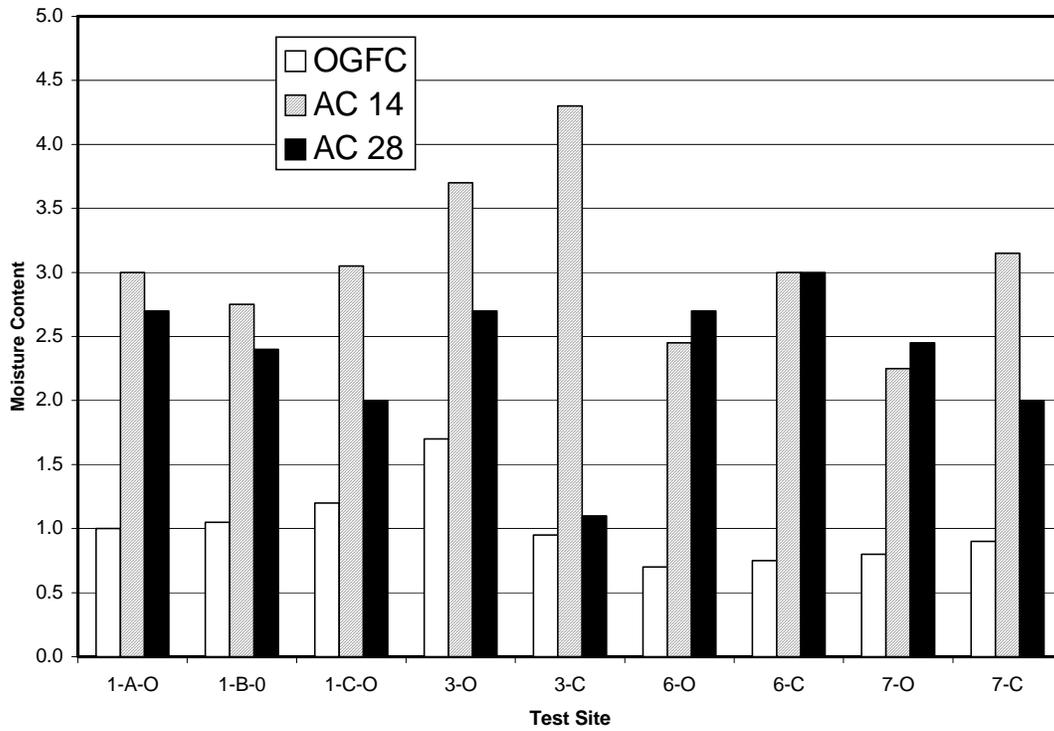
Figure 29. Comparative moisture contents at Sites 1, 3, 6, and 7.

Figure 29 shows the relative comparison of moisture contents in OGFC, AC 14 and AC 28 courses obtained in nine test pits. The following observations can be made.

1. The moisture profile shows decreasing moisture contents from surface downwards. However, the air voids in both AC 14 and AC 28 are almost completely saturated with moisture.
2. The existing asphalt course was not significantly stripped. Only AC 28 and AC 14 and bottom 1/3 of the OGFC were stripped in the slow traffic lane. Figure 27 shows a piece of badly stripped AC 28.
3. Both AC 14 and AC 28 courses did not strip in the shoulder obviously due to reduced saturation and lack of traffic loading.

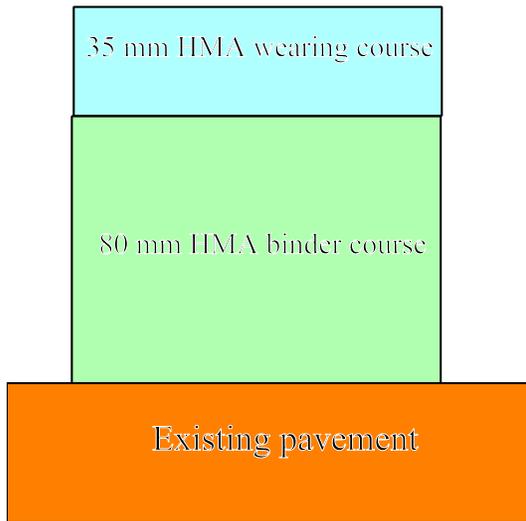
Figure 34. Typical time/moisture profile in asphalt overlay without OGFC (after Rickards, 4).

The preceding hypothesis is explained further in Figures 34 through 37. Figures 34 and 35 depict typical time/moisture profiles in dense-graded HMA courses without and with OGFC, respectively. Figures 36 and 37 show schematic representation of moisture movement in dense-graded HMA courses due to thermal pumping without and with OGFC, respectively.

IMMEDIATELY POST CONSTRUCTION

- Surface & mix slightly permeable
- Moisture ingress & accumulation in capillaries relatively slow
- Surface drying rapid due to traffic/heat
- Liquid ingress balanced by vapour egress

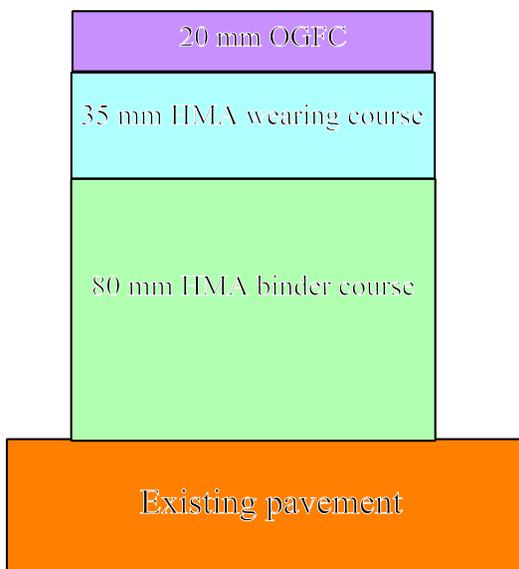
Figure 35. Typical time/moisture profile in asphalt overlay with OGFC (after Rickards, 4).

The conditions that occur when a fresh dense-graded HMA course is overlaid by an OGFC are illustrated in Figures 35 and 37 (after Rickards, 4). In such conditions the permeability of the dense graded HMA course is not significantly reduced with time due to the absence of kneading action of traffic and densification. Compaction by traffic is diminished because (a) tire load stress is dissipated by the OGFC, and (b) the temperature of the dense-graded HMA course is generally 5-10°C lower.

IMMEDIATELY POST CONSTRUCTION

- Surface, mix, & interface slightly permeable
- Interface drying very slow due to absence of traffic and reduced temperature
- Moisture ingress & accumulation in capillaries is relatively rapid
- Moisture ingress is accelerated by pumping
- Moisture ingress is not balanced by vapor egress

- Mix densification slowed because of lower temperature regime
- Long term permeability in location of high stress
- Saturation, high stress, high temperature -all the critical components of stripping are present
