# *Instrumentation of Bridge #MEG-124-6.78*

**Draft Final Report to the Sponsor:**

**Ohio Department of Transportation  
October 1999**

**University of Cincinnati  
Department of Civil and Environmental Engineering  
P. O. Box 210071  
Cincinnati, OH 45221-0071**

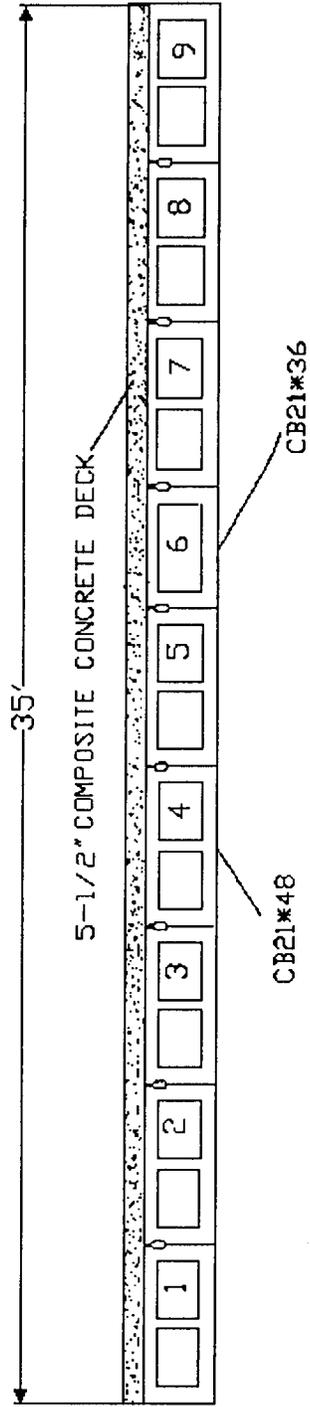
Figure 1.1 - Bridge Cross Section

- 1) The beam on the southwest edge (numbered 9 in Figure 1.1 and shown in Figure 1.3) had diagonal cracks and straight cracks in the exposed side of the beam. These cracks continued to the bottom of the box where they became transverse (perpendicular to the span). Whether the cracks continued up the other side of the beam was not clear as the other side of the beam (being up against the adjacent beam) was not visible. The worst cracking occurred at the northwest corner where the cracks appeared to be diagonal shear cracks. Less severe cracking, which appeared to a vertical flexural crack, occurred at the other end of the beam as well. In both cases, the cracks formed about 4 ft. from the obtuse corner.

- 2) Each of the adjacent beams (numbered 7 and 8 in Figure 1.1) had transverse cracks along the bottom. The sides of the beam were not visible so it could not be ascertained if the diagonal cracks existed along the sides of the beam. Again, cracking occurred at both ends of the beams approximately 4 ft. from the obtuse corner.

Inspection of the MEG-124-6.78 bridge revealed that Beam #9 (Figure 1.1), an edge beam, had a large, diagonal crack at one end and what looked to be a flexural crack at the other. Two other beams, #8 and #7 had cracks in the bottom flanges at each end (cracking in the webs could not be seen because the structure is made of adjacent boxes). As an initial attempt to determine the cause of cracking, three possibilities were explored:
