# Acoustic Emission Monitoring of Fatigue Cracks in Steel Bridge Girders

1. Report No. MN/RC - 1999-36		2.		3. Recipients Accession No.	
4. Title and Subtitle ACOUSTIC EMISSION MONITORING OF FATIGUE CRACKS IN STEEL BRIDGE GIRDERS				5. Report Date September 1999

# **ACOUSTIC EMISSION MONITORING OF FATIGUE CRACKS IN STEEL BRIDGE GIRDERS**

## **Final Report**

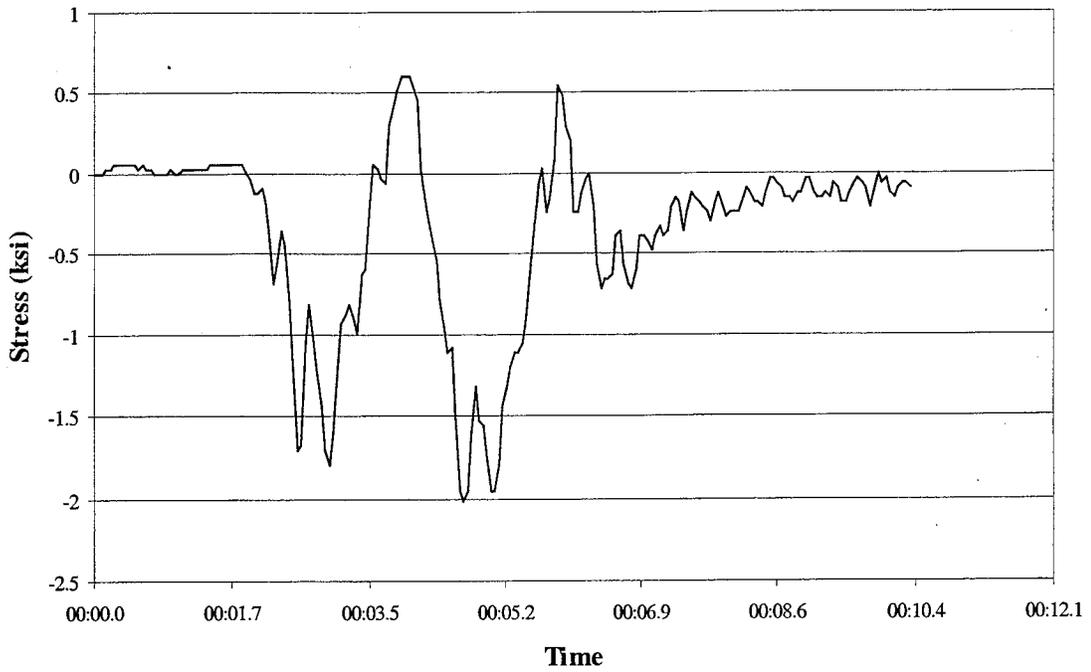
Figure 6.15: Strain in the Bottom Flange on TH-36 with Trucks too Closely Spaced

TH-36 was the third and final bridge to be monitored for AE activity. The sand truck passes made here were sometimes different than the previous two bridges because the trucks were often not separated enough to cause two distinct stress histories. As can be seen in Fig. 6.14, the two trucks were separated enough that two distinct stress histories were created. However, in Fig. 6.15 the trucks were too close together and only one distinct history can be seen. This complicates the determination of the number of truck passes, and hence makes it difficult to come up with a reasonable event to truck pass ratio. Each history was looked at carefully and those that resemble Fig. 6.14, with ample truck spacing, were considered two truck passes and those that resemble Fig. 6.15 were only counted as one truck pass. Although 24 total truck passes were made, only 16 distinct truck histories were recorded. A total of 6 possible crack events were counted for the 16 truck histories. This results in a ratio of 0.375 crack events per truck history.

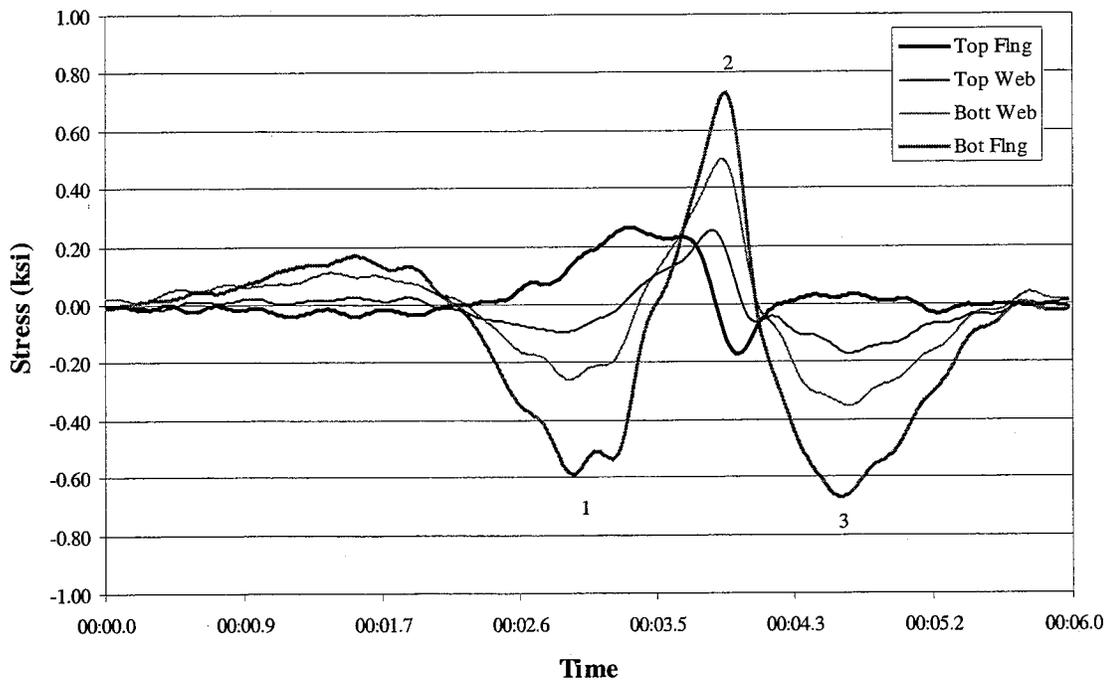
Figure 6.16: West 7<sup>th</sup> Street Bridge Northbound Stress History After Retrofit

The stress history for a typical sand truck for the West 7<sup>th</sup> Street bridge with the truck traveling in the northbound direction after the retrofit can be seen in Fig. 6.16. Stresses depicted in this figure are from the bottom flange gage, both web gages and the top flange gage. Stress ranges experienced in the section were less than those before the retrofit had been applied. The average stress range for all sand truck passes at the bottom of the top flange was 0.43 ksi with a standard deviation of 0.013 ksi. The bottom flange average stress range for all sand trucks was 1.44 ksi with a standard deviation of 0.05 ksi. Stresses were reduced by an average of 43% in the top flange by the addition of the retrofit and bottom flange stresses were reduced by 10%. A listing of before and after retrofit stress ranges and percent reductions is shown in Table 6.5.

A cross-sectional view of the stresses through the cracked section for the stress history depicted in Fig. 6.16, is shown in Fig. 6.18. Just as before the retrofit, the three cases depicted are the minimum and maximum stresses achieved at the bottom flange strain gage denoted by a 1, 2, and 3 in Fig. 6.16. For the northbound direction, the first minimum is achieved when the sand truck was on the cracked span moving toward the crack, producing negative moment. The maximum stress occurs when the truck was over the cracked section inducing positive moment at the section. The third and final case was when the truck had passed over the pier and again created negative moment at the section.

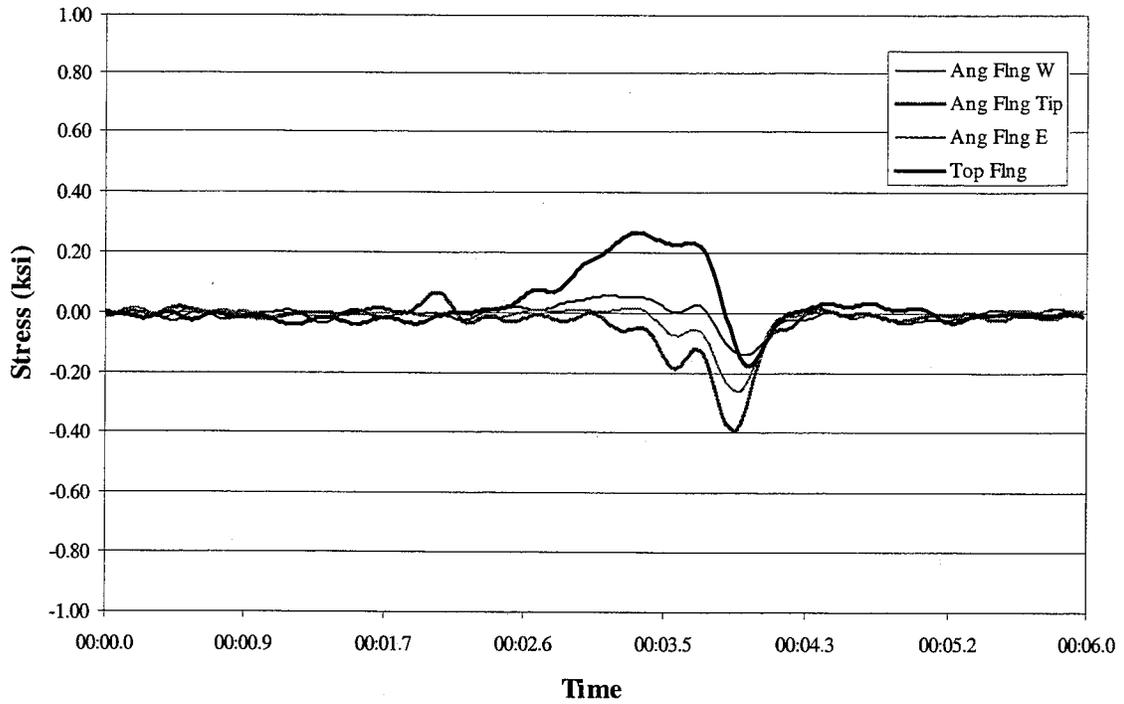
Figure 6.17: West 7<sup>th</sup> Street Bridge Northbound Stress History Angle Gage After Retrofit

Figure 6.17 shows stress results for some of the gages located on the retrofit angle plotted along with the gage on the top flange of the girder for reference. Gages on the flange of the retrofit angles stay in live load compression the entire time although the gage located on the flange of the girder starts out in live load tension before it goes into live load compression.

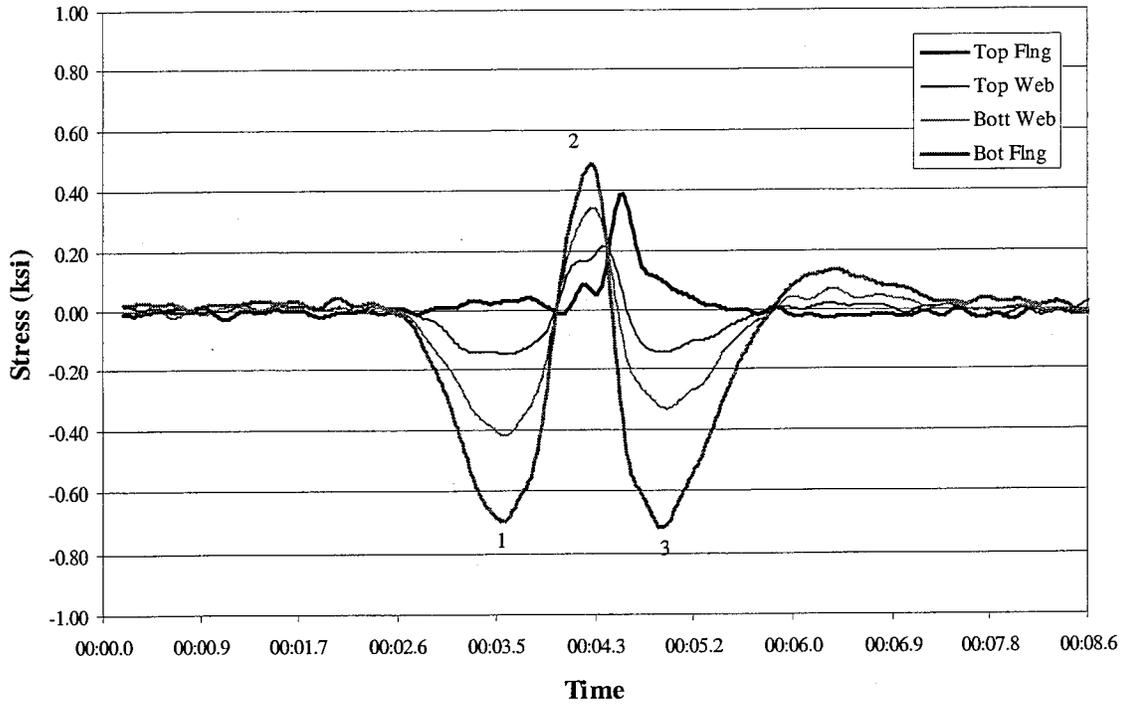
Figure 6.19: West 7<sup>th</sup> Street Bridge Southbound Stress History After Retrofit

A southbound sand truck on West 7<sup>th</sup> Street created different stresses in the section than did a northbound truck. Figure 6.19 shows a stress history for a typical southbound sand truck. Stresses plotted are for the bottom flange gage, both girder web gages and the girder top flange gage. The stress ranges were reduced from those seen previously without the retrofit for this truck direction also. The average top flange stress range for all sand trucks was 0.39 ksi with a standard deviation of 0.015 ksi. The bottom flange of the section had an average stress range of

The cross-sectional stress representation for the stress history depicted in Fig. 6.19, are shown in Fig. 6.21. Again, the loading conditions for the southbound truck occurred in the opposite order than those for a northbound truck. The truck approached from the span on the other side of the pier away from the crack, denoted by a 1 in Fig. 6.19. Once it passed over the pier it was directly over the cracked section, denoted by a 2 in Fig. 6.19. The truck then proceeded away from the crack toward the center of the cracked span inducing negative moment at the cracked section, denoted by a 3 in Fig. 6.19.

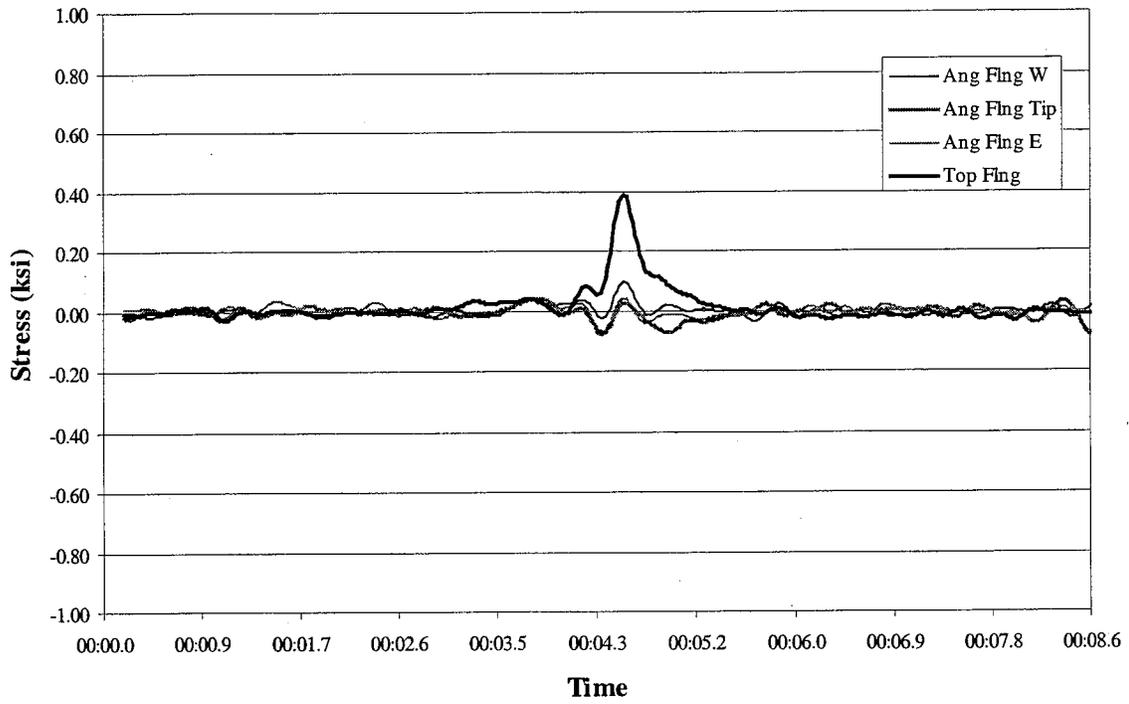
Figure 6.20: West 7<sup>th</sup> Street Bridge Southbound Stress History Angle Gage After Retrofit

For the southbound truck direction, stresses in the angles themselves were smaller and varied slightly between live load compression and live load tension throughout the history. Shown in Fig. 6.20 are the stresses seen in the retrofit for the same truck that was depicted in Fig. 6.19. The angle flange tip stresses were very close in value to those seen in the angle flange gage closer to the web. This would indicate that little shear lag was present.

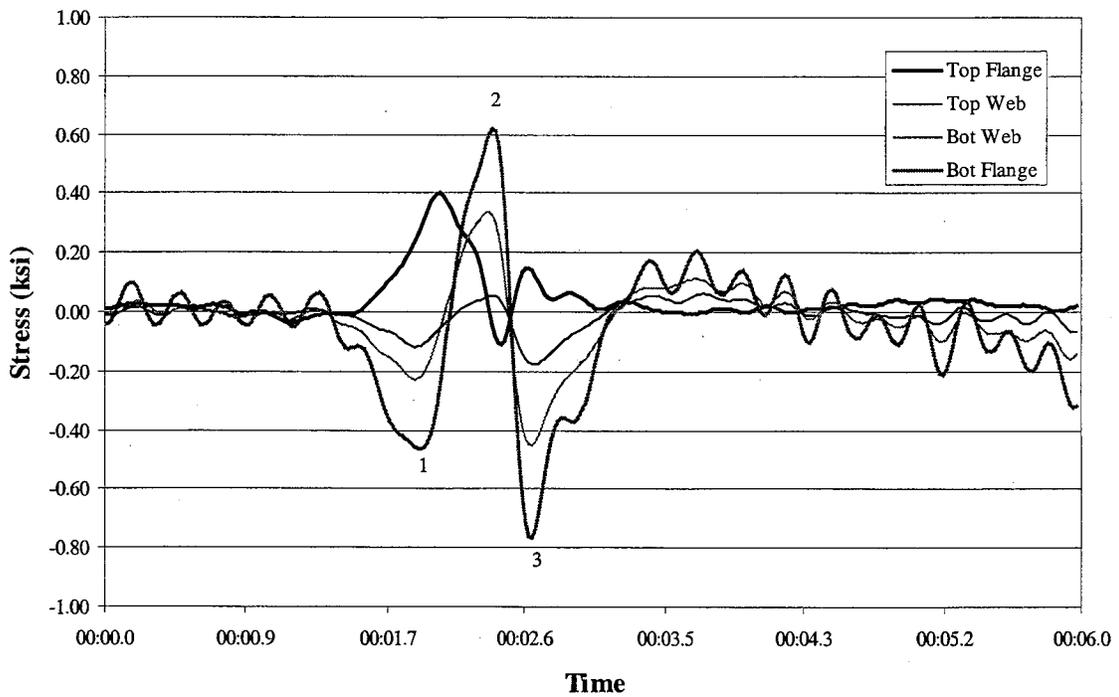
Figure 6.22: I-94 Bridge Stress History After Retrofit

The other bridge load tested after retrofit was the I-94 Bridge. A stress history for a sand truck after the retrofit application is shown in Fig. 6.22. Stresses were reduced somewhat with the addition of the retrofit. The average stress range for all sand truck passes at the top flange strain gage was 0.54 ksi with a standard deviation of 0.026 ksi. The average bottom flange stress range was 1.36 ksi and a standard deviation of 0.068 ksi. Reductions in stress due to the retrofit

A cross-sectional stress representation of the cracked section for the stress history depicted in Fig. 6.22, is shown in Fig. 6.23. The three loading cases shown correspond to the peaks achieved in the bottom flange stress and are denoted by a 1, 2, and 3 in Fig. 6.22. When the location of the neutral axis for these three cases after the retrofit was compared to those before the retrofit, no change was witnessed. This was expected after noticing that there really was not substantial reduction in stress ranges for the section, due to the addition of the retrofit. This finding also points to the theory that the retrofit was not taking stress away from the section to aid in stress reduction in the top flange.
