# TRUCK ROUTE ACCESS EVALUATION

Kenmor Stone and Ruth Brothers Quarry  
Olive Hill  
Site # 2620

Report No. KTC-98-27

September 1998

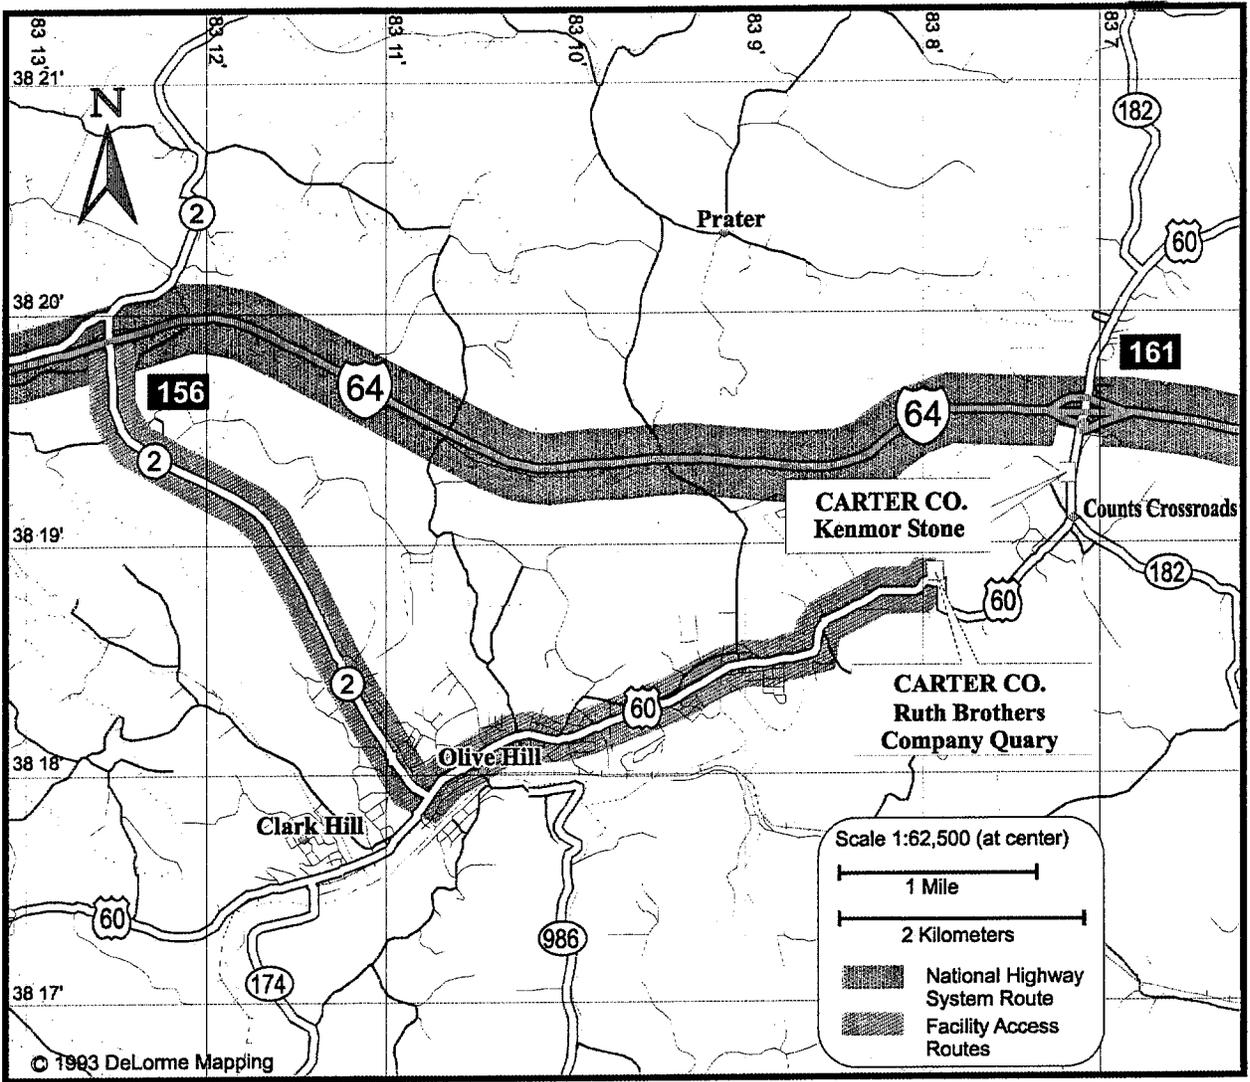
**Figure 1: Location of Truck Generating Sites**

As shown in Figure 1, there are two routes used by trucks to reach the National Highway System. The eastern route (shown in yellow) is used by the trucks from Kenmor Stone and by most of the trucks accessing Ruth Brothers Quarry. The route follows US 60 east to exit 161 of Interstate 64, a distance of approximately 1.9 miles. The western route (shown in green) is used by trucks from the Ruth Brothers facility that travel west to exit 156 of I-64. The route takes US 60 west to KY 2 then north to I-64, a distance of 5.5 miles. US 60 is a winding two lane road with minimal shoulders. There are traffic signals where US 60 passes through Olive Hill and at the intersection with KY 2. KY 2 is a two lane rural highway with a full shoulder. Both roads are state maintained.
