**COMPLIANCE CRASH TESTING OF THE TYPE 60K CONCRETE
BARRIER USED IN SEMI-PERMANENT INSTALLATIONS**
FINAL REPORT # FHWA/CA/TL-2001/08

August, 2001

CALTRANS STUDY # 680841

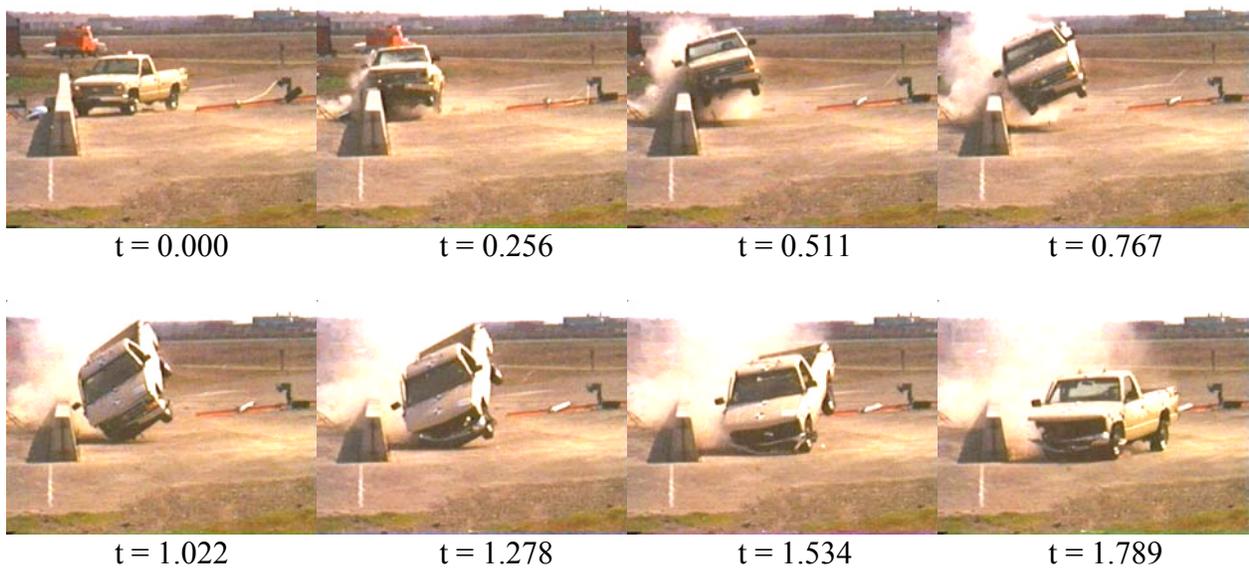
Figure 2-5 - Test 562 Data Summary Sheet

Barrier Damage: There was no damage to the concrete trough. Several of the segments spalled along the bottom edges.

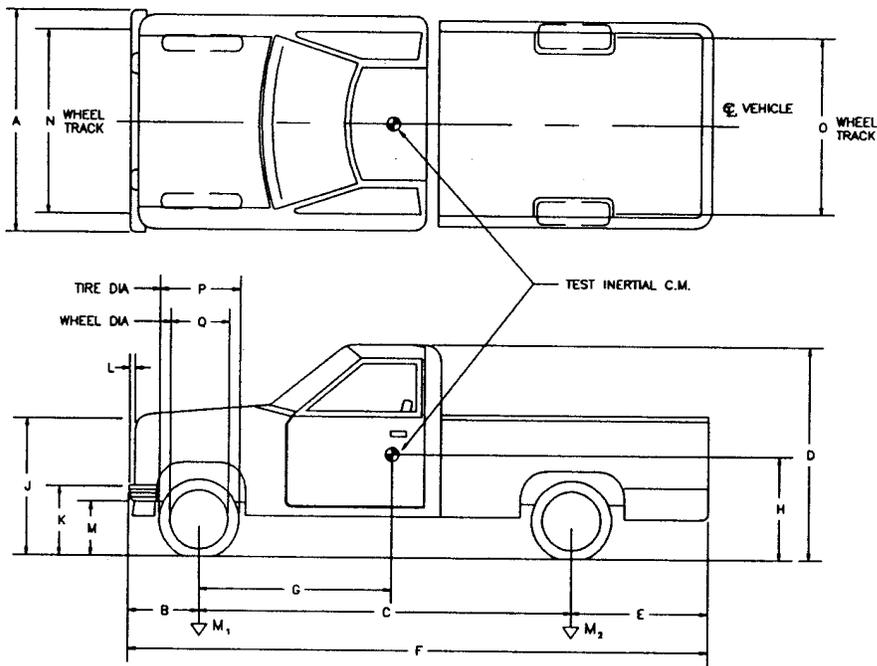
DESCRIBE ANY DAMAGE TO VEHICLE PRIOR TO TEST: Right door, lower rear corner has a shallow dent. The right side of the bed has a long shallow dent in front of the rear wheel.
