CONCEPT DEVELOPMENT OF A BULLNOSE GUARDRAIL SYSTEM FOR MEDIAN APPLICATIONS

MIDWEST ROADSIDE SAFETY FACILITY

MwRSF Research Report No. TRP-03-73-98

May 22, 1998

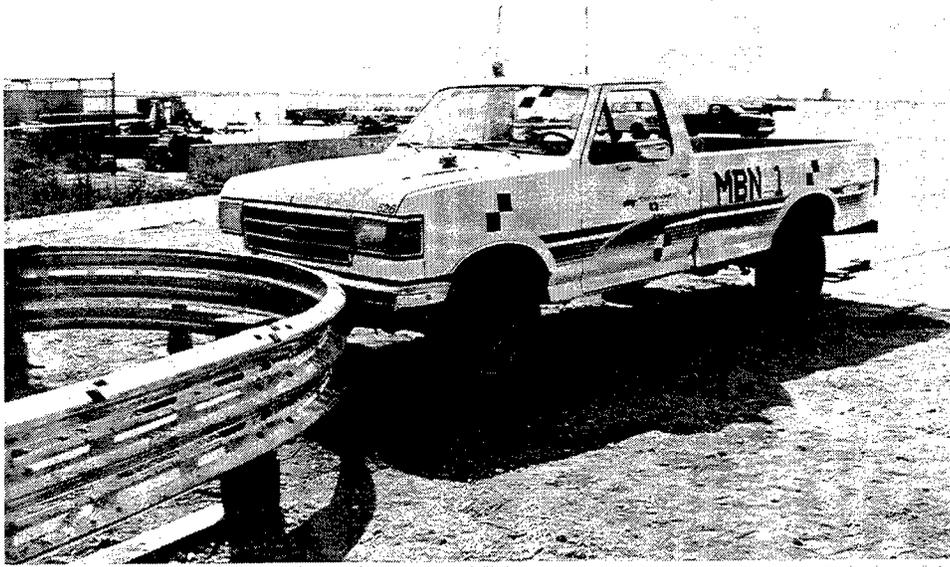
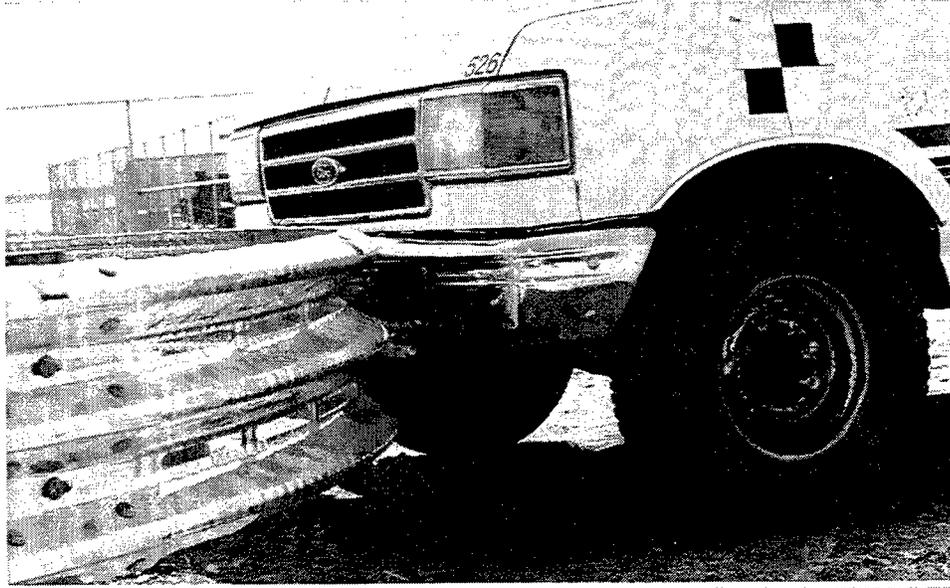
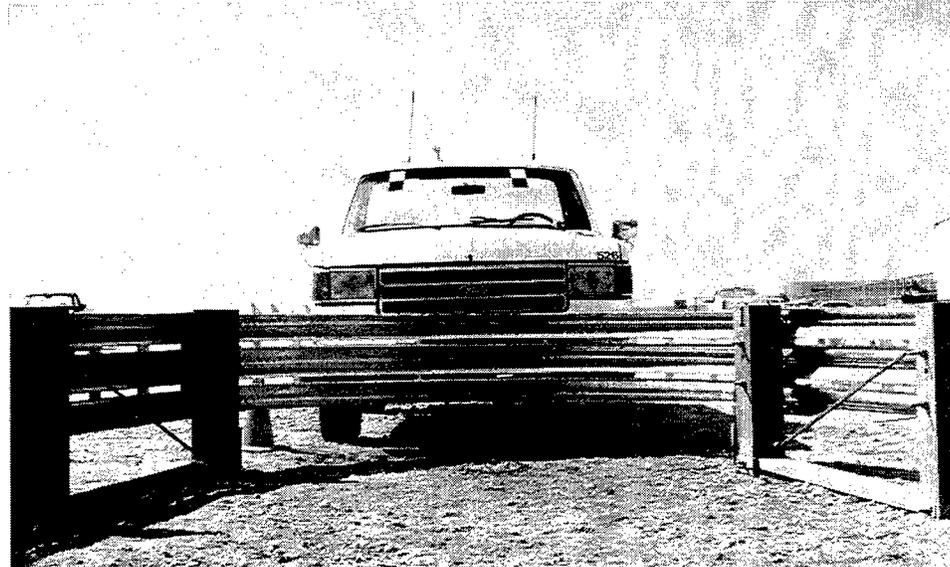
Figure 21. Impact Location MBN-1

The 1998-kg pickup truck impacted the bullnose barrier terminal at a speed of 101.4 km/h and an angle of 0.1 degrees, as shown in Figure 21. A summary of the test results and the sequential photographs are shown in Figure 22. Additional sequential photographs are shown in Figure 23.

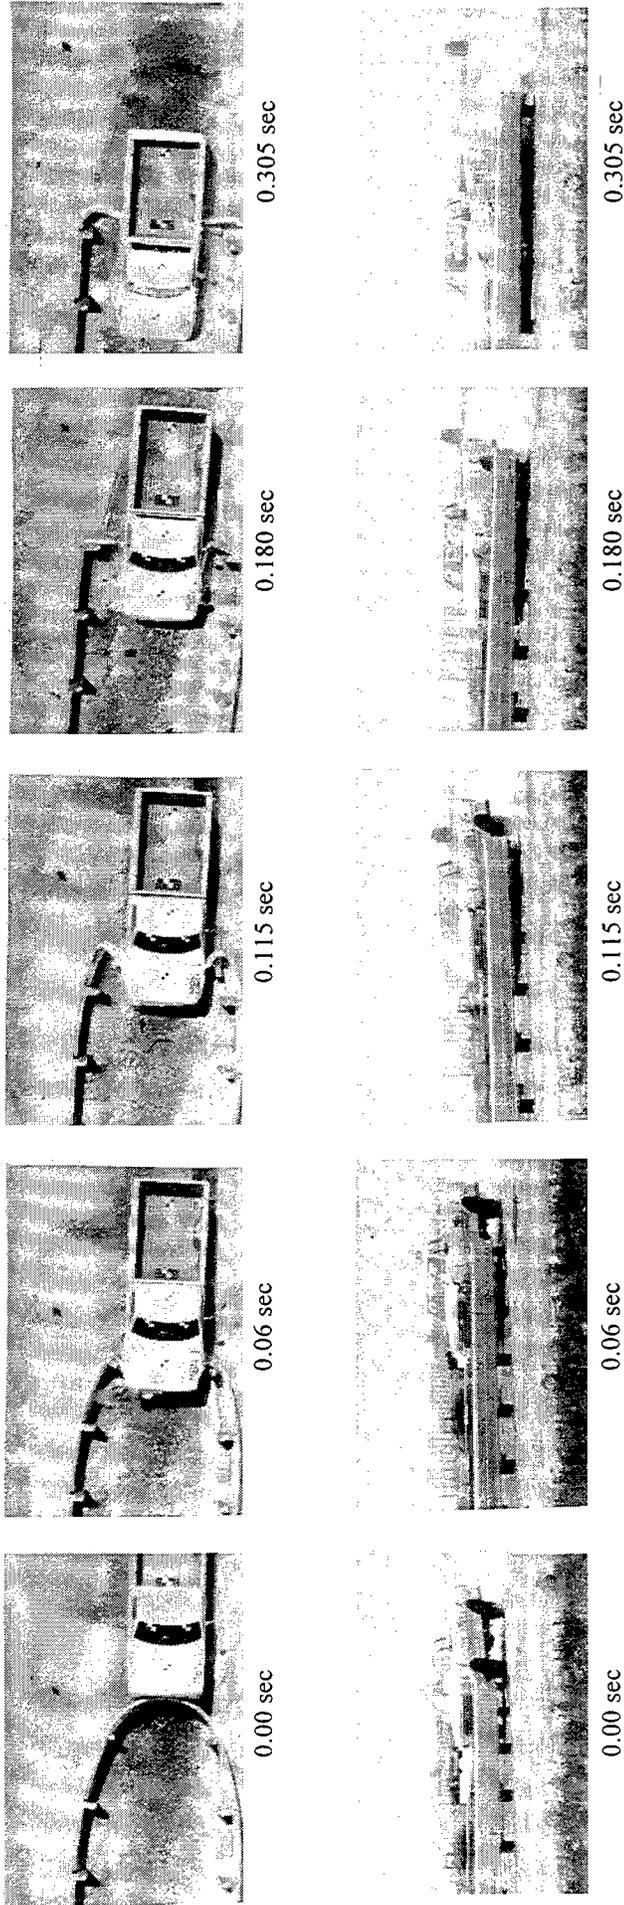
Following test MBN-1, a safety performance evaluation was conducted, and the bullnose barrier design was determined to be unacceptable according to NCHRP Report No. 350 criteria. The bullnose barrier did not contain or stop the test vehicle in a controlled manner due to the fracture of the thrie beam during the impact. However, it should be noted that the pickup truck did not override the thrie beam during the impact prior to the thrie beam fracture. Detached elements and debris from the test article did not penetrate or show potential for penetrating the occupant compartment. There was no deformation of, or intrusion into, the occupant compartment that could have caused serious injury. The vehicle remained upright during and after collision and the vehicle's trajectory did not intrude into adjacent traffic lanes. Vehicle trajectory behind the test article was unacceptable as the test vehicle penetrated through the barrier and into the median area behind the bullnose. The occupant impact velocities and ridedown accelerations were within the suggested limits imposed by NCHRP Report No. 350.

- Vehicle Angle
 - Impact 0.1 deg
 - Exit NA deg
- Vehicle Snagging None
- Vehicle Stability Satisfactory
- Occupant Ridedown Deceleration (10 msec avg.)
 - Longitudinal 9.95 g's
 - Lateral (not required) NA
- Occupant Impact Velocity (Normalized)
 - Longitudinal 4.83 m/s
 - Lateral (not required) NA
- Vehicle Damage Moderate
 - TAD 12-FD-4
 - SAE 12FDEW5
- Vehicle Stopping Distance 24.69 m downstream
 - 8.38 m left of centerline
 - Extensive rail damage and five fractured posts
- Barrier Damage
- Maximum Deflections
 - Permanent Set NA
 - Dynamic NA

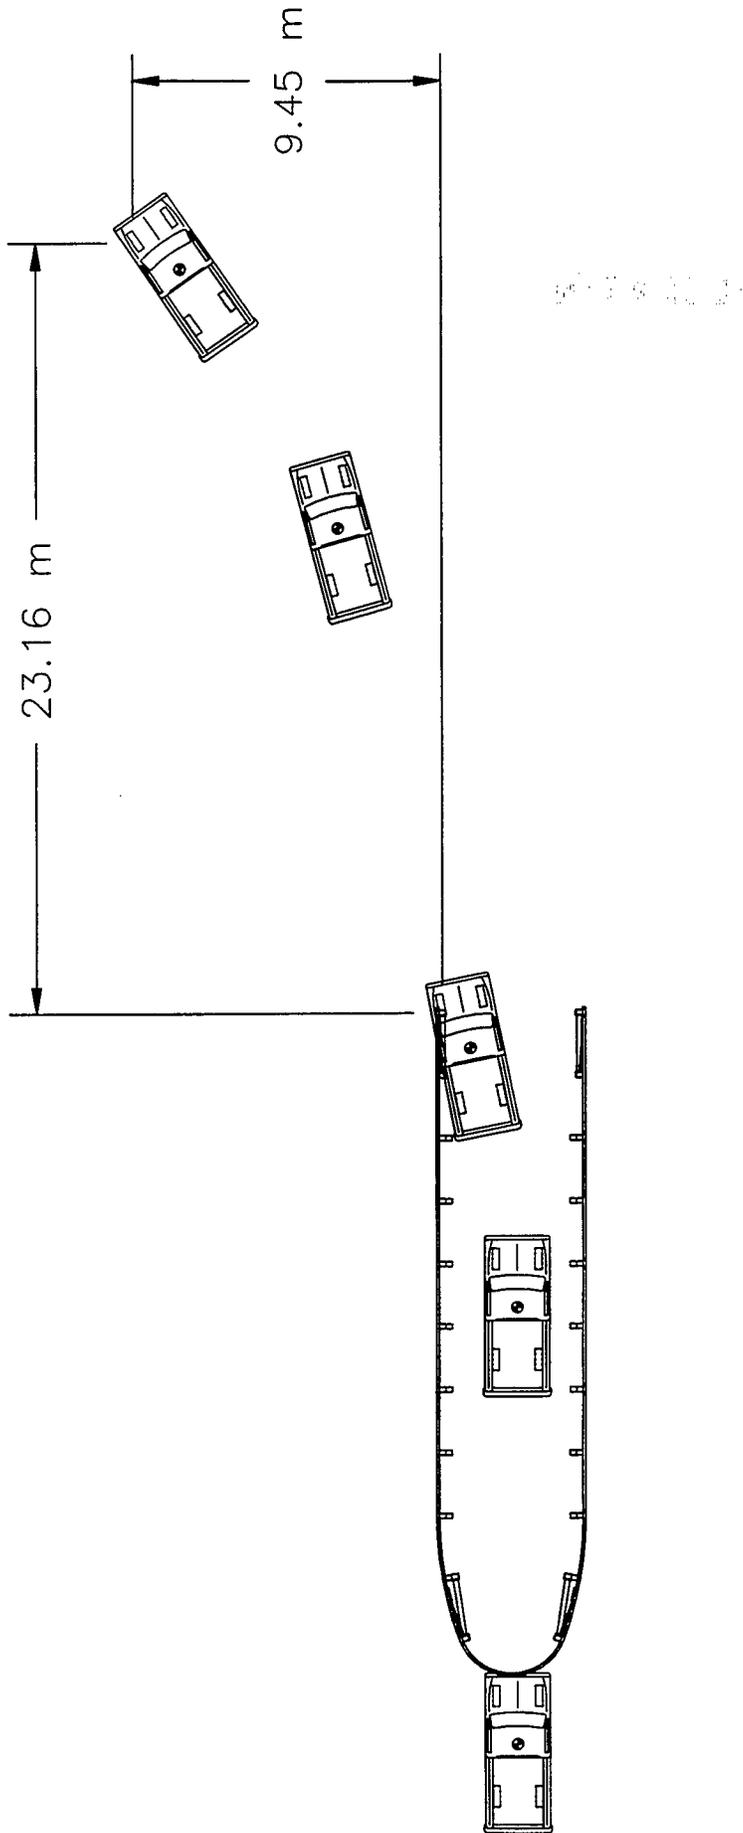
Figure 24. Vehicle Trajectory, MBN-1

Following the initial impact with the pickup truck, the thrie beam rail immediately began to deform inward. At 0.064 sec after impact, post no. 1 on both sides of the barrier fractured and the front quarter of the truck penetrated into the bullnose. The slotted thrie beam flattened across the front of the truck capturing the bumper and grill of the truck. A large “knee” or kink formed in the rail on the left side of the barrier between post nos. 1 and 2 at 0.11 sec after impact. As the truck continued to penetrate the barrier, post no. 2 on both sides of the barrier failed at 0.18 sec after impact. At this point, the front of the truck was even with post no. 3. The thrie beam snagged at post no. 3 on the right side of the barrier at a time of 0.31 sec after impact causing the thrie beam to rupture. At this time, the velocity of the pickup truck was 75.7 km/hr. This allowed the truck to continue traveling forward in the middle region of the barrier. At time 1.20 sec after impact, the truck impacted and fractured post no. 7 on the left side of the barrier as it exited the system. Figure 24 shows the trajectory of the pickup during the crash test.

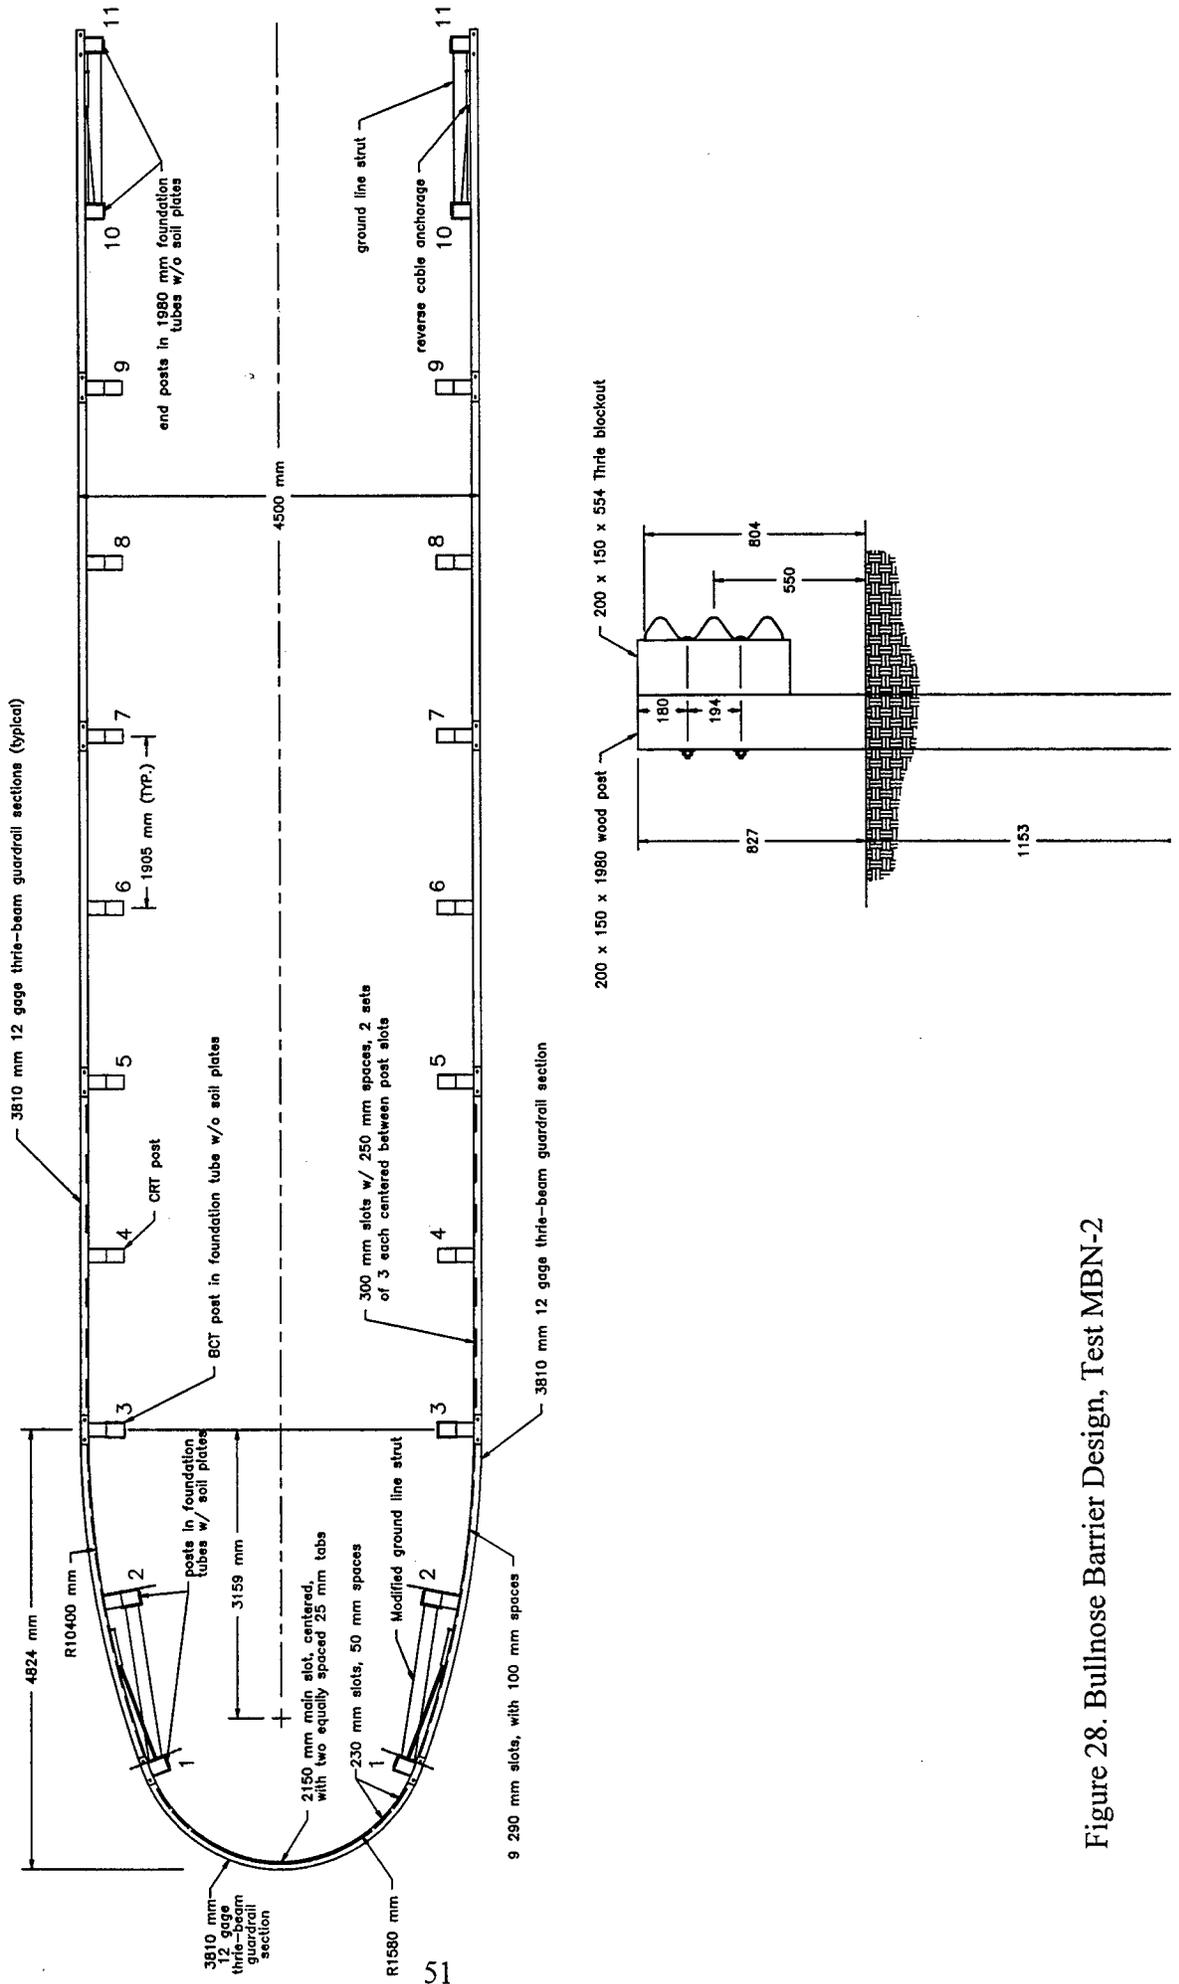
Figure 28. Bullnose Barrier Design, Test MBN-2

the slotted thrie beam rail prevented the pickup truck from overriding the nose section of the system. Therefore, the researchers believed that the system could be significantly improved by weakening the buckling and bending strength of the thrie beam rail after post no. 3 as well as replacing post nos. 3 and 4 with posts that would fracture more easily. Following the failure of test MBN-1, modifications were made to the guardrail system. These modifications to the bullnose guardrail system consisted of changing of post nos. 3 and 4 to breakaway posts and incorporating slots in another section of the thrie beam rail. A schematic of the modified design is shown in Figure 28, and photographs are provided in Figures 29 through 30.

For the first modification, post no. 3 on each side of the system was replaced by a 140-mm by 190.5-mm BCT post set in a foundation tube without a bearing plate, while post no. 4 on each side was replaced by a CRT post. These post changes were made to accelerate the fracture of the posts in those areas, prevent high loads being imparted into the thrie beam rail, and reduce the high rail stresses from occurring at concentrated locations. These changes would also allow for a more gradual dissipation of the vehicle's kinetic energy.

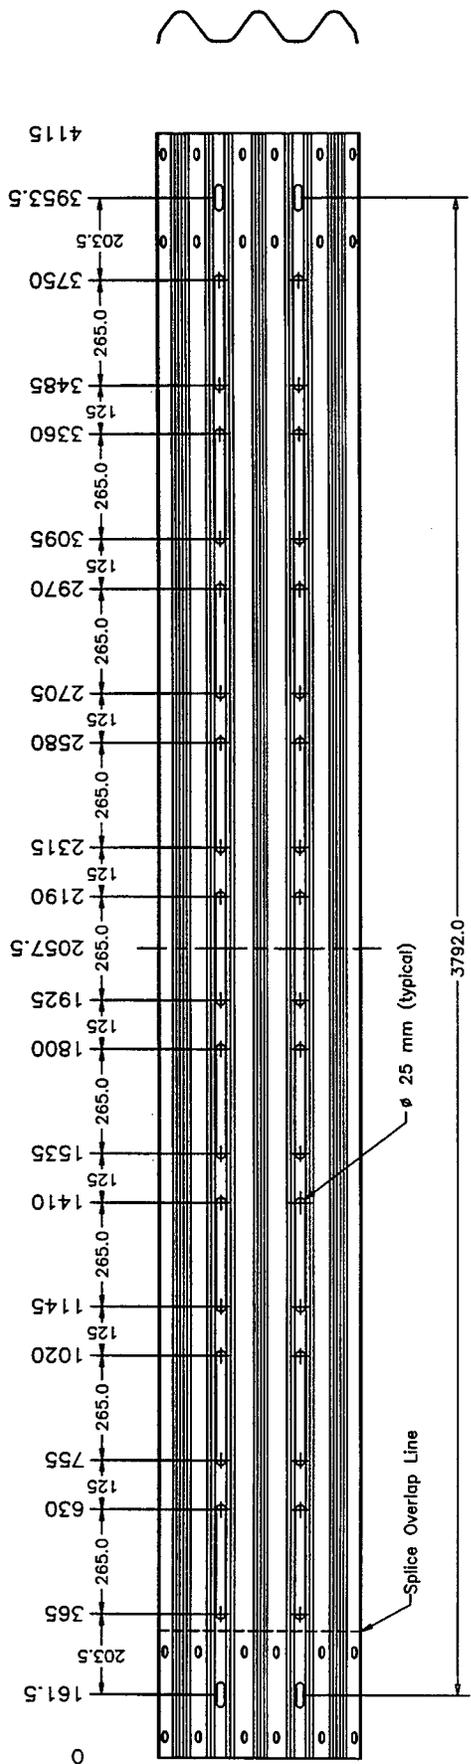
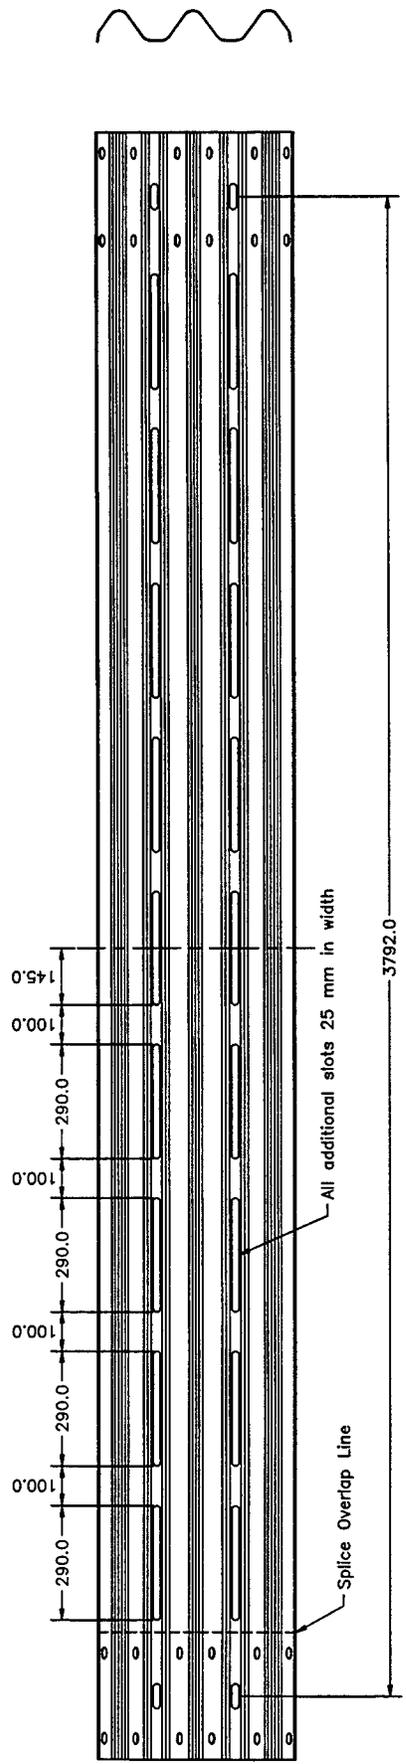
Figure 32. Rail No. 2 Detail Test, MBN-2

The slot pattern for rail section no. 2 on both sides of the bullnose barrier terminal was also modified slightly from the original design. The new slot pattern for rail no. 2 is shown in Figure 32. The slot pattern was changed to form eighteen 290-mm long slots, 9 in each valley. Each of the slots is separated by a 100-mm gap. The slot width remained 25 mm. The final major modification to the bullnose system was the addition of slots to rail section no. 3 on both sides of the system. The slot pattern of rail section no. 3 is shown in Figure 33. Twelve 300-mm slots were cut out of the valleys, six in each valley, with 250-mm spaces between them. The modification of the slots in section no. 2 and the addition of slots to section no. 3 serve to reduce the strength of the beam. Reducing the

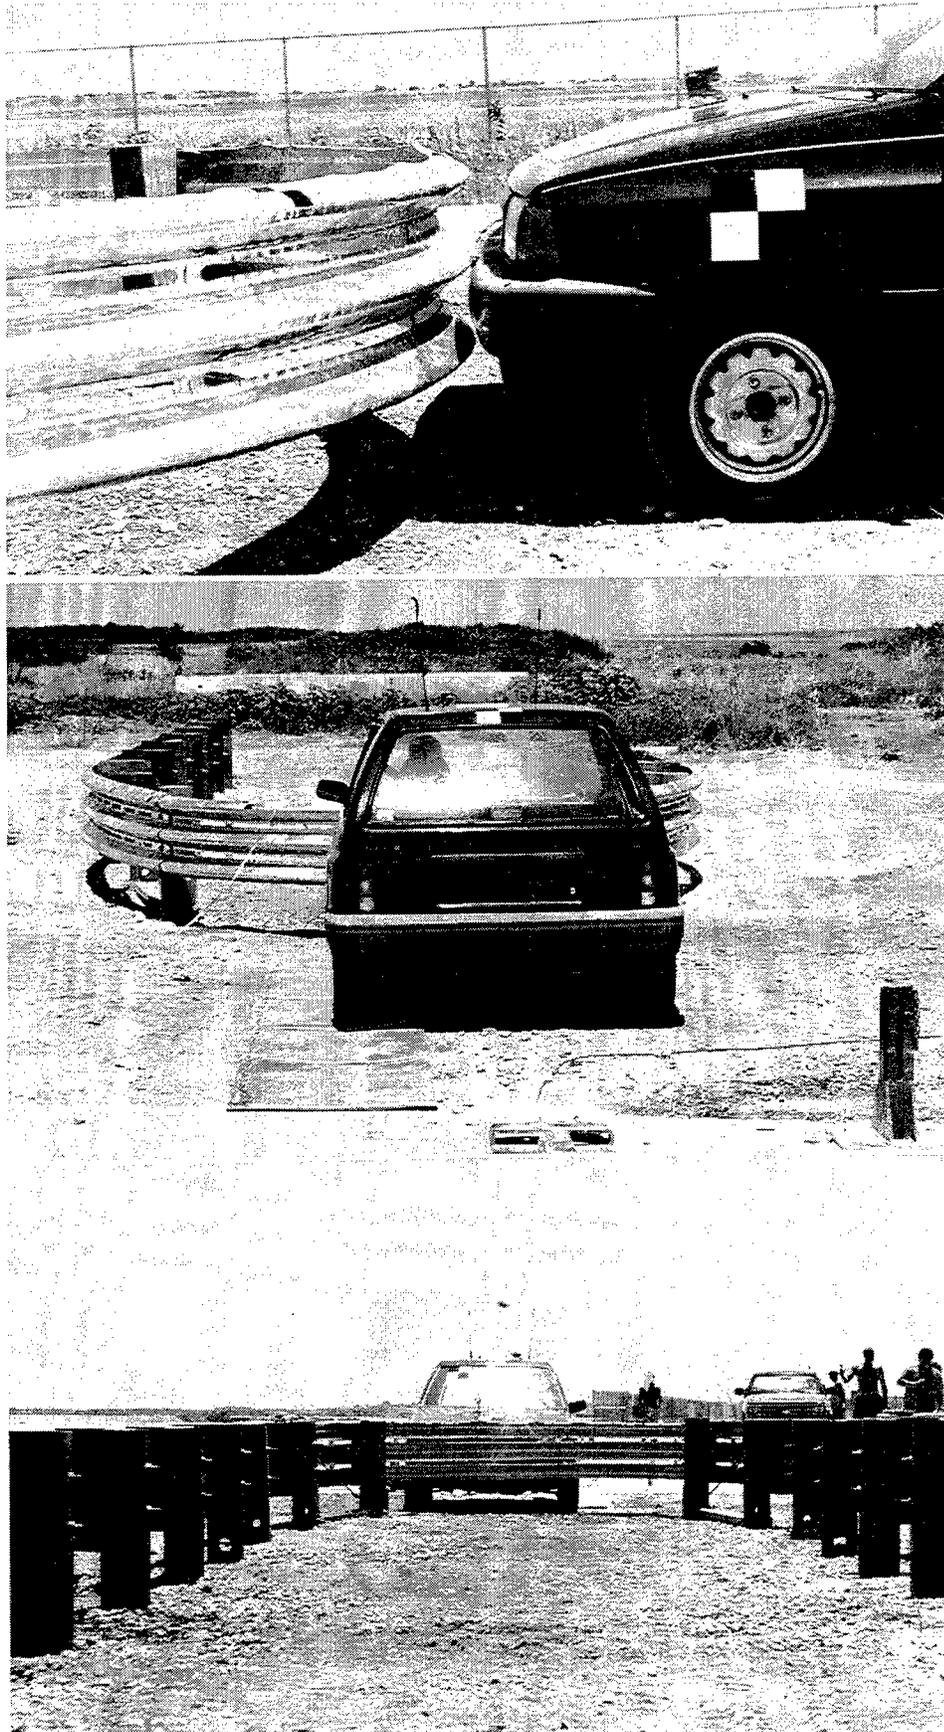
Figure 34. Impact Location Test MBN-2

The 886-kg small car impacted the bullnose barrier terminal at a speed of 103.3 km/h and an angle of -3.4 degrees with a 1/4-point offset. A summary of the test results and the sequential photographs are shown in Figure 35. Additional sequential photographs are shown in Figure 36. Full-scale crash documentary photographs are shown in Figure 37 through Figure 38.

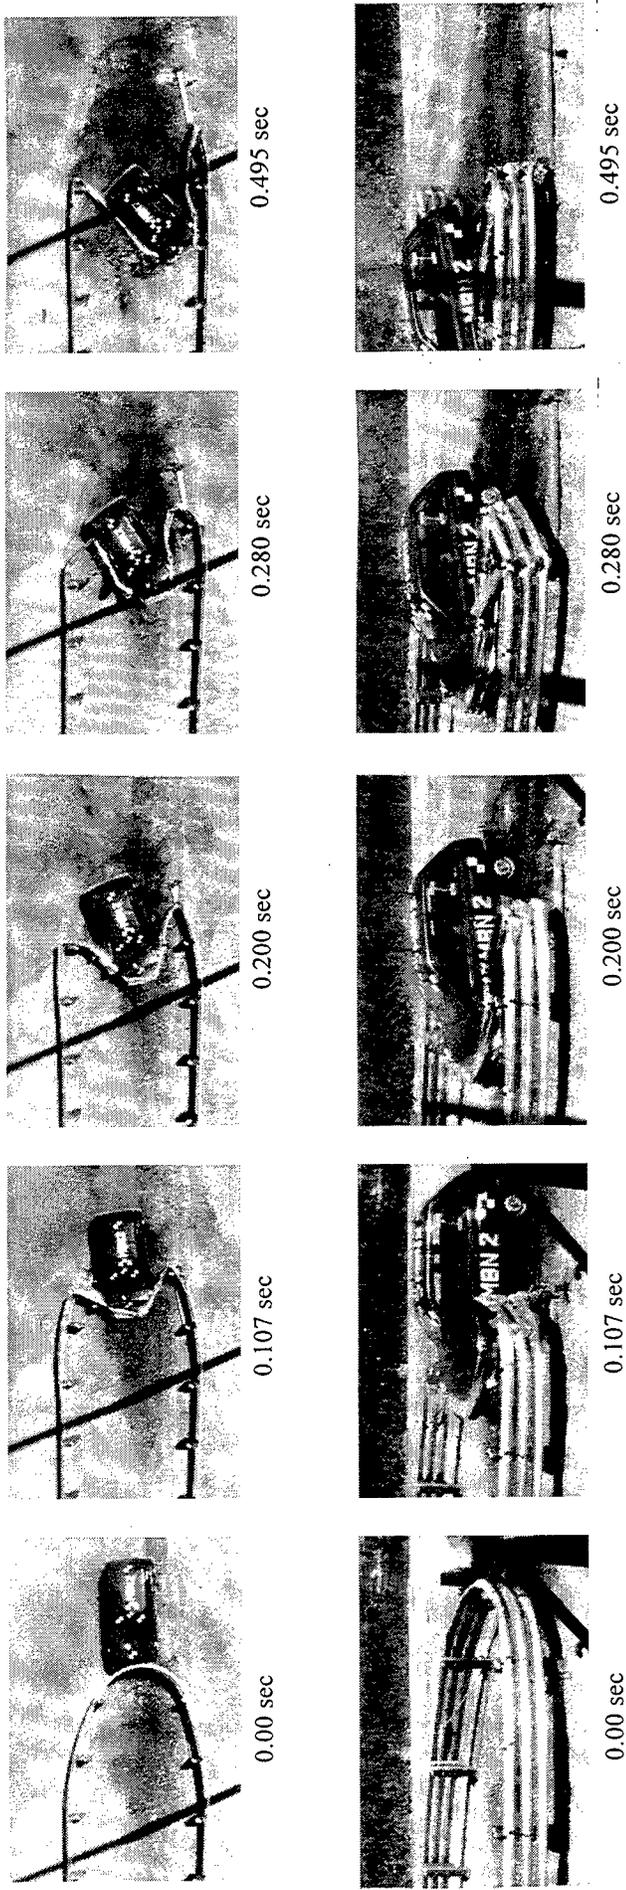
The normalized longitudinal and lateral occupant impact velocities (OIV) were determined to be 9.60 m/s and 3.27 m/s respectively. The maximum 0.010-sec average occupant ridedown decelerations (ORD) in the longitudinal and lateral directions were 11.37 g's and -9.98 g's respectively. It is noted that the occupant impact velocities and occupant ridedown decelerations were within the suggested limits provided in NCHRP Report No. 350. The results of the occupant risk, determined from the accelerometer, are summarized in Figure 35. Results are shown graphically in Appendix A.

<ul style="list-style-type: none"> ● Test Number MBN-2 ● Date 7/25/97 ● Appearance Bullnose Median Barrier ● Total Length 20,144 m ● Steel Thrie Beam (Nested) Thickness 12 gauge (2.66 mm) Top Mounting Height 804 mm ● Wood Posts Post Nos. 1 - 3, 10 - 11 (BCT) 140 mm x 190.5 mm x 1,080-mm long Post No. 4 (CRT) 150 mm x 200 mm x 1,980-mm long Post Nos. 3 - 9 150 mm x 200 mm x 1,980-mm long ● Wood Spacer Blocks Post Nos. 1 - 8 150 mm x 200 mm x 554-mm long ● Soil Type Grading B - AASHTO M 147-65 (1990) ● Vehicle Model 1988 Ford Festiva Curb 753 kg Test Inertial 811 kg Gross Static 886 kg ● Vehicle Speed Impact 103.3 km/hr Exit 0.0 km/hr 	<ul style="list-style-type: none"> ● Vehicle Angle Impact -3.4 deg Exit NA ● Vehicle Snagging None ● Vehicle Stability Satisfactory ● Occupant Ridedown Deceleration (10 msec avg.) Longitudinal 11.37 g's Lateral (not required) 9.09/-9.98 g's ● Occupant Impact Velocity (Normalized) Longitudinal 9.60 m/s Lateral (not required) 3.27 m/s ● Vehicle Damage Moderate TAD 12-FD-5 // 3-RBQ-4 SAE 12FDEW5 // 03RBEK9 ● Vehicle Stopping Distance 6.55 m downstream 1.58 m west of centerline ● Barrier Damage Extensive rail damage and four fractured posts ● Maximum Deflections Permanent Set 7.11 m downstream 0.97 m west of centerline Dynamic NA

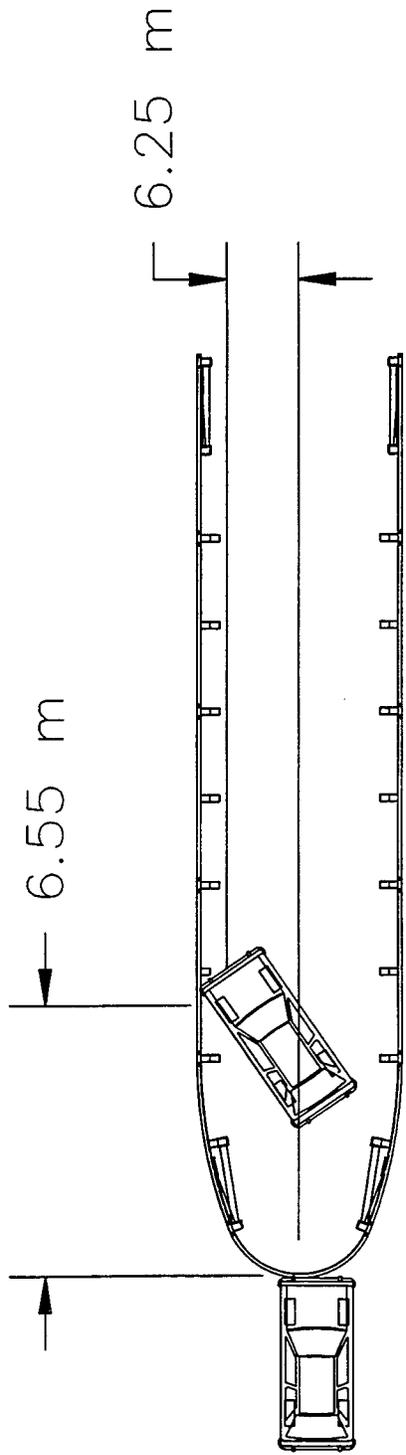
Figure 39. Vehicle Trajectory, Test MBN-2

The nose section of the bullnose barrier began to deform immediately after the initial impact of the 886-kg small car. At 0.107 sec after impact, post no. 1 on both sides of the barrier failed and approximately one half of the small car had penetrated the bullnose barrier. The slotted nose sections of the beam rail wrapped around the front of the vehicle capturing the vehicle's bumper and grill. After the failure of post no. 1, the back of the vehicle began to rotate counterclockwise towards the right side of the barrier. Post no. 2 on the right side of the barrier failed at 0.196 sec after impact. A rail "knee" or kink formed in the beam rail on the right side of the barrier as the vehicle continued to penetrate and deform the barrier. The knee impacted the right-rear quarter panel of the small car at 0.282 sec after initial impact, deforming the right-side of the vehicle and shattering the rear window. At 0.542 sec, the vehicle was brought to a complete stop. The vehicle trajectory is shown in Figure 39.
