# Relationship Between Timber Bridge Characteristics and Asphalt Pavement Wear Surface Performance

## **Summary Report**

Wood & Paper Science Department  
University of Minnesota

**June 1997**

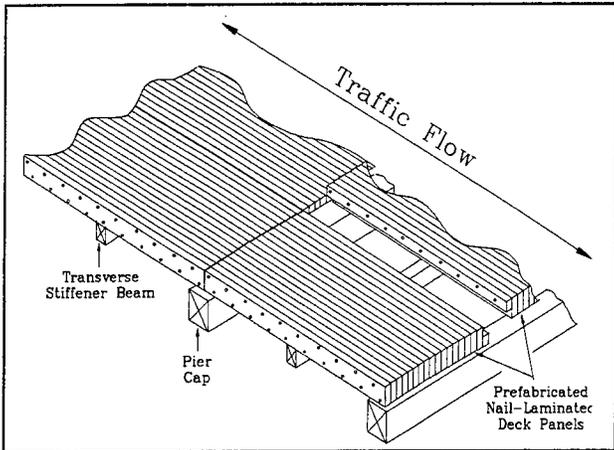
**Figure 1 - Panelized, Longitudinally Nail-Laminated Superstructure**

Since 1970, these bridge designs have incorporated prefabricated panelized deck systems. This systems utilizes factory laminated panels which are joined together by means of shiplap joints (Figure 1 & Figure 2). Nail-laminated bridge decks older than 1970 were laminated together entirely in the field. Field laminated LNL have every tenth lamination extending across the pier-cap support, and thus can be easily distinguished from panelized systems (Figure 3).

(TSB) as a lateral load-transferring device for the superstructure. The TSB is attached to the mid-span locations of the bridge (Figure 1 & Figure 3).

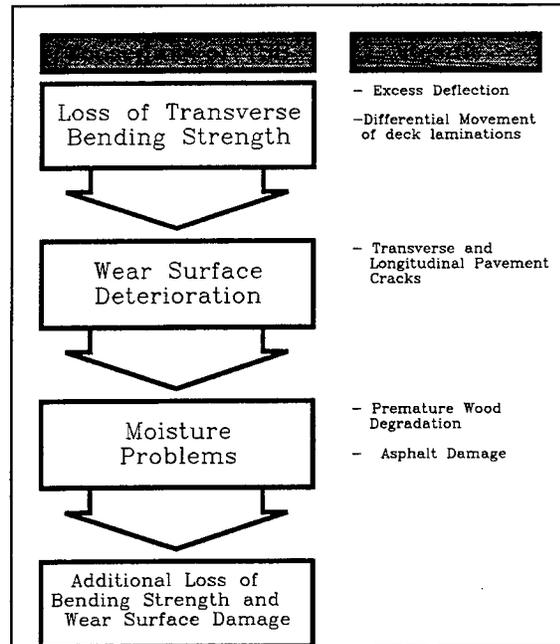
**Figure 5 - Proposed Steps Involved in Additive Wear Surface Deterioration**

As cracks project through the depth of an asphalt overlay, water and other material begin to infiltrate into and through the wear surface, and down to the timber members. Freeze-thaw cycles expand the wet material causing the pavement to buckle and further deteriorate. The timber members can also suffer from the moisture with a loss of strength, and increased susceptible to fungal attack if the optimal conditions prevail. This additive form of

deterioration is shown in a flow chart form (Figure 5).
